# Experimental Study of Various Techniques to Protect Ice-Rich Cut Slopes

August 2014

Alaska Department of Transportation  
Statewide Research Office  
3132 Channel Drive  
Juneau, AK 99801-7898

**Number:** 4000(113)B

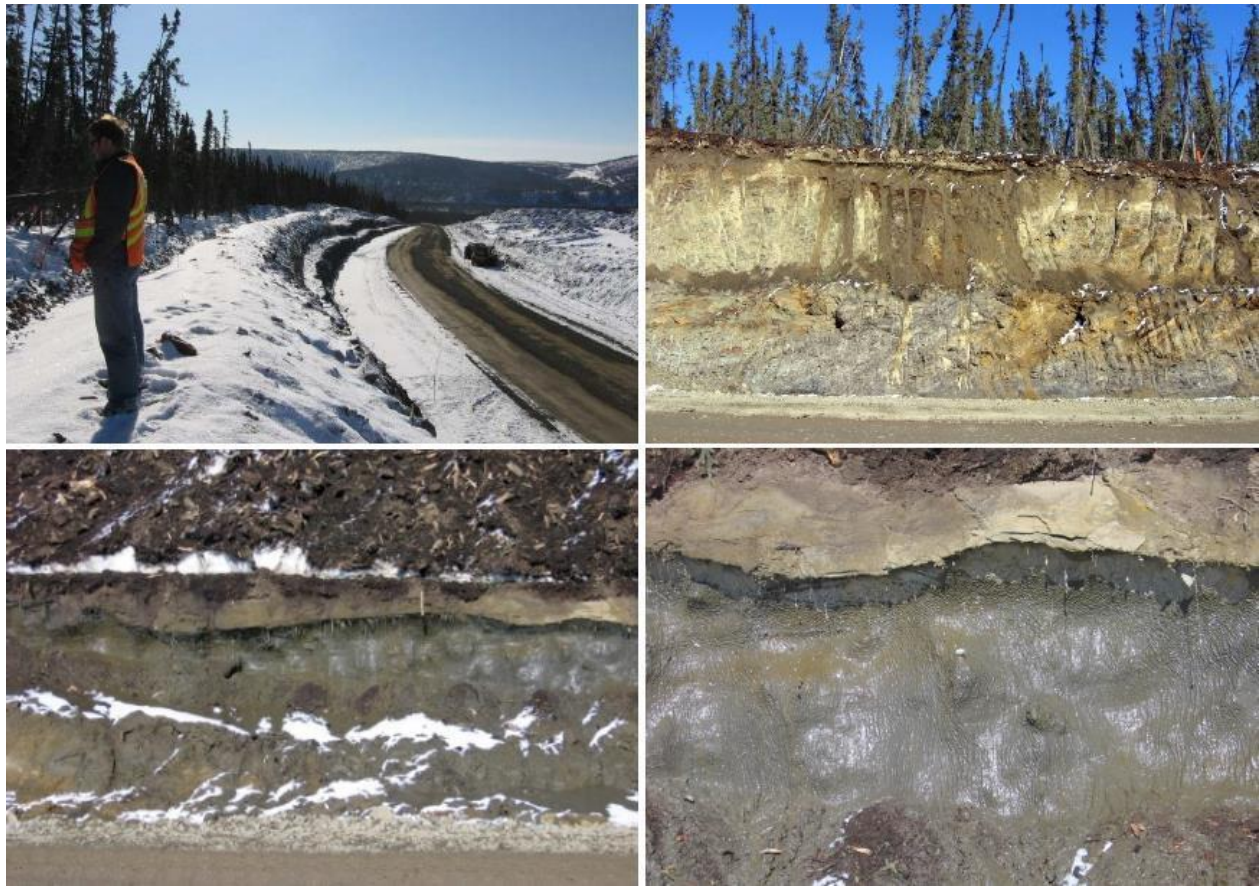
A recent example (Vinson and McHattie, 2009) related to thermal erosion of cut slopes in ice-rich permafrost is located along the Dalton Highway, Milepost 37 to 49 (see Figure 2.3). The cut volume, originally considered bedrock and weathered bedrock, was actually highly weathered ice-rich bedrock. The cut design, though appropriate for weathered bedrock, was inappropriate for the unexpected ice-rich mineral soils. Uncontrolled erosion, thawed slurry runoff, and slope failure resulted in significant environmental concern.

**Figure 2.3 Dalton Highway cut in ice-rich permafrost (Vinson and McHattie, 2009)**

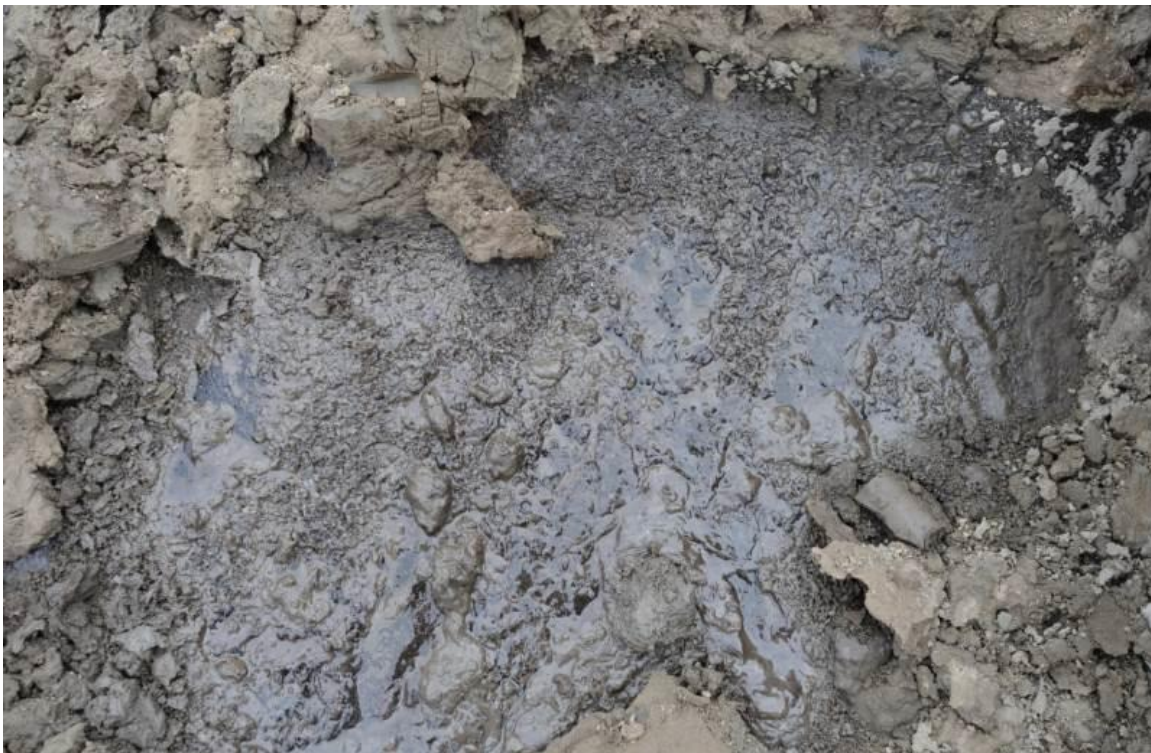
**Figure 4.9 Ice exposed in the cut slope**

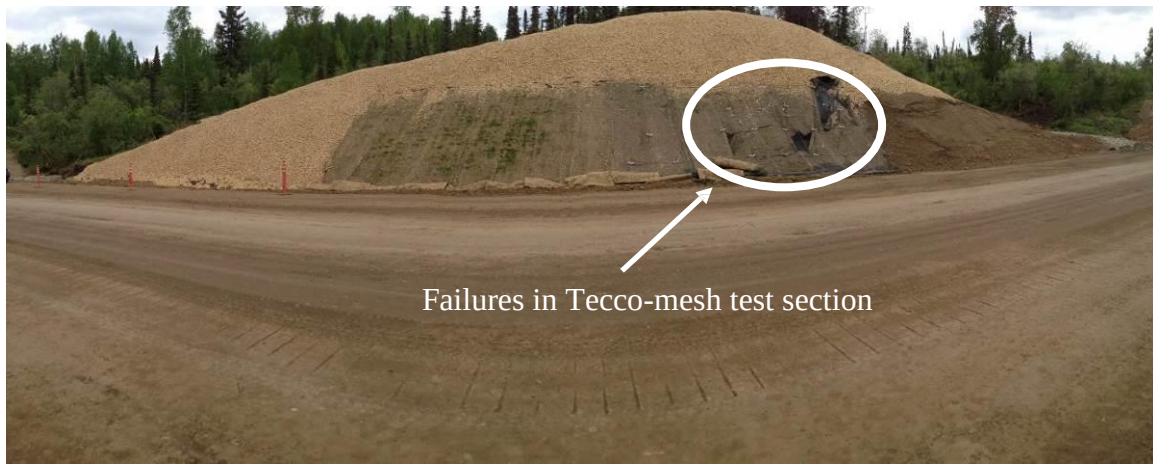
The panorama photo labeled Figure 6.1 shows the entire face of the Experimental Feature and the circled failure areas within the Tecco-mesh section. Observation at the site revealed an obvious loss in volume of original cut slope soil from the slope face. This loss of volume could be seen easily through the Tecco-mesh—an observation that was confirmed by probing and peering through the Tecco-mesh at many locations along the mesh surface.

**Figure 6.1 Panorama view of Experimental Feature showing failure in Tecco-mesh section**

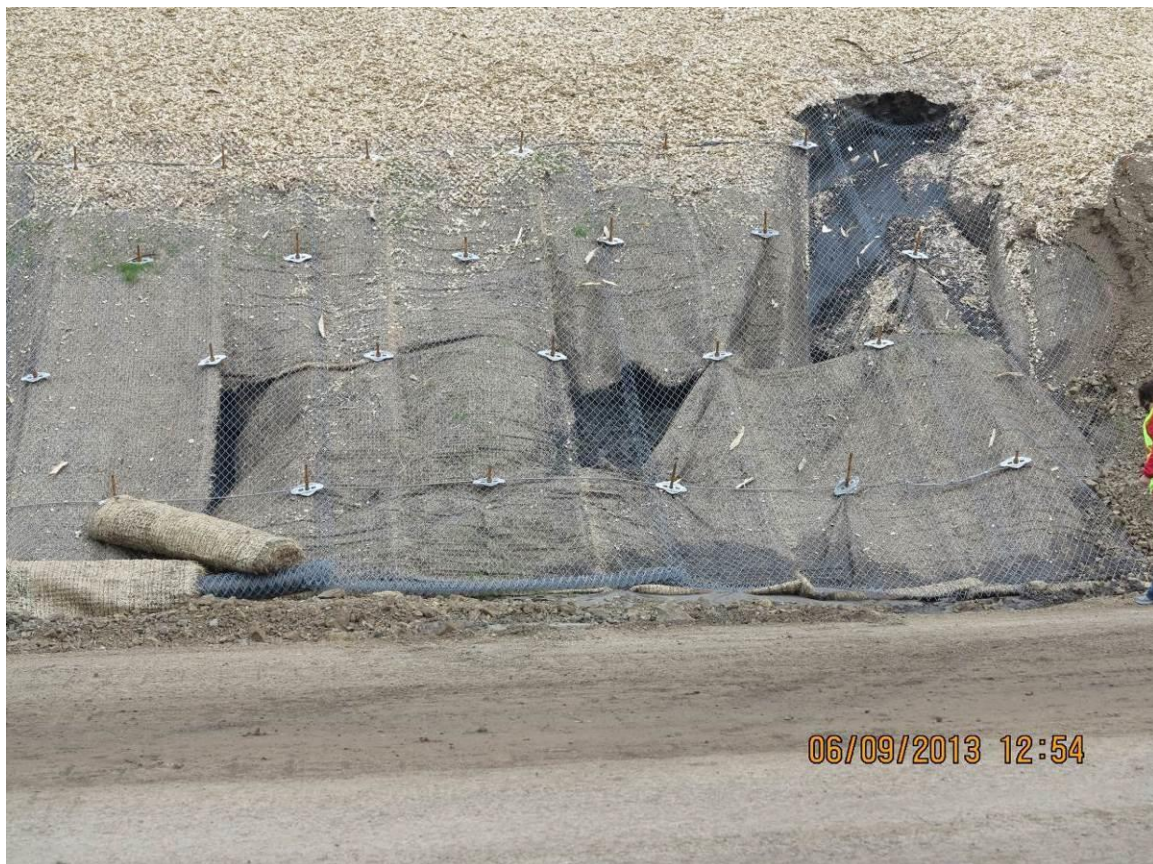
**Figure 6.2 Close view of failure within the Tecco-mesh section**

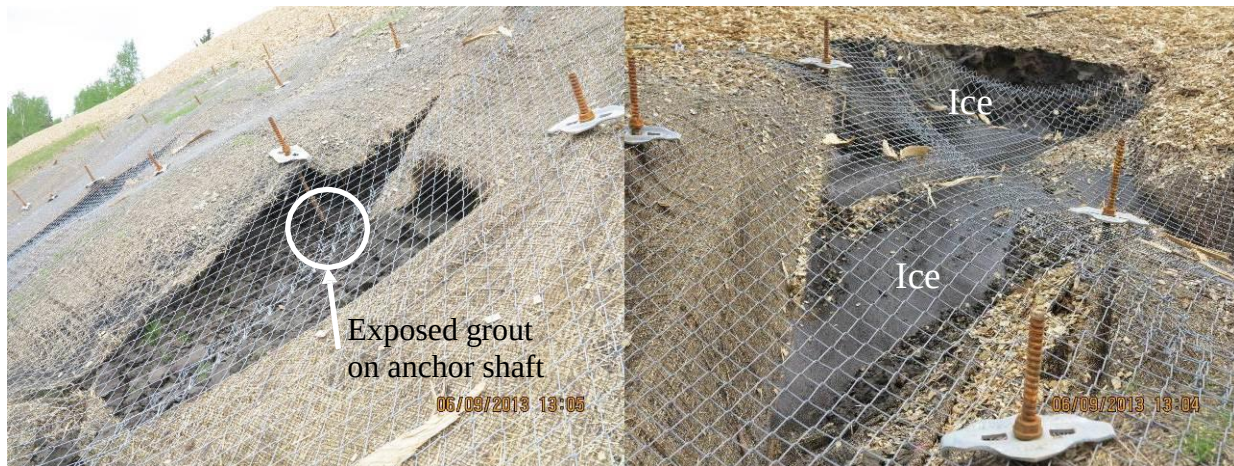
The significant loss of material from the original cut slope is evident in the left side of Figure 6.3, where the anchor grout is exposed. The depth from cut slope face to top-of-grout was 3 ft. The lighter gray material labeled in the right side of Figure 6.3 is some of the massive ground ice that caused serious problems with the Tecco-mesh experimental section.

**Figure 6.3 Close views showing exposure of soil anchor grout (left) and portion of massive ice feature under Tecco-mesh (right)**

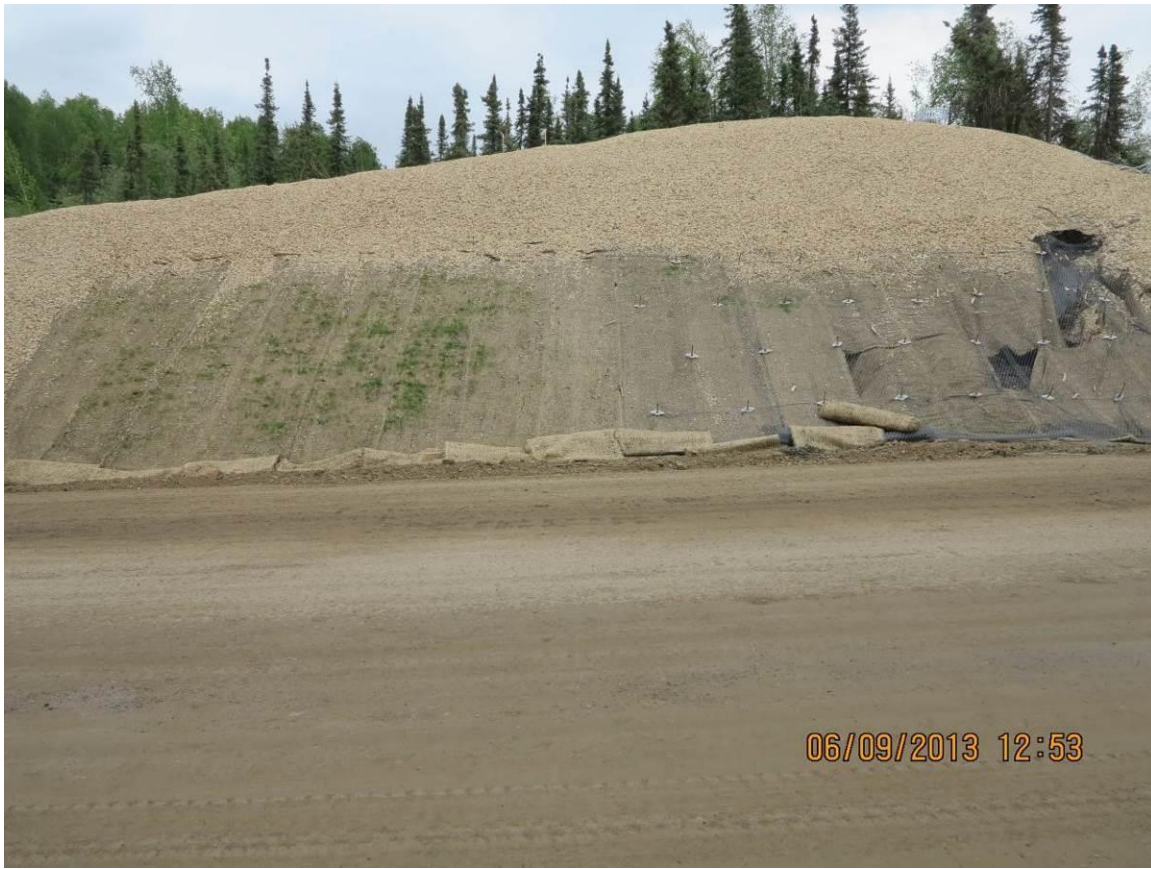
In Figure 6.4, the areas where the ground surface is *not* in contact with the Tecco-mesh or the adjoining coconut matting are those areas where no grass had yet appeared. As Figure 6.4 shows by the appearance of grass, only the very top portion of the Tecco-mesh section still has soil/Tecco-mesh contact.

**Figure 6.4 Surface protection matting in area showing no grass growth is not in direct contact with ground surface**

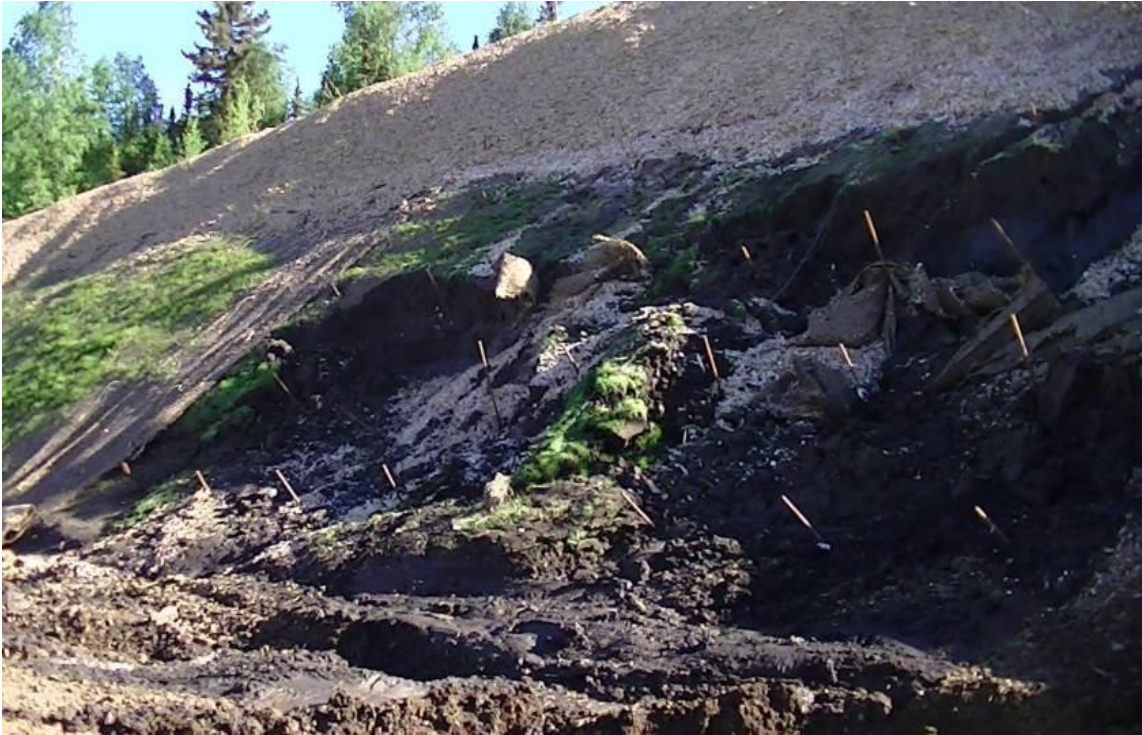
**Figure 6.5 Section C without Tecco-mesh and coconut blanket**

According to the recommendations listed above, on June 17, 2013, Tecco-mesh and the coconut erosion control blankets at Section C were removed (shown in Figure 6.5). The great loss of volume in cut slope soil at Section C can be seen in Figure 6.6, especially where massive ice is exposed. Crushed rock was hauled to the test site, and an excavator was used to cover Section C with crushed rock (see Figure 6.7). The hollow rebar anchors were left intact during these repairs to serve as survey and photogrammetric reference points. Figure 6.8 shows the cut slope after completion of repairs on June 17, 2013.

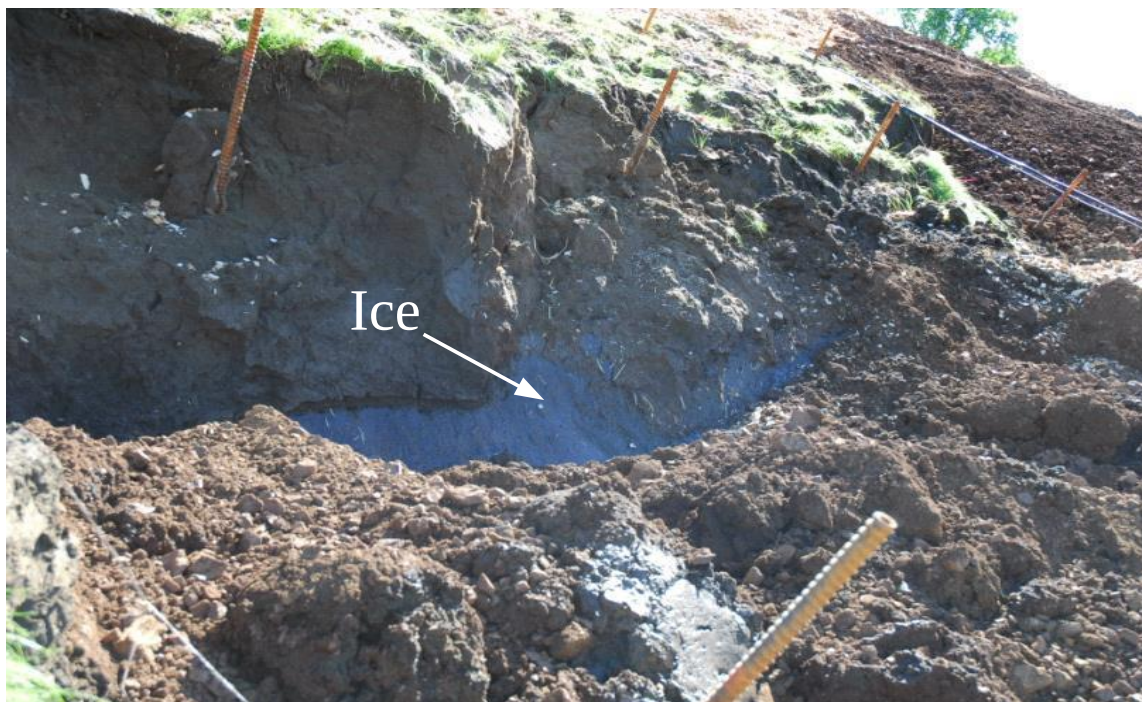
**Figure 6.6 Massive ice in Section C**
