Montana Department of Transportation
Research Programs
December 2018

SMART CUSHION INNOVATIONS (SCI) 100GM CRASH ATTENUATOR

Project Name: Taft-West

Project Number: IM-90-1(84)0

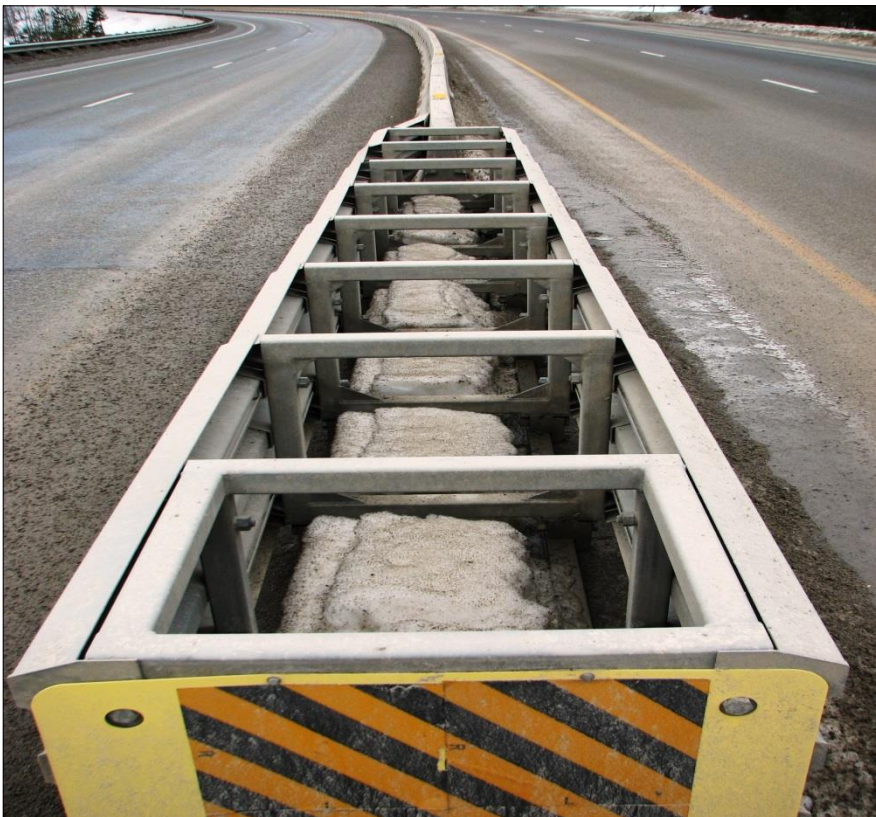
← SCI crossover installation at approximately mile point eight (8), view west.

Image shows minor accumulation of snow and ice in the interior of the SCI unit.

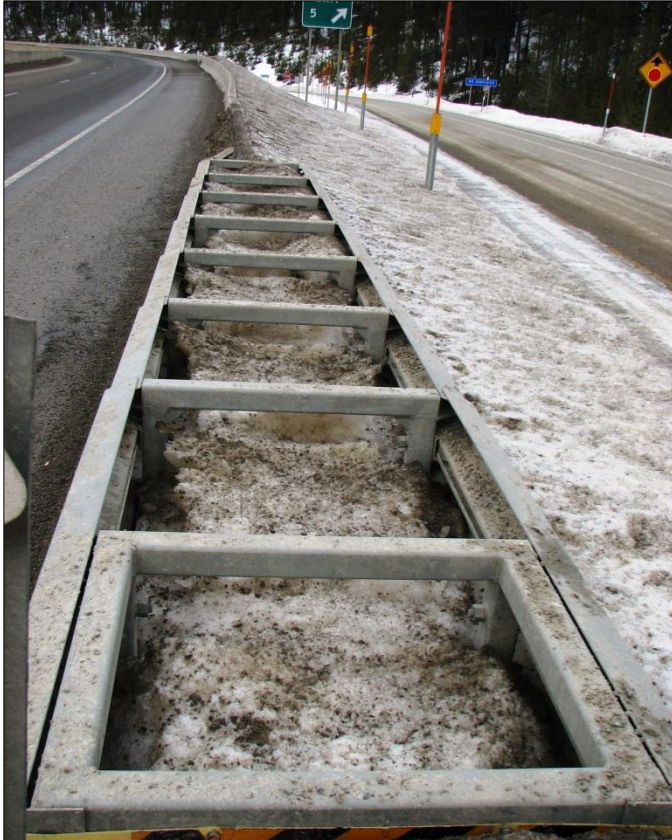
↙ Northbound I-90 at reference point 6. Exit 5 location of SCI unit.

Note the level of snow and ice inside and in front of the attenuator.

As stated earlier it is uncertain how this condition would affect the performance of the cushion if struck by a vehicle.

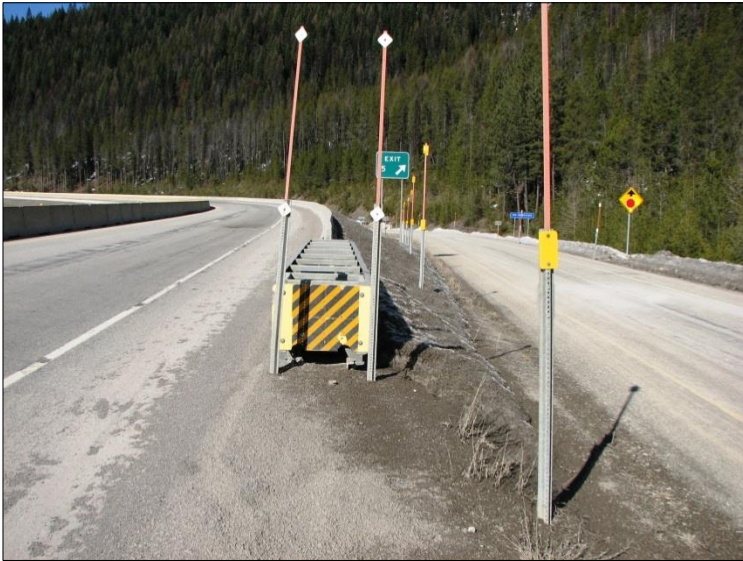
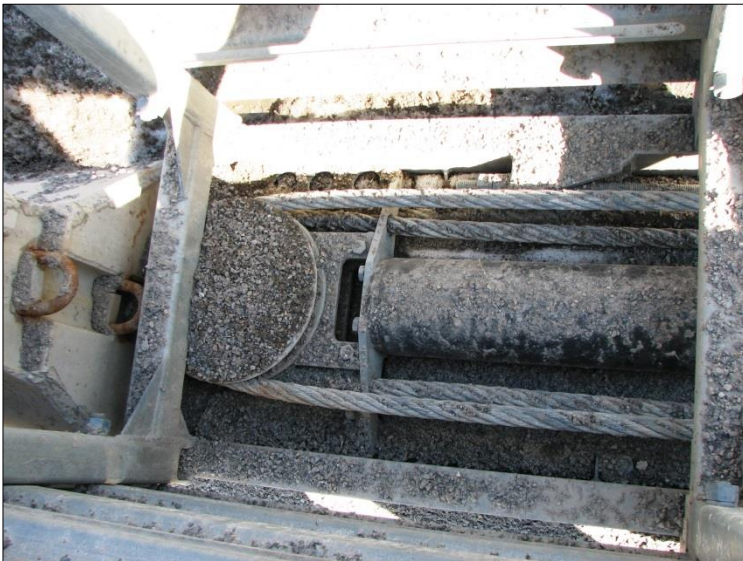
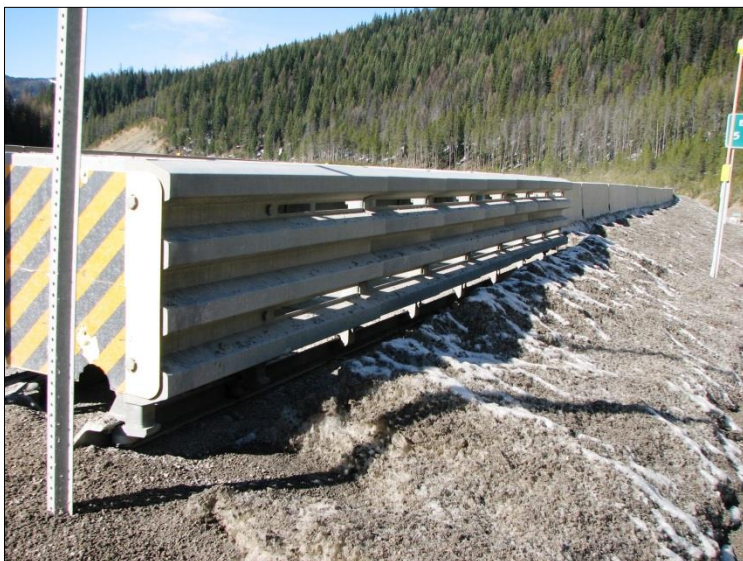
↙ Westbound I-90 at
approximate reference point
6. Exit 5 location of SCI unit.

These images represent the
general condition of all of the
SCI units on the project.

As documented in earlier
inspections sand and grit
accumulates in and around
the cable, guides and
cylinders systems.

If this effects the hydraulic
porting during impact is
unknown at this time.

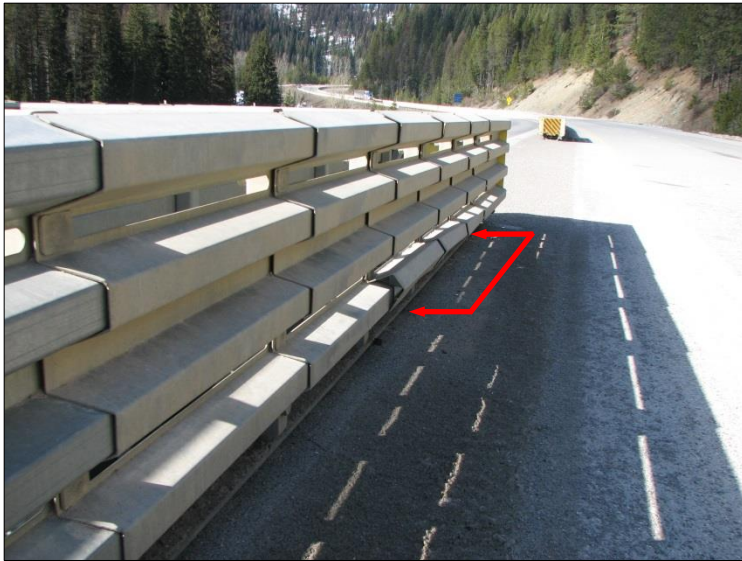
←↓ Westbound lane I-90 at approximate reference point 7: East end unit, north side.

Damaged side panels were noticed on the east end crossover unit near reference point 7 located on the north side of the SCI. The side panels affected was the lower tier and involved two panels. What hit the panels or how this will affect the efficacy of the cable hydraulic porting unit is unknown.

Noticeable damage to a section of the bottom side panels (delineated by the red arrows).

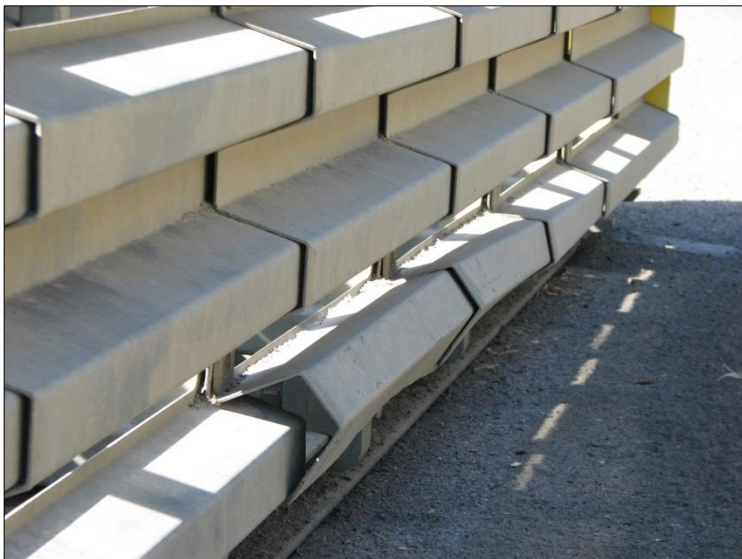
← Close-up of panel damage.

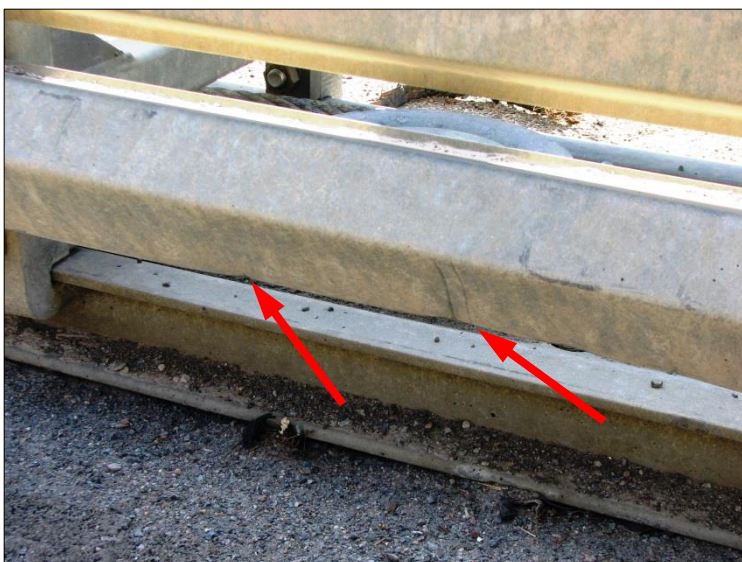
← Arrows show strike dents on the lower panel. It is difficult to determine if this type of damage will affect the performance of the unit.

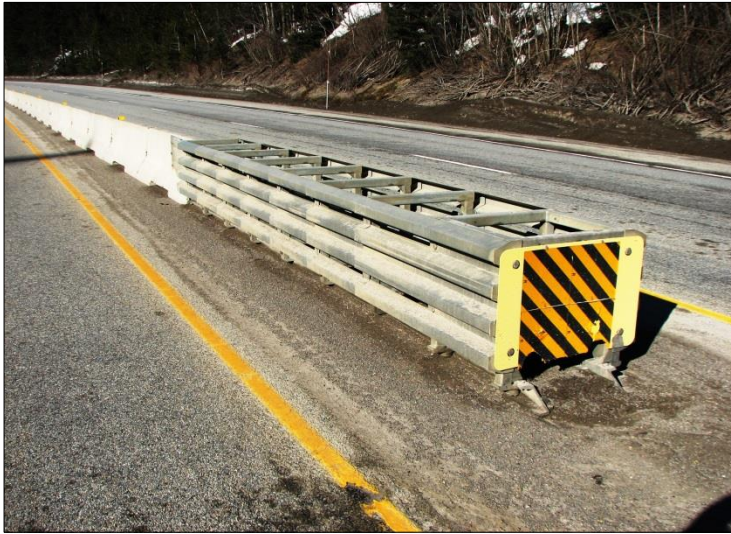
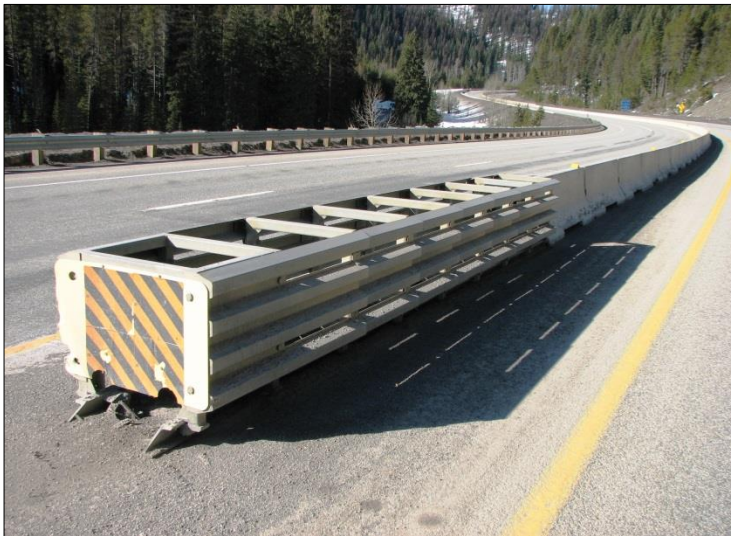
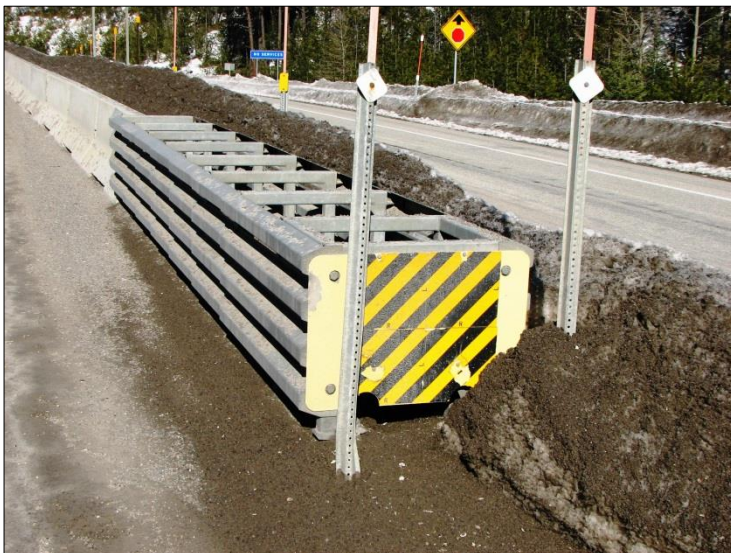
←↓ Representative images of the SCI units at the three locations between references post 6-7.

As noted in previous inspections sanding grit accumulates in and around the hydraulic porting mechanism.

No information to date suggests the accumulated material will affect the unit's ridedown function.

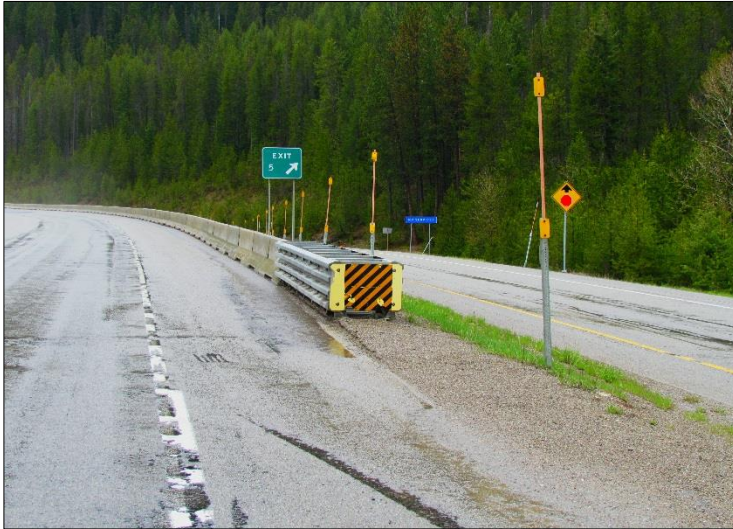
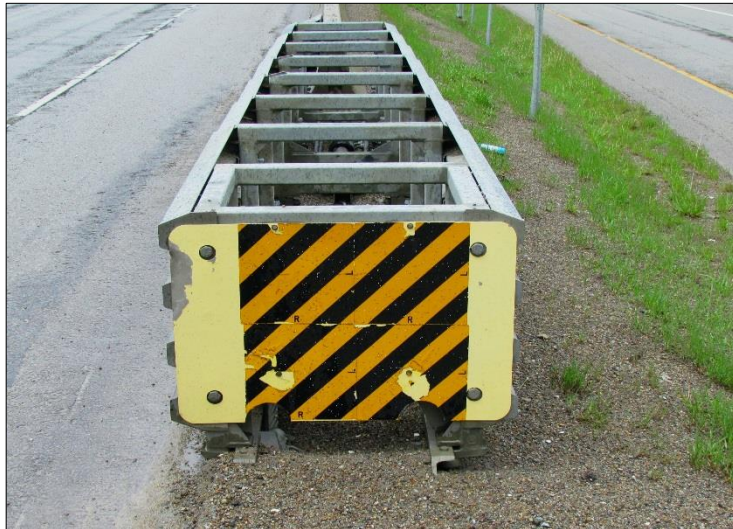
↙ ↓ Representative images of the SCI unit located at Exit 5.

As noted in previous inspections sanding grit accumulates in and around the hydraulic porting mechanism.

No information to date suggests the accumulated material will affect the unit's ridedown function.

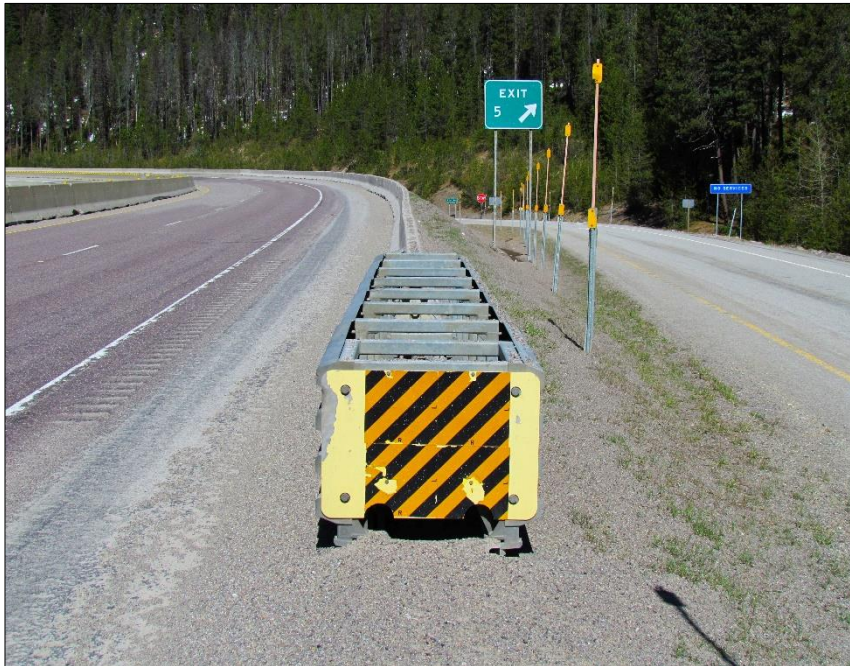
↙ Representative images of the SCI unit located at Exit 5.

No issues to report. SCI Units are in same condition as reported in 2017.

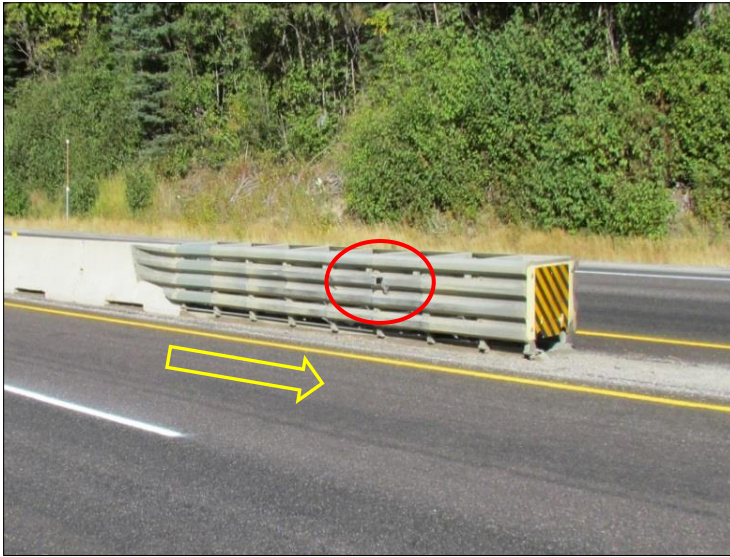
The SCI is located at approximate reference point 7.8 and is the west end unit. The vehicle strike came from the eastbound passing lane. It is unsure if the damaged side panel will inhibit the functional use of the attenuator.

← Damaged SCI located at first set of crossover units (going westbound) at approximate RF 7.8.

Unit seen is the westbound SCI; red circle is the area of damaged side panel.

Damage occurred apparently by a side swipe from an eastbound vehicle (yellow arrow denotes direction of travel).

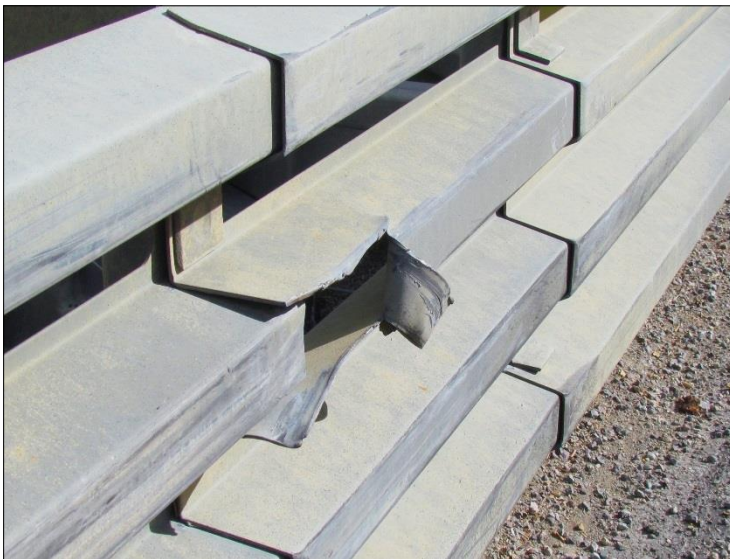
← Level of damage to SCI side panel.

It is unsure if the damaged panel will affect the ride-down function of the attenuator upon impact.

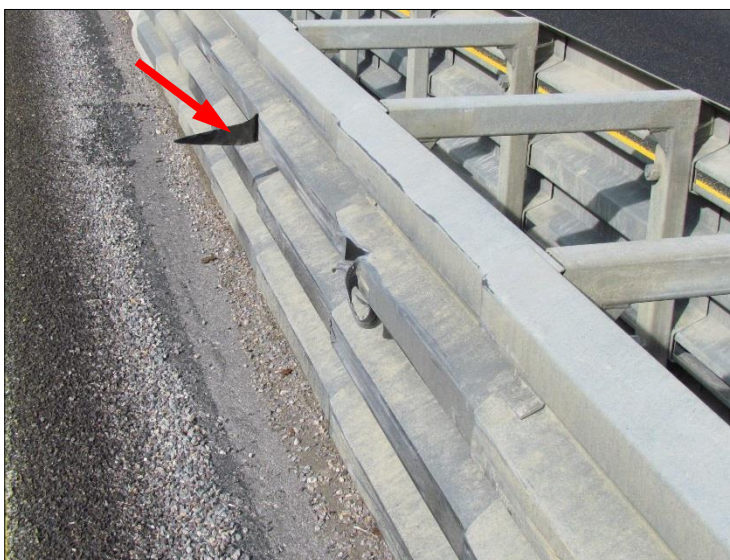
← The red arrow shows a piece of vehicle plastic wedged between a section of the scalloped side panel.
