**EXPERIMENTAL PROJECTS CONSTRUCTION REPORT AND ANNUAL  
EVALUATION**

**SMART CUSHION INNOVATIONS (SCI) 100GM CRASH ATTENUATOR**

**Project Name:** Taft-West

**Project Number:** IM-90-1(84)0

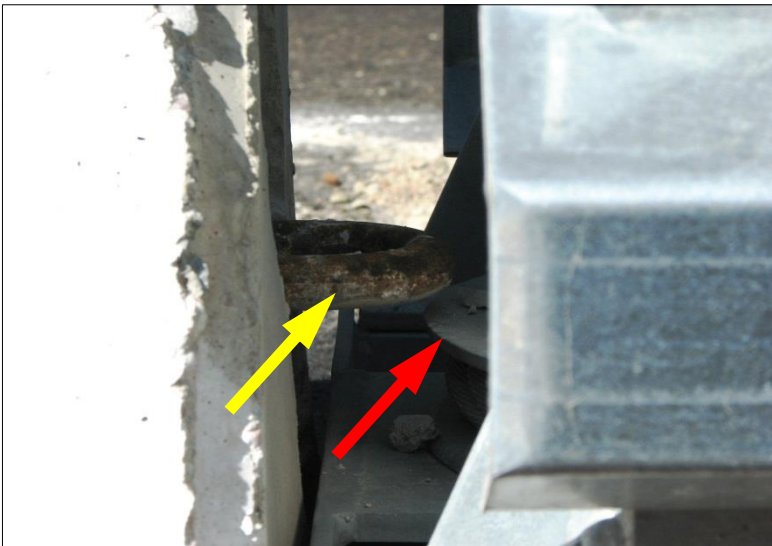
← Although difficult to see in this image, the lower loop of the concrete jersey barrier (yellow arrow) must not interfere with the attenuator's cable sheave cover (red arrow).

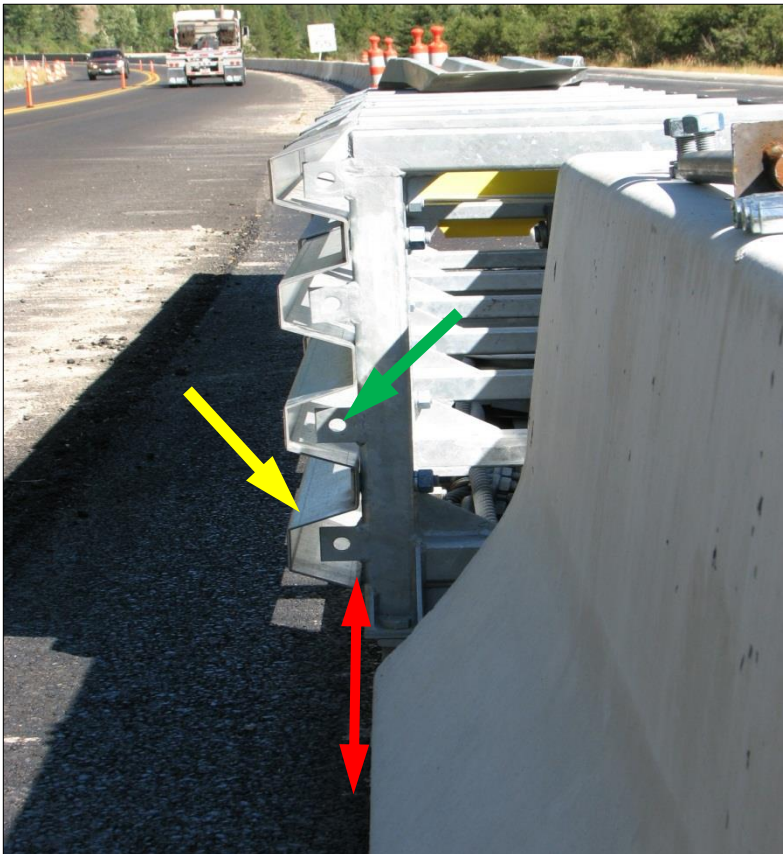
← This image details how the rear panel of the attenuator (yellow arrow) must not be obstructed by the (F shape) jersey barrier (red arrow).

The green arrow points to the bolt holes which the transition panel will attach to.

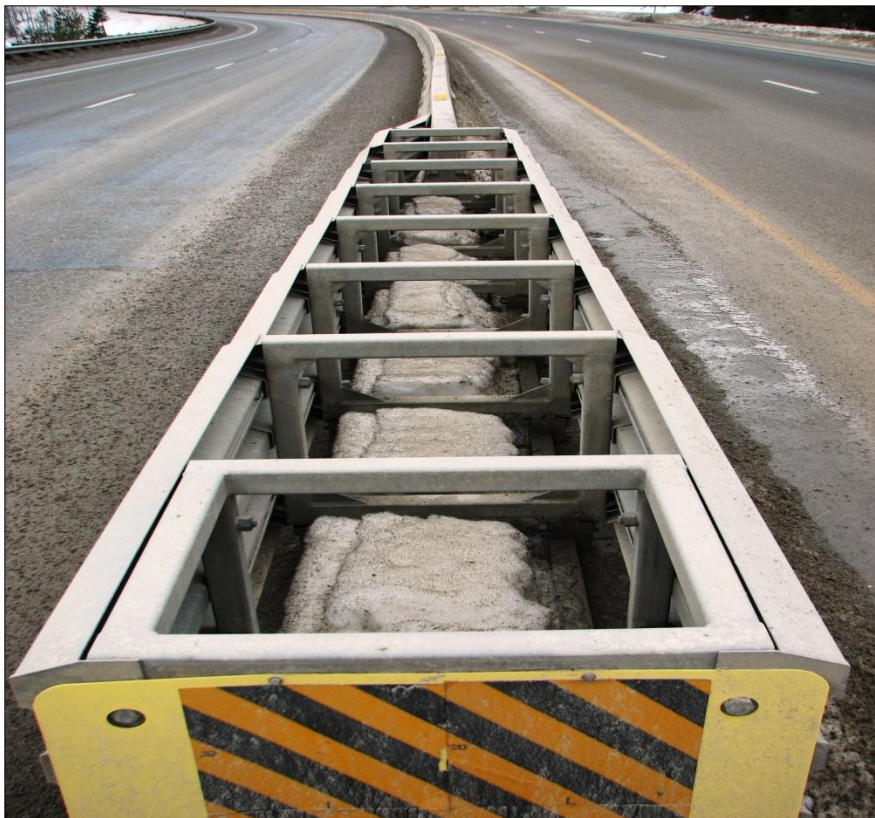
← SCI crossover installation at approximately mile point eight (8), view west.

Image shows minor accumulation of snow and ice in the interior of the SCI unit.

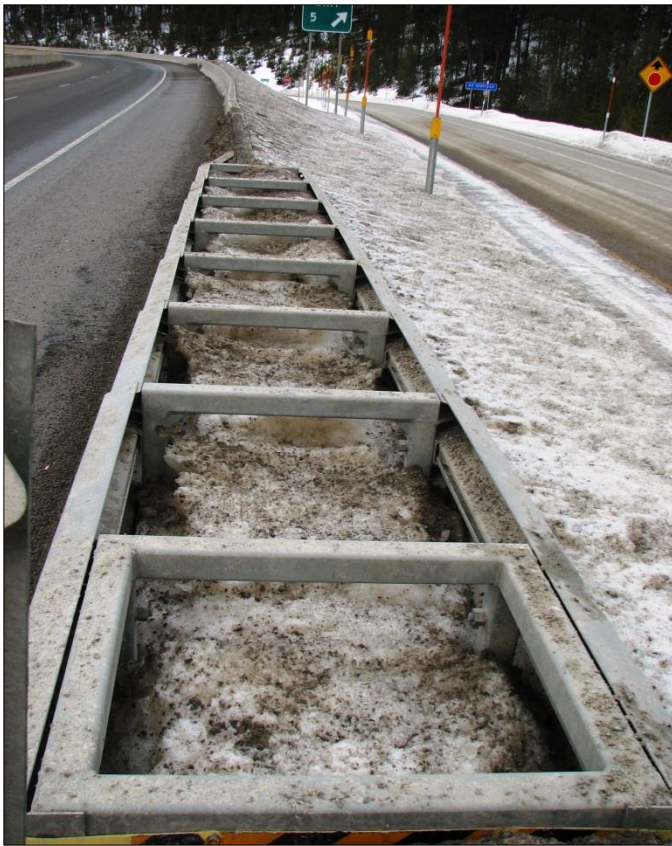
This inspection was scheduled to document the SCI units under winter conditions. No impacts to the units have occurred. Road sanding material has accumulated in and around the SCI components as documented in the 2013 site visit. Hard-pack snow and ice has collected to a depth of 3-4" over the cylinder and cable/sheave assembly on the four SCI units located at the crossover sites. Most noticeable is the northbound SCI unit at exit 5 (Reference point 6). The accumulation of snow and ice has almost completely filled the body of the attenuator to a density that you are able to walk on top without depressing the mass.

↙ Northbound I-90 at reference point 6. Exit 5 location of SCI unit.

Note the level of snow and ice inside and in front of the attenuator.

As stated earlier it is uncertain how this condition would affect the performance of the cushion if struck by a vehicle.

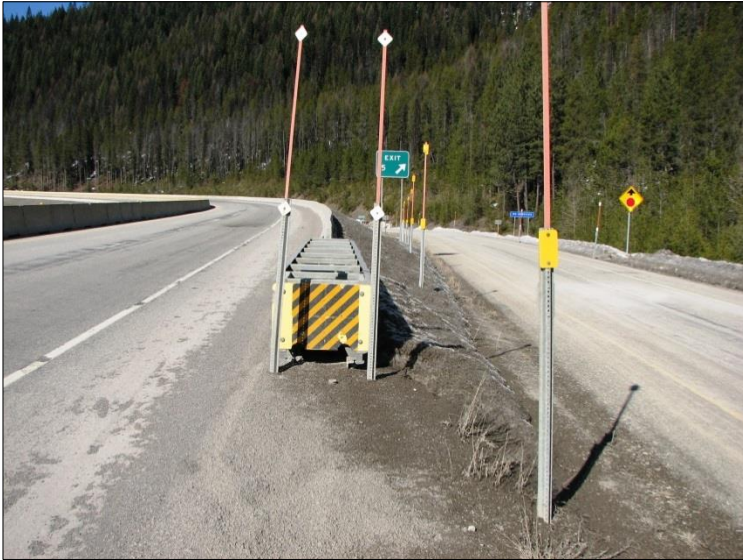
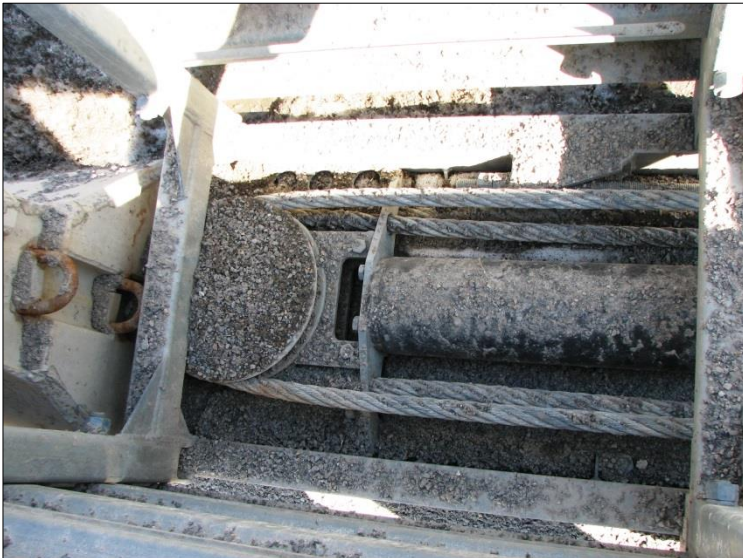
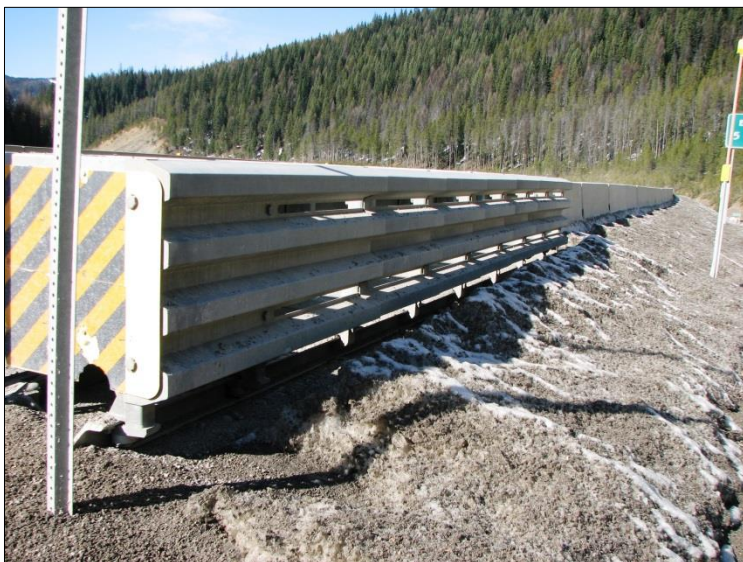
No impacts to the SCI units have occurred since installation. Conditions were dry and as reported in the 2014 inspection sanding debris and particulates have coated, at various levels, the cable sheaves and hydraulic porting.

↙ Westbound I-90 at approximate reference point 6. Exit 5 location of SCI unit.

These images represent the general condition of all of the SCI units on the project.

As documented in earlier inspections sand and grit accumulates in and around the cable, guides and cylinders systems.

If this effects the hydraulic porting during impact is unknown at this time.

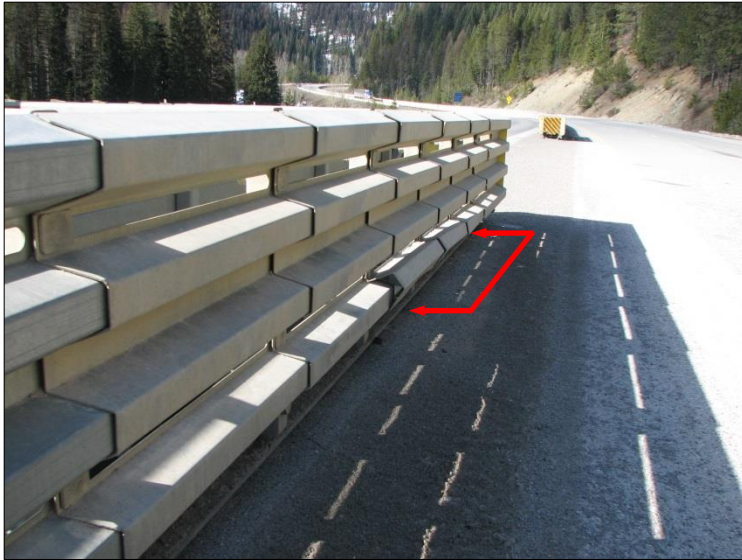
Damaged side panels were noticed on the east end crossover unit near reference point 7 located on the north side of the SCI. The side panels affected was the lower tier and involved two panels. What hit the panels or how this will affect the efficacy of the cable hydraulic porting unit is unknown.

↙ Westbound lane I-90 at approximate reference point 7: East end unit, north side.

Noticeable damage to a section of the bottom side panels (delineated by the red arrows).

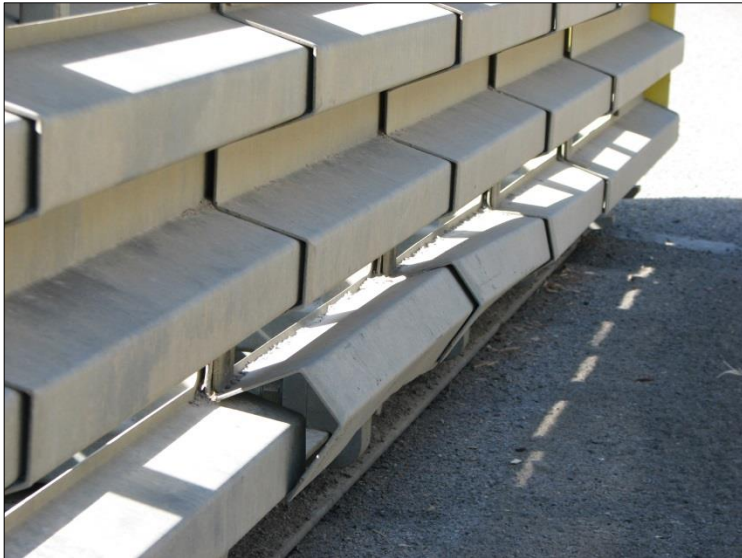
↙ Close-up of panel damage.

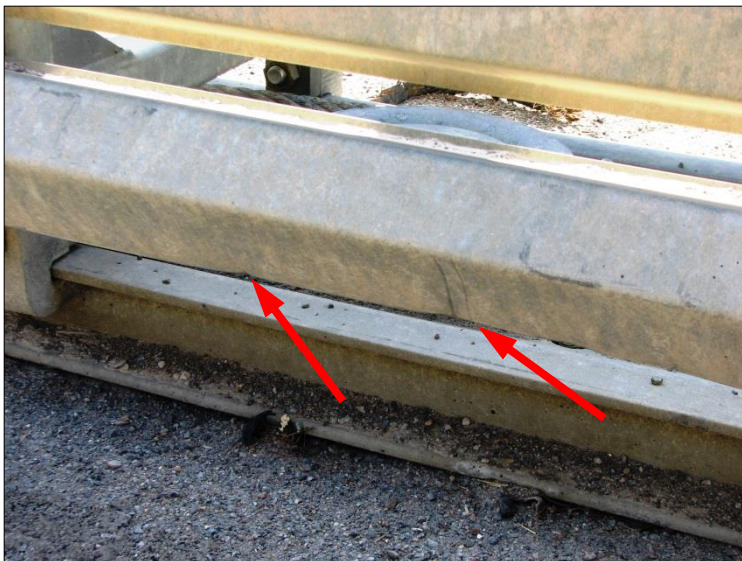
↙ Arrows show strike dents on the lower panel. It is difficult to determine if this type of damage will affect the performance of the unit.
