**EXPERIMENTAL PROJECTS CONSTRUCTION AND 2014 SITE INSPECTION
REPORT**

EVALUATION OF THE BREAK-OUT SQUARE POST BREAKAWAY SYSTEM

Project Name: Break-Out Square Post

Exp. Project Number: MT-12-08

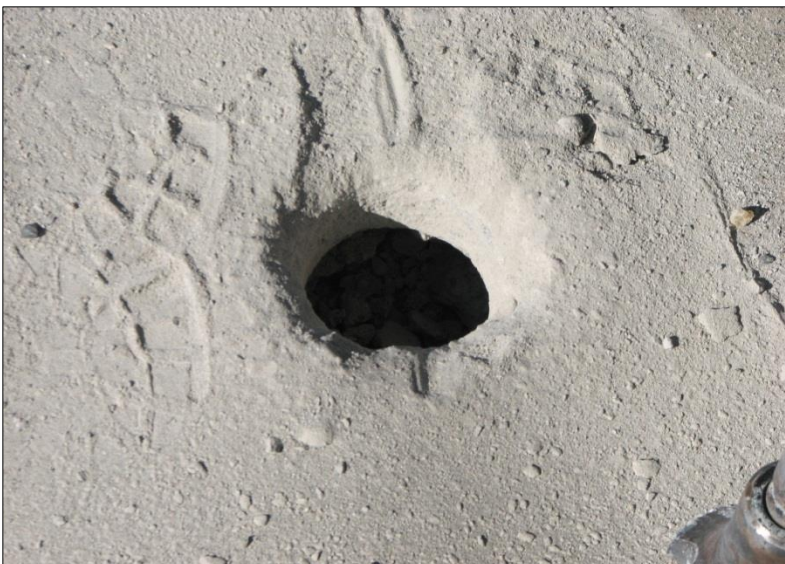
← Boring completed. It was found the depth of the concrete was approximately 2.5" (6.4 cm).

Normally for slabs less than 4" thick an extension is added to the anchor adaptor for added base support.

Since an extension was not supplied it was decided to use only the adaptor with this installation.

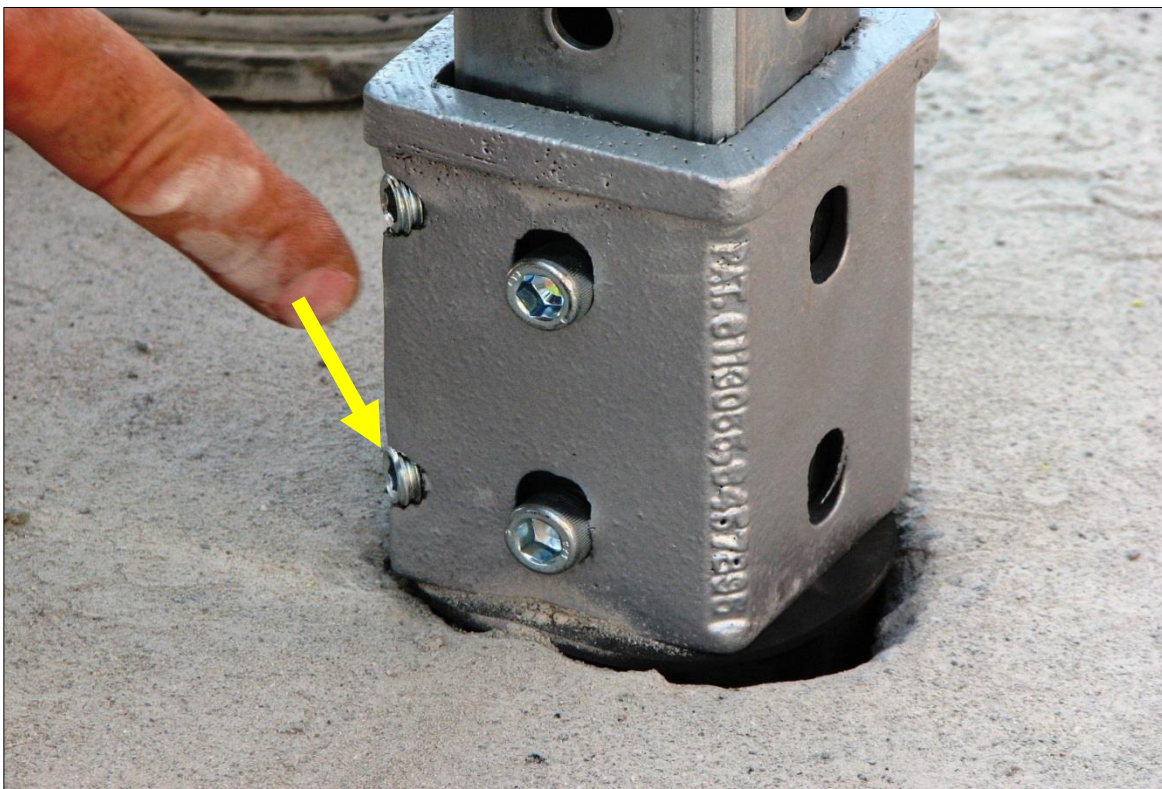
As stated above in the initial remarks, the concrete base thickness was less than 2.5" which to date, appears proven inadequate to support the anchor with sign; however the installation went ahead. In retrospect with the thickness of the base as it was, an anchor extension (which attaches to the anchor adaptor) may have kept the anchor to base a stable installation. These extensions range from twelve inches (12") to twenty-six inches (26"). Another option with the thinness of the PCC base would have been to apply concrete (or mortar) to the interior in and around the hole to make a solid connection.

↩️ In comparing the lower image taken in 2012 of the completed BOS unit, and the upper image taken during the April 2013 inspection, shows that the anchor (wedge) adaptor has recessed almost a half inch ($\frac{1}{2}$ ") into the concrete base.

Also note the corner hex screws (yellow arrows) appear to have reversed out of the top coupler hex attachment.

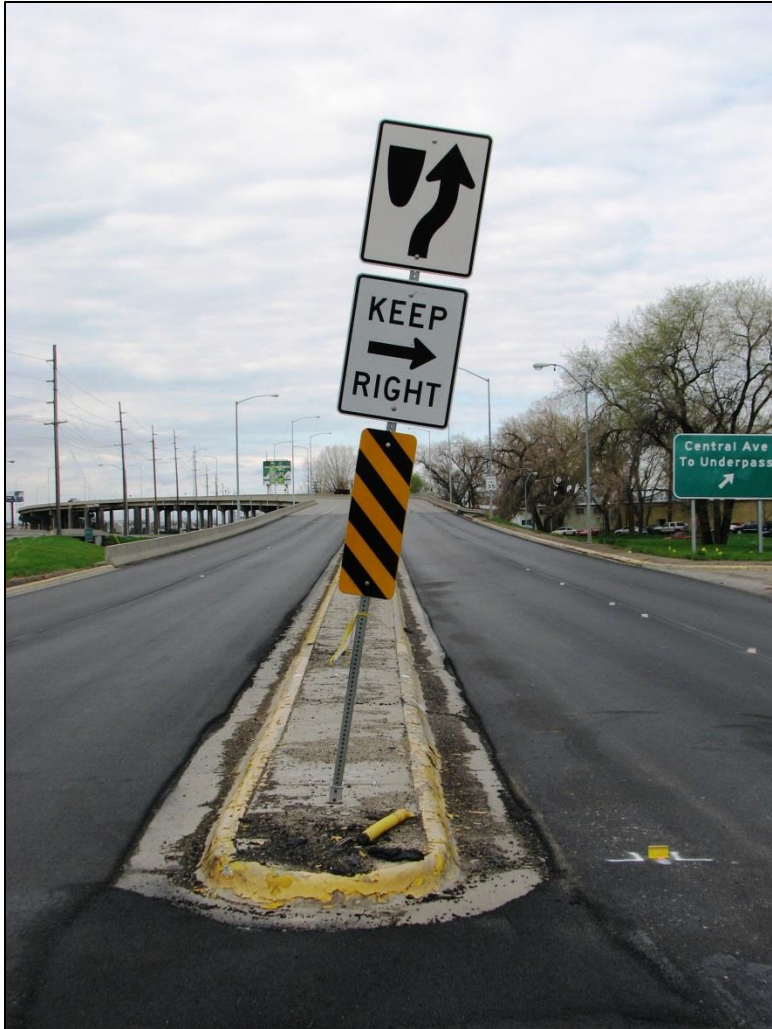
Condition of the sign is the same as reported on April 2013. The tilt and lean was more pronounced. See page 18.

↙↓ As compared to the image taken in April 2014 the sign incline has increased. Even at this severe angle and in shallow placement, the anchor adapter has held.

↓ Close-up of top coupler and anchor base.
