MASH TL-4 CRASH TESTING AND EVALUATION OF THE RESTORE BARRIER

MIDWEST ROADSIDE SAFETY FACILITY

MwRSF Research Report No. TRP-03-318-15

November 3, 2015

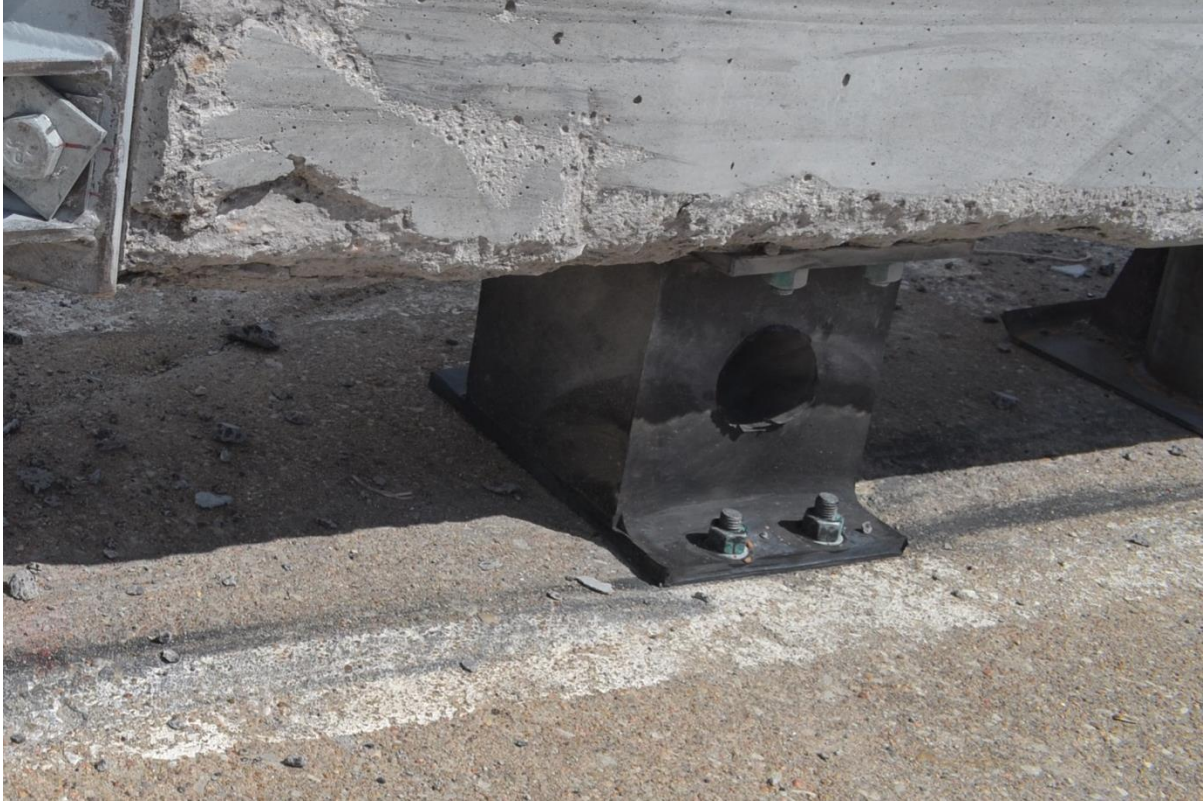
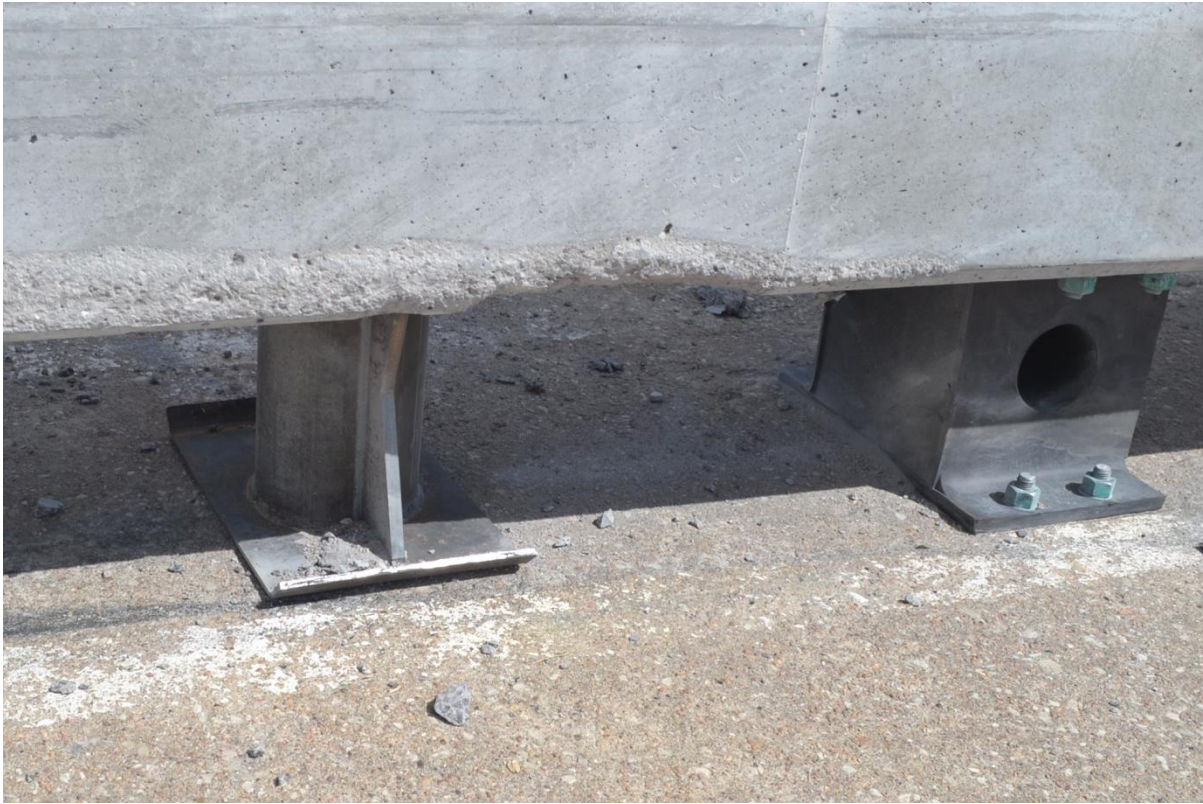
Figure 53. System Damage, Post Contact Marks Under Barrier No. 6, Test No. SFH-1

Damage to the barrier was minimal, as shown in Figures 52 and 53. Barrier damage consisted of contact marks, concrete spalling and gouges, and hairline concrete cracks. The

length of vehicle contact along the barrier was approximately 15 ft – ¼ in. (4.6 m), which spanned from 56½ in. (1,435 mm) upstream from the downstream edge of barrier no. 5 to 4 in. (102 mm) downstream from the mid-span of barrier no. 6. Gouging extended from the impact point through the end of the concrete beam along the bottom of the front face of barrier no. 5. Gouging was found along the height of barrier no. 6 located around the upstream splice on the front face. Further gouging was found along the bottom of the front face of barrier no. 6 extending 80 in. (2,032 mm) downstream from the upstream joint. Spalling occurred between barrier nos. 5 and 6 located between the front and back ACJ splices. There were hairline fractures on the back face of barrier no. 6 extending downstream from the bottom splice bolt hole approximately 5 in. (127 mm), as well as underneath the barrier beginning at the center of the upstream end of barrier no. 6 and extending downstream to the hexagonal hole. The first two posts downstream from the splice between barrier nos. 5 and 6 had contact marks along the front face and part of the upstream face.

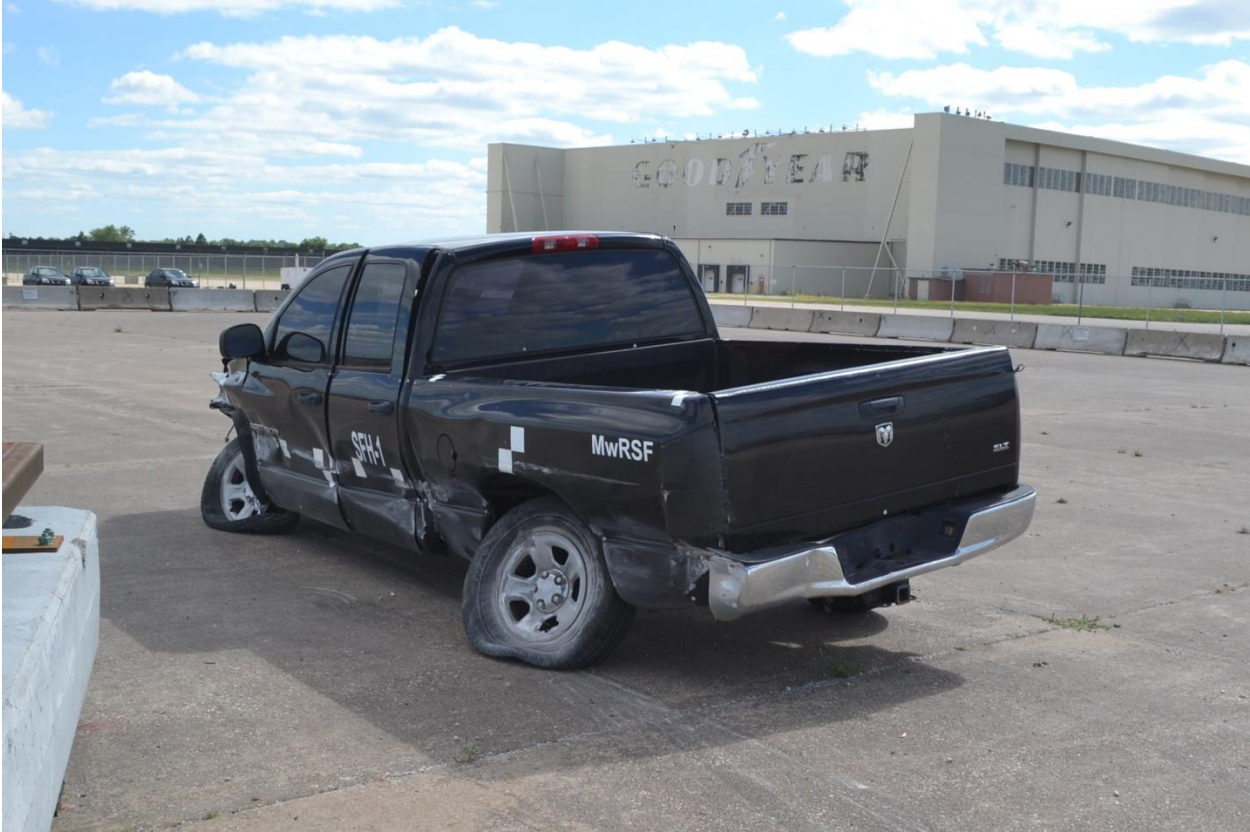
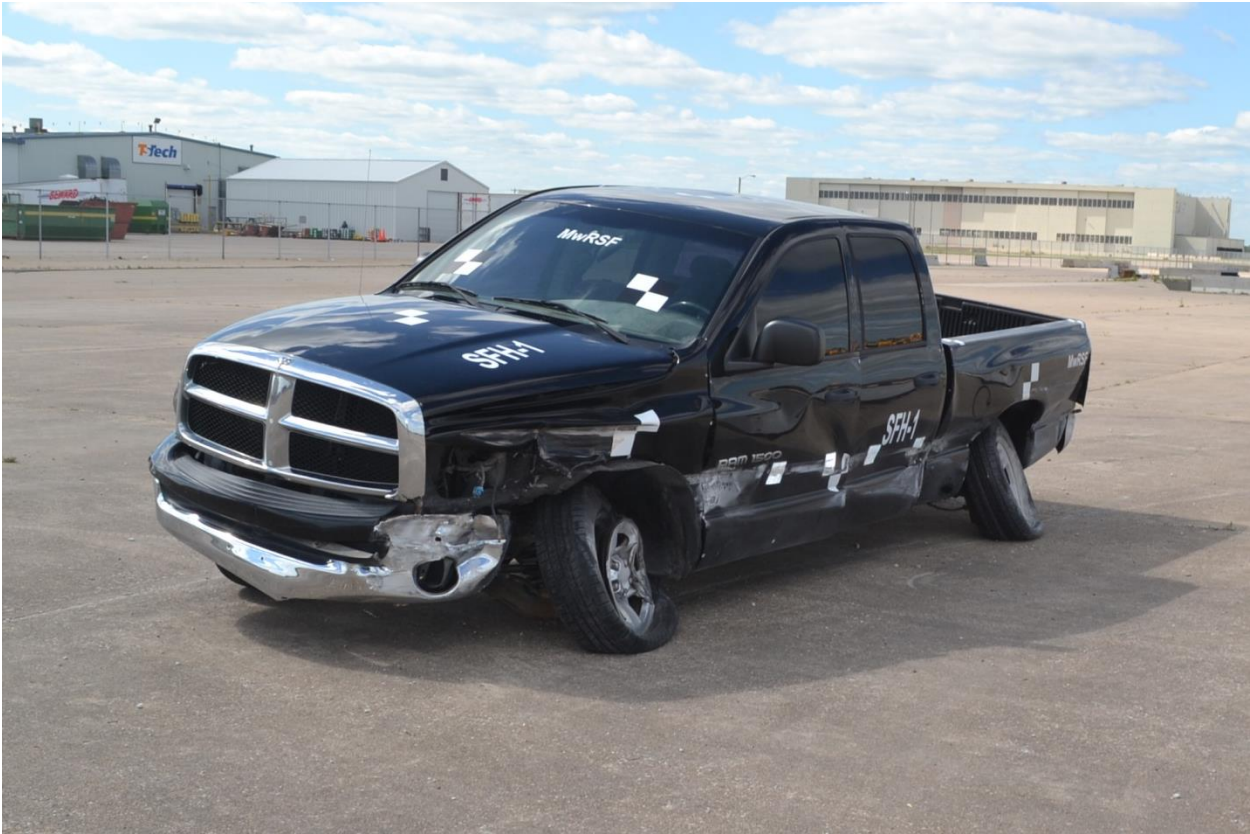
Figure 54. Vehicle Damage, Left Side, Test No. SFH-1

The damage to the vehicle was moderate, as shown in Figures 54 and 55. The maximum occupant compartment deformations are listed in Table 6 along with the deformation limits established in MASH for various areas of the occupant compartment. Note that none of the MASH-established deformation limits were violated. Complete occupant compartment and vehicle deformations and the corresponding locations are provided in Appendix C.

The majority of the damage was concentrated on the left-front corner and left side of the vehicle where the impact occurred. A 3-in. (76-mm) buckle was found in the center of the front bumper surrounded by 3 in. (76 mm) of scraping. A kink was located in the bottom of the front bumper, located 5 in. (127 mm) left of center. Both the left and right fog lights were disengaged. The left headlight was disengaged. The left-front bumper had an 8-in. (203-mm) vertical tear. The left-front bumper was deformed inward below the light fixture.

The entire left side of the vehicle had scrapes. Multiple dents were found on the left-front door and left-rear door. A 2¼-in. (57-mm) gap was found between the hood and the left fender. The left-front fender was crushed laterally inward approximately 6 in. (152 mm). A 45-in. (1,143-mm) long dent was found in the top of the left fender below the hood. The front of the left-front door was ajar 1 in. (25 mm), while the back of the left-front door overlapped the left-rear door ½ in. (13 mm). The left-rear door was ajar 1 in. (25 mm). The left tail-light separated 1½ in. (38 mm) due to the rear end of the vehicle contacting the top corner of the concrete beam. The left-rear tire deflated with a 1½-in. (38-mm) long tear from contact with the bolts underneath the beam. The outer edge of the left-rear rim was gouged and scraped. A vertical buckle was found on the rear bumper that was 8½ in. (216 mm) tall, located 19 in. (483 mm) left of center. The damage on the right side of the vehicle was present prior to test no. SFH-1.

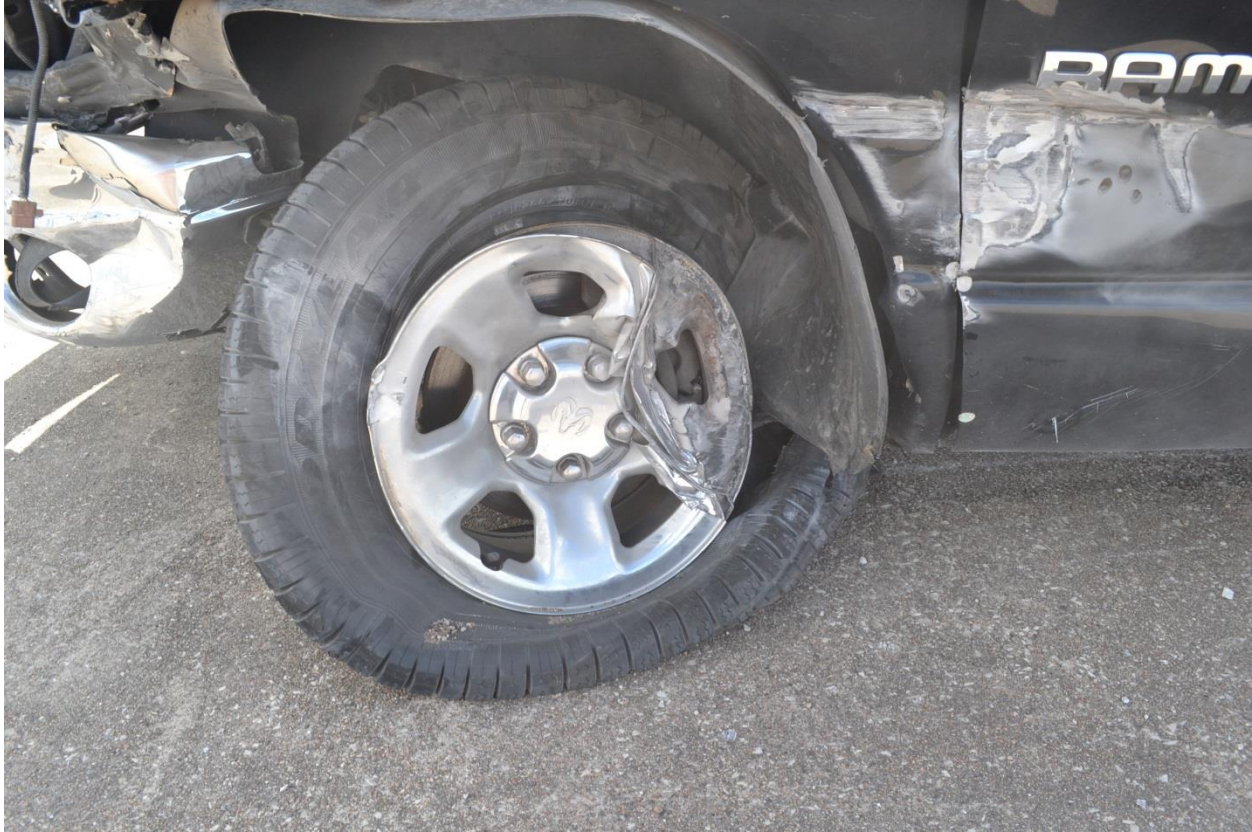
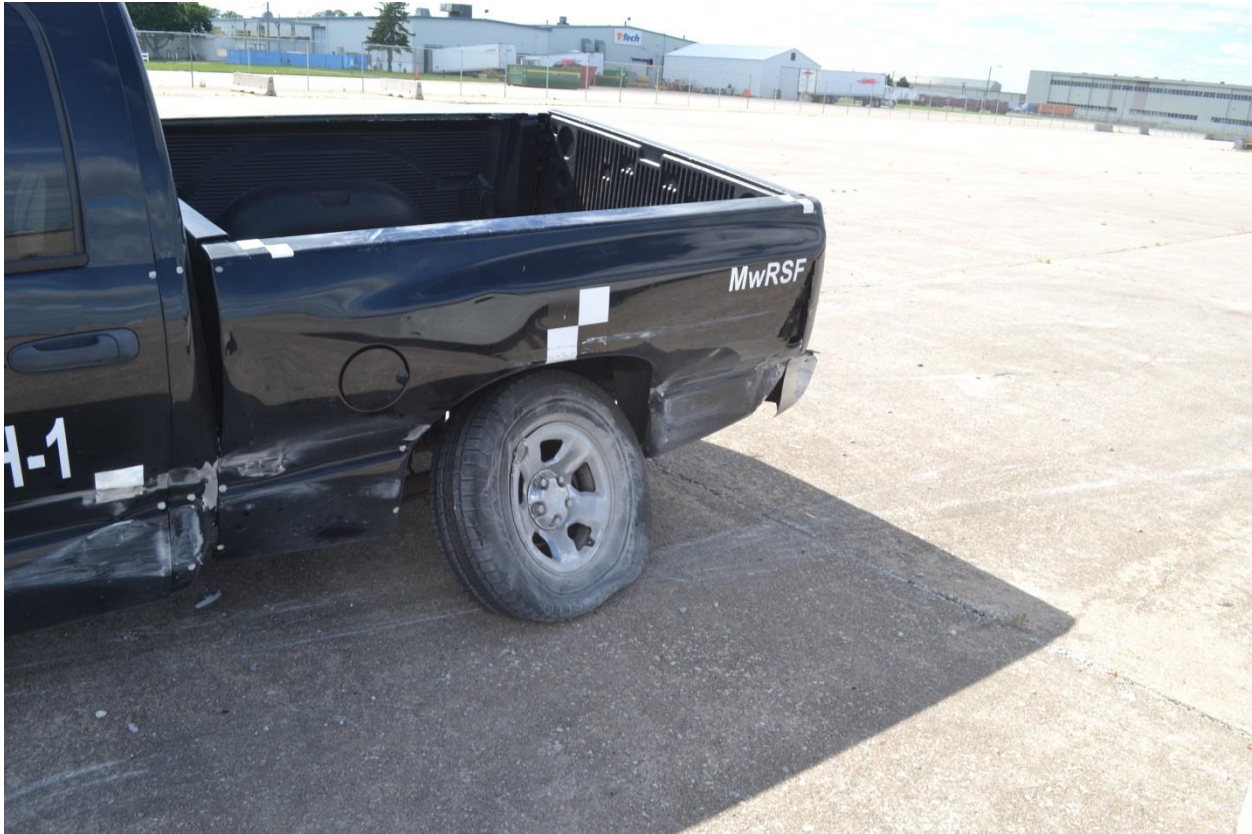
Figure 55. Vehicle Damage, Left-Front and Left-Rear Tires, Test No. SFH-1

The left-front control arm disengaged. The left-front tire deflated and released from the rim. The left-front tire rim had scraping along the edge, and the outer hub cap folded 6 in. (152 mm). Multiple tears were found on the left-front tire, including in the tire's treads.

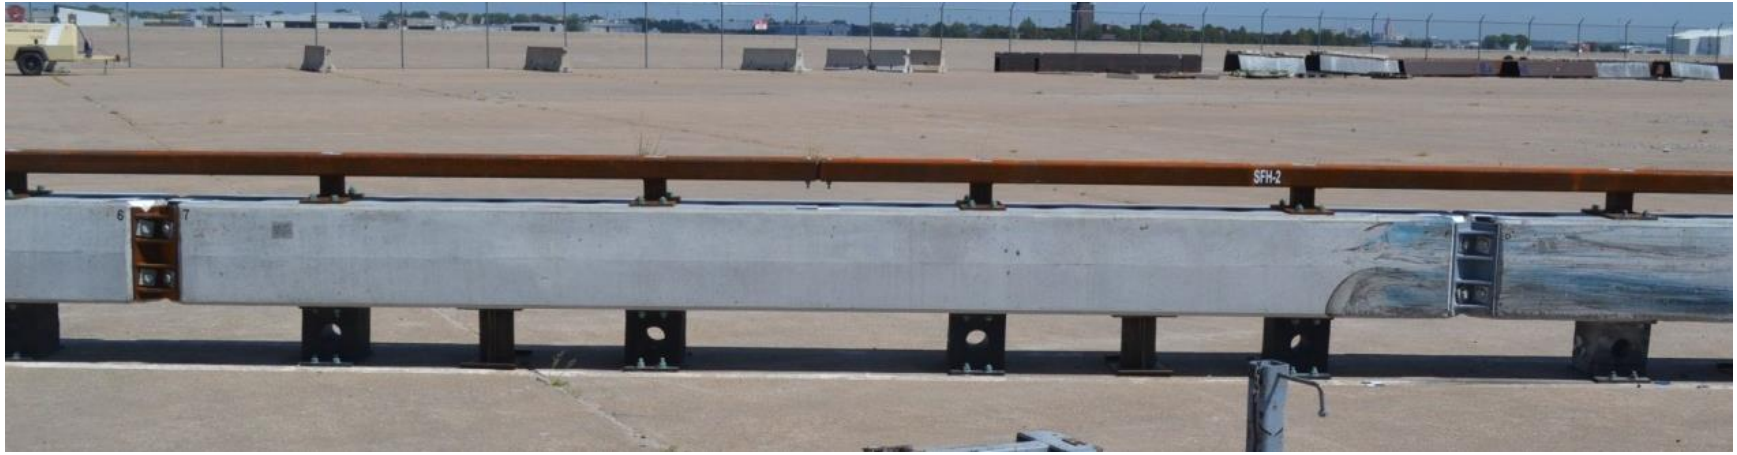
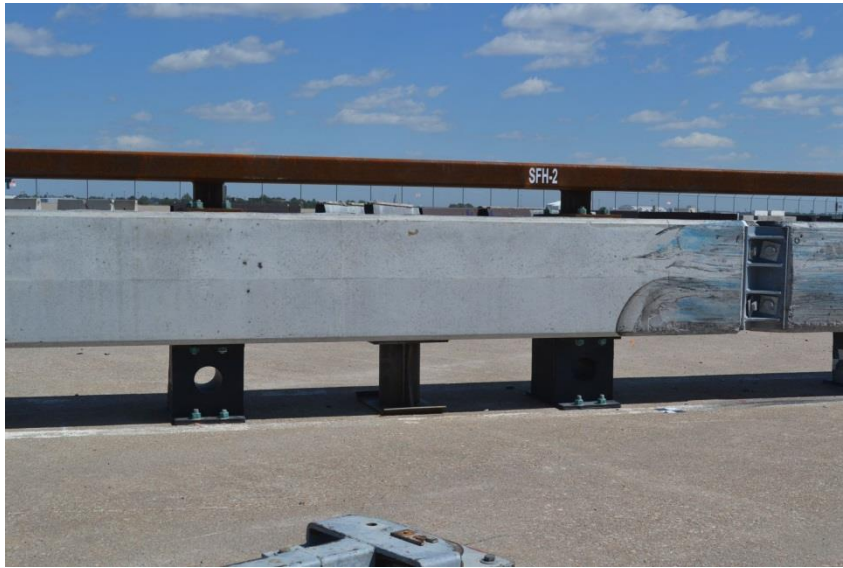
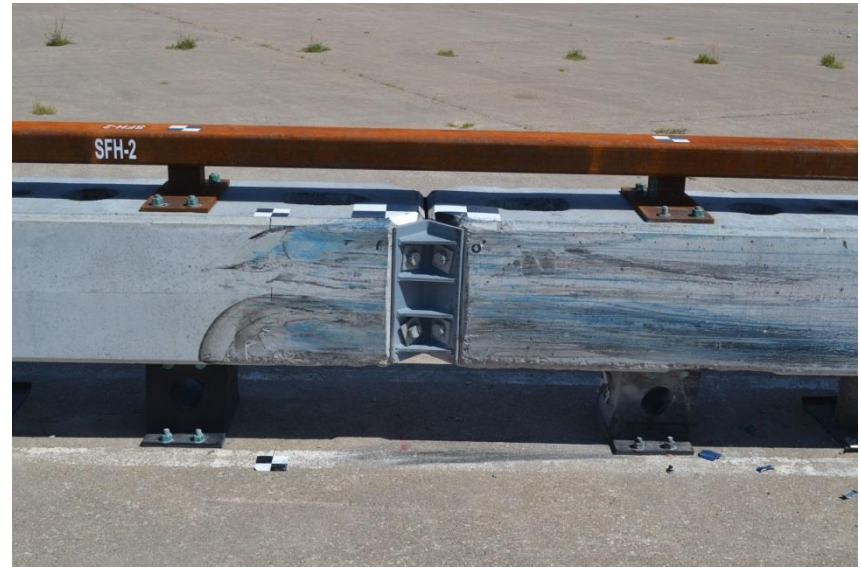
Figure 69. System Damage, Barrier No. 7, Test No. SFH-2

Damage to the barrier was minimal, as shown in Figures 69 through 72. Barrier damage consisted of gouging and contact marks on the front face of the concrete segments and cuts in the rubber posts. The length of the vehicle contact along the barrier was approximately 12 ft – 7 in. (3.8 m), which spanned from 27 in. (686 mm) upstream of the joint between barrier nos. 7 and 8

Gouging was present on the bottom of barrier no. 7 along the last 20 in. (508 mm) of the barrier at the downstream end. The gouging continued on the bottom of barrier no. 8 for 39 in. (991 mm). Tire contact marks were found on the upstream face of the first post downstream from the joint between barrier nos. 7 and 8 that were 3½ in. (89 mm) wide x 7 in. (178 mm) tall. From contact with the vehicle's rim, this same post was cut along the length of the front face 3 in. (76 mm) above the groundline that had a maximum depth of ½ in. (13 mm). The second post downstream from the joint between barrier nos. 7 and 8 was cut along the length of the front face located 4 in. (102 mm) above the groundline to a maximum depth of 2 in. (51 mm). The upstream corner of the front face had contact marks 5¼ in. (133 mm) wide x 7 in. (178 mm) tall. Contact marks were present on the upstream corner of the front face along the upper tube assembly post located just downstream from the joint between barrier nos. 7 and 8. From the second impact, the bottom of barrier no. 11 had gouges starting 93 in. (2,362 mm) upstream from the downstream end of barrier no. 11 that continued for 28 in. (711 mm).

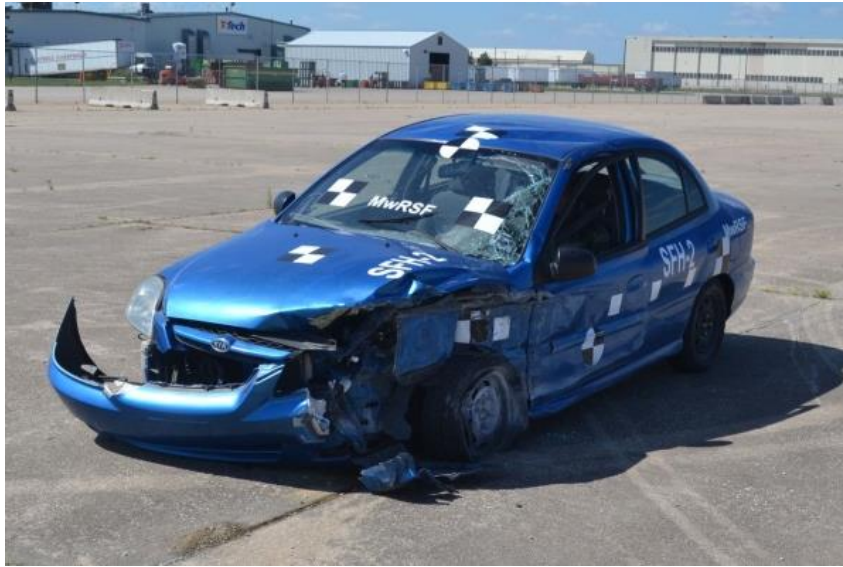
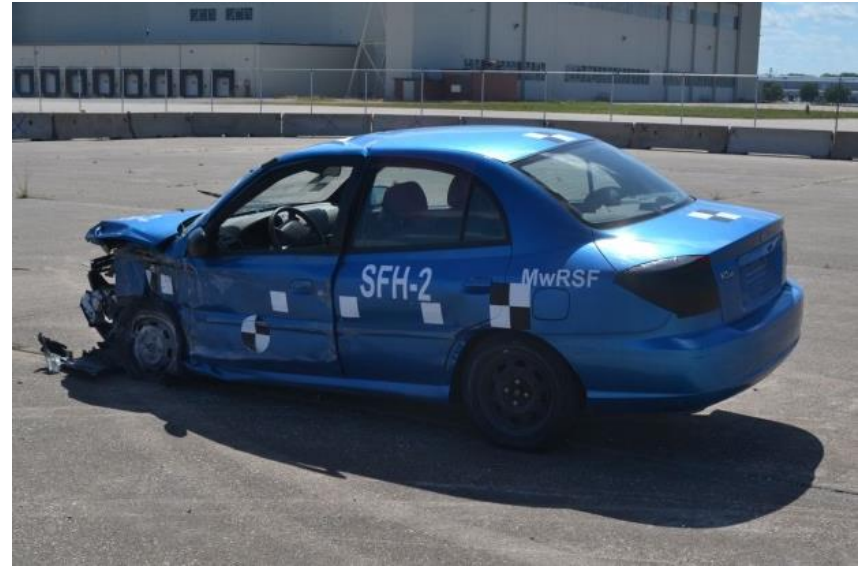
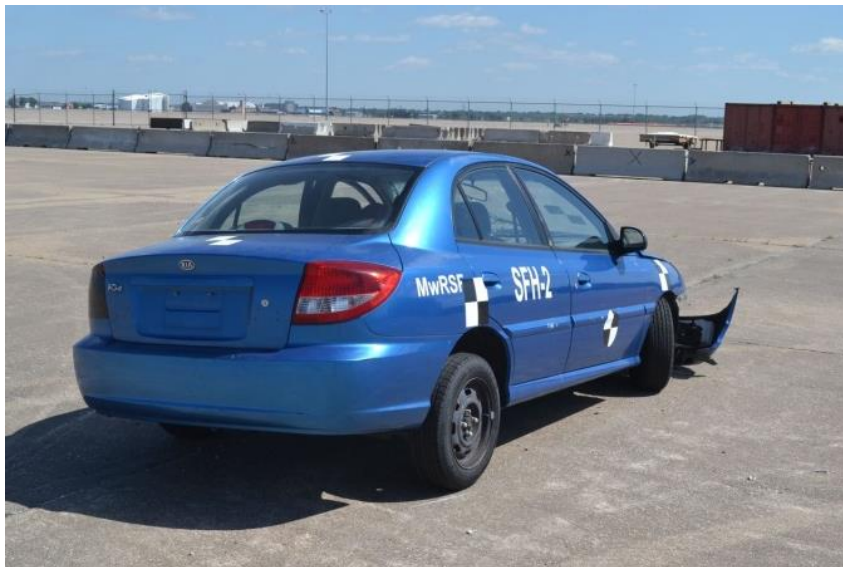
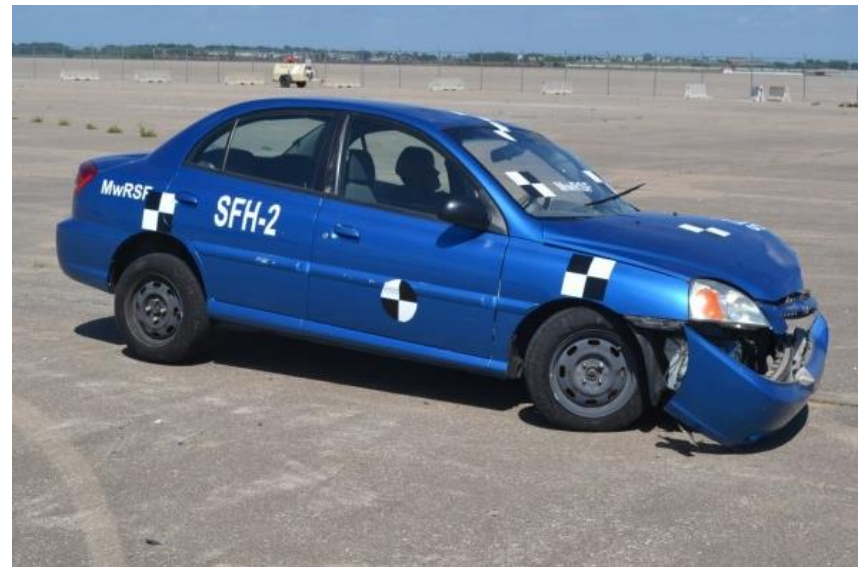
Figure 73. Vehicle Damage, Test No. SFH-2

The damage to the vehicle was moderate, as shown in Figures 73 and 74. The maximum occupant compartment deformations are listed in Table 12 along with the deformation limits established in MASH for various areas of the occupant compartment. Note that none of the MASH-established deformation limits were violated. Complete occupant compartment and vehicle deformations and the corresponding locations are provided in Appendix C.

The majority of the damage was concentrated on the left-front corner and left side of the vehicle where the impact occurred. The front bumper and the left headlight were both disengaged. The hood separated 1 in. (25 mm) near the right headlight compartment. A 5-in. (127-mm) deep x 18-in. (457-mm) long dent was found along the left edge of the hood located 5 in. (127 mm) left of center. The front windshield had cracking through the entire windshield. The left fender had a 20-in. (508-mm) long cut along the top of the fender.

A 6¾-in. (171-mm) cut was found in the left-front door located 9½ in. (241 mm) above the bodyline. The left-front tire was deflated, with gouges around the outer rim. The left fender was crushed inward approximately 6 in. (152 mm). The A-pillar had dents located 5 in. (127 mm) and 11½ in. (292 mm) from the bottom of the pillar. The left-front window shattered from contact with the dummy head. A 2½-in. (64-mm) gap was located between the left-front door and the A-pillar. The top of the B-pillar had a 2-in. (51-mm) dent. Contact marks extended from the left fender through 17 in. (432 mm) back of the center of the left-rear wheel well. The left-front roof had a dent measuring approximately 25 in. (635 mm) x 9 in. (229 mm) x 1 in. (25 mm) deep. The bottom of the left-front door was crushed inward.

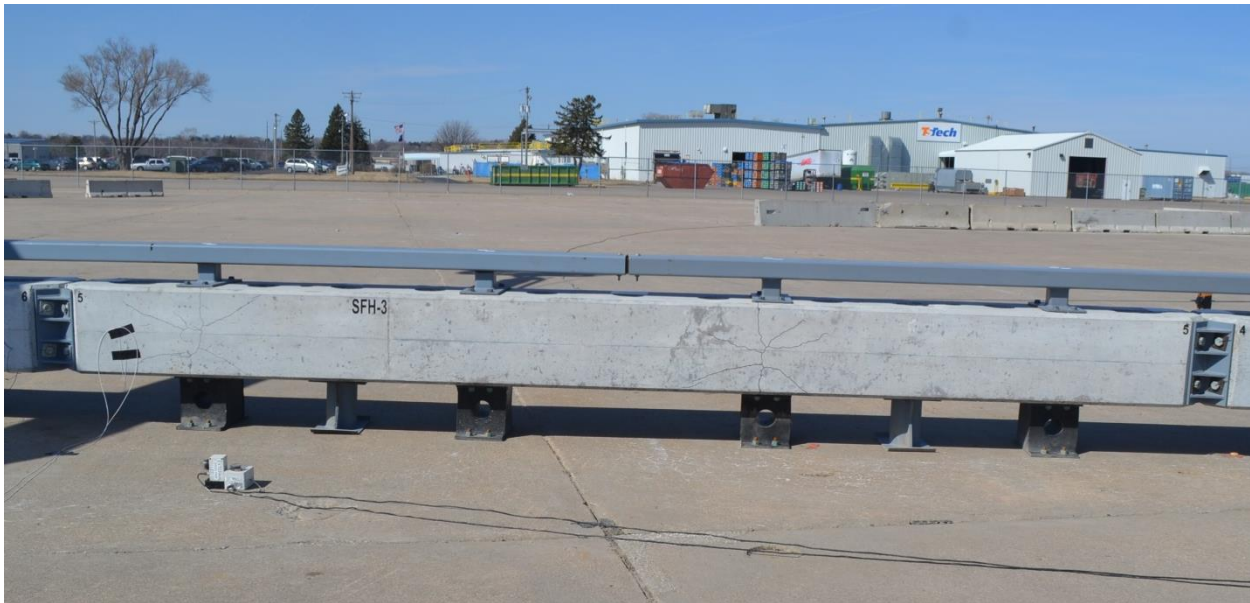
Figure 103. Concrete Beam Cracks Due to Freeze-Thaw

After the system was installed, it was exposed to 6 months of winter weather conditions. With the rubber posts and steel plates attached, the vertical bolt holes in the concrete beams were allowed to fill with water and were subjected to several freeze-thaw cycles. After discussing with Concrete Industries, Inc., the fabricator of the concrete beams, it was believed that as the water froze within the holes, the front and back faces of the concrete beams expanded outward at twenty-three locations, which caused the beams to micro crack, as shown in Figure 103. The cracks were noted as existing damage; however, it was believed that they would not affect the structural integrity of the system and testing continued.

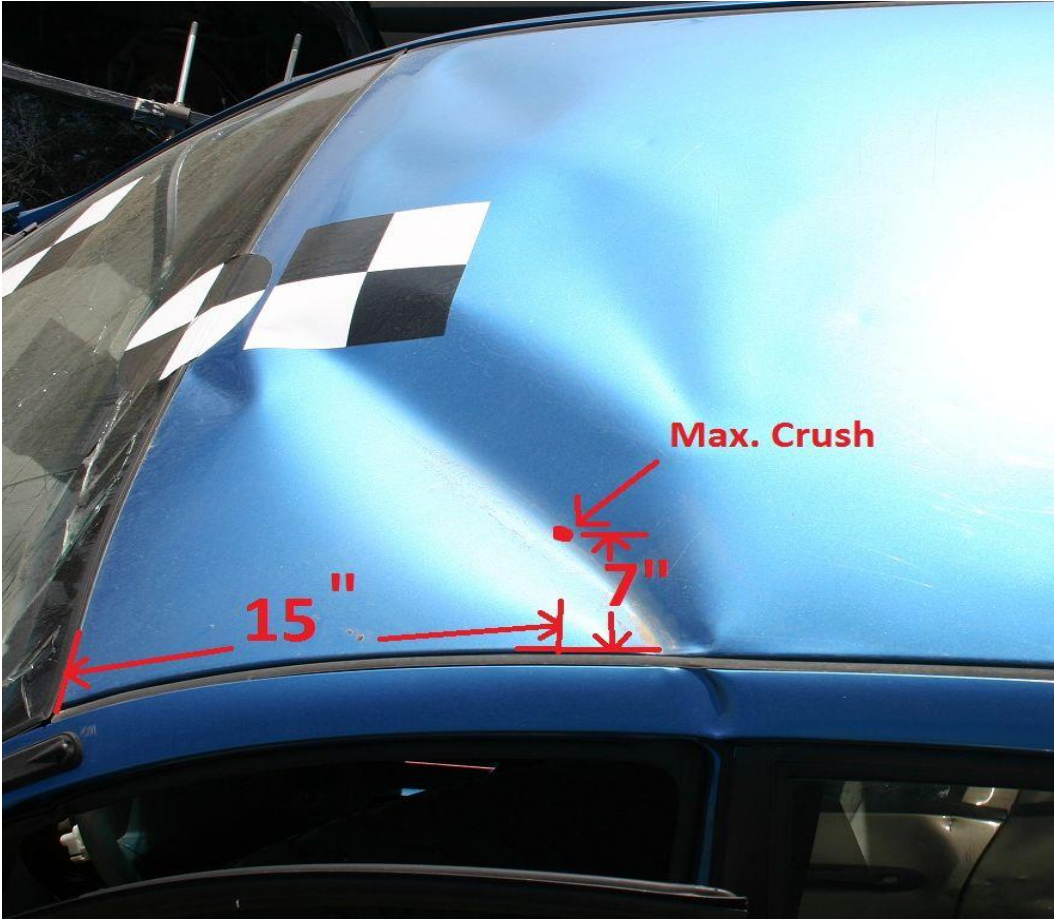
Comparative measurement of SFH-2 roof damage to undamaged vehicle:

SFH-2 at max point of crush	6.75"
Undamaged vehicle	<u>5.5"</u>
Total crush	1.75"
