## **MASH TEST NOS. 3-17 AND 3-11 ON A NON-PROPRIETARY CABLE MEDIAN BARRIER**

### **MIDWEST ROADSIDE SAFETY FACILITY**

MwRSF Research Report No. TRP-03-303-15

November 3, 2015

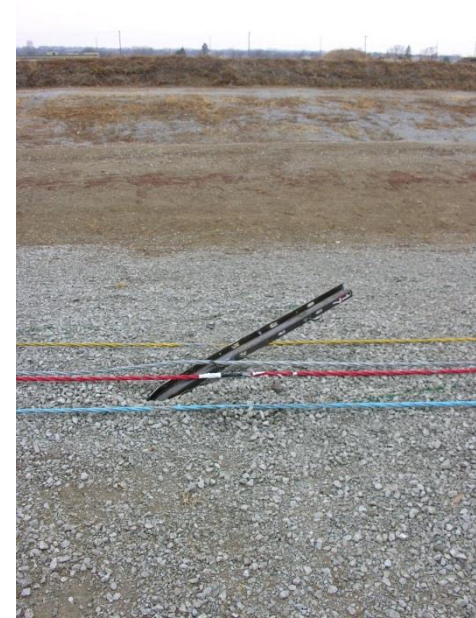
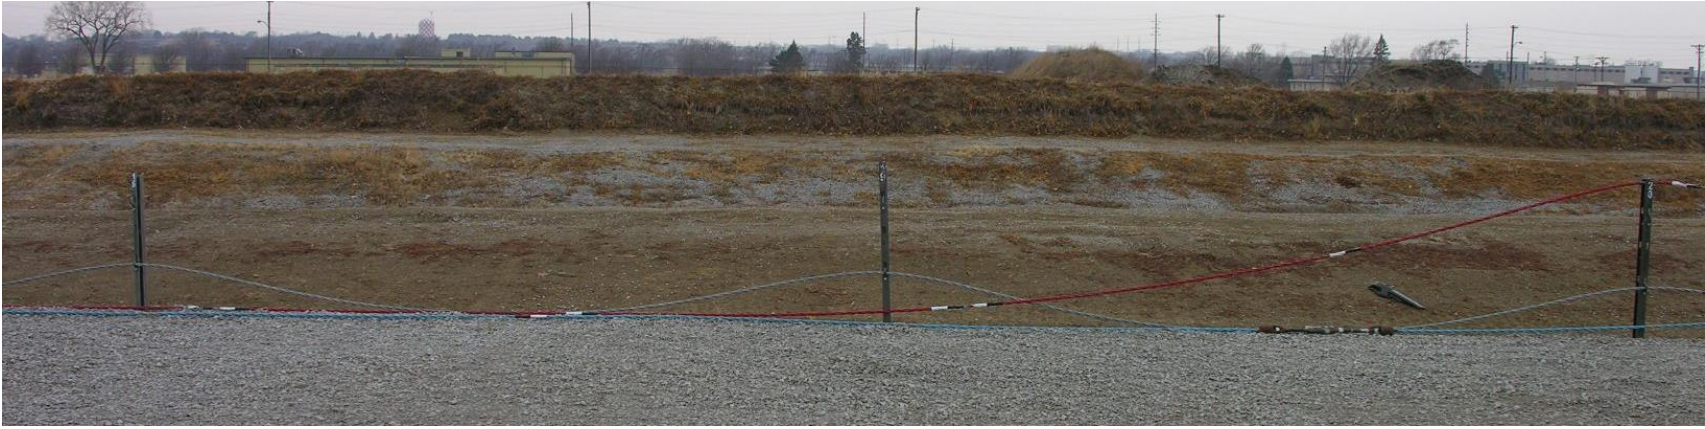
Figure 46. System Damage, Post Nos. 15 through 17, Test No. MWP-1

Damage to the barrier was moderate, as shown in Figures 46 through 50. Barrier damage consisted of bent posts, disengaged cables, and deformed brackets. At its final resting position, the vehicle was still in contact with the cables. Cable no. 2 was on the left side and the remaining cables were on the right side.

Cable no. 4 disengaged from post nos. 16 through 19, as well as post nos. 24 through 28, due to fracture of the brass keeper rods. Cable no. 3 disengaged from post nos. 12 through 20 and 25 through 28, cable no. 2 disengaged from post nos. 17 through 28, and cable no. 1 disengaged from post nos. 17, and 23 through 28. All of the brackets releasing cable no. 2 fractured due to high lateral cable loads pulling away from the posts. All other brackets releasing cables nos. 1 and 3 opened up with the tabs rotating through the keyway to release the cables vertically. Separation of the cable splices was documented, but the displacements were small. The maximum displacement at a splice was ¼ in. (6 mm) at the splice of cable no. 2.

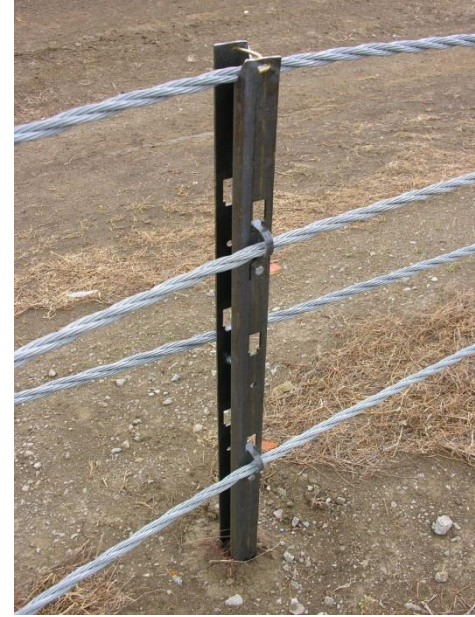
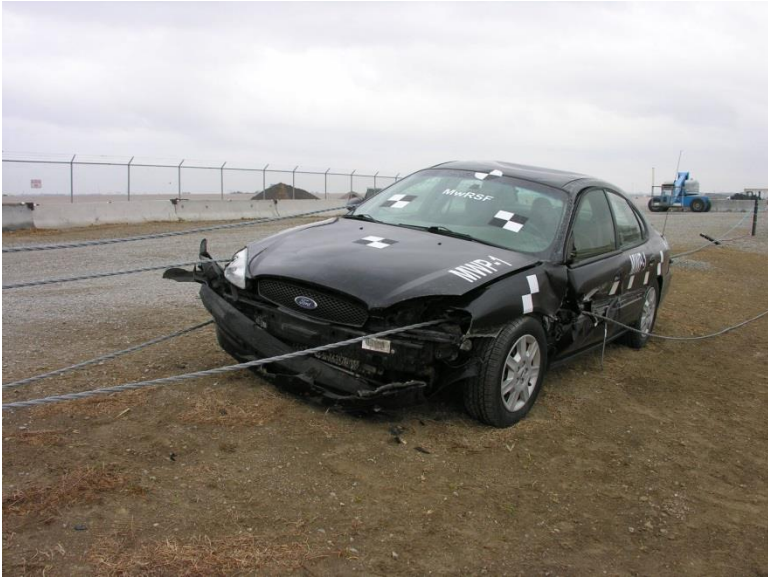
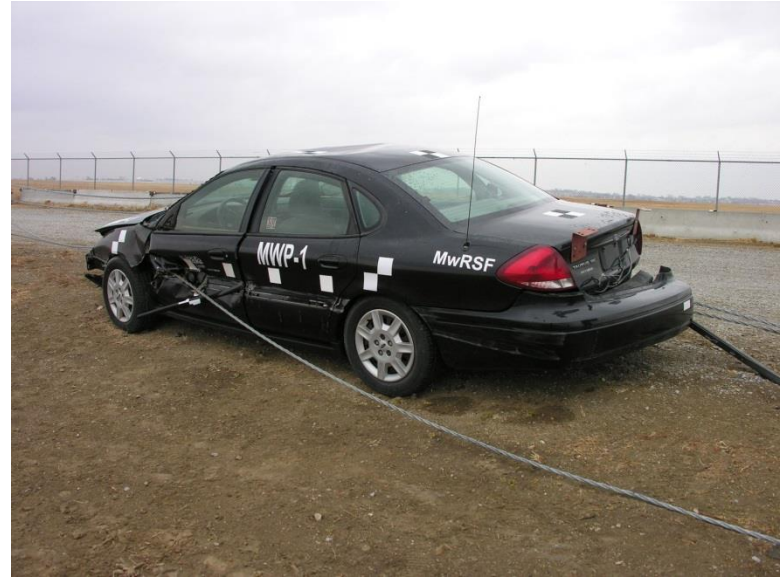
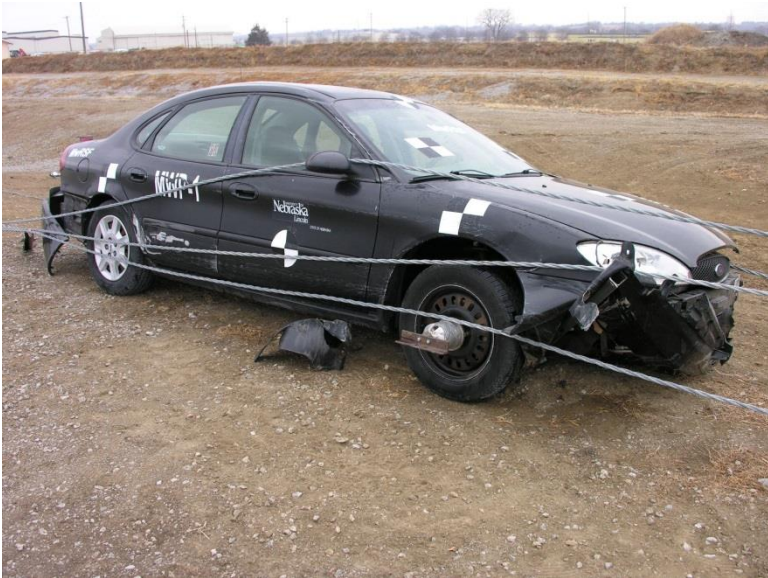
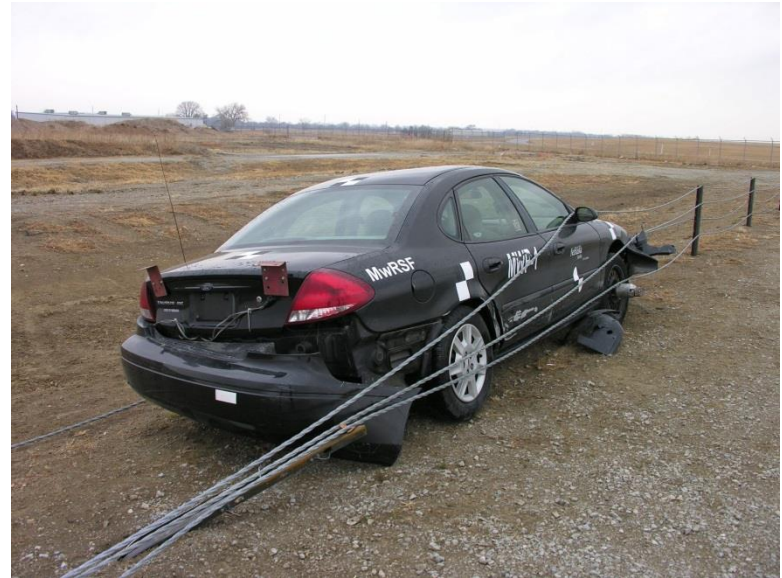
Figure 51. Vehicle Damage, Test No. MWP-1

The damage to the vehicle was moderate, as shown in Figures 51 through 53. The maximum occupant compartment deformations are listed in Table 6 along with the deformation limits established in MASH for various areas of the occupant compartment. Note that none of the MASH-established deformation limits were violated. Complete occupant compartment and vehicle deformations and the corresponding locations are provided in Appendix D.

The majority of the vehicle damage was concentrated on the left-front corner and left side of the vehicle where the impact occurred. The front bumper was under the front of the car. The left-front fender disengaged from the front bumper. There was a 2½-in. (64-mm) gap at the left headlight on the fender. The left-front tire was torn and a 10½-in. (267-mm) tear was located on the left-front fender. There were scrapes and gouges along the left side of the vehicle. Gouges were present along the A-pillar, and there were multiple cracks along the left side of the windshield. The left-side mirror was disengaged. There was a 6-in. (152-mm) wide, 32-in. (813-mm) long tear in the left-front door, starting at the back of the left-front fender and continuing along the left side of the car. The roof was scraped from the cables and was indented 2½ in. (64 mm). There was a 12-in. (305-mm) long dent on the right-rear quarter panel. The right side of the vehicle was scraped, including the right-front rim. The right-front bumper was crushed around post no. 28. The right-front headlight was broken but still attached. The remaining window glass remained undamaged. Minor scrapes were found on the undercarriage along the engine and transmission oil pans, control arms, exhaust pipe, and driver's side floor pan. A 23-in. (584-mm) long and ¼-in. (6.4-mm) deep gouge was located on the fuel tank.

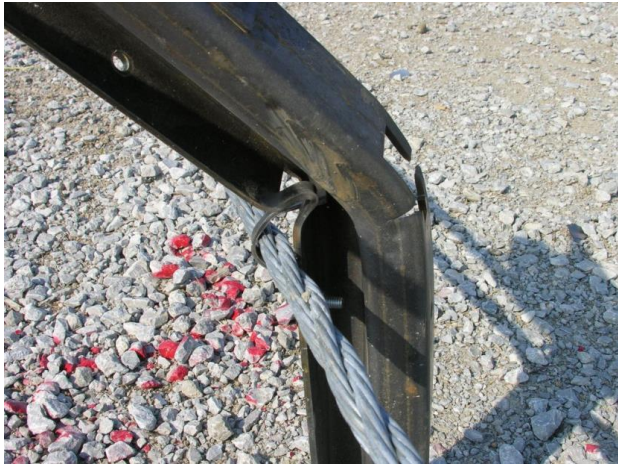
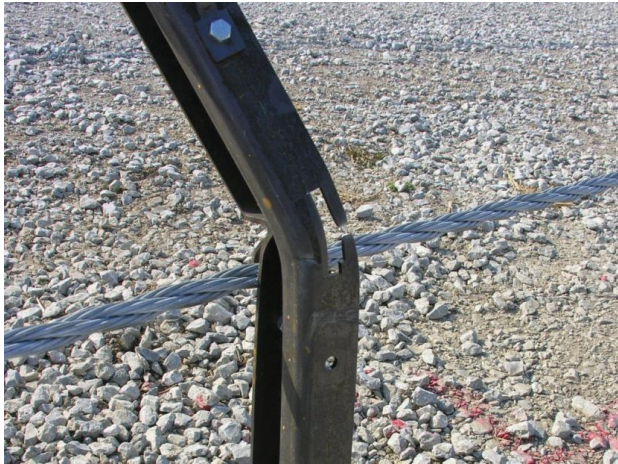
Figure 66. Damage to Lower Keyhole, Post Nos. 27 through 29, Test No. MWP-2

Modifications were made to the system posts in order to prevent the MWPs from bending and tearing at the keyways for cable no. 1 as seen in test no. MWP-2. The keyways were adjusted so that each post contained only four keyways as opposed to the six seen in the previous tests. Three keyways were placed on one side of each post at the same heights used previously. However, the opposite side had only one keyway, located at the middle cable position. This modification eliminated the symmetry of the posts, but still allowed for median and roadside versions of the system (all cables on front) with a single post. The sizes of the keyways were also modified. The height of the upper portion of each keyway was reduced by  $\frac{1}{4}$  in. (6 mm) to increase the buckling strength of the steel strip located between the keyway and the free edge of the post. This change was intended to increase bending strength in the post and prevent plastic hinges from forming around the first cable keyway. Based on analysis of previous bogie testing results, this reduced keyway height was determined to not affect the bracket exiting the keyway. Finally, the tops of the posts were extended  $\frac{1}{4}$  in. (6 mm) to prevent damage to the brass rod installation slot in the post flange when driving the posts into the ground. During installation of the posts for test no. MWP-2 some of the slots closed slightly from the repeated impacts of the

driver, and the brass rods were difficult to install. The added material above the slots should strengthen the post and prevent the slot from deforming. However, the bottom of the V-notch holding the top-cable was also deepened  $\frac{1}{4}$  in. (6 mm) with the extension. This adjustment produced slightly steeper slopes for the V-notch. The complete drawing set can be found in Figures 69 through 92. Photographs of the test installation are shown in Figure 93. Material specifications, mill certifications, and certificates of conformity for the system materials are shown in Appendix A.
