No. FHWA/RD-80/502

SH TESTS OF SMALL HIGHWAY SIGN SUPPORTS

May 1980

Interim Report

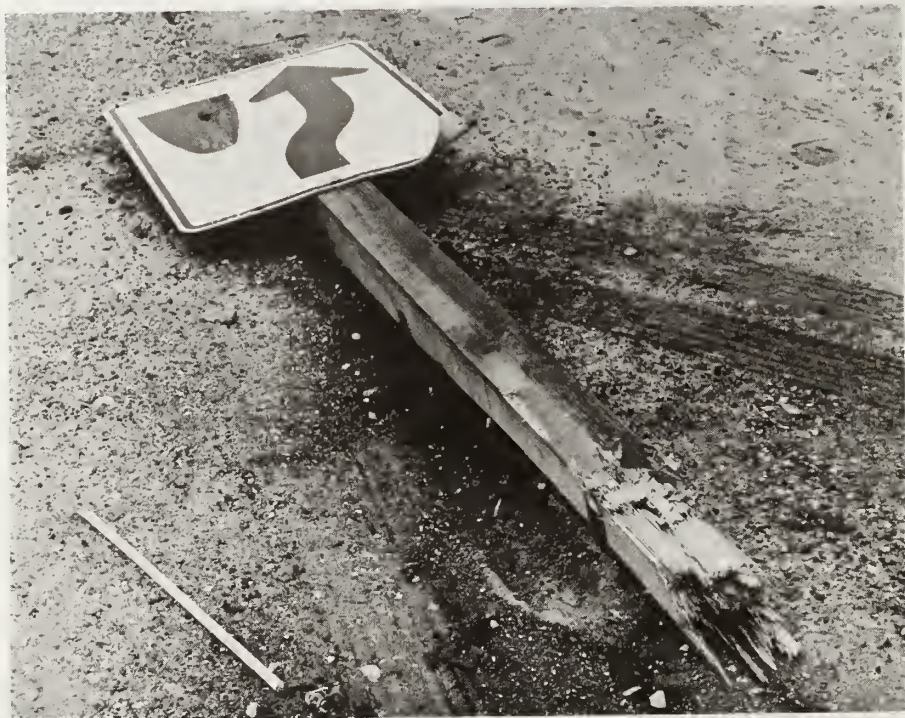
| TEST NO. | SYSTEM | IMPACT SPEED (mph) | POST SIZE | STUB SIZE | METHOD OF EMBEDMENT | DEPTH OF EMBEDMENT (ft) | WINDSHIELD BROKEN? | WINDSHIELD PENETRATED? | VEHICLE DAMAGE | | RESTORATION REQUIRED FOR SIGN INSTALLATION | CHANGE IN VEHICLE MOMENTUM (lb-sec) |
|---|--|---|---|---|---|---|---|---|---|---|--|---|
| 1 | Wood (Southern Pine) | 21.2 | 4 in. x 4 in. | None | Drill and Backfill | 4.0 | No | - | FL-1 | 12FLEN1 | Replace post; Repair and reuse sign panel | 484 |

(b) PANEL AND POST

Figure 36. Sign installation damage, test 1.

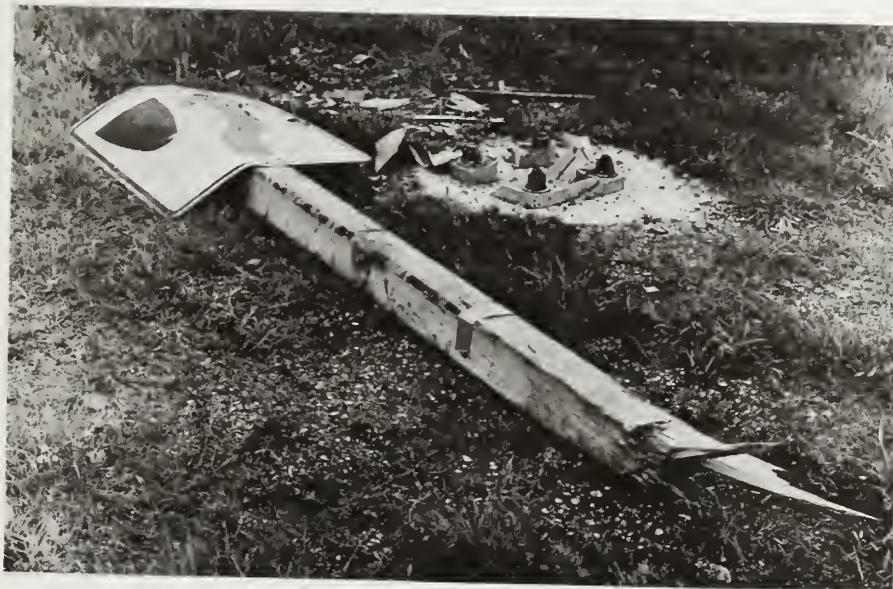
| TEST NO. | SYSTEM | IMPACT SPEED (mph) | POST SIZE | STUB SIZE | METHOD OF EMBEDMENT | DEPTH OF EMBEDMENT (ft) | WINDSHIELD BROKEN? | WINDSHIELD PENETRATED? | VEHICLE DAMAGE | | RESTORATION REQUIRED FOR SIGN INSTALLATION | CHANGE IN VEHICLE MOMENTUM (lb-sec) |
|---|--|---|---|---|---|---|---|---|---|---|--|---|
| 2 | Wood (Southern Pine) | 64.6 | 4 in. x 4 in. | None | Drill and Backfill | 4.0 | Yes by Panel | No | FR-1 | 12FREN1 | Replace post; repair and reuse sign panel | 478 |

(b) POST AND PANEL

Figure 42. Sign installation damage, test 2.

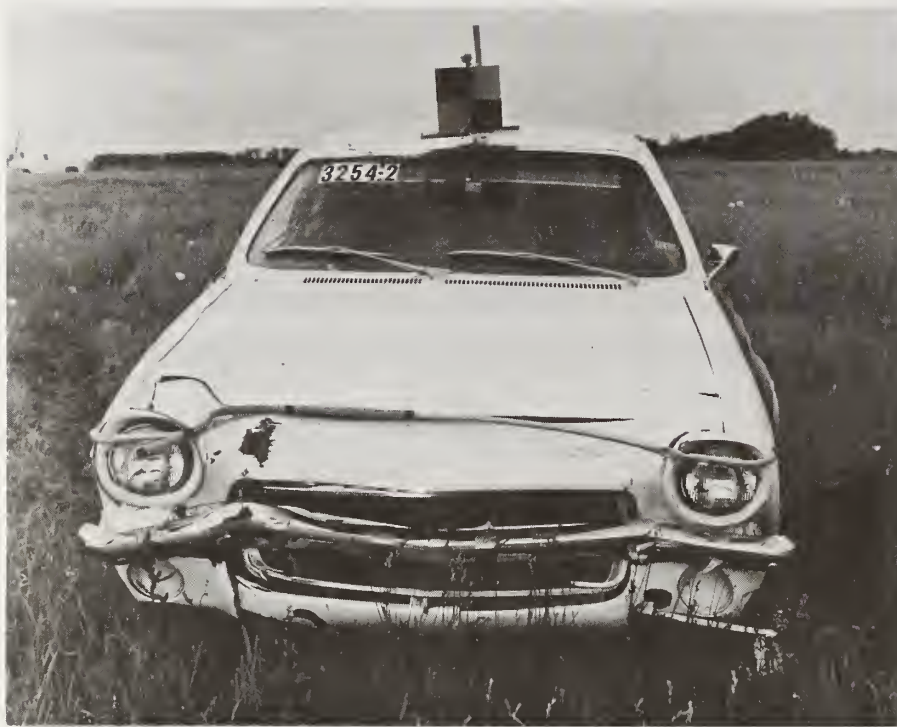
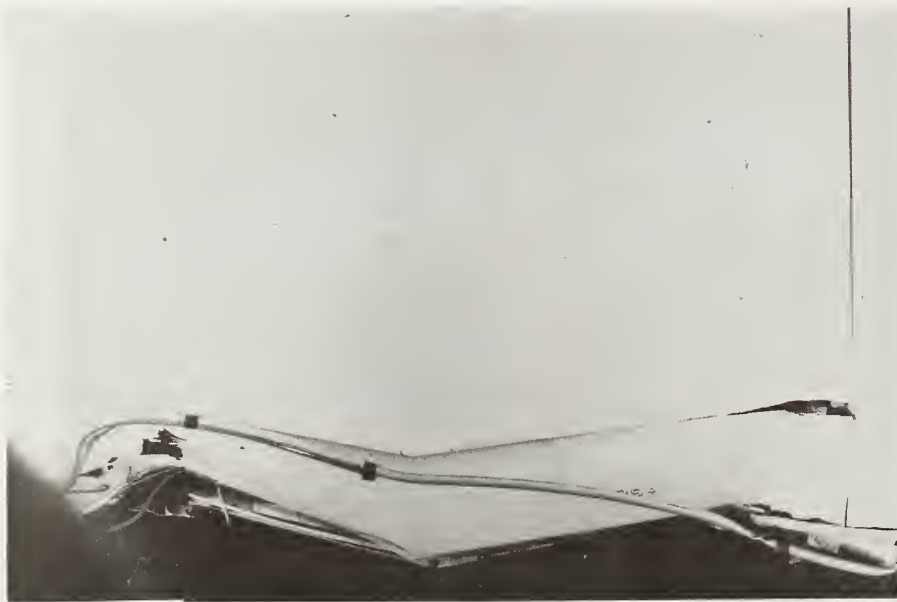
Figure 43. Vehicle damage, test 2.

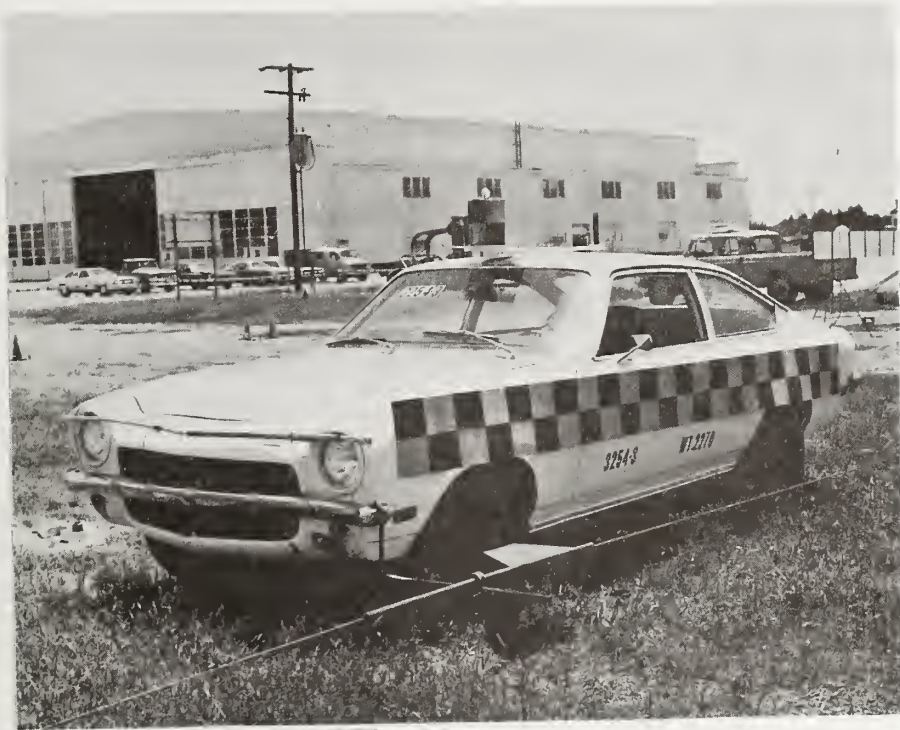
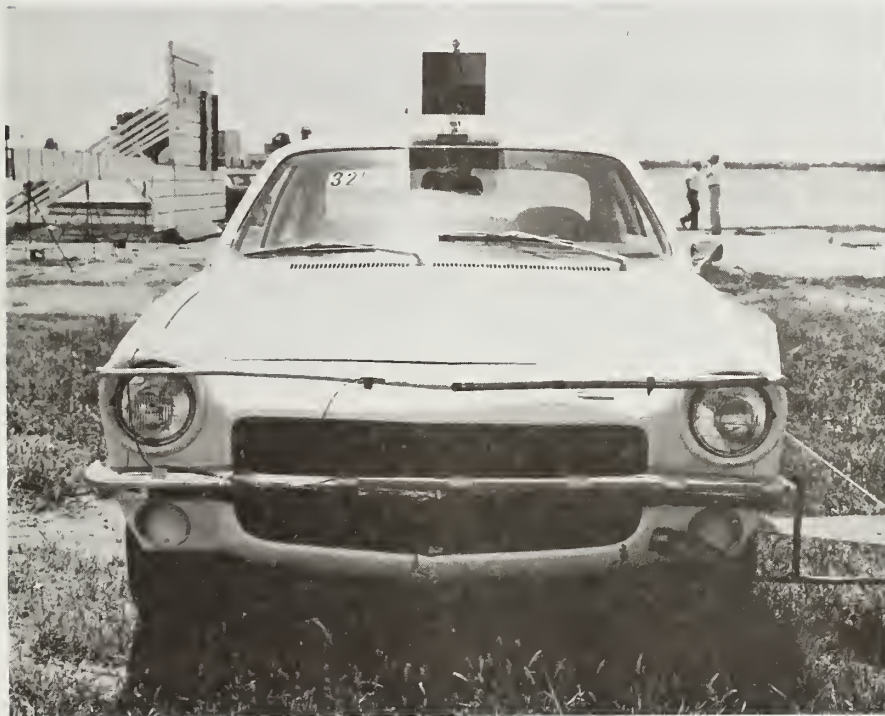
| TEST NO. | SYSTEM | IMPACT SPEED (mph) | POST SIZE | STUB SIZE | METHOD OF EMBEDMENT | DEPTH OF EMBEDMENT (ft) | WINDSHIELD BROKEN? | WINDSHIELD PENETRATED? | VEHICLE DAMAGE | | RESTORATION REQUIRED FOR SIGN INSTALLATION | CHANGE IN VEHICLE MOMENTUM (lb-sec) |
|---|--|---|---|---|---|---|---|---|---|---|--|---|
| 3 | Steel U-Post (Billet Steel) | 20.8 | 3 lb/ft | None | Driven | 3.5 | No | - | FL-D | 12FLEN1 | Replace post; Sign panel reusable | 318 |

Figure 49. Vehicle damage, test 3.

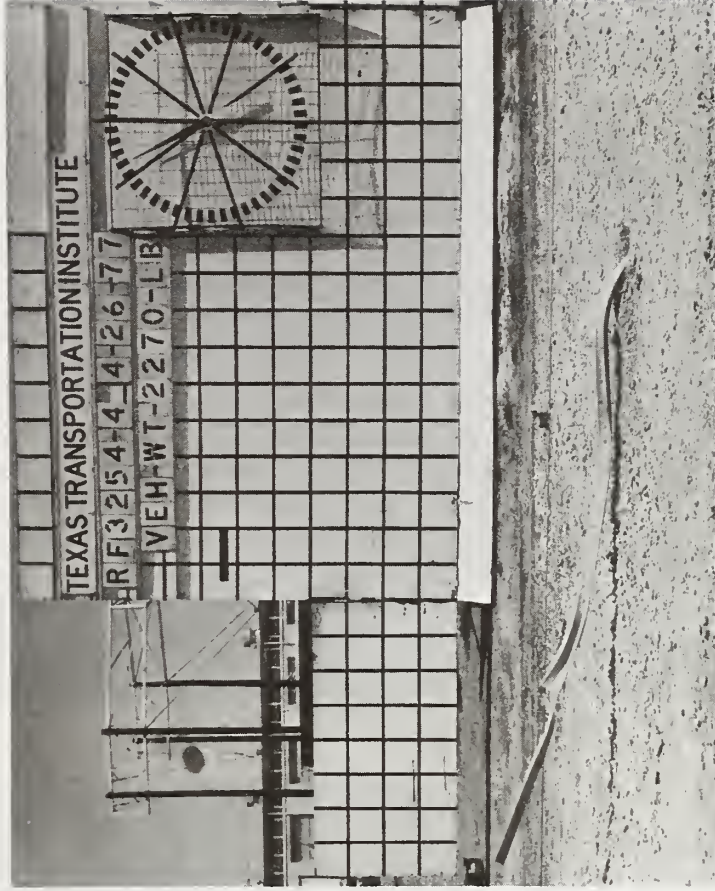
| TEST NO. | SYSTEM | IMPACT SPEED (mph) | POST SIZE | STUB SIZE | METHOD OF EMBEDMENT | DEPTH OF EMBEDMENT (ft) | WINDSHIELD BROKEN? | WINDSHIELD PENETRATED? | VEHICLE DAMAGE | | RESTORATION REQUIRED FOR SIGN INSTALLATION | CHANGE IN VEHICLE MOMENTUM (lb-sec) |
|---|--|---|---|---|---|---|---|---|---|---|--|---|
| 4 | Steel U-Post (Billet Steel) | 61.2 | 3 lb/ft | None | Driven | 3.5 | No | No | FR-4 | 12FREN3 | Replace complete installation | 950 |

Figure 54. Sign installation damage, test 4.

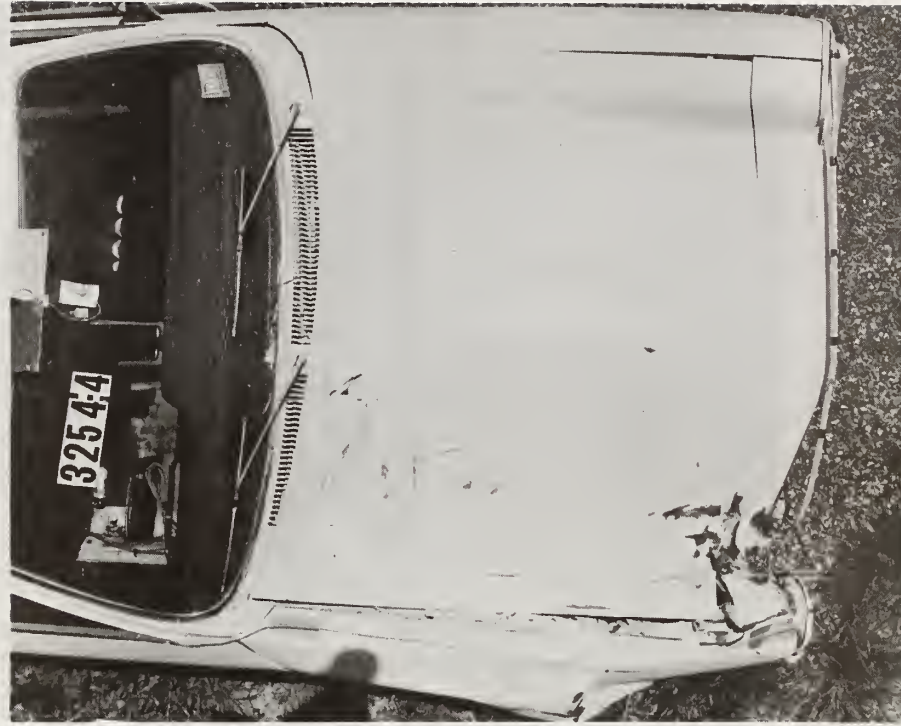
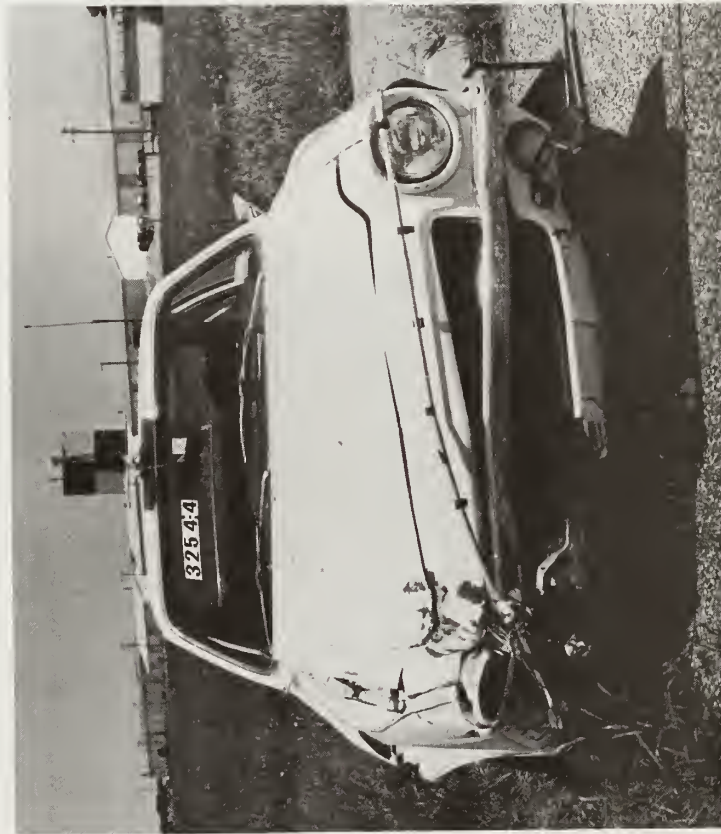
Figure 55. Vehicle damage, test 4.

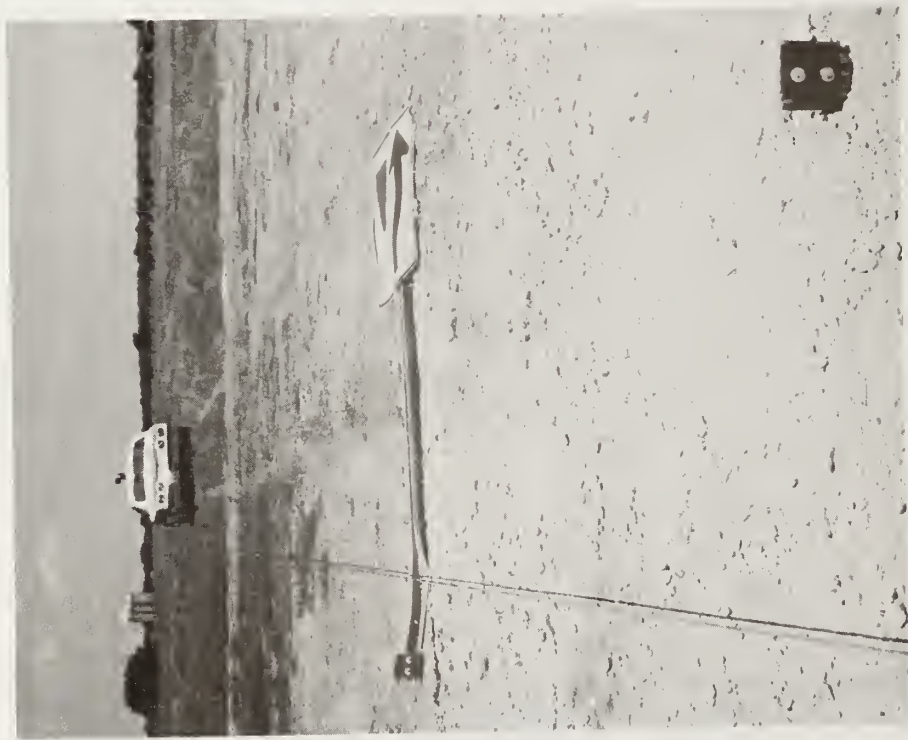
| TEST NO. | SYSTEM | IMPACT SPEED (mph) | POST SIZE | STUB SIZE | METHOD OF EMBEDMENT | DEPTH OF EMBEDMENT (ft) | WINDSHIELD BROKEN? | WINDSHIELD PENETRATED? | VEHICLE DAMAGE | | RESTORATION REQUIRED FOR SIGN INSTALLATION | CHANGE IN VEHICLE MOMENTUM (lb-sec) |
|---|--|---|---|---|---|---|---|---|---|---|--|---|
| 5 | Steel U-Post and Stub (Billet Steel) with Frangible Coupling | 21.9 | 3 lb/ft | 3 lb/ft | Driven | 3.08 | No | - | FL-0 | 12FLEN1 | Replace post, frangible coupling, retaining straps and possibly the stub; Repair and reuse sign panel | 267 |

Figure 60. Sign installation damage, test 5.

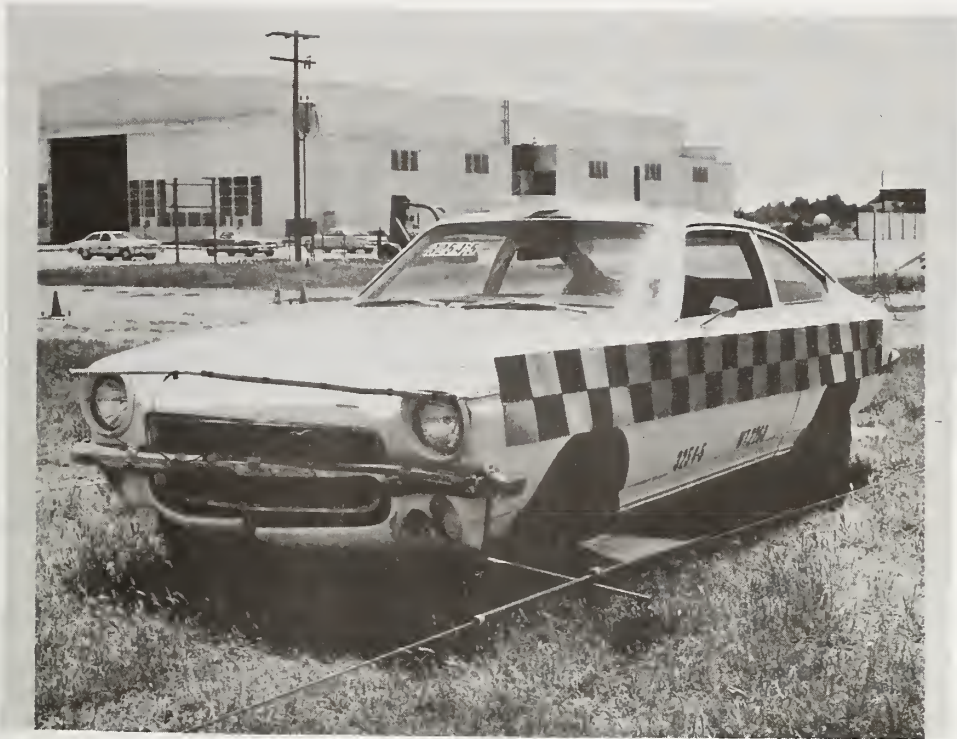
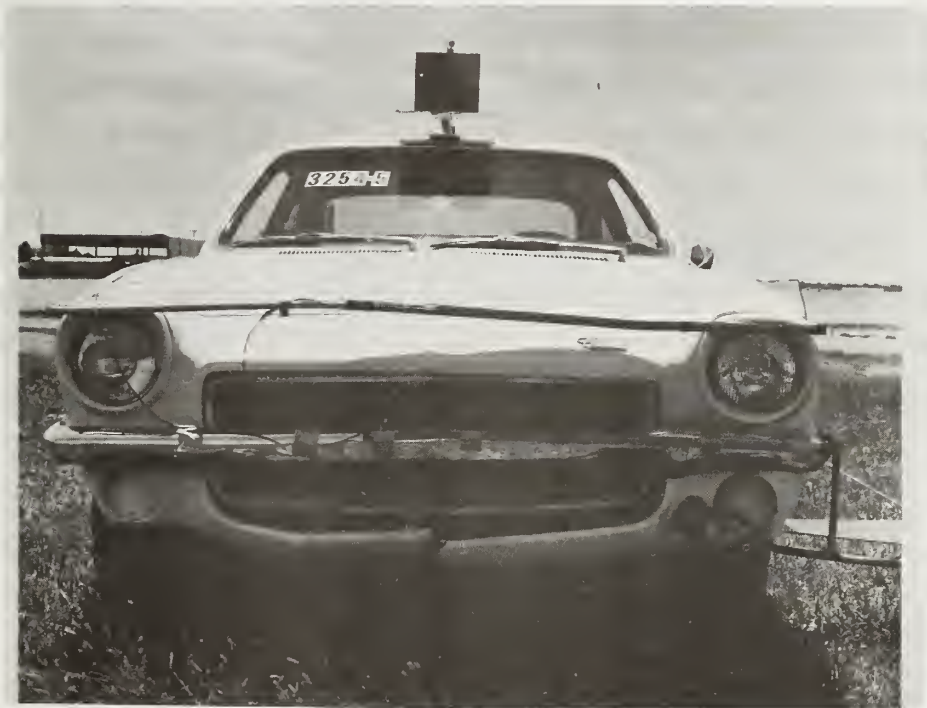
Figure 61. Vehicle damage, test 5.

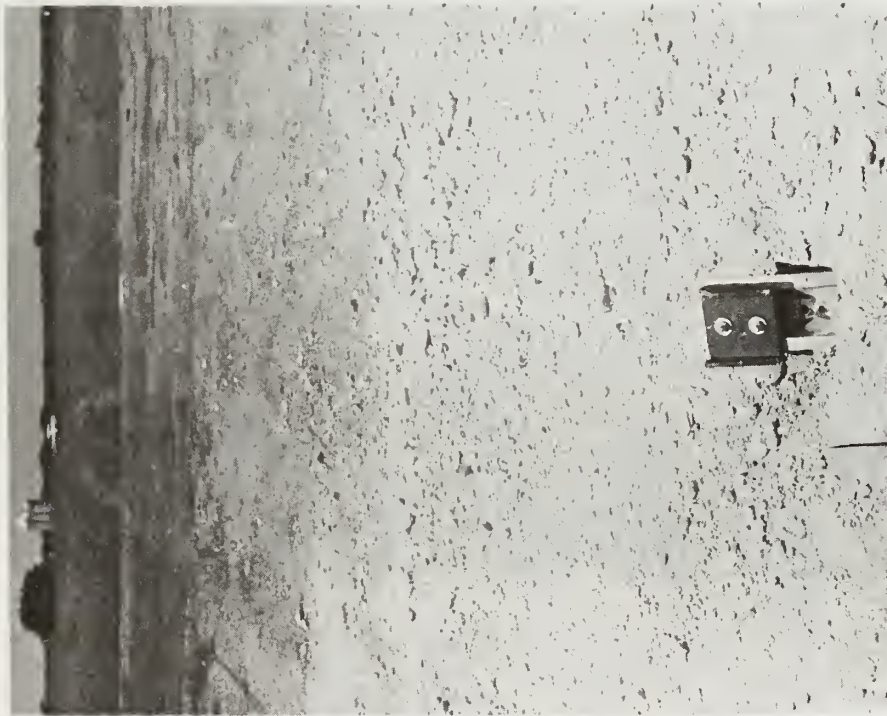
| TEST NO. | SYSTEM | IMPACT SPEED (mph) | POST SIZE | STUB SIZE | METHOD OF EMBEDMENT | DEPTH OF EMBEDMENT (ft) | WINDSHIELD BROKEN? | WINDSHIELD PENETRATED? | VEHICLE DAMAGE | | RESTORATION REQUIRED FOR SIGN INSTALLATION | CHANGE IN VEHICLE MOMENTUM (lb-sec) |
|---|--|---|---|---|---|---|---|---|---|---|--|---|
| 6 | Steel U-Post and Stub (Billet Steel) with Frangible Coupling | 66.1 | 3 lb/ft | 3 lb/ft | Driven | 3.08 | Yes by Panel | No | FR-1 | 12FREN1 | Replace frangible coupling, retaining straps and stub; Sign post possibly reusable with straightening; Repair and reuse sign panel | 287 |

Figure 66. Damage to stub, test 6.

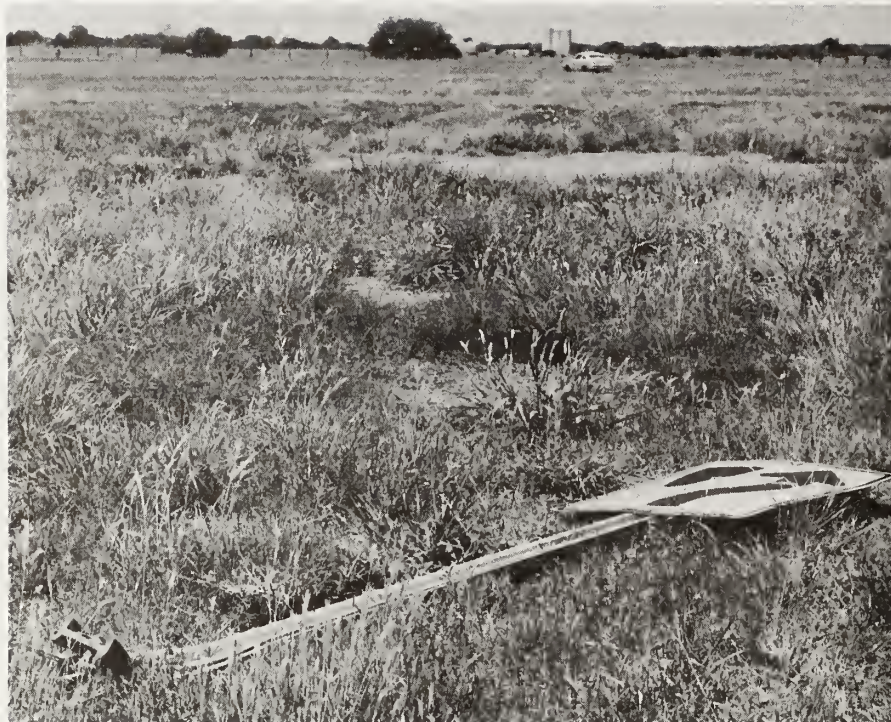
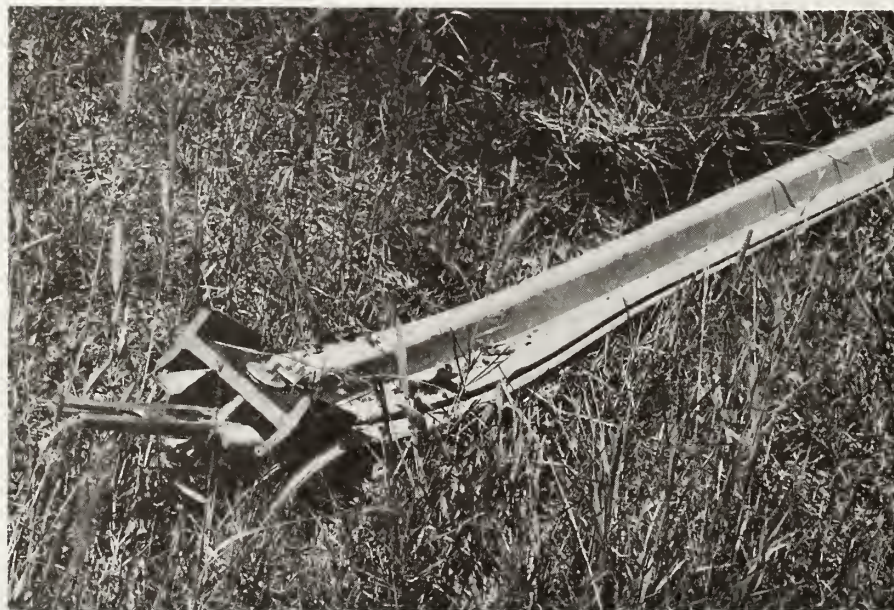
Figure 67. Post damage, test 6.

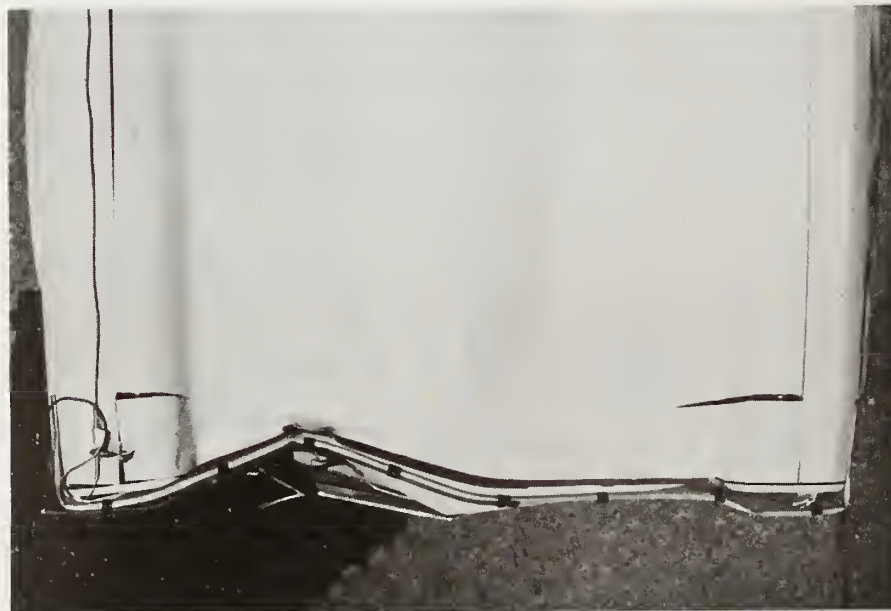
Figure 68. Vehicle damage, test 6.

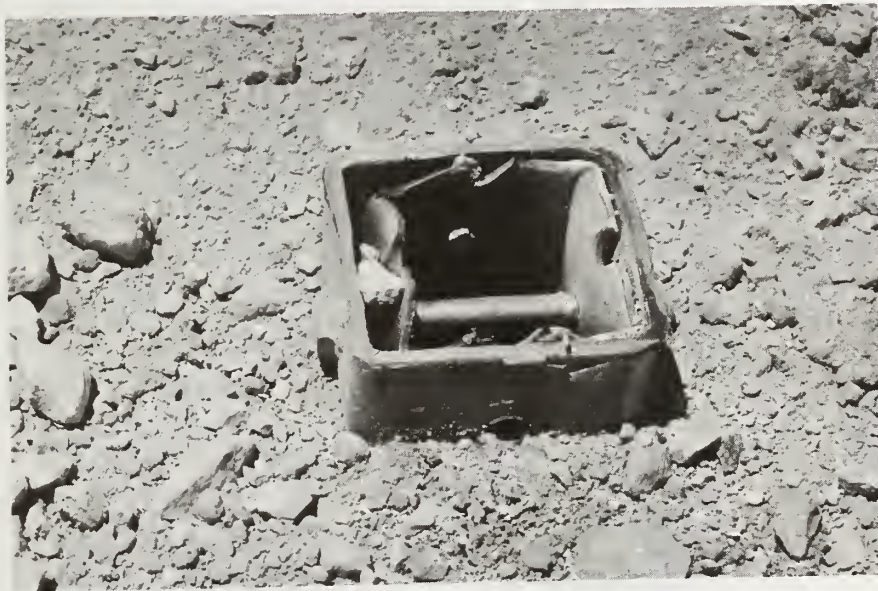
| TEST NO. | SYSTEM | IMPACT SPEED (mph) | POST SIZE | STUB SIZE | METHOD OF EMBEDMENT | DEPTH OF EMBEDMENT (ft) | WINDSHIELD BROKEN? | WINDSHIELD PENETRATED? | VEHICLE DAMAGE | | RESTORATION REQUIRED FOR SIGN INSTALLATION | CHANGE IN VEHICLE MOMENTUM (lb-sec) |
|---|--|---|---|---|---|---|---|---|---|---|--|---|
| 7 | Square Perforated Steel Tube -- Post and Stub | 61.4 | 2.5 in. x 2.5 in. (10 ga.) | 3 in. x 3 in. x 3/16 in. | Driven | 2.92 | Yes Due to hood hitting it | No | FL-4 | 12FLEN3 | Stub possibly reusable; Replace post; Sign panel reusable | 559 |

Figure 73. Sign installation damage, test 7.

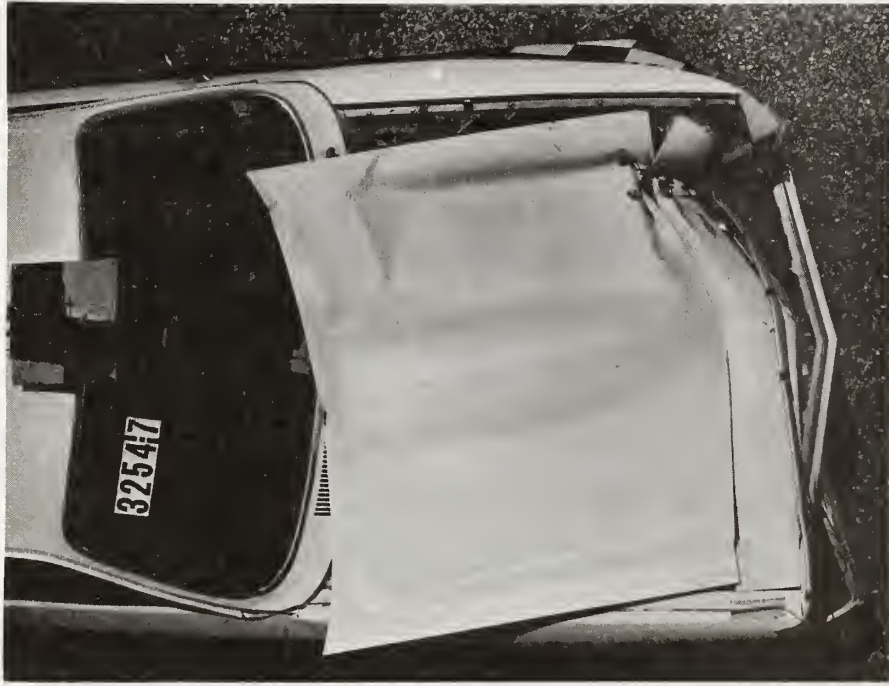
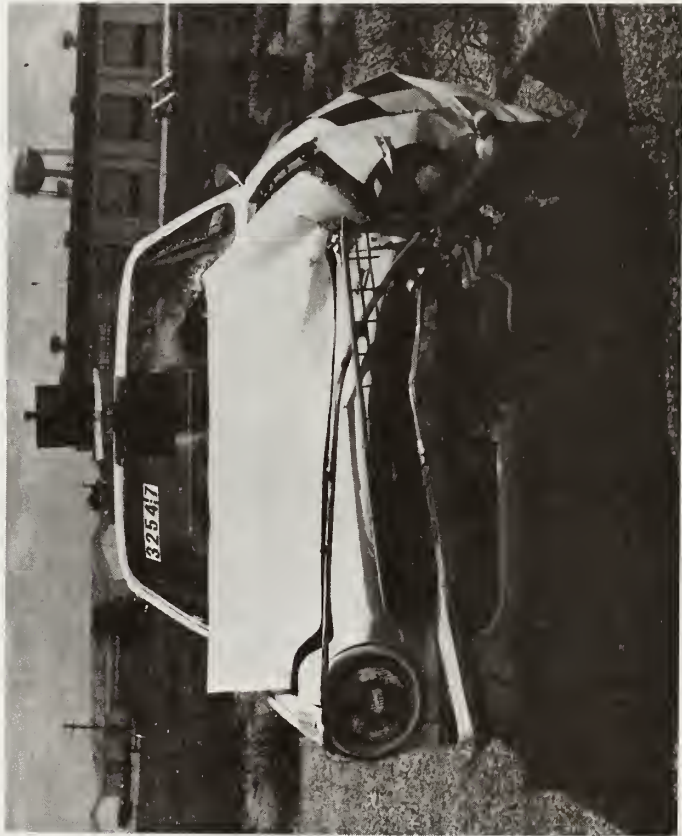
Figure 74. Vehicle damage, test 7.

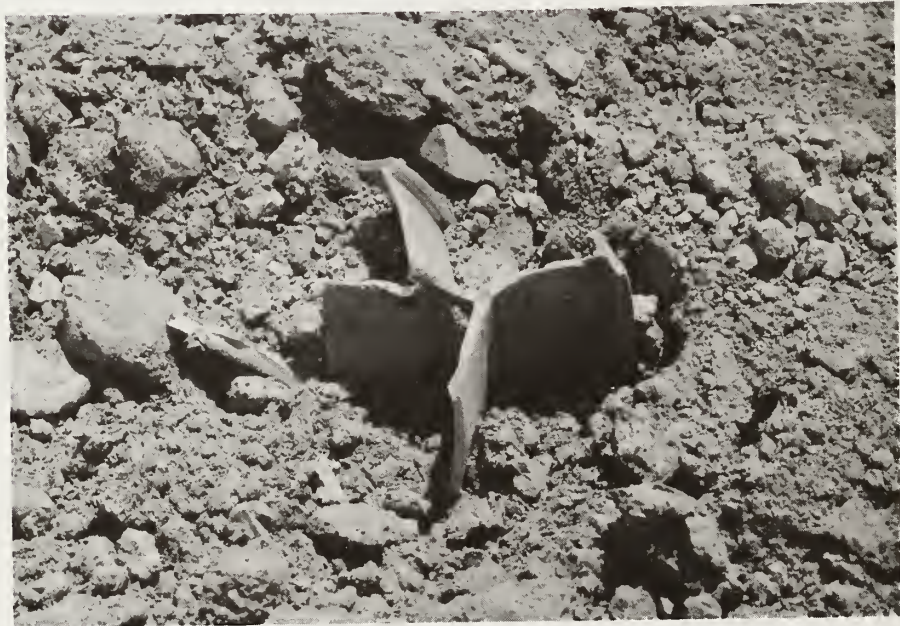
| TEST NO. | SYSTEM | IMPACT SPEED (mph) | POST SIZE | STUB SIZE | METHOD OF EMBEDMENT | DEPTH OF EMBEDMENT (ft) | WINDSHIELD BROKEN? | WINDSHIELD PENETRATED? | VEHICLE DAMAGE | | RESTORATION REQUIRED FOR SIGN INSTALLATION | CHANGE IN VEHICLE MOMENTUM (lb-sec) |
|---|--|---|---|---|---|---|---|---|---|---|--|---|
| 8 | Aluminum Type X | 63.7 | 3X | None | Drill and Backfill | 3.5 | No | - | FR-1 | 12FREN1 | Replace post; Repair and reuse sign panel | 414 |

Figure 79. Sign installation damage, test 8.

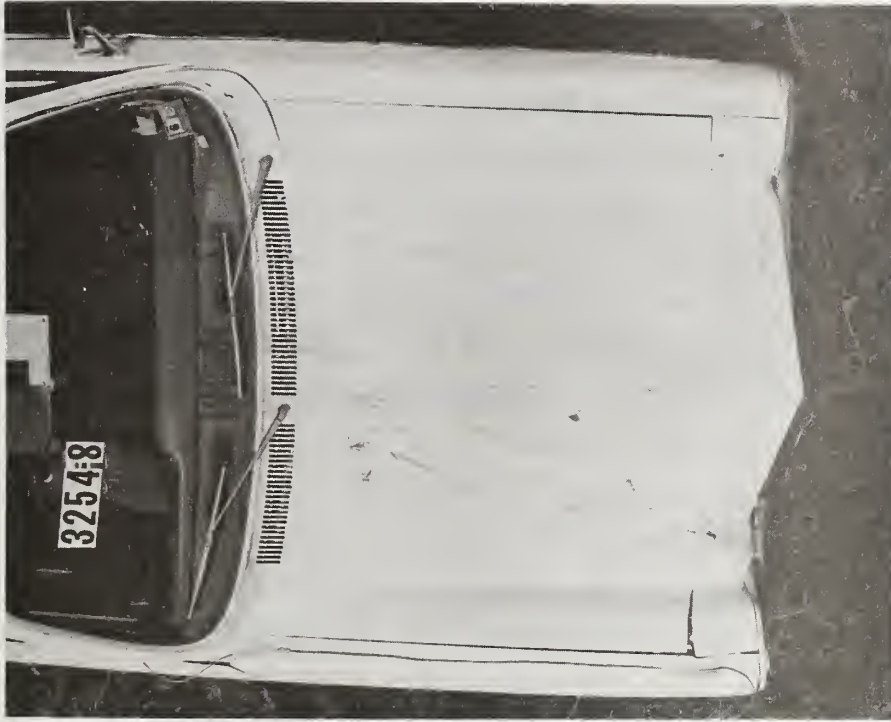
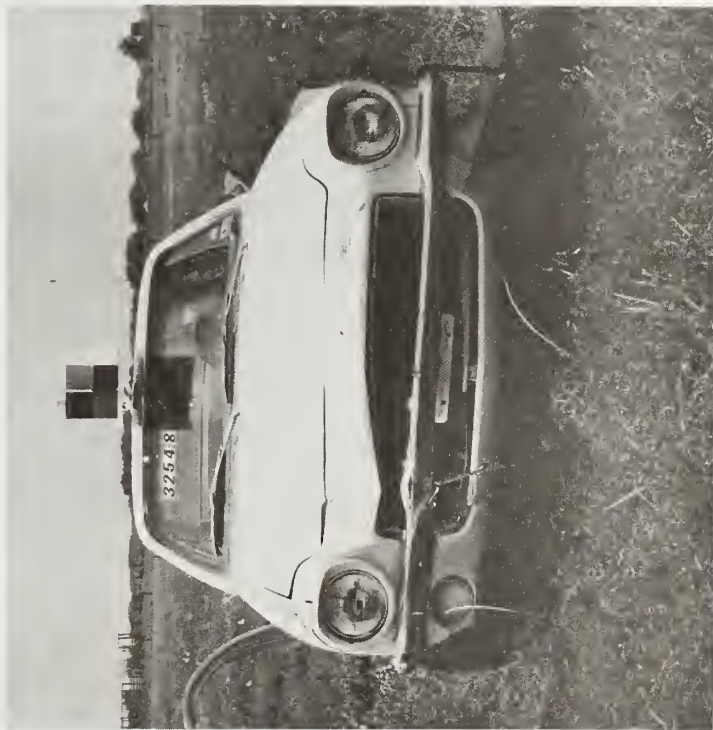
Figure 80. Vehicle damage, test 8.

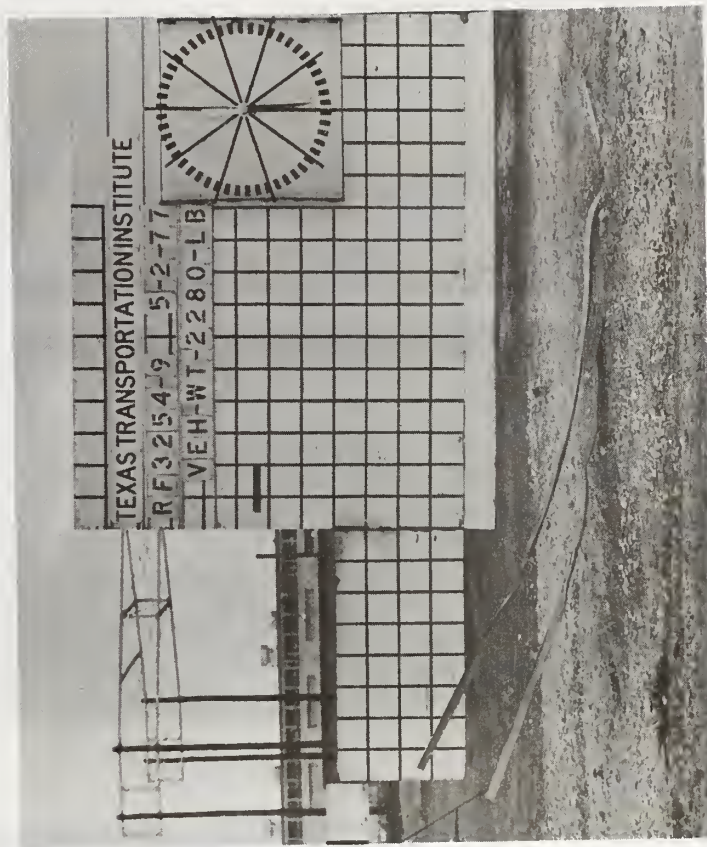
| TEST NO. | SYSTEM | IMPACT SPEED (mph) | POST SIZE | STUB SIZE | METHOD OF EMBEDMENT | DEPTH OF EMBEDMENT (ft) | WINDSHIELD BROKEN? | WINDSHIELD PENETRATED? | VEHICLE DAMAGE | | RESTORATION REQUIRED FOR SIGN INSTALLATION | CHANGE IN VEHICLE MOMENTUM (lb-sec) |
|---|--|---|---|---|---|---|---|---|---|---|--|---|
| 9 | Steel U-Post Back-to-Back (Billet Steel) | 61.2 | 6 lb/ft | None | Drill and Backfill | 4.0 | Yes Due to hood hitting it | No | FL-5 | 12FLEN4 | Replace complete installation | 2249 |

Figure 85. Sign installation damage, test 9.

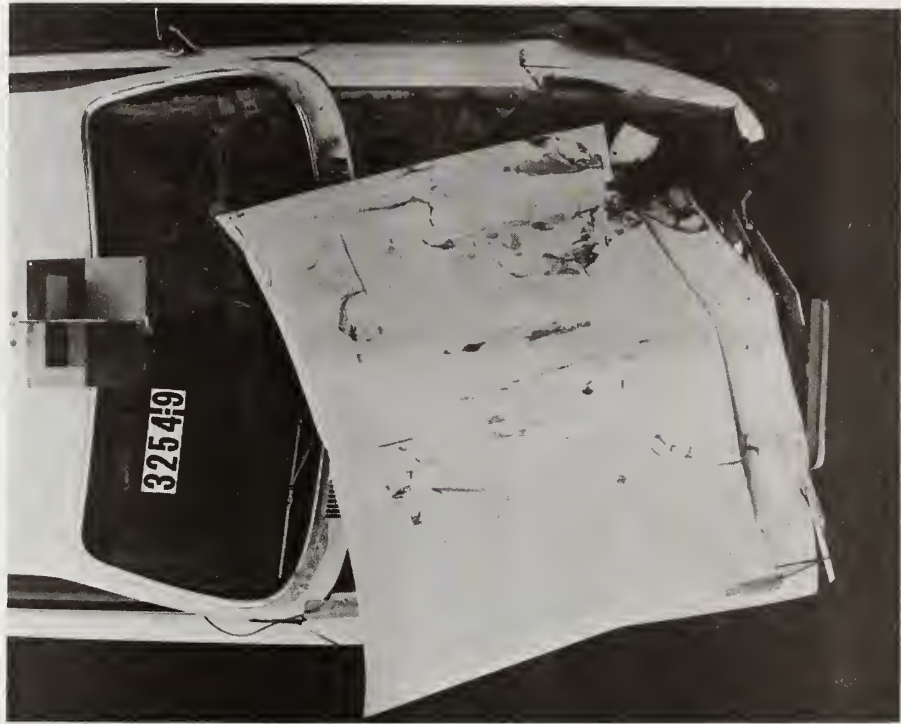
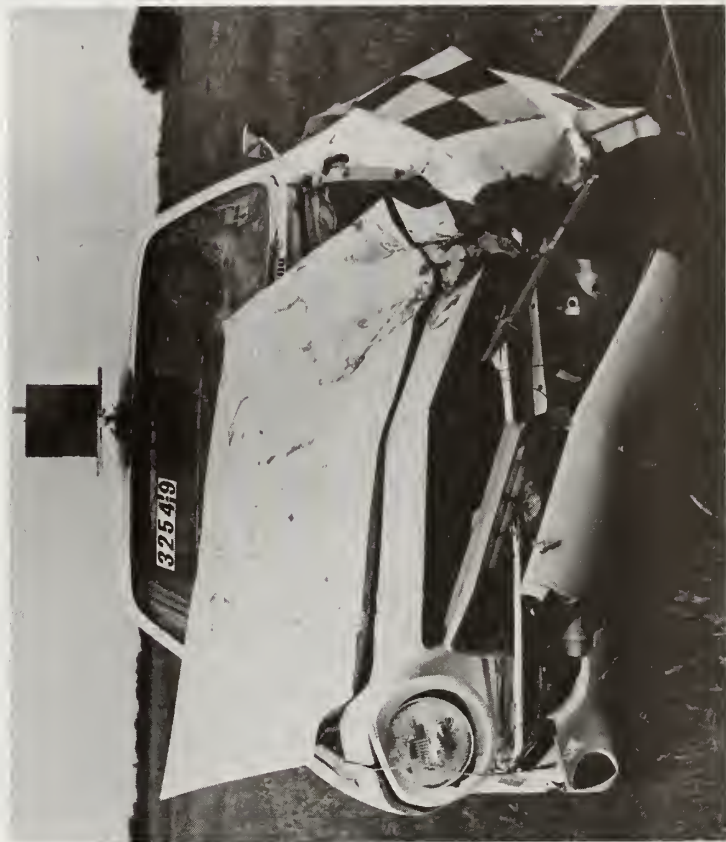
Figure 86. Vehicle damage, test 9.

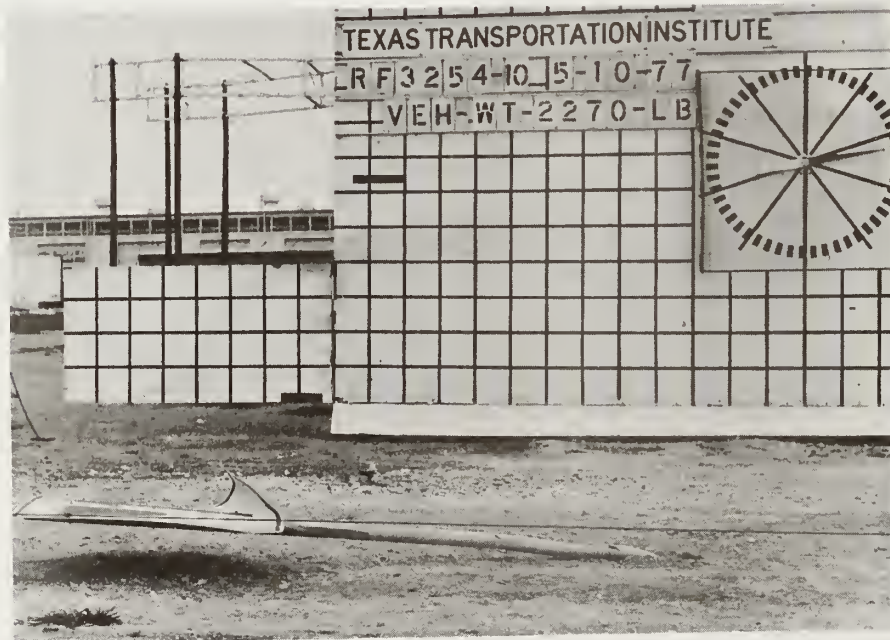
| TEST NO. | SYSTEM | IMPACT SPEED (mph) | POST SIZE | STUB SIZE | METHOD OF EMBEDMENT | DEPTH OF EMBEDMENT (ft) | WINDSHIELD BROKEN? | WINDSHIELD PENETRATED? | VEHICLE DAMAGE | | RESTORATION REQUIRED FOR SIGN INSTALLATION | CHANGE IN VEHICLE MOMENTUM (lb-sec) |
|---|--|---|---|---|---|---|---|---|---|---|--|---|
| 10 | Standard Steel Pipe | 18.9 | 2.5 in. dia. | None | Drill and Backfill | 4.0 | No | - | FL-1 | 12FLEN1 | Replace post; Repair and reuse sign panel | 883 |

Figure 91. Sign installation damage, test 10.

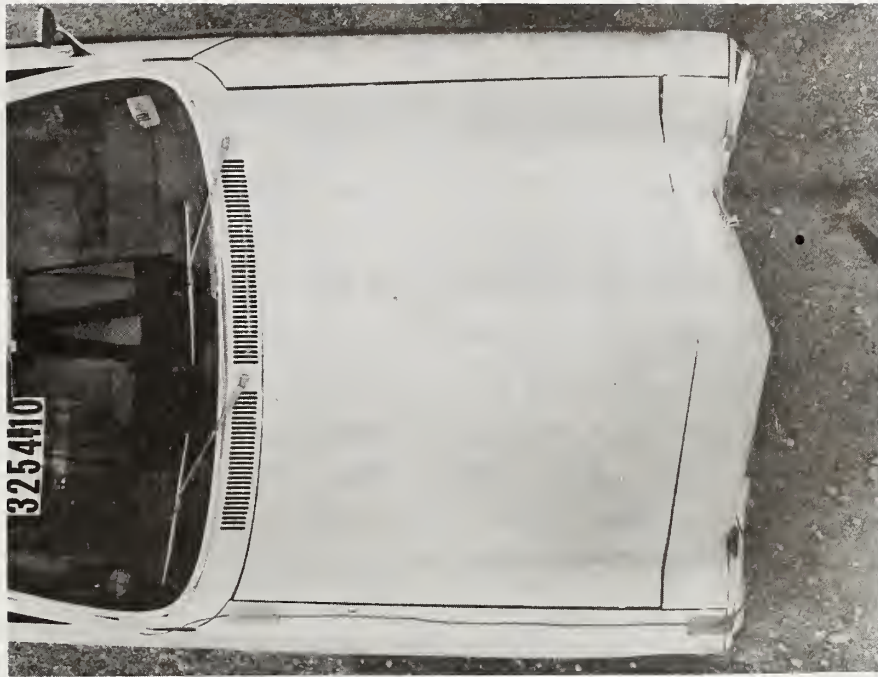
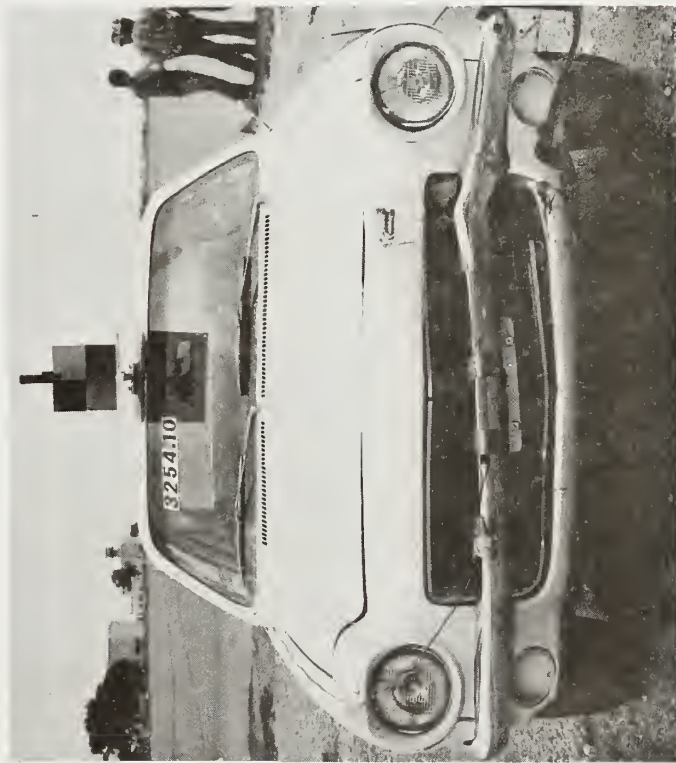
Figure 92. Vehicle damage, test 10.

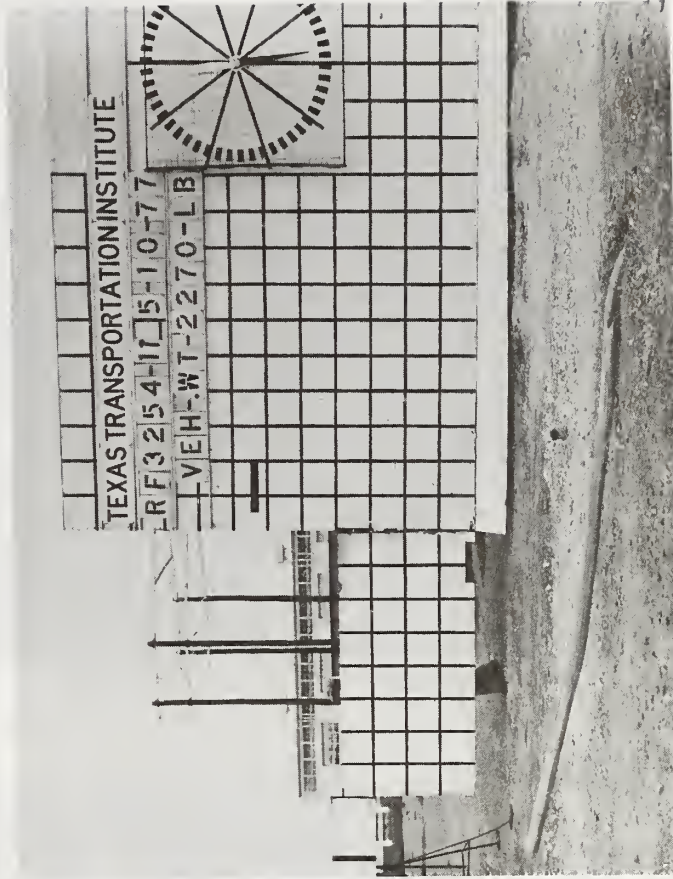
| TEST NO. | SYSTEM | IMPACT SPEED (mph) | POST SIZE | STUB SIZE | METHOD OF EMBEDMENT | DEPTH OF EMBEDMENT (ft) | WINDSHIELD BROKEN? | WINDSHIELD PENETRATED? | VEHICLE DAMAGE | | RESTORATION REQUIRED FOR SIGN INSTALLATION | CHANGE IN VEHICLE MOMENTUM (lb-sec) |
|---|--|---|---|---|---|---|---|---|---|---|--|---|
| 11 | Standard Steel Pipe | 61.4 | 2.5 in. dia. | None | Drill and Backfill | 4.0 | Yes Due to Car Rolling | No | L&T-5 R&T-5 FR-4 | DOTBAD4 12FREN3 | Replace post; Repair and reuse sign panel | 1252 |

Figure 97. Sign installation damage, test 11.

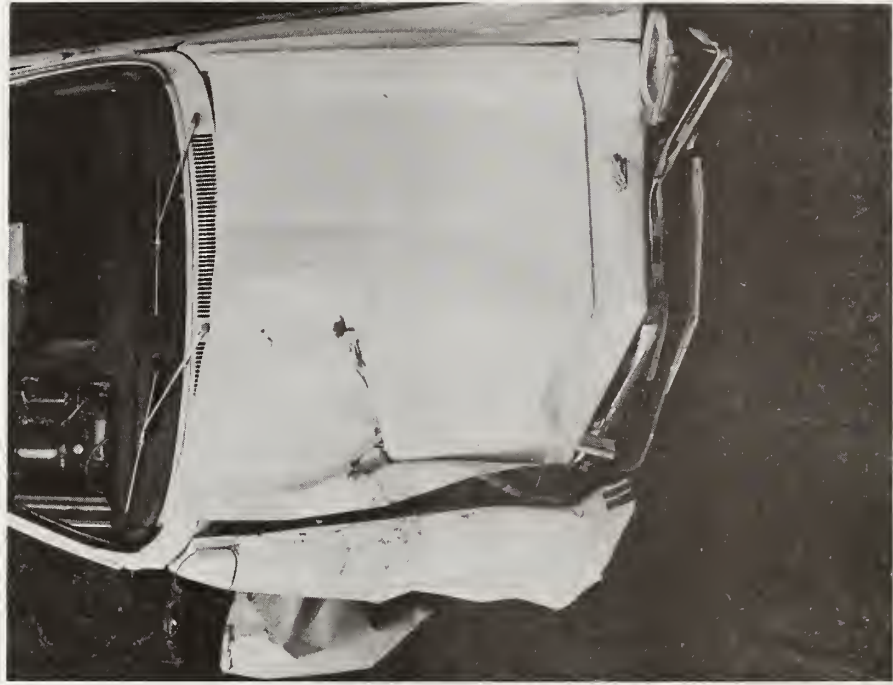
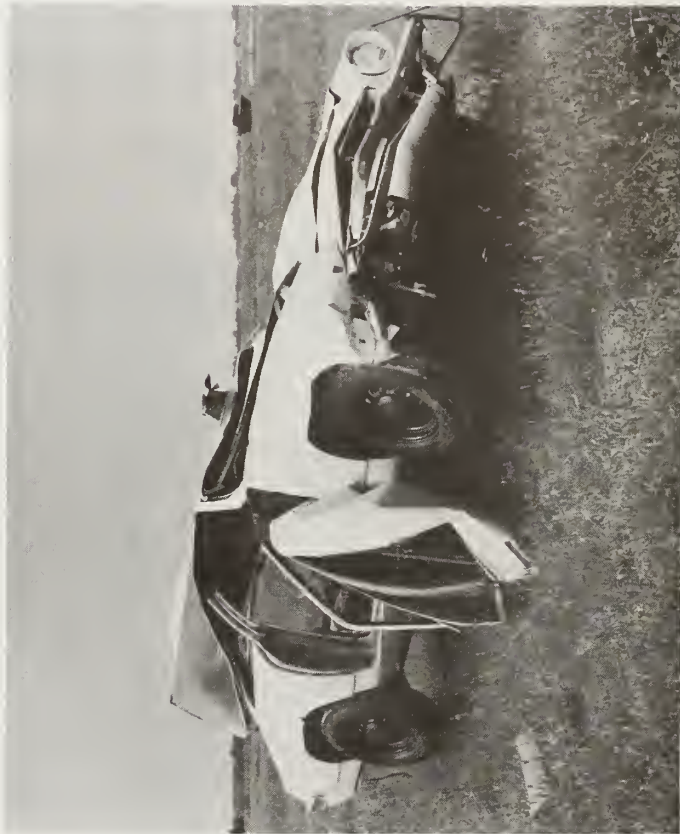
Figure 98. Vehicle damage, test 11.

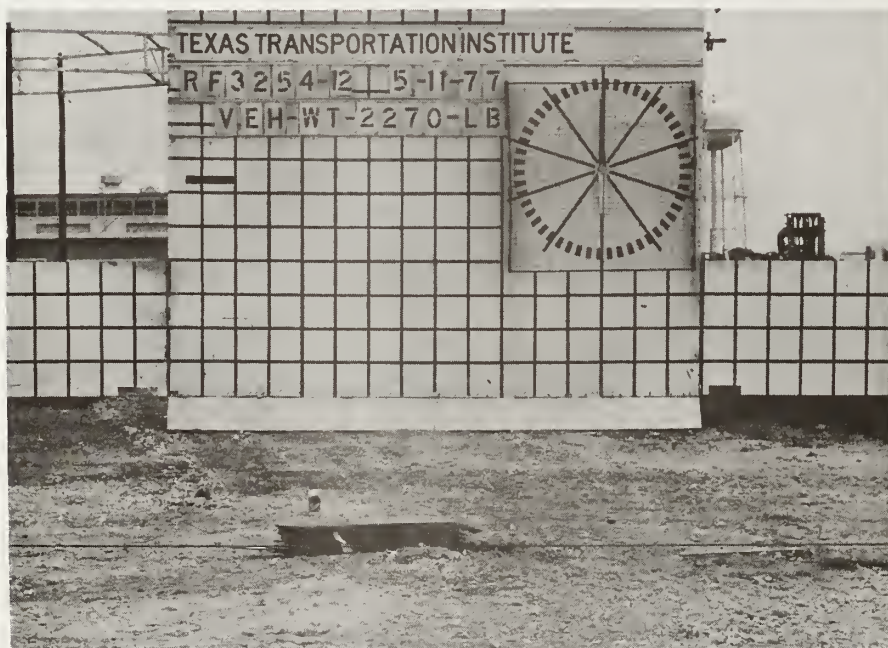
| TEST NO. | SYSTEM | IMPACT SPEED (mph) | POST SIZE | STUB SIZE | METHOD OF EMBEDMENT | DEPTH OF EMBEDMENT (ft) | WINDSHIELD BROKEN? | WINDSHIELD PENETRATED? | VEHICLE DAMAGE | | RESTORATION REQUIRED FOR SIGN INSTALLATION | CHANGE IN VEHICLE MOMENTUM (lb-sec) |
|---|--|---|---|---|---|---|---|---|---|---|--|---|
| 12 | Wood (Southern Pine) | 20.7 | 4 in. x 6 in. (Nominal Size) | None | Drill and Backfill | 4.0 | No | - | FL-2 | 12FLEN1 | Replace post; Sign panel reusable | 525 |

Figure 103. Sign installation damage, test 12.

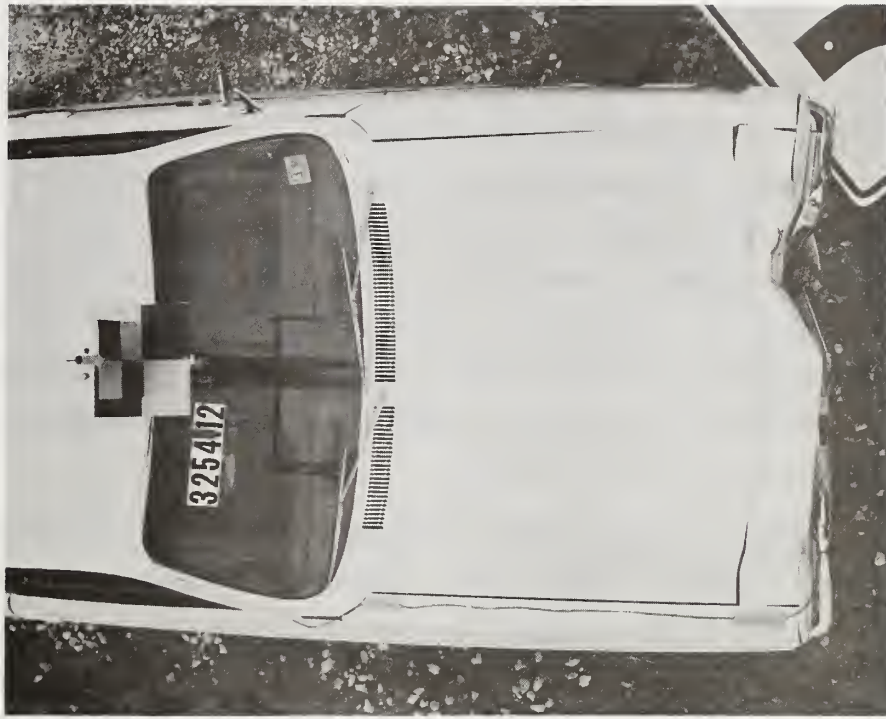
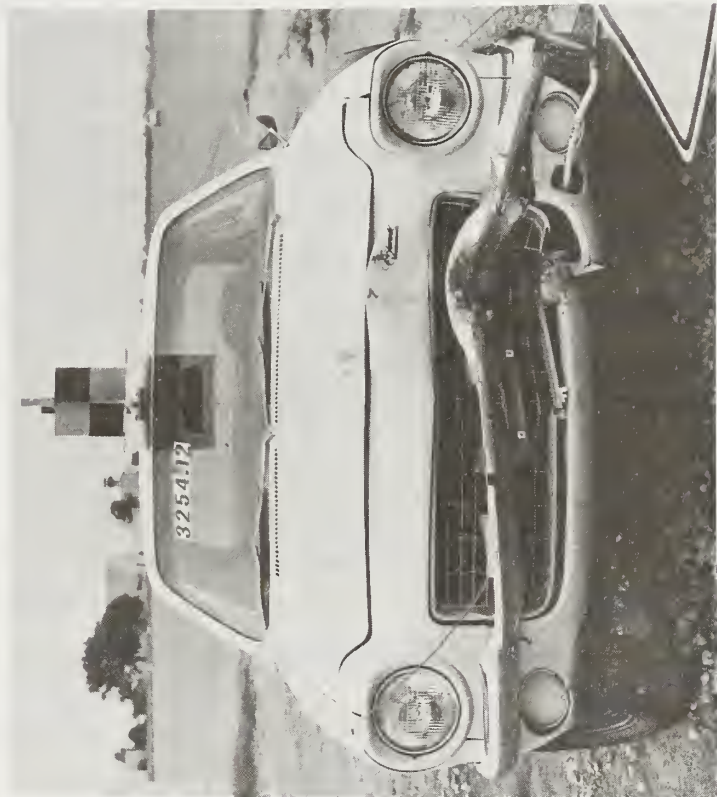
Figure 104. Vehicle damage, test 12.
