No. FHWA/RD-80/502

SH TESTS OF SMALL HIGHWAY SIGN SUPPORTS

May 1980

Interim Report

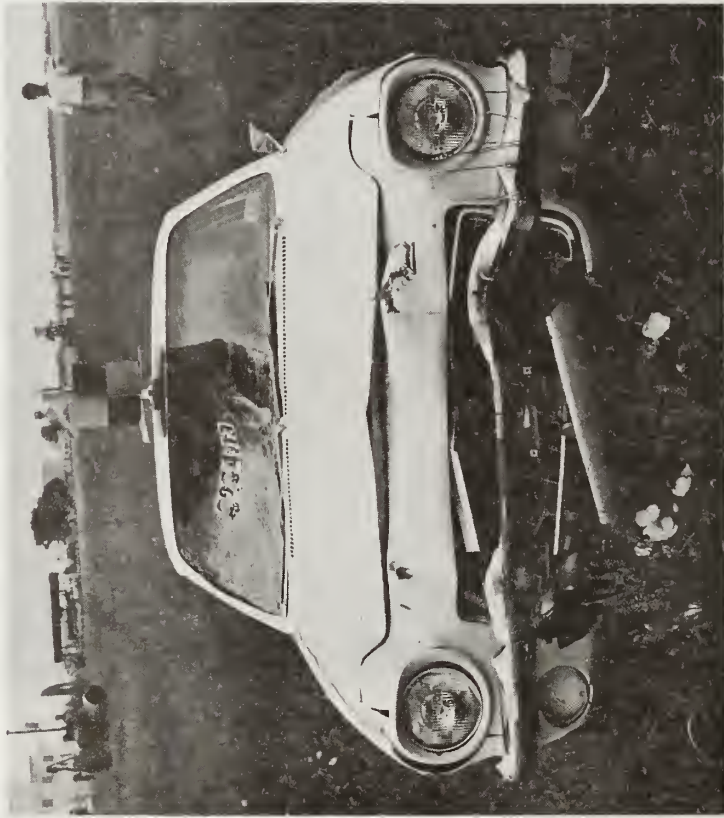
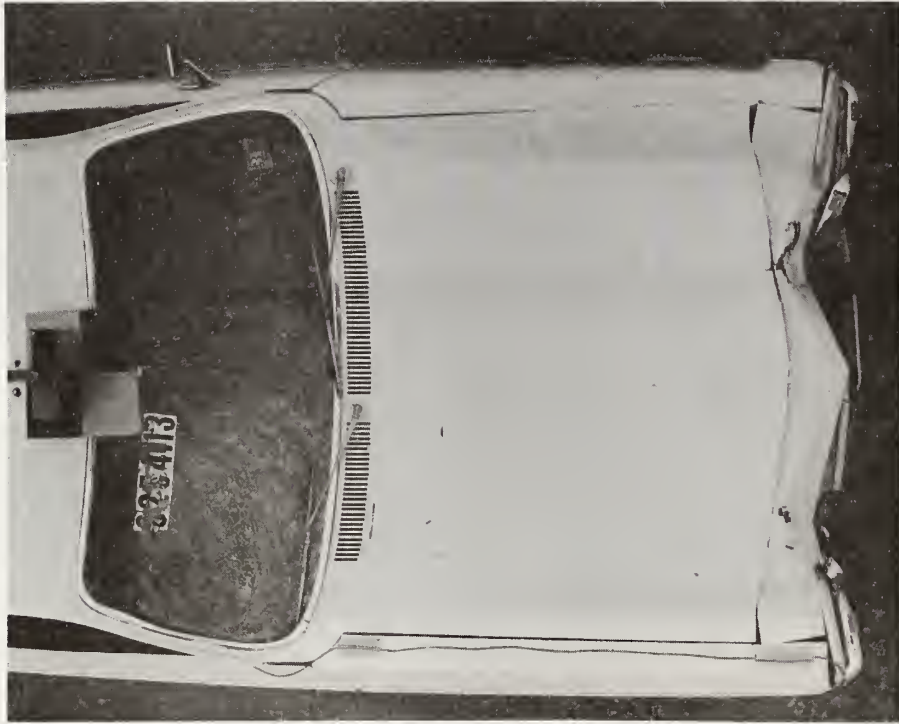
| TEST NO. | SYSTEM | IMPACT SPEED (mph) | POST SIZE | STUB SIZE | METHOD OF EMBEDMENT | DEPTH OF EMBEDMENT (ft) | WINDSHIELD BROKEN? | WINDSHIELD PENETRATED? | VEHICLE DAMAGE | | RESTORATION REQUIRED FOR SIGN INSTALLATION | CHANGE IN VEHICLE MOMENTUM (lb-sec) |
|---|--|---|---|---|---|---|---|---|---|---|--|---|
| 13 | Steel U-Post (Rail Steel) | 63.8 | 3 lb/ft | None | Driven | 3.5 | Yes by Panel | No | FR-2 | 12FREN1 | Replace post; Repair and reuse sign panel | 255 |

Note: Damage caused by test 13 is that on the right side of the vehicle.

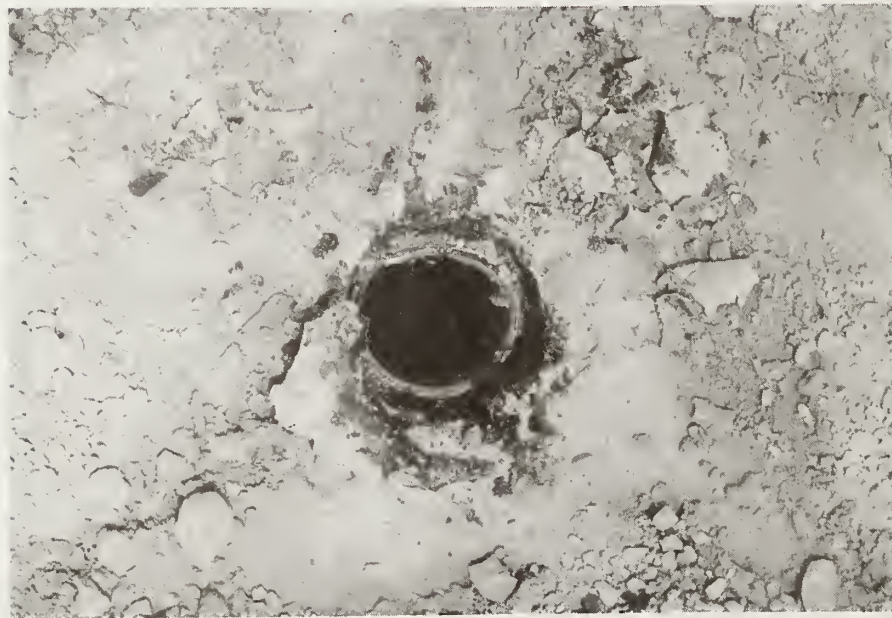
| TEST NO. | SYSTEM | IMPACT SPEED (mph) | POST SIZE | STUB SIZE | METHOD OF EMBEDMENT | DEPTH OF EMBEDMENT (ft) | WINDSHIELD BROKEN? | WINDSHIELD PENETRATED? | VEHICLE DAMAGE | | RESTORATION REQUIRED FOR SIGN INSTALLATION | CHANGE IN VEHICLE MOMENTUM (lb-sec) |
|---|--|---|---|---|---|---|---|---|---|---|--|---|
| 14 | Standard Steel Pipe Post and Stub with Breakaway Collar | 20.3 | 2.5 in. dia. | 2.5 in. dia. | Concrete Footing | 2.5 (footing) 2.0 (stub) | No | - | FL-1 | 12FLEN1 | Replace post, sign, and footing; Sign panel reusable | 802 |

Figure 115. Sign installation damage, test 14.

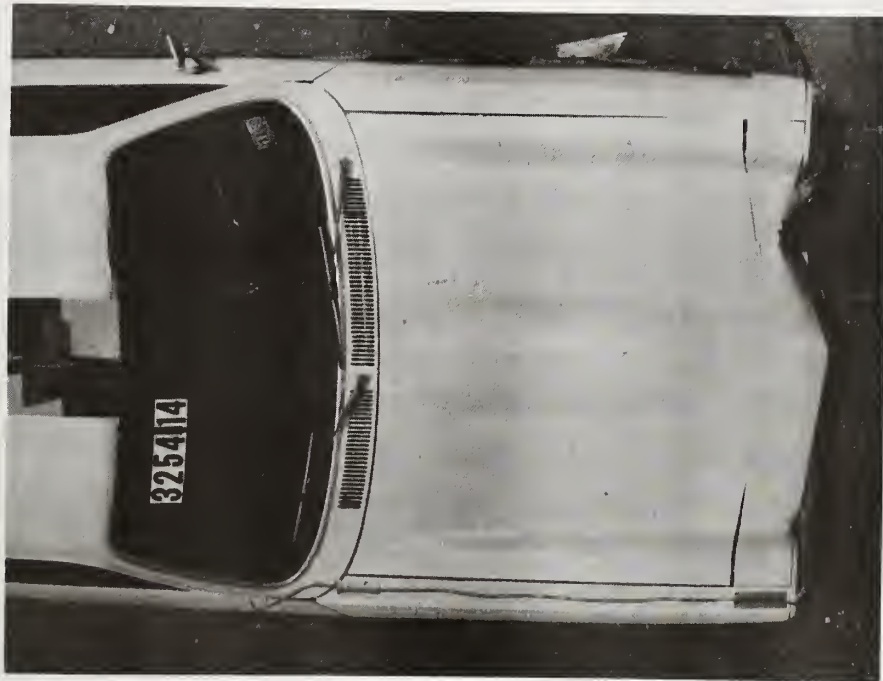
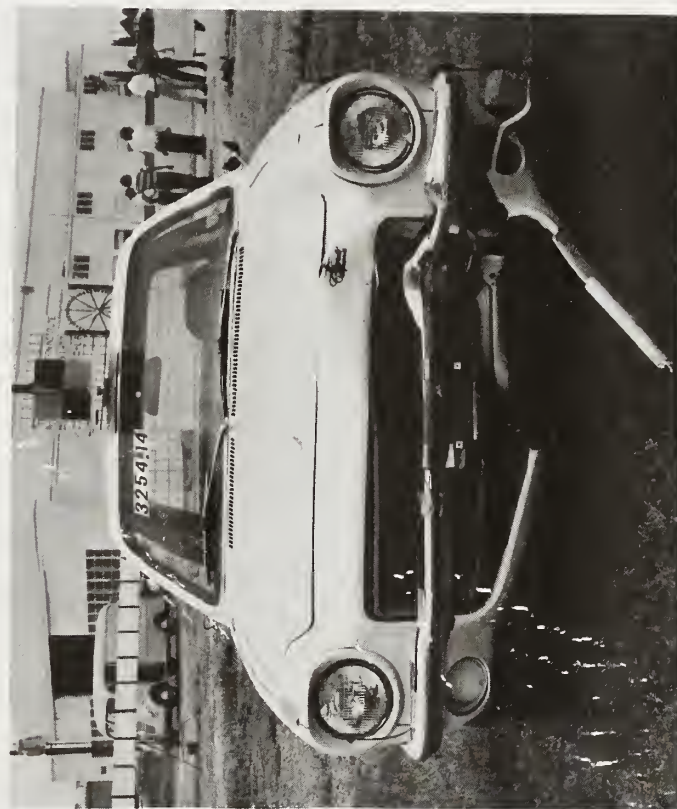
Figure 116. Vehicle damage, test 14.

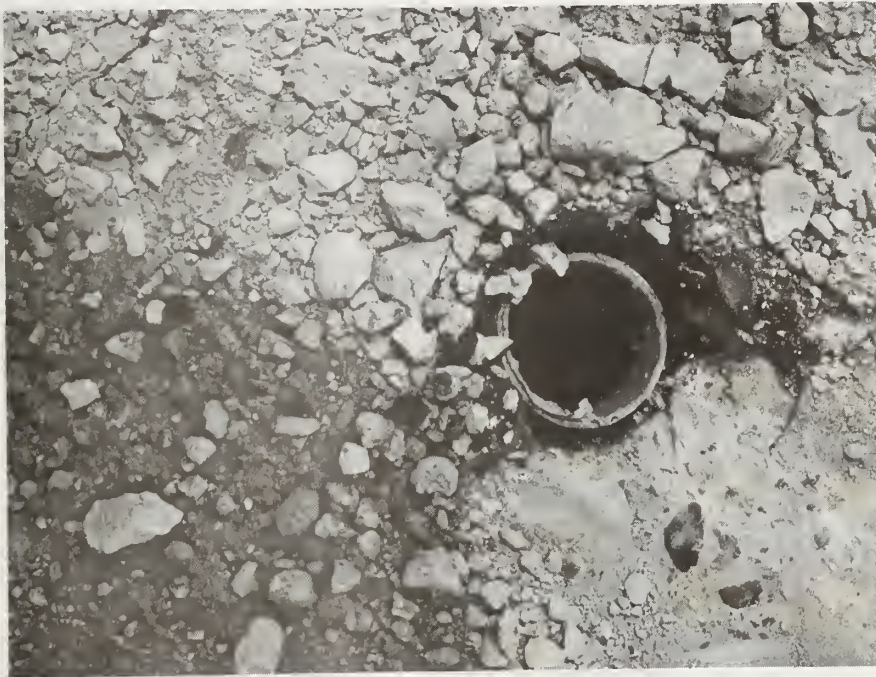
| TEST NO. | SYSTEM | IMPACT SPEED (mph) | POST SIZE | STUB SIZE | METHOD OF EMBEDMENT | DEPTH OF EMBEDMENT (ft) | WINDSHIELD BROKEN? | WINDSHIELD PENETRATED? | VEHICLE DAMAGE | | RESTORATION REQUIRED FOR SIGN INSTALLATION | CHANGE IN VEHICLE MOMENTUM (lb-sec) |
|---|--|---|---|---|---|---|---|---|---|---|--|---|
| 15 | Standard Steel Pipe Post and Stub with Breakaway Collar | 63.3 | 2.5 in. dia. | 2.5 in. dia. | Concrete Footing | 2.5 (footing) 2.0 (stub) | No | - | FR-1 | 12FREN1 | Replace post, stub, and footing; Repair and reuse sign panel | 379 |

Figure 121. Sign installation damage, test 15.

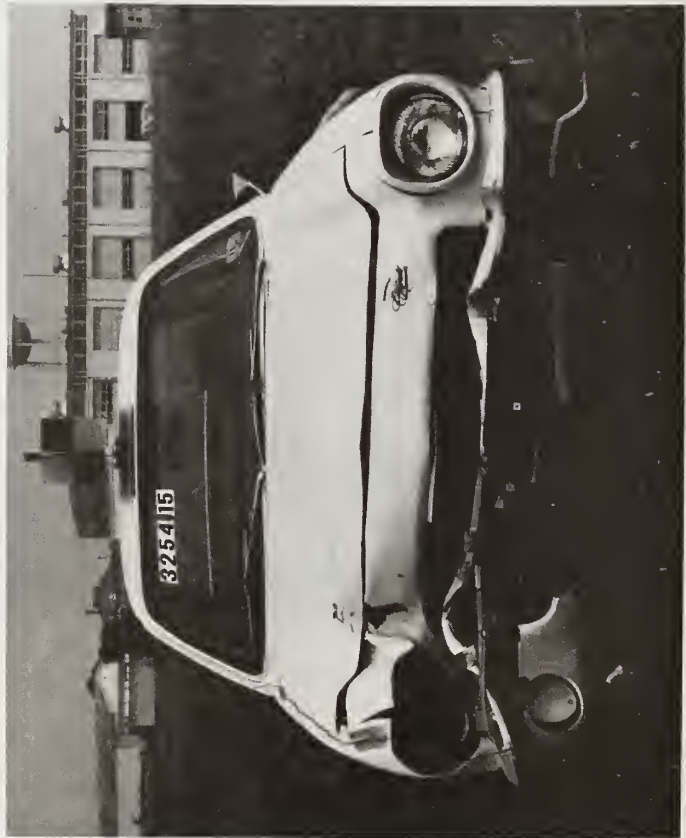
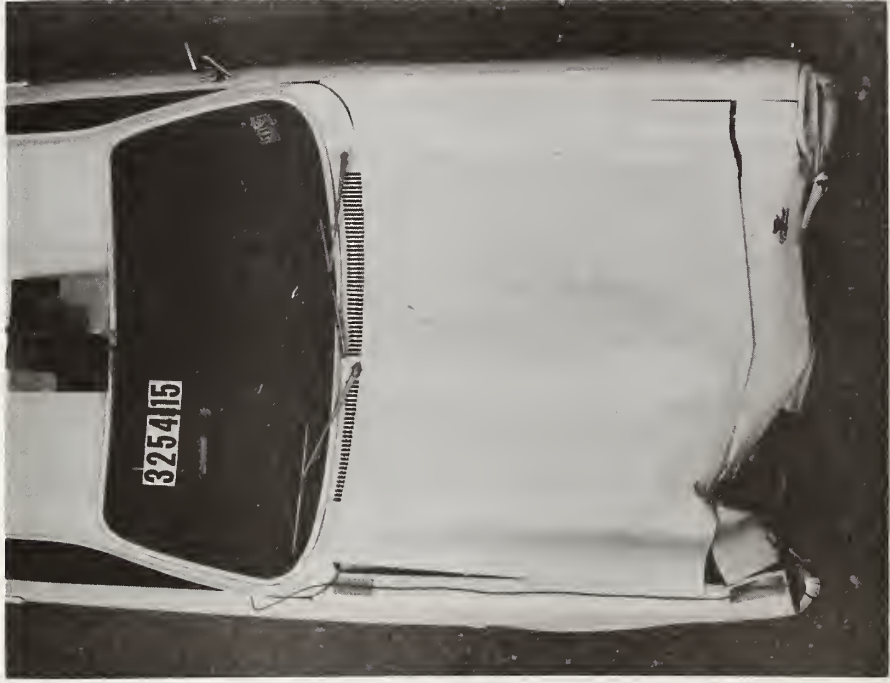
Note: Damage caused by test is that on right front of vehicle.

Figure 122. Vehicle damage, test 15.

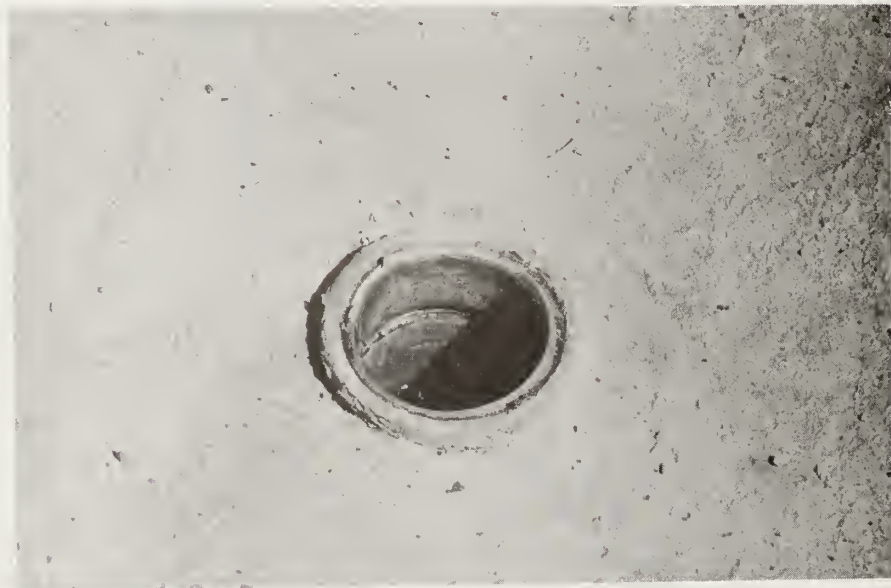
| TEST NO. | SYSTEM | IMPACT SPEED (mph) | POST SIZE | STUB SIZE | METHOD OF EMBEDMENT | DEPTH OF EMBEDMENT (ft) | WINDSHIELD BROKEN? | WINDSHIELD PENETRATED? | VEHICLE DAMAGE | | RESTORATION REQUIRED FOR SIGN INSTALLATION | CHANGE IN VEHICLE MOMENTUM (lb-sec) |
|---|--|---|---|---|---|---|---|---|---|---|--|---|
| 16 | Standard Steel Pipe Post and Stub with Breakaway Collar | 19.2 | 2.5 in. dia. | 2.5 in. dia. | Concrete Footing | 2.5 (footing) 2.0 (stub) | No | - | FL-1 | 12FLEN1 | Replace post; stub reusable; Sign panel reusable | 638 |

Figure 127. Sign installation damage, test 16.

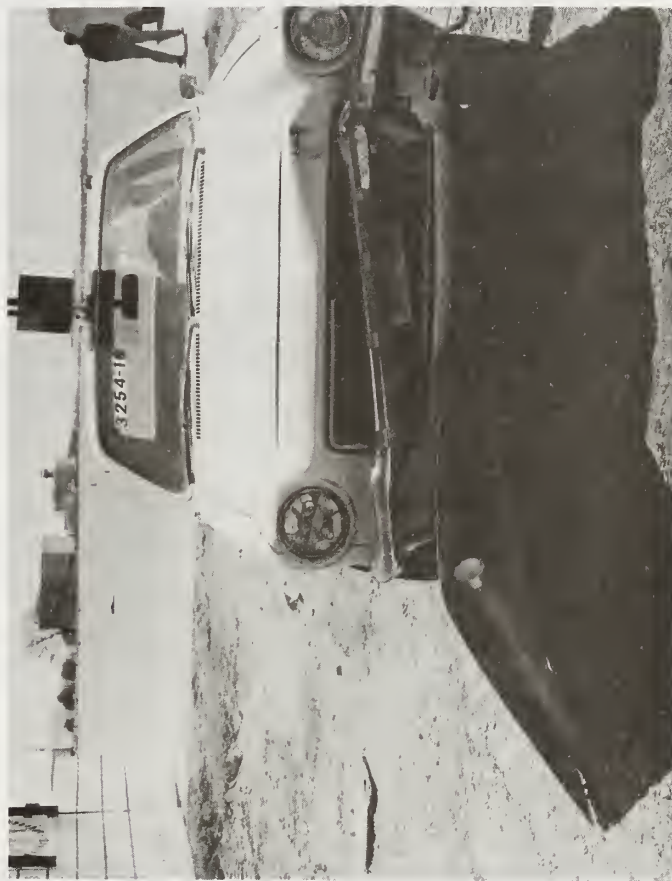
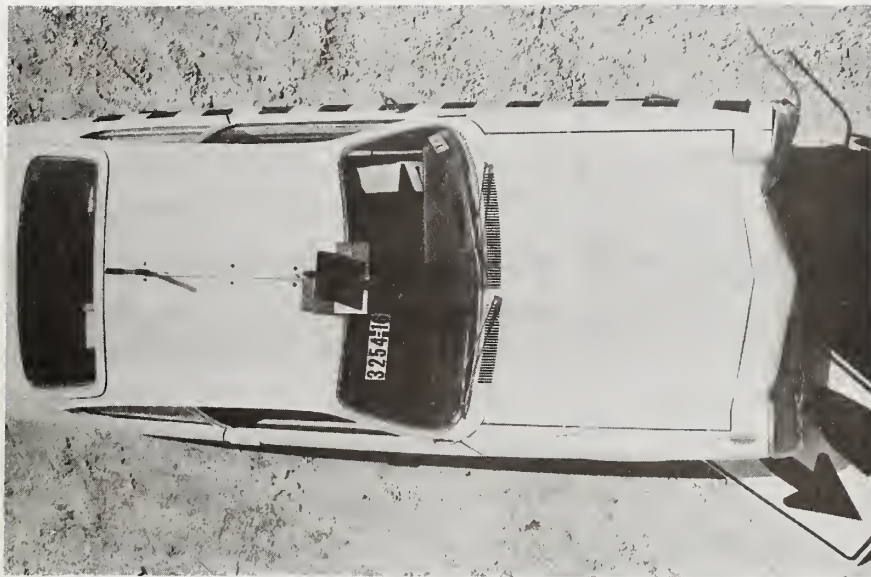
Figure 128. Vehicle damage, test 16.

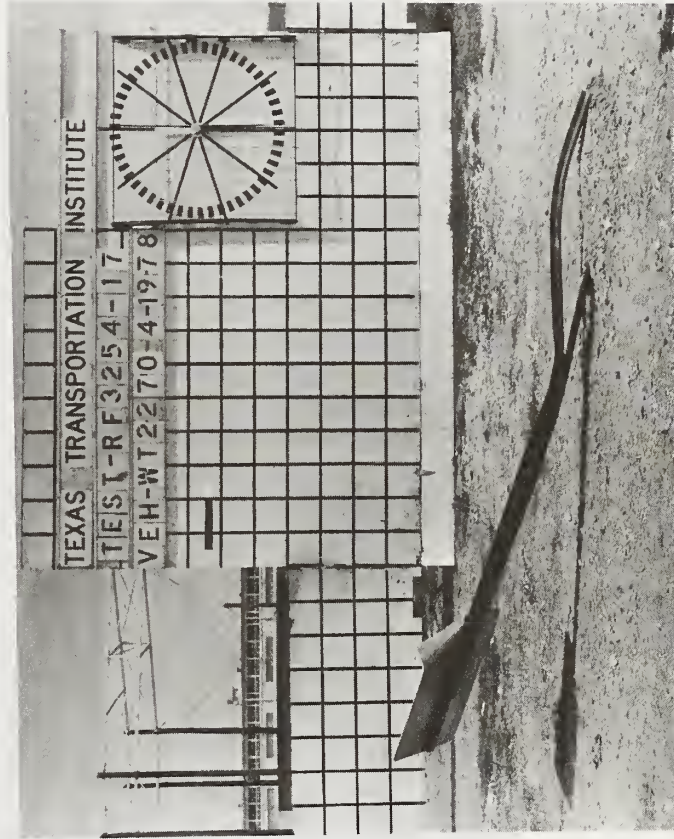
| TEST NO. | SYSTEM | IMPACT SPEED (mph) | POST SIZE | STUB SIZE | METHOD OF EMBEDMENT | DEPTH OF EMBEDMENT (ft) | WINDSHIELD BROKEN? | WINDSHIELD PENETRATED? | VEHICLE DAMAGE | | RESTORATION REQUIRED FOR SIGN INSTALLATION | CHANGE IN VEHICLE MOMENTUM (lb-sec) |
|---|--|---|---|---|---|---|---|---|---|---|--|---|
| 17 | Steel U-Post Braced Leg Design (Billet Steel) | 19.9 | 2 lb/ft post 2 lb/ft brace | None | Driven | 2.5 Post 2.0 Brace | No | - | FR-D | 12FREN1 | Replace post and brace; Sign panel possibly reusable with straightening | 783 |

Figure 133. Sign installation damage, test 17.

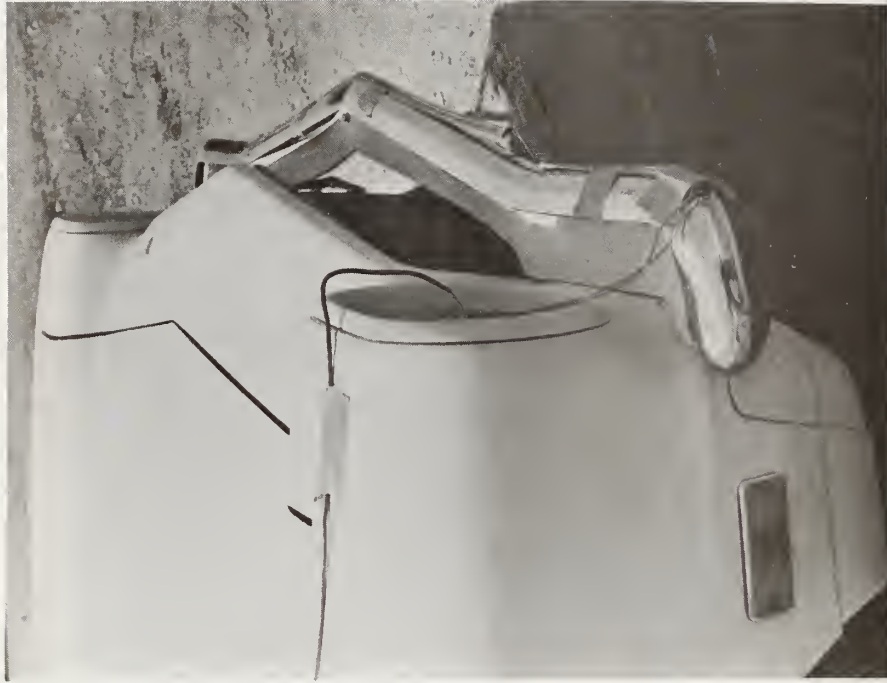
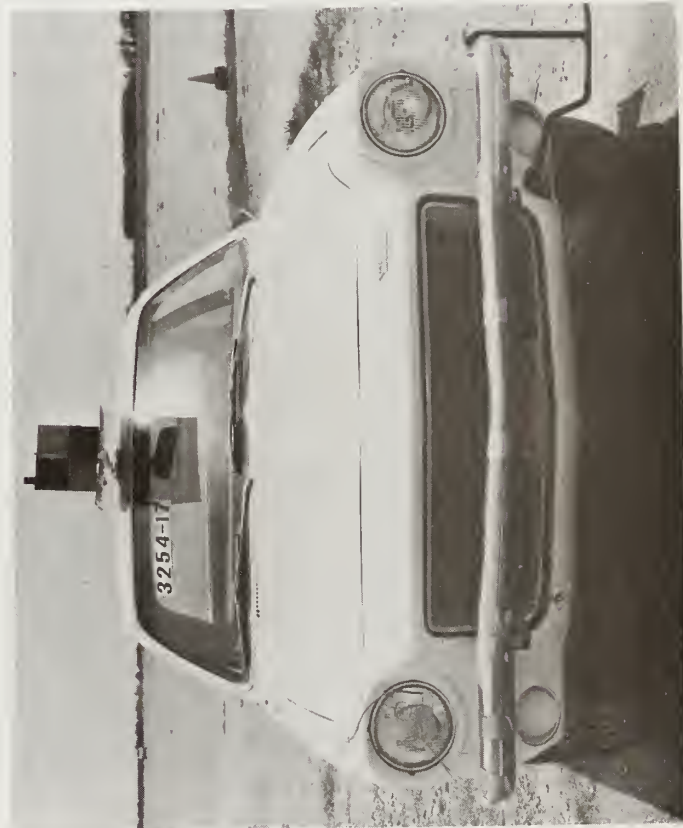
Figure 134. Vehicle damage, test 17.

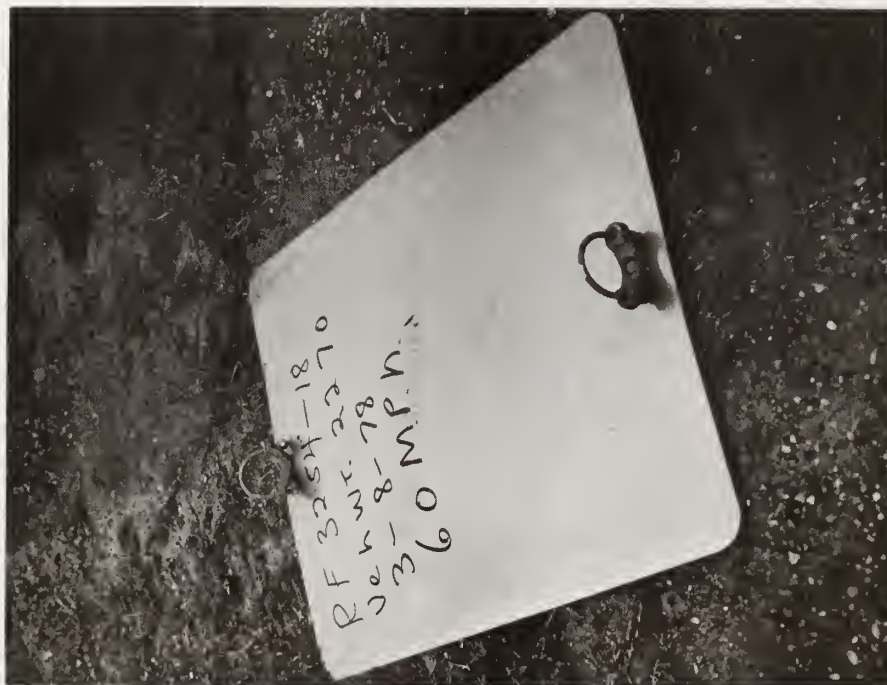
| TEST NO. | SYSTEM | IMPACT SPEED (mph) | POST SIZE | STUB SIZE | METHOD OF EMBEDMENT | DEPTH OF EMBEDMENT (ft) | WINDSHIELD BROKEN? | WINDSHIELD PENETRATED? | VEHICLE DAMAGE | | RESTORATION REQUIRED FOR SIGN INSTALLATION | CHANGE IN VEHICLE MOMENTUM (lb-sec) |
|---|--|---|---|---|---|---|---|---|---|---|--|---|
| 18 | Standard Steel Pipe | 56.5 | 2.0 in. dia. | None | Drill and Backfill | 4.0 | No | - | FR-1 | 12FREN1 | Replace post; Sign panel reusable | 462 |

Figure 139. Sign installation damage, test 18.

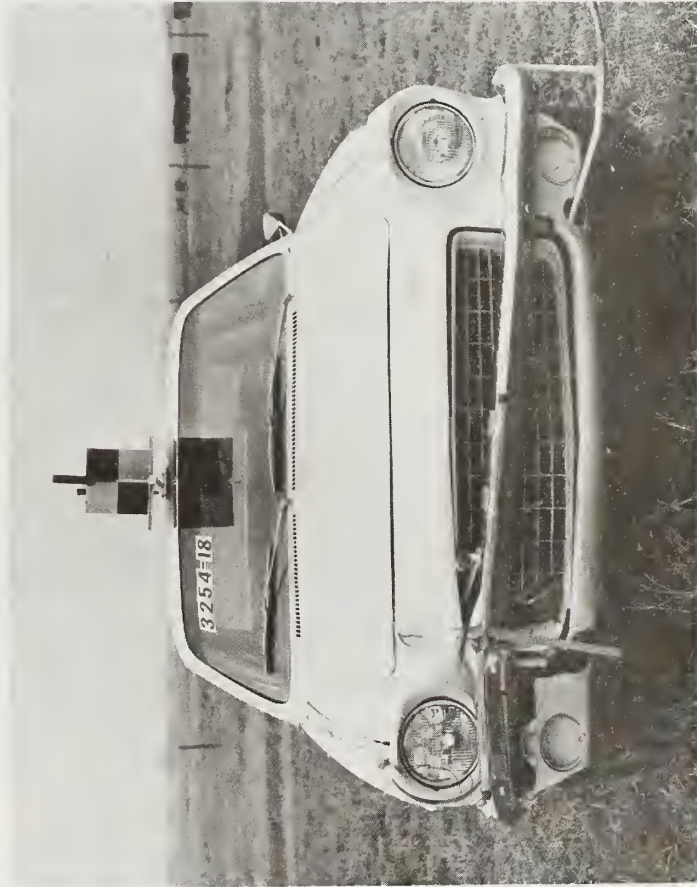
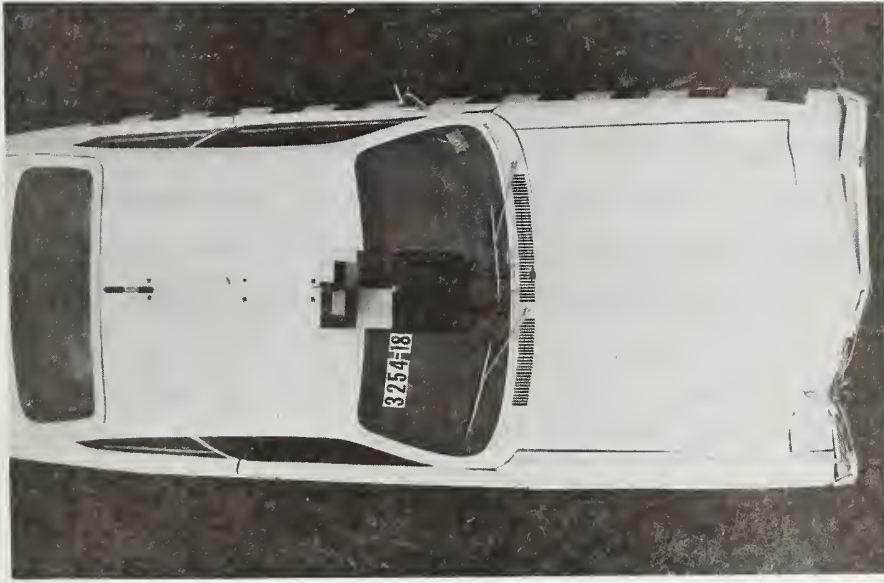
Figure 140. Vehicle damage, test 18.

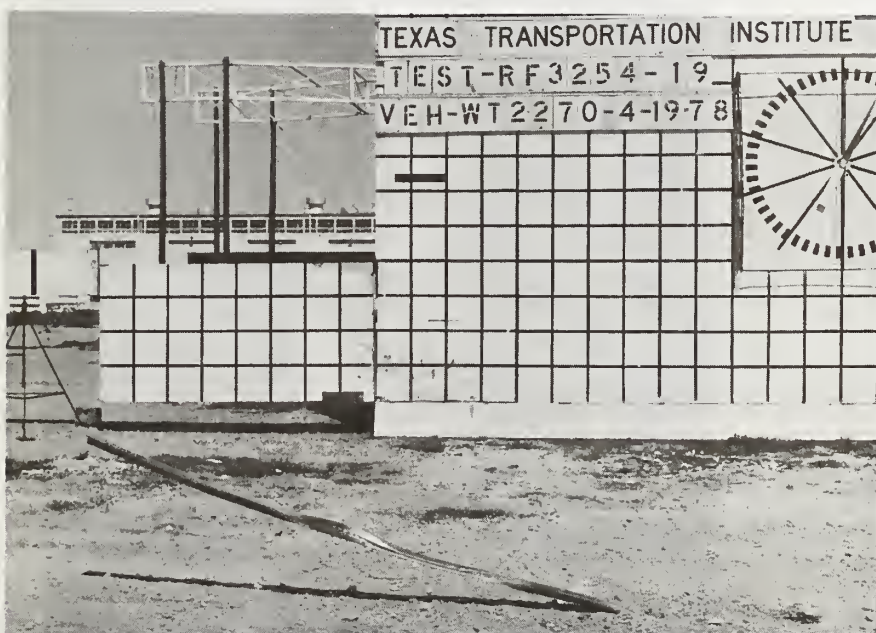
| TEST NO. | SYSTEM | IMPACT SPEED (mph) | POST SIZE | STUB SIZE | METHOD OF EMBEDMENT | DEPTH OF EMBEDMENT (ft) | WINDSHIELD BROKEN? | WINDSHIELD PENETRATED? | VEHICLE DAMAGE | | RESTORATION REQUIRED FOR SIGN INSTALLATION | CHANGE IN VEHICLE MOMENTUM (lb-sec) |
|---|--|---|---|---|---|---|---|---|---|---|--|---|
| 19 | Steel U-Post Braced Leg Design (Billet Steel) | 60.6 | 2 lb/ft post 2 lb/ft brace | None | Driven | 2.5 Post 2.0 Brace | Yes | No | FL-2 | 12FLEN1 | Replace post and brace; Sign panel reusable | 529 |

Figure 145. Sign installation damage, test 19.

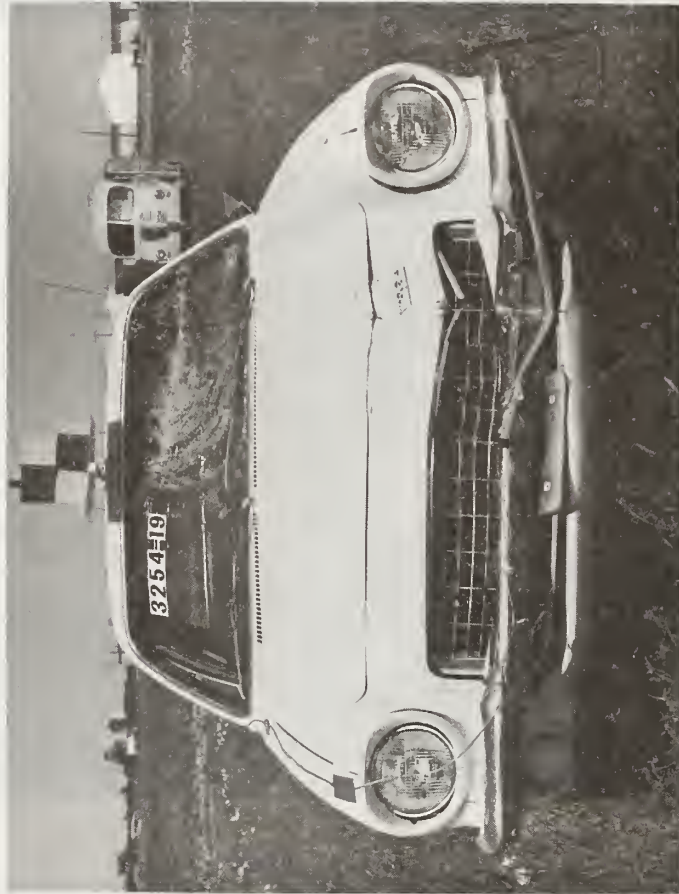
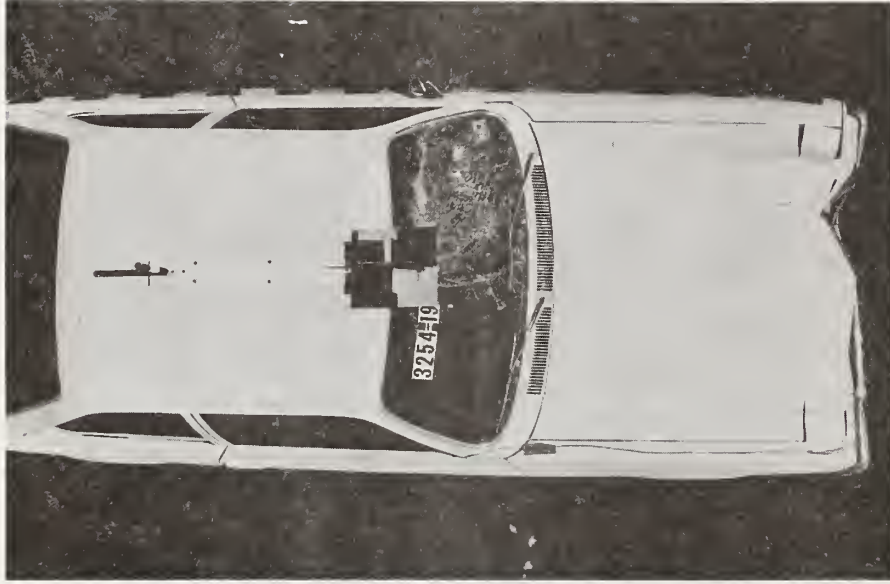
Figure 146. Vehicle damage, test 19.

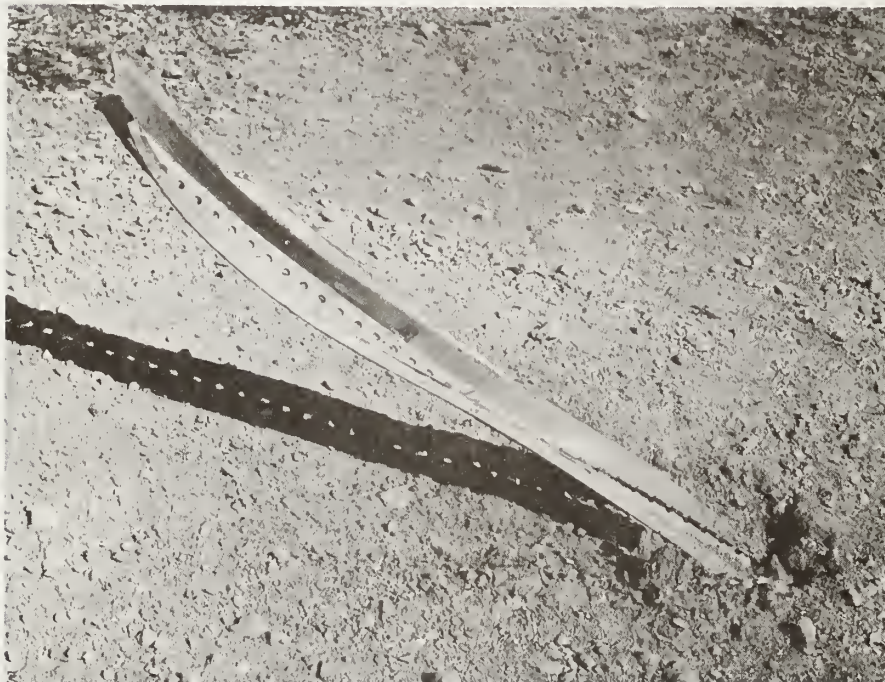
| TEST NO. | SYSTEM | IMPACT SPEED (mph) | POST SIZE | STUB SIZE | METHOD OF EMBEDMENT | DEPTH OF EMBEDMENT (ft) | WINDSHIELD BROKEN? | WINDSHIELD PENETRATED? | VEHICLE DAMAGE | | RESTORATION REQUIRED FOR SIGN INSTALLATION | CHANGE IN VEHICLE MOMENTUM (lb-sec) |
|---|--|---|---|---|---|---|---|---|---|---|--|---|
| 20 | Steel U-Post Back-to-Back (Rail Steel) | 67.3 | 6 lb/ft | None | Drill and Backfill | 4.0 | Yes | No | FR-4 | 12FREN3 | Replace post; Repair and reuse sign panel | 701 |

Figure 151. Sign installation damage, test 20.

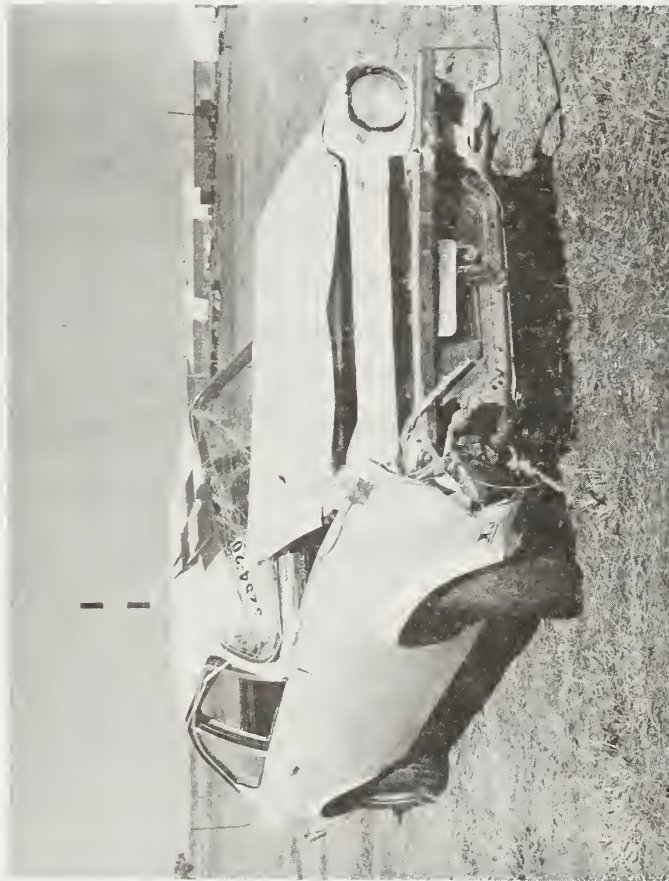
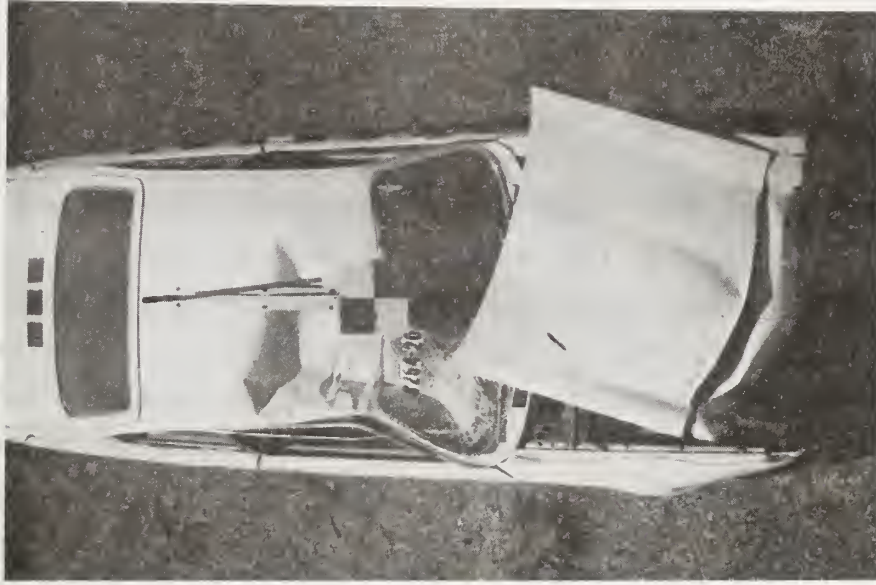
Figure 152. Vehicle damage, test 20.

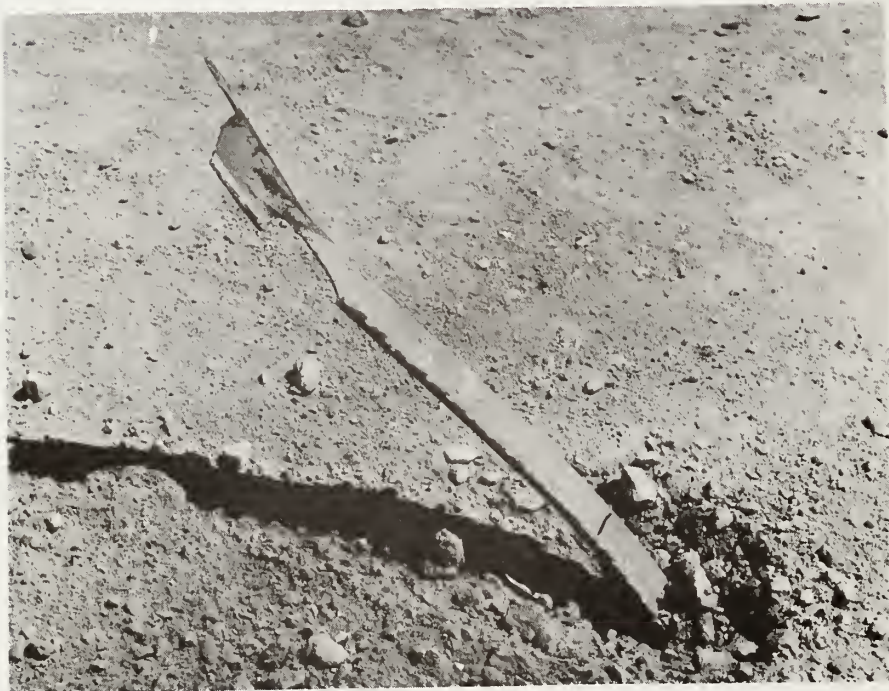
| TEST NO. | SYSTEM | IMPACT SPEED (mph) | POST SIZE | STUB SIZE | METHOD OF EMBEDMENT | DEPTH OF EMBEDMENT (ft) | WINDSHIELD BROKEN? | WINDSHIELD PENETRATED? | VEHICLE DAMAGE | | RESTORATION REQUIRED FOR SIGN INSTALLATION | CHANGE IN VEHICLE MOMENTUM (lb-sec) |
|---|--|---|---|---|---|---|---|---|---|---|--|---|
| 21 | Steel U-Post Back-to-Back (Experimental Billet Steel) | 57.9 | 6 lb/ft | None | Drill and Backfill | 4.0 | Yes | No | FR-2 | 12FREN1 | Replace post; Repair and reuse sign panel | 430 |

Figure 163. Sign installation damage, test 21.

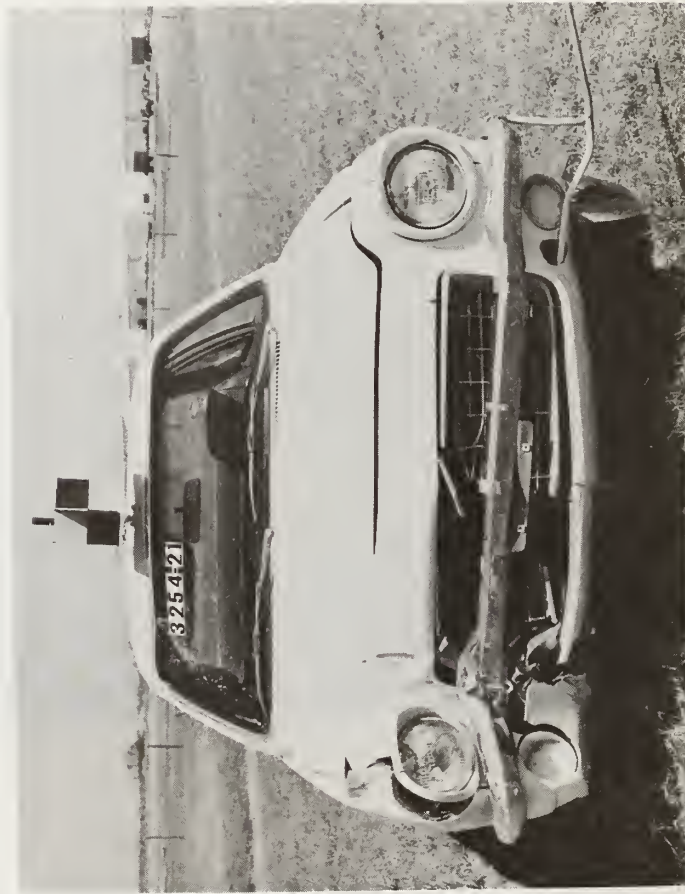
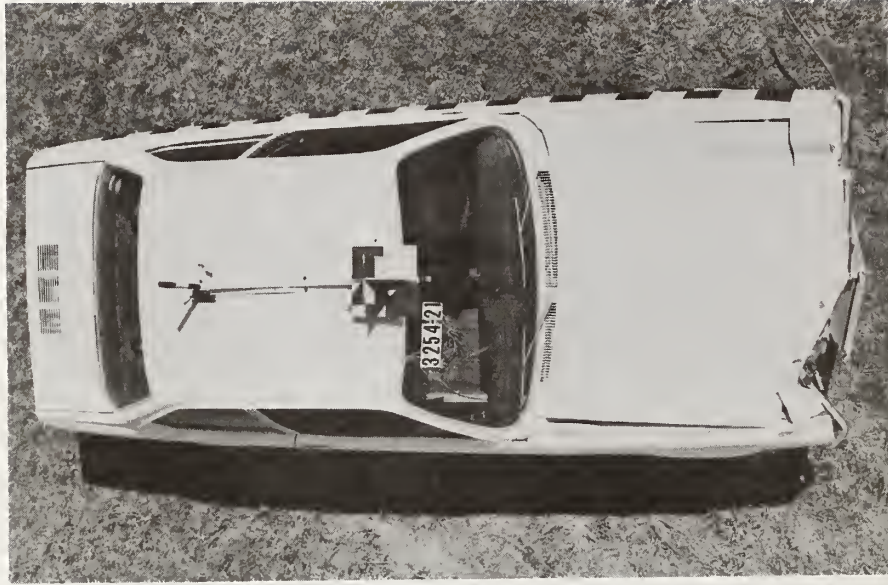
Figure 164 shows vehicle damage. Damage was assessed according to the TAD and SAE scales and is given in Table 51.

Figure 164. Vehicle damage, test 21.
