Report No. FHWA-RD-79-133

# FATIGUE OF CURVED STEEL BRIDGE ELEMENTS

## Fatigue Tests of Curved Plate Girder Assemblies

April 1980  
Interim Report

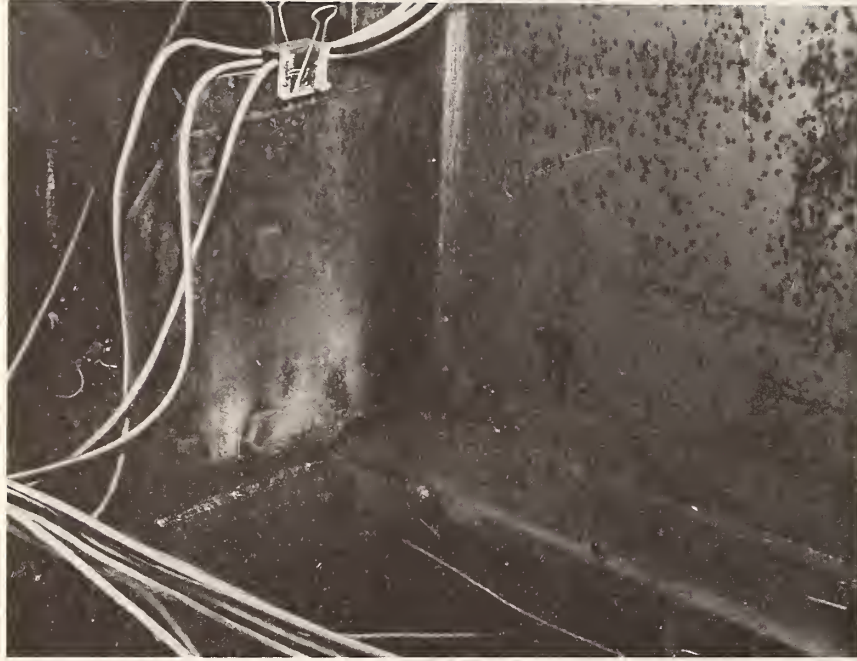
Fig. 60 Web Crack Repairs - Location ww on Girder 2 of Assembly 3

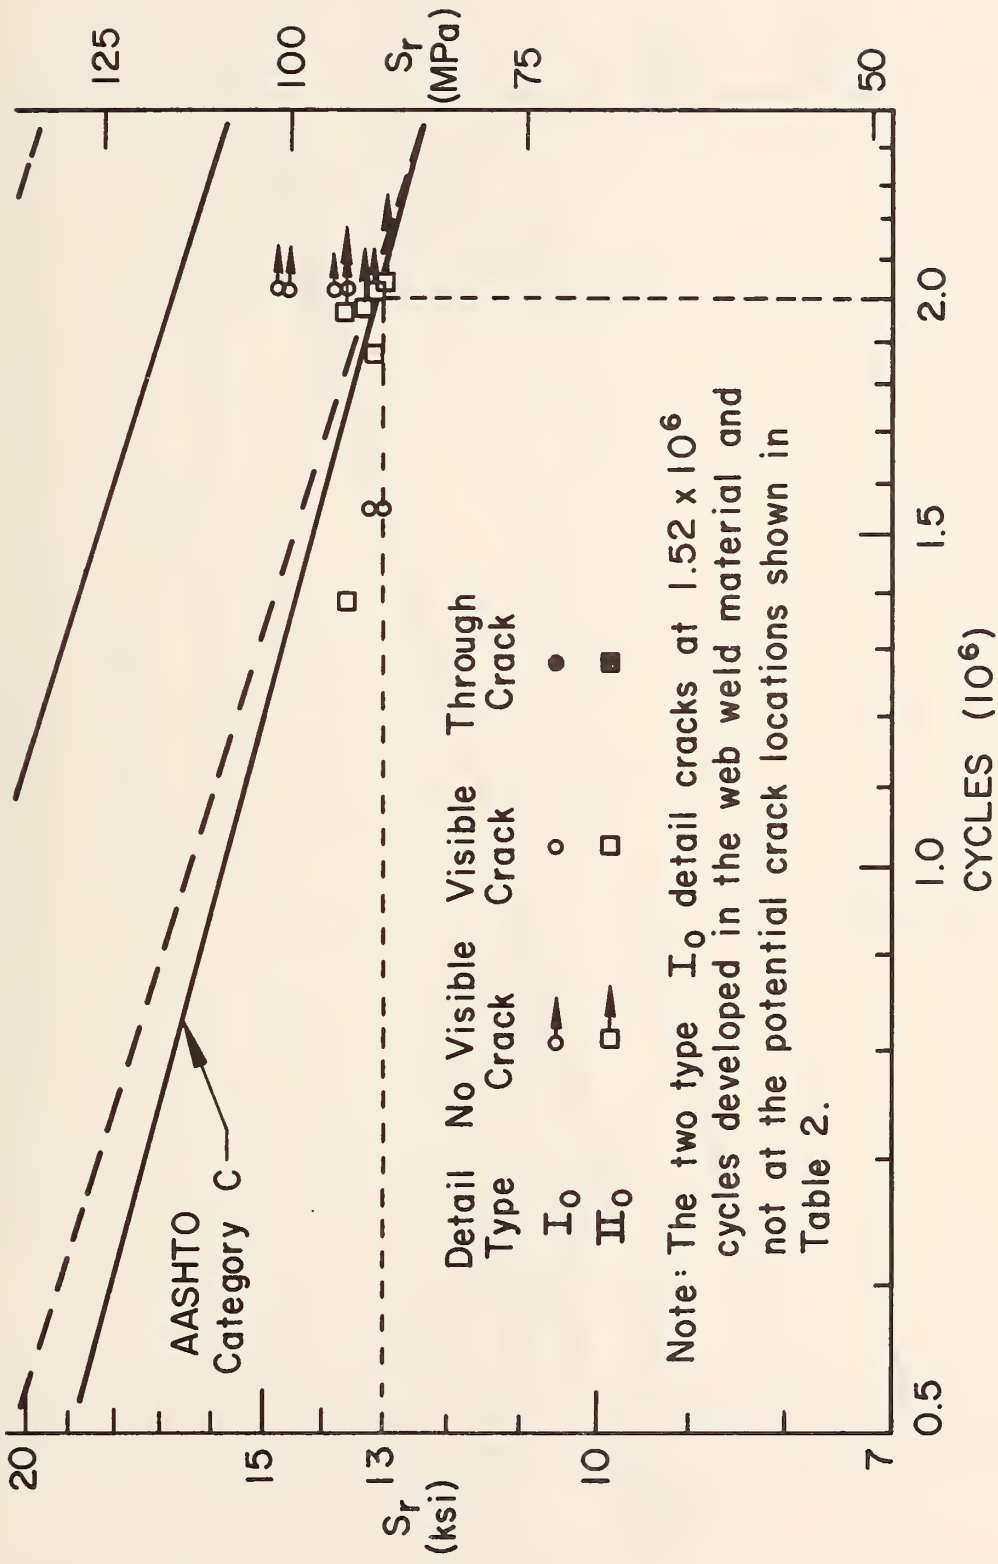
Fig. 67 Fatigue Results - Assembly 2 Category C Details

Note: The two type I<sub>0</sub> detail cracks at  $1.52 \times 10^6$  cycles developed in the web weld material and not at the potential crack locations shown in Table 2.

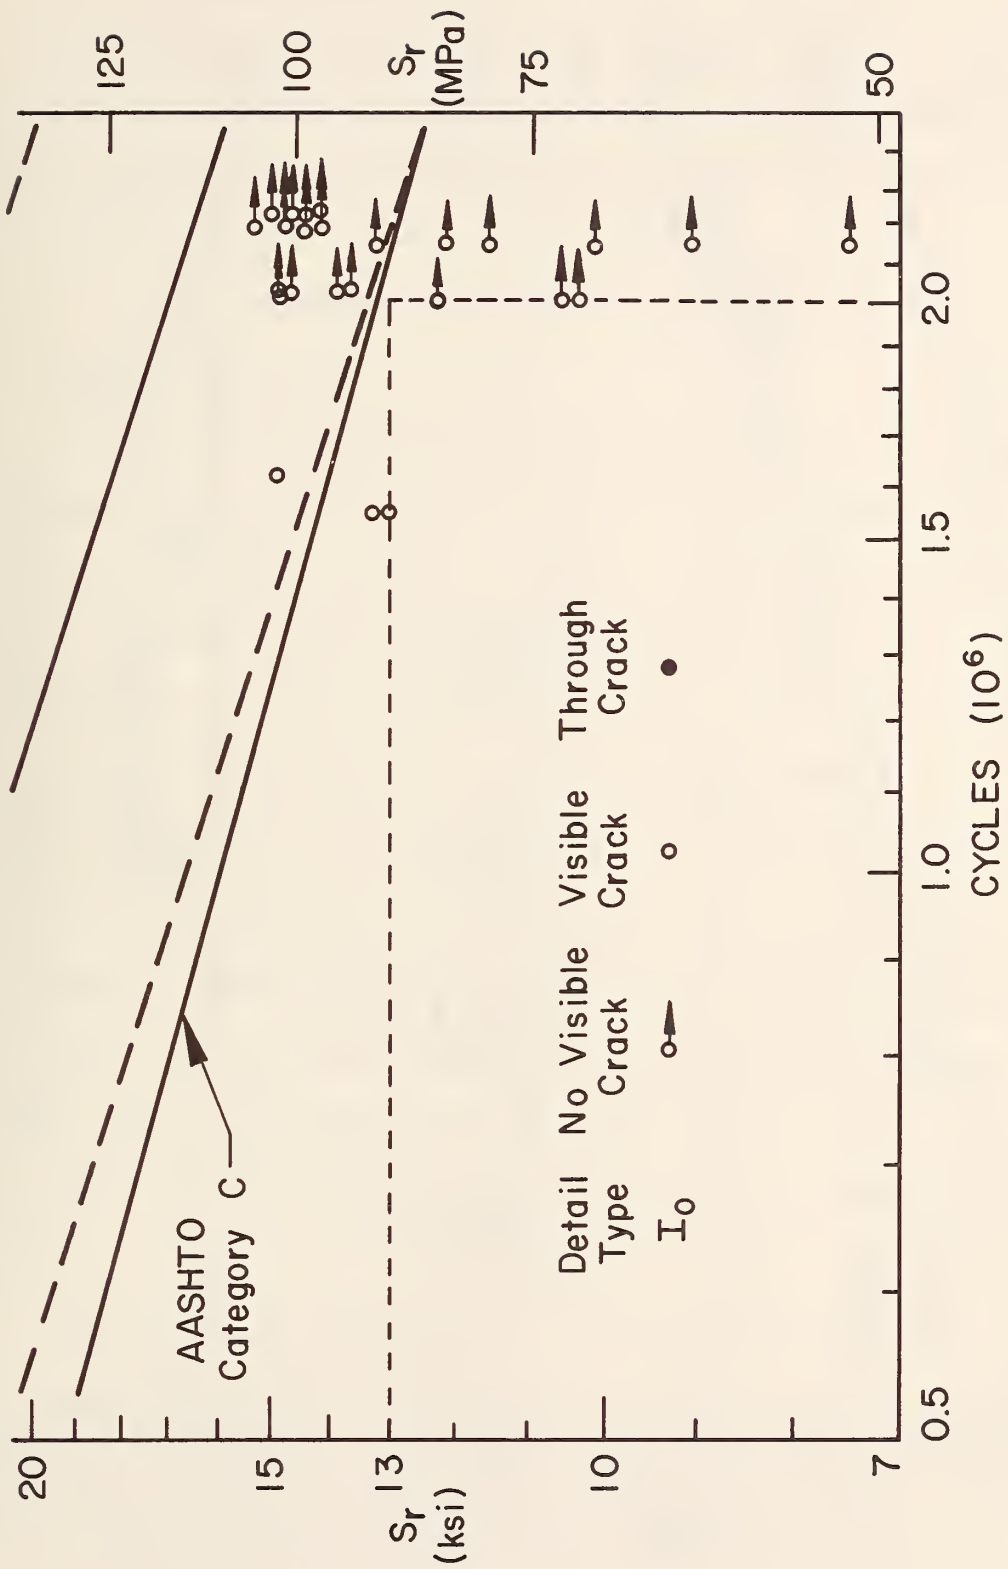
Fig. 75 Fatigue Results - Type I<sub>0</sub> Details

The two open symbols at 1.52 million cycles on Fig. 75 represent two visible cracks which formed in the weld metal near the bottom of the web vertical weld on two separate type I<sub>o</sub> details. No visible flaws exist at the two locations and the cracks did not grow through the web thickness.

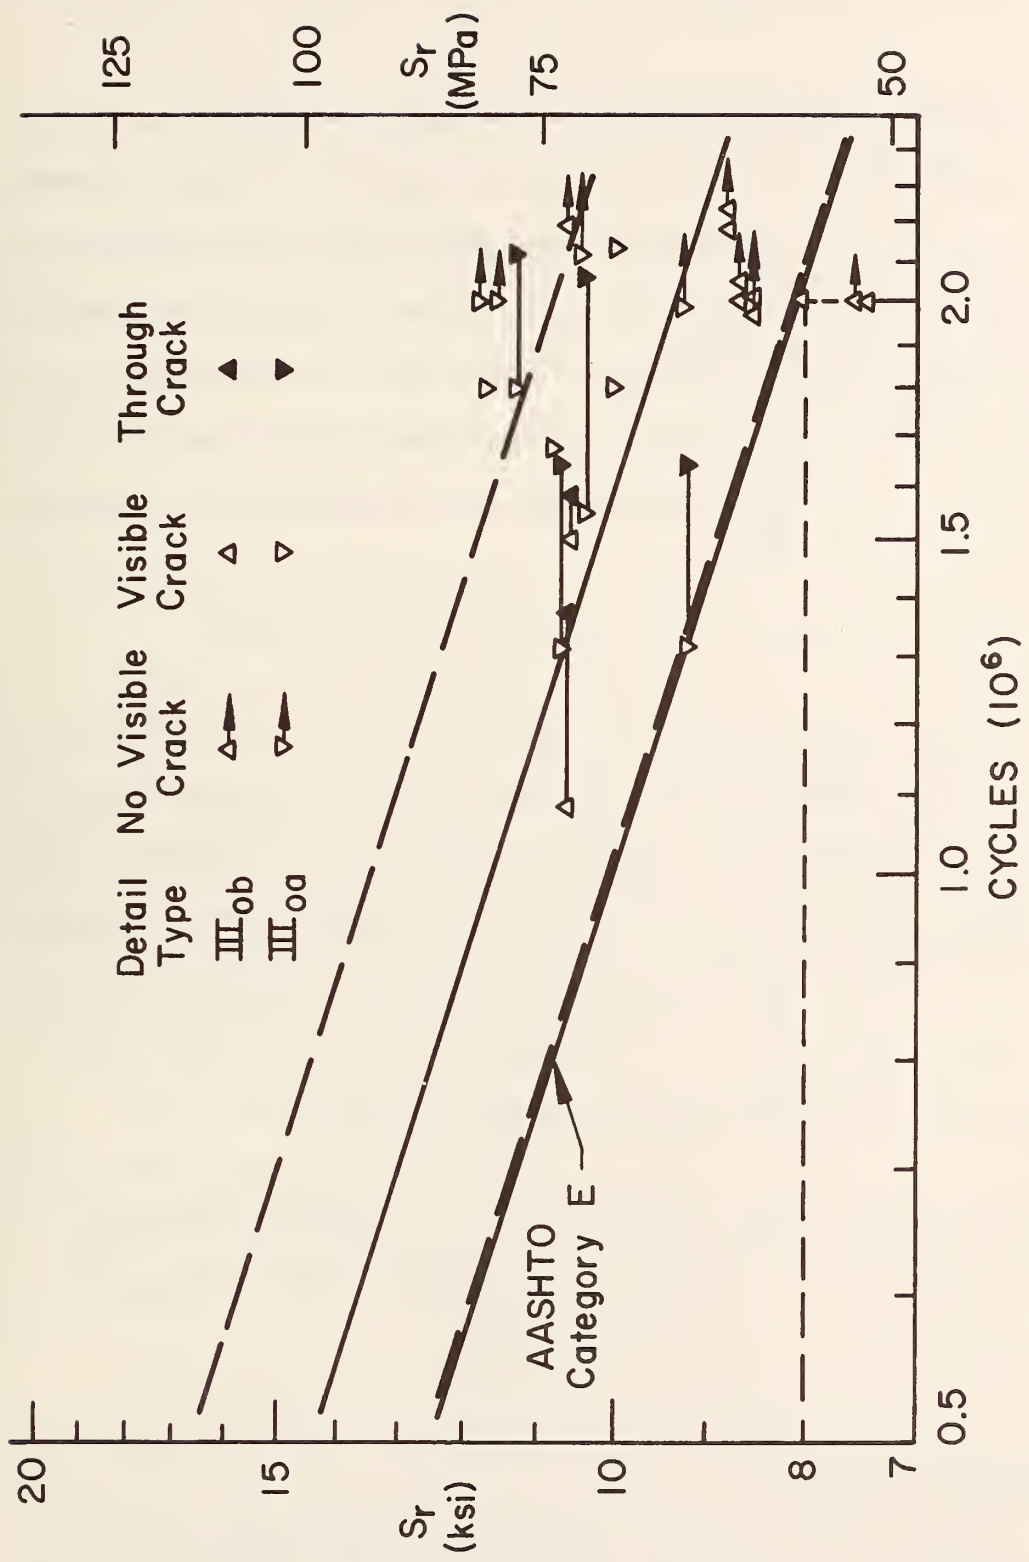
Fig. 77 Fatigue Results - Type III<sub>oe</sub> and III<sub>ob</sub> Details

Figure 77 presents the III<sub>oa</sub> and III<sub>ob</sub> detail test results for all five assemblies. Just as for type II<sub>o</sub>, these web details on a curved girder should behave as though they existed on a straight girder. Although the stress ranges varied from 51.7 MPa (7.5 ksi) to 80.7 MPa (11.7 ksi) a majority of the results lie within the 95 percent

confidence limits in Fig. 77. Only one visible crack at a type III<sub>ob</sub> detail lies below the AASHTO Category E curve.
