NATIONAL PARTS RETURN PROGRAM

Kappa Systems, Inc.
1501 Wilson Blvd.
Arlington, Virginia 22209

Final Report
January 1978

Technical and Summary Report
National Parts Return Program
June 1977
Final Report

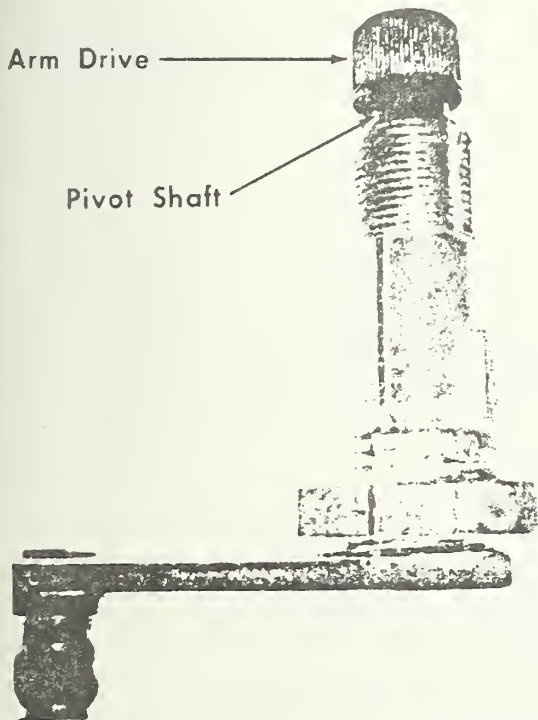
The defect involves the wiper pivot shaft assembly (see photo) which extends through the windshield cowl panel, and drives the wiper arm

Defective windshield wiper found on 1971-1973 Mercury Capris automobiles.

and blade across the windshield. The end of the pivot shaft above the windshield cowl is splined, or serrated, and press fitted into the bore of the arm drive. On some 1972 and 1973 models, the pivot shaft also is staked. The wiper arm and blade assembly fits onto the arm drive. When failure by separation of the wiper linkage occurs, the arm and blade assembly often flies off completely as the arm drive separates from the pivot shaft, denoting failure of the interference fit. The pivot shaft splines usually show evidence of severe wear when this type of failure occurs.

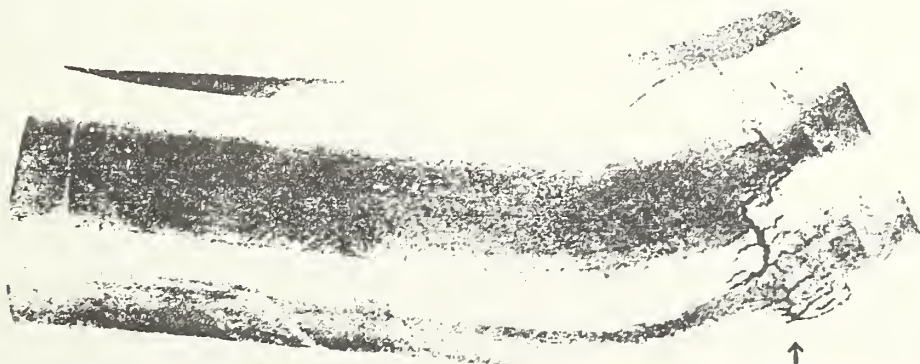
Figure 1

↑
Hose
Deterioration

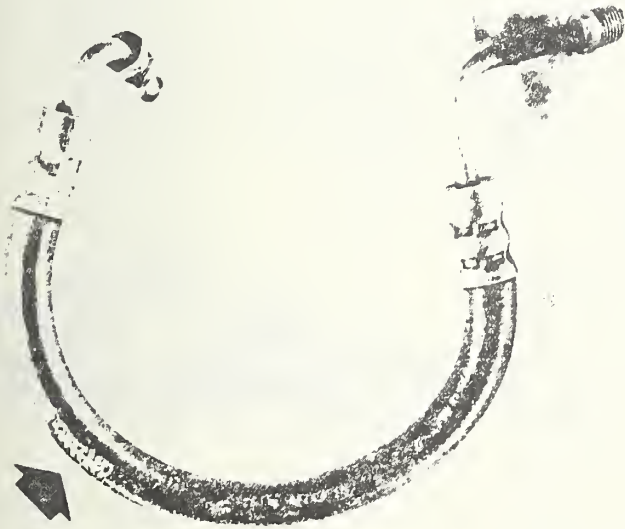
Figure 1

The high pressure power steering hose that is shown was sent in by WINSLOW'S MOBILE STATION in Gorham, Maine. The hose was removed from a 1975 AMC Hornet Sportabout with a mileage of 35,070. As indicated in the photograph, a two inch section of the rubber surface on the hose has cracked and fallen off. This reportedly resulted in a loss of power steering. The NHTSA has received two other similar reports involving 1975 AMC Hornets. In those two cases engine compartment fires were reported as a result of hose deterioration and power steering fluid leakage. The NHTSA is analyzing the reports. If your shop knows of similar failures, the PRP would like to hear from you.

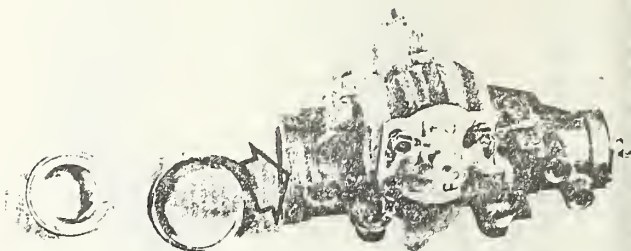
Figure 3

BEACON AUTO BODY in Pennsauken, New Jersey sent in the power steering gear that is shown. The gear was removed from a 1976 Oldsmobile Delta Royals with mileage of 7,413. As indicated in the photograph, the end of the gear housing is cracked. The crack extends about $\frac{1}{3}$ of the way around the gear housing circumference. The end plate and snap ring are also shown. The vehicle reportedly struck a pole after the owner made a sharp right turn to avoid a bicyclist. There is no evidence of external damage to the gear housing.

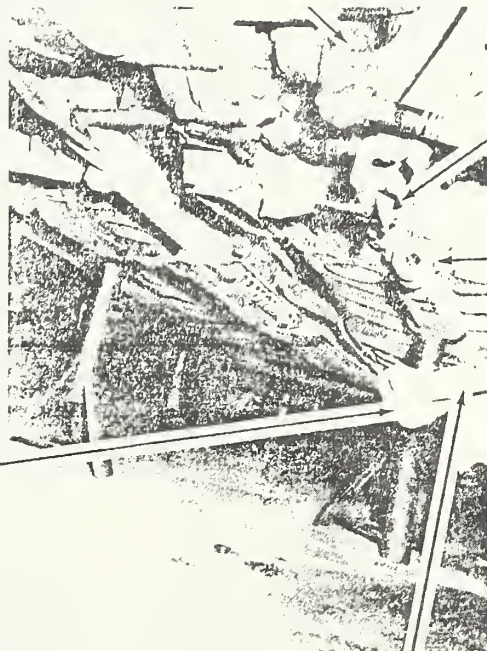
Left front lower control arm frame mount bracket still attached to the left front lower control arm by the original undisturbed mounting bolt.

Frame support area where the left front control arm bracket is normally welded in place.

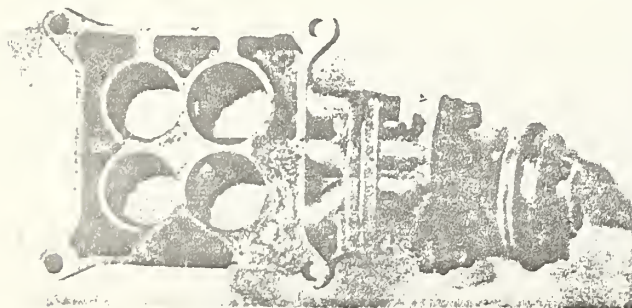
EGR Spacer Plate

Since July of 1976, the PRP has received twelve EGR carburetor spacer plates removed from Ford Motor Company products equipped with two and four-barrel carburetors. The parts were removed from 1973 and 1974 Ford and Mercury products with vehicle mileages ranging from 20,000 to 65,000. The spacer plate shown, removed from a 1974 Mercury Marquis with 65,565 miles, is representative of the types of components received and shows the typical appearance of the corrosion and deposits which occur. Some contributing shops have indi-

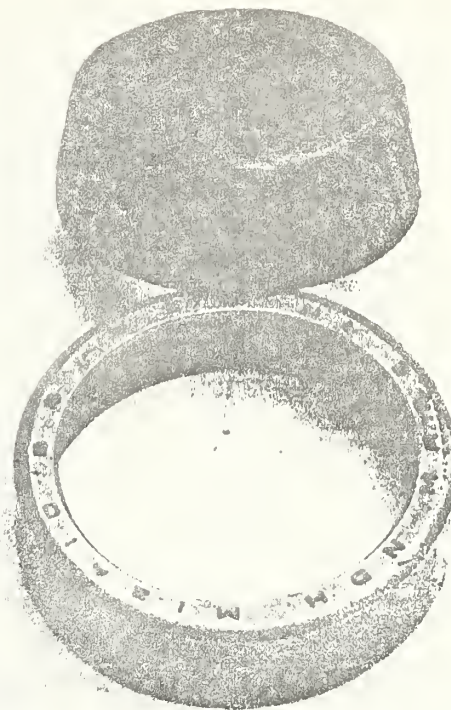
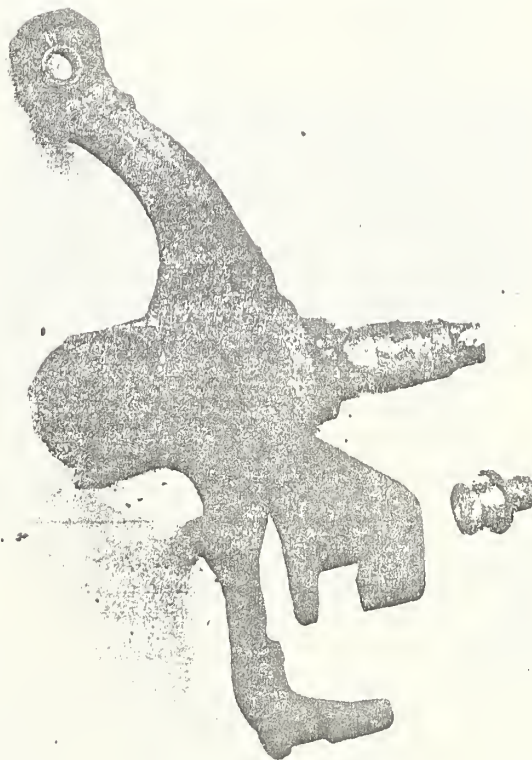
According to ROEHL'S there have been several other similar failures on 1975 and 1976 General Motors mid-size and full-size vehicles. The shop reports repairing an Oldsmobile Cutlass and a Cadillac, and knows of an Oldsmobile full-size station wagon on which the spindle and the disc hub were both damaged beyond repair. According to the shop, the outer bearings appear to have an insufficient amount of grease, however the inner bearings appear well lubricated.

The PRP has also received a right front wheel spindle (photo) that was removed from a 1974 Chevrolet Caprice with 41,720 miles. The spindle is broken at the outer bearing location and the outer bearing race is frozen on the broken end. The spindle does not have a blue appearance that

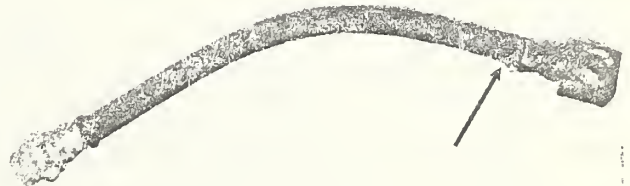
The throttle cable shown below was taken from a 1975 two-door Granada, which had accumulated 30,000 miles and was equipped with a 302 CID V8 engine. The cable was removed by Dick Jordan's STANDARD SERVICE STATION of Clayton, Missouri and sent to the PRP. As shown in the photograph, the cable is frayed on one end. This reportedly caused the throttle to stick in the open position when the vehicle was started. In addition to this cable, the PRP recently received two other throttle cables from vehicles involved in similar incidents. One was from a 1971 Chevrolet Caprice with 46,391 miles and was sent in by CLEMENS AUTO REPAIR of Racine, Wisconsin. The other was from a 1972 Chevrolet Nova with 52,103 miles and was sent in by DOYLE AUTOMOTIVE of Seattle, Washington. We would like all of our PRP members to keep this reported incident in mind in the coming months, and report to us any similar failures that are encountered.
