NATIONAL PARTS RETURN PROGRAM VOLUME II

OCTOBER 1980
FINAL REPORT

1. Report No. DOT-HS-805-638		2. Government Accession No.		3. Recipient's Catalog No.	
4. Title and Subtitle National Parts Return Program Final Report - Volume II				5. Report Date 1 October 1980

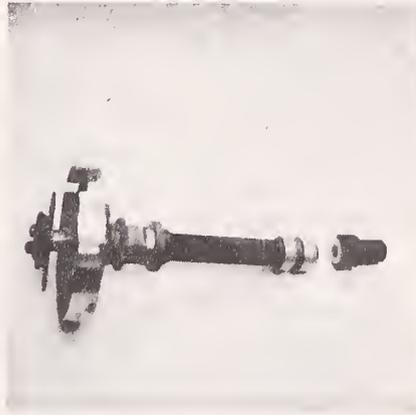
Jack's Auto Service in Chamblee, Georgia submitted to the PRP the distributor from a 1976 Chevrolet C-10 pick-up with 81,207 miles. Reportedly, while the truck was in operation, the engine backfired, stalled out and could not be restarted. Upon inspection, it was discovered that the lower end of the distributor gear shaft had broken off as shown in the photo below. It

is unknown if the backfire was the cause or the result of the shaft breaking. The PRP is interested in similar problems with other GM H. E. I. distributors.

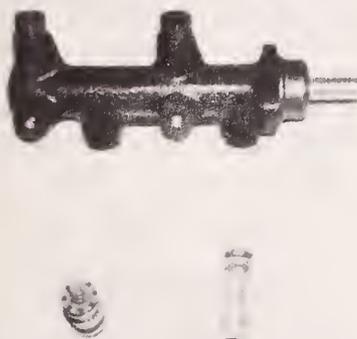
The PRP is interested in gathering information on brake master cylinders from various VW vehicles as reported in past issues. Several PRP members have contributed parts and information concerning brake master cylinders during recent months.

The contributing shops reported similar accounts of sudden partial loss of the vehicles' braking ability. Upon inspection, it was discovered that the seals in the master cylinders had worn out, allowing internal leakage of the brake fluid. Because of this, pressure may be applied to only one set of brakes in the tandem system. No external loss of brake fluid has been reported. Also, many reports have been received indicating the primary and secondary braking systems fail simultaneously, resulting in the brake pedal traveling to the floor with little or no braking action.

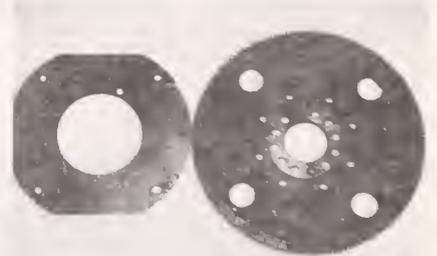
Service of San Diego, California. This flywheel was removed from a 1974 Jaguar XJ6. As seen in the photo, the flex plate broke free from the flywheel. The shop states that this is a fairly common problem among late model Jaguar XJ6's.

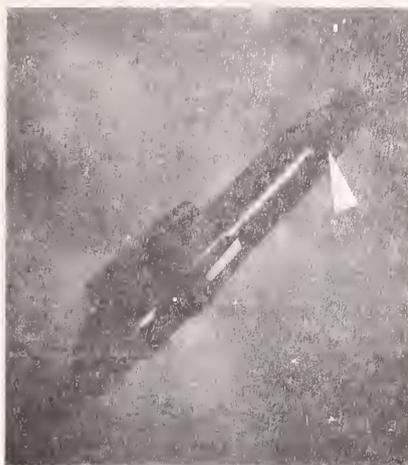
The steering sector shaft shown in the accompanying photo, was submitted to the PRP by **Art Dell's Garage** in Rensselaer, New York. It was removed from a 1977 Chevrolet

Impala with 22,329 miles. As indicated by the arrow in the photo, the shaft has several cracks and twisted threads at the point where it meets the steering arm. The result is an unstable connection between the two and potential loss of steering control. Any further information on this type of problem would be appreciated.

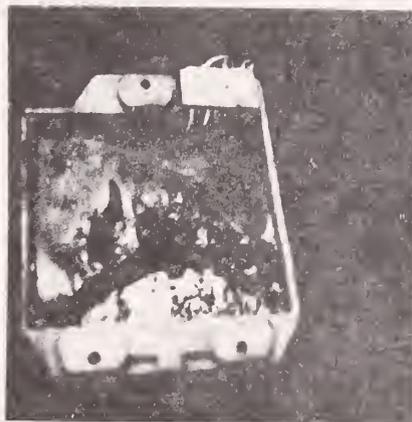
Wales Garage, Fort Lauderdale, Florida, recently submitted the ignition amplifier shown in the picture. The amplifier was removed from a 1974 Ford Maverick with 56,000 miles. The vehicle owner has experienced intermittent stalling prior to the discovery of the problem. What is unique in this instance is that the insulation backing of the amplifiers has melted away. Other amplifiers submitted to the PRP have had a clear, hard backing. In this case, the backing is soft and discolored, indicating an intense heat build-up. Please keep an eye out for similar situations.

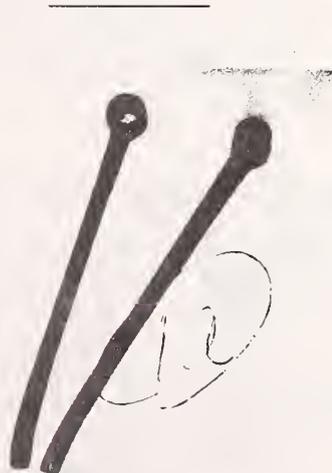
The stabilizer bar pictured above, manufactured with a hollow center, was submitted by EAST SIDE AUTO SERVICE CENTER, Columbus, Ohio, having been removed from a 1977 Toyota Celica with 42,000 miles. The bar reportedly snapped in two while the vehicle was in motion.

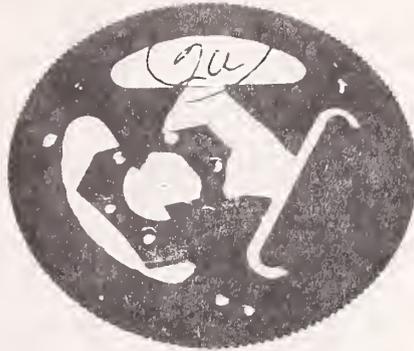
We've recently received two GM flywheels from PRP members. Both flywheels had similar failures, having broken completely through at the center, as shown in the accompanying picture. The illustrated flywheel was submitted by **HENNIKER AUTOMOTIVE**, Henniker, New Hampshire and was removed from a 1976 Buick Century with 22,000 miles. The other flywheel was contributed by **ISE AUTOMOTIVE SERVICE**, Hollywood, California and came from a Cadillac Eldorado with 72,000 miles.

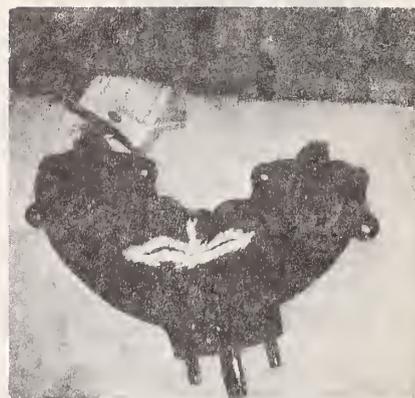
The exhaust manifold in the accompanying picture, taken from a 1978 Toyota Celica with 52,000 miles shows several cracks near the exhaust pipe mounting flange. The cracks, outlined with chalk, appear to be caused by excessive heating of the manifold, although the exhaust pipe mounting sheds did not show the type of corrosion and rust normally associated with such heat.
