Final Report 552

## **Repair of Morganza Spillway Bridge Bent Pile Cap Using Carbon Fiber Reinforcement (CFR)**

1. Report No. <b>FHWA/LA.15/552</b>		2. Government Accession No.	3. Recipient's Catalog No.
4. Title and Subtitle  <b>Repair of Morganza Spillway Bridge Bent Pile Cap Using Carbon Fiber Reinforcement (CFR)</b>		5. Report Date <b>April 2016</b>

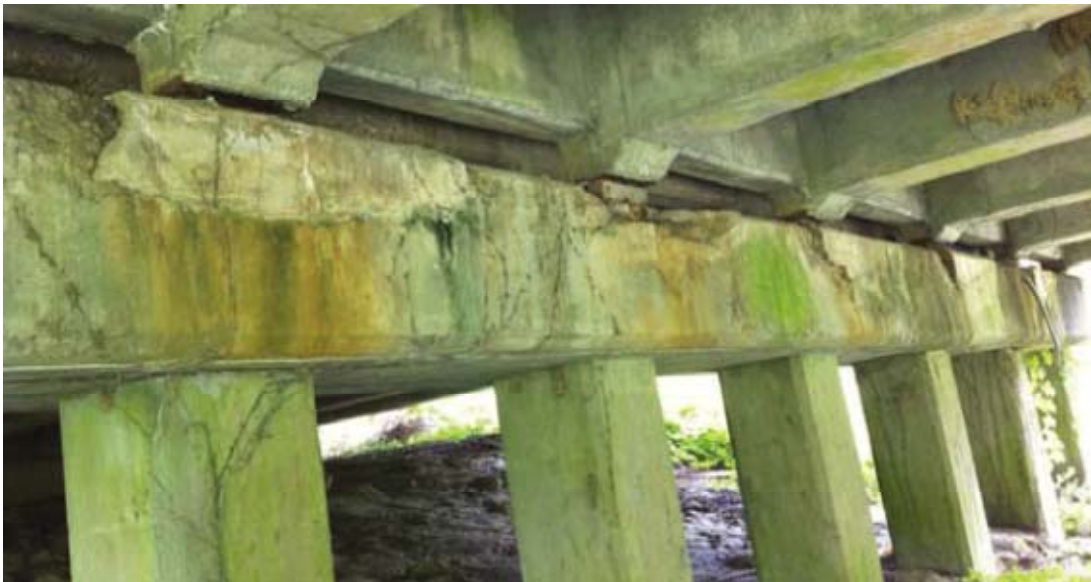
The pile cap of an end bent of the Morganza Spillway Bridge suffered extensive damage at the girder bearing locations, particularly on the side where the pounding of the girders by the adjacent concrete deck located on the approach side of the bent. The lack of a gap or an expansion joint between the two adjacent bridge decks contributed to the distress in the pile cap. The pounding caused heavy spalling of the concrete on the west face of the pile cap at the girder bearing locations, and the spalling extends all the way to bearing plates, shown in Figure 1. In conjunction with a major repair that was being undertaken on the bridge, the repair of the damaged pile cap (Bent 458) was completed using the latest technology.

**Figure 1**  
**Pier cap pre-repair: Delamination under the bearing plate**

The primary repair of the damaged pile cap and the replacement of the bearing plates were completed by the contractor working on the project. Structural grade high-adhesive material epoxy concrete was utilized to patch the damaged areas of the pile cap. In similar repairs conducted earlier, the epoxy concrete patch under the bearing plates delaminated. To prevent a repeat of this delamination, the repaired areas of the pile cap, namely the bearing plate locations, were strengthened by preventing delamination of the repair material by confining it with high modulus carbon composite wrapping. An inorganic polymer coating that provides UV protection and prevents deterioration was applied to the entire pile cap surface. This coating also has self-cleaning properties that prevent and eliminate the growth of mold or mildew and deposits of organic materials. The project was conducted to demonstrate the application of high strength composites for rehabilitation of the transportation infrastructure.

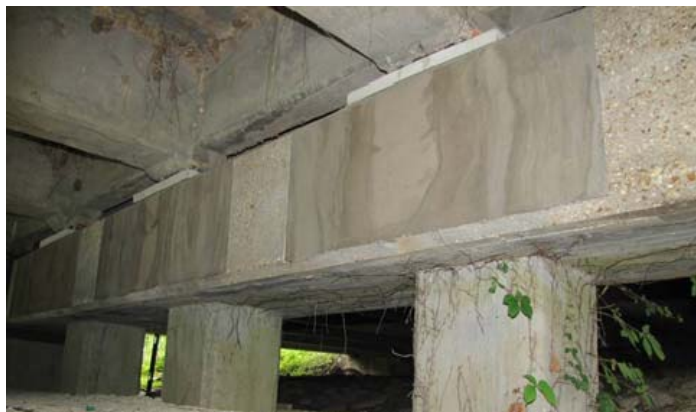
During the major-repair process, the size of the girder's bearing plate was increased to reduce the stress concentrations. The new 18-in. x 24-in. plate, shown in Figure 2, reduced the compressive (bearing) stress to 65 psi for a maximum wheel load of 28,000 lb. This value is based on the transfer of the entire wheel load to the support and an infinitely rigid plate. In practice, the actual stress will be lower than this value. Note that the stress induced by the weight of the bridge is not included because the repair material was applied after the entire bridge is in place. The actual bearing stress on concrete will be much higher.

**Figure 2**  
**View of the bent after the initial repair: Note the base plates under the beams and the repair material that replaced delaminated concrete**

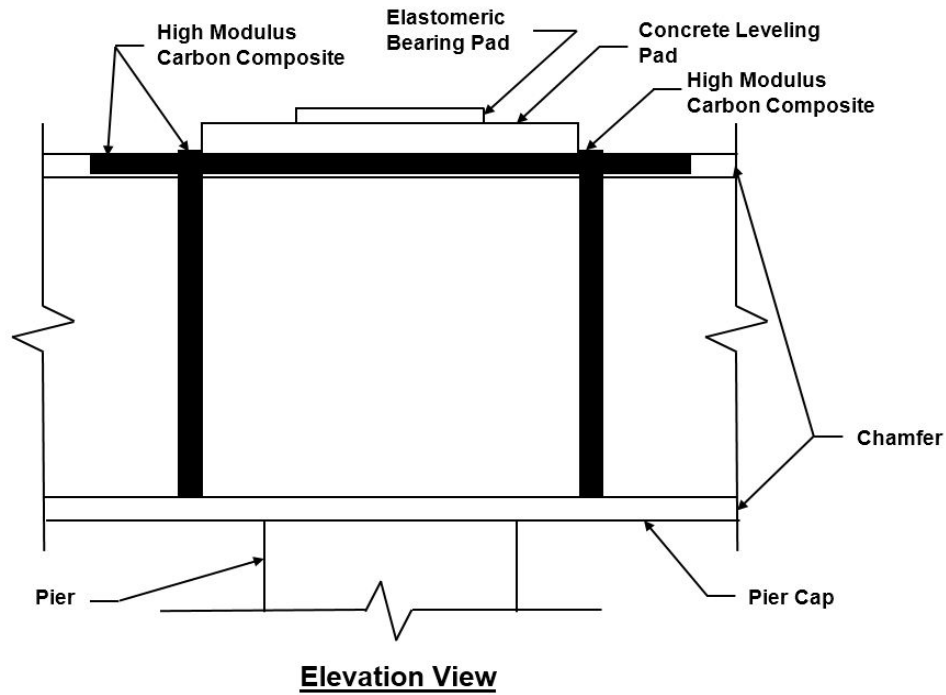
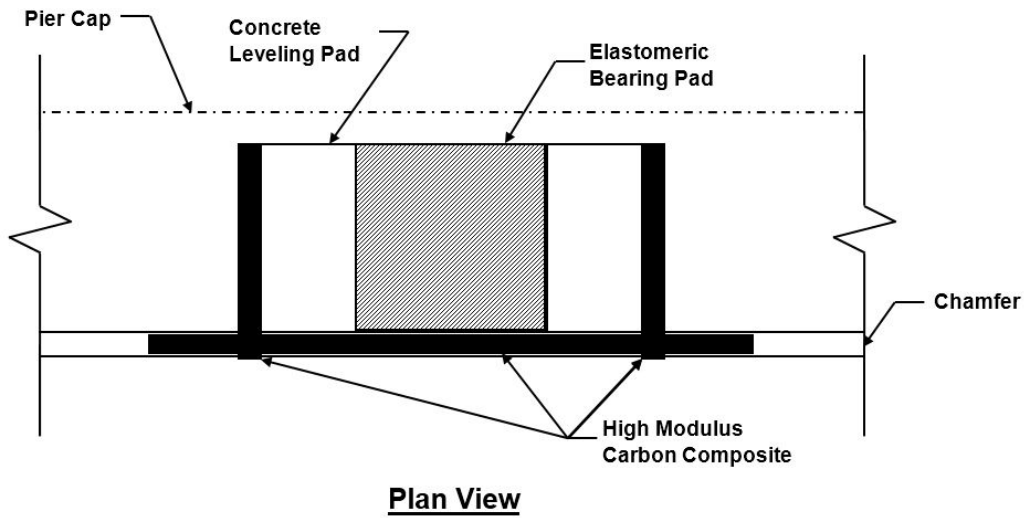
**Figure 3**  
**Line drawing of the anchoring system**

**Figure 4**  
**Line drawing of the anchoring system**

Line drawings of the system are presented in Figures 3 and 4. The original layout of placing carbon fibers at X pattern was changed to the current pattern because of the change of the support system to a larger bearing plate. The modified pattern will also provide stronger anchoring near the top, where the splitting potential is high.

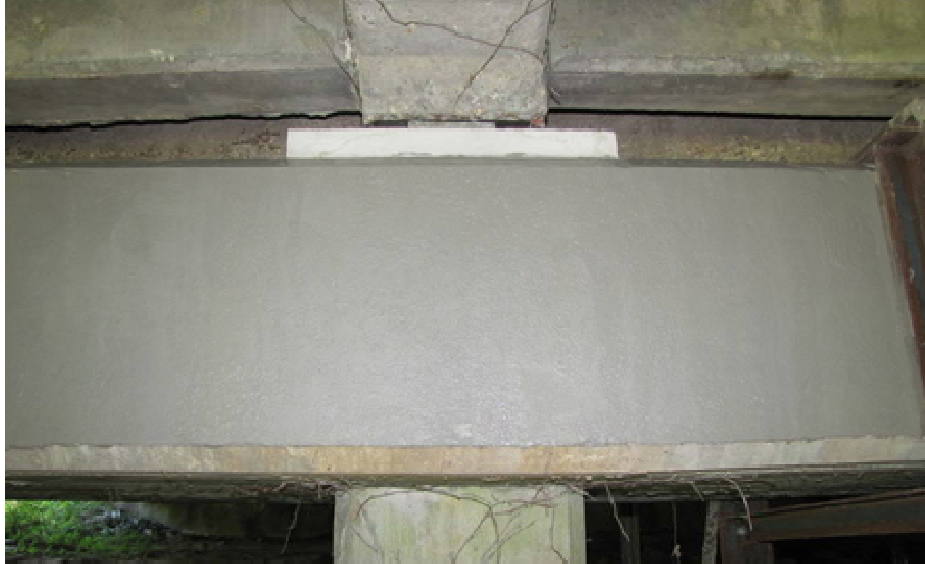
**Figure 9**  
**Initial coating with short discrete fiber reinforced composite**

After an initial coating of short-carbon fiber composite coating, shown in Figure 9, the tows along the bearing plate was placed using the inorganic polymer, shown in Figure 10. This was followed by the placement of confining tows, shown in Figure 11. Note that the confining tows extent from bottom of the bent to the end of the bearing plate proving more than sufficient development length.

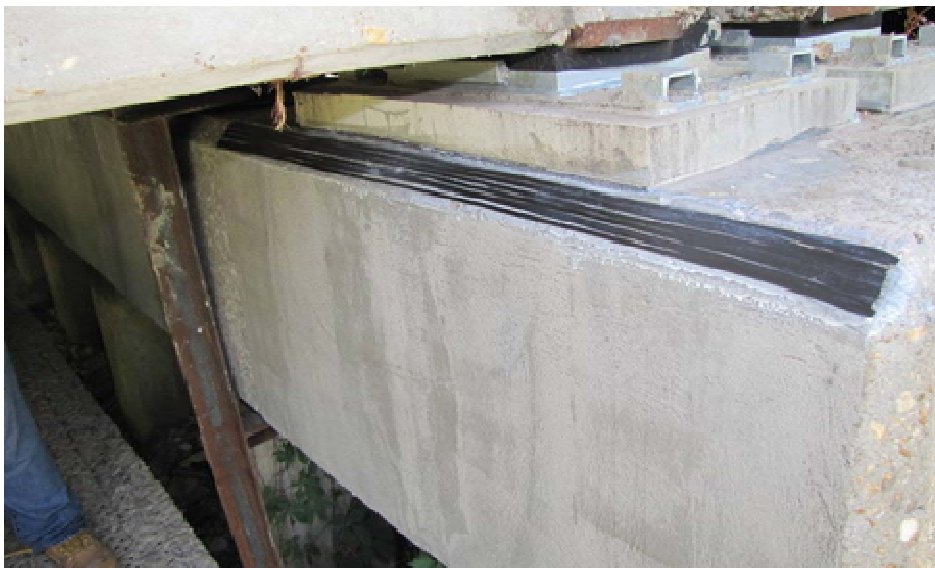
**Figure 10**  
**Details of fiber reinforcement along the bearing plate**

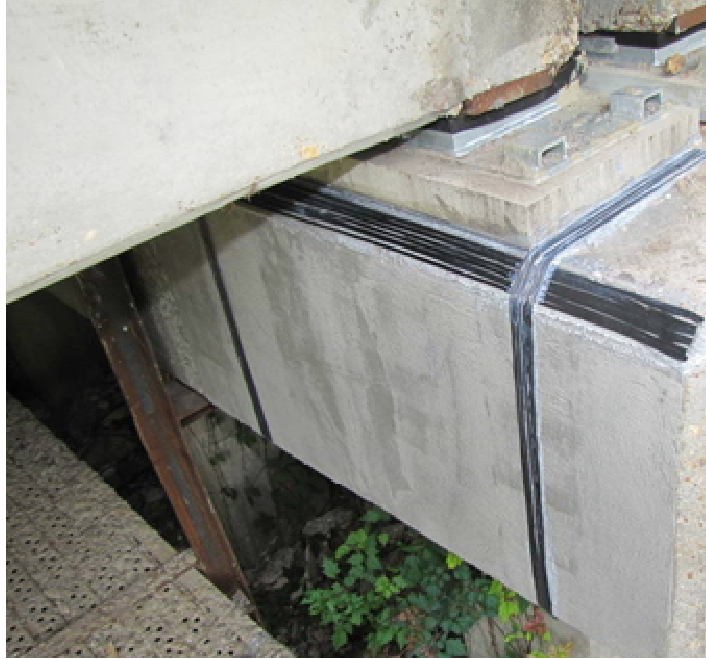
**Figure 11**  
**Details of the confining reinforcement**

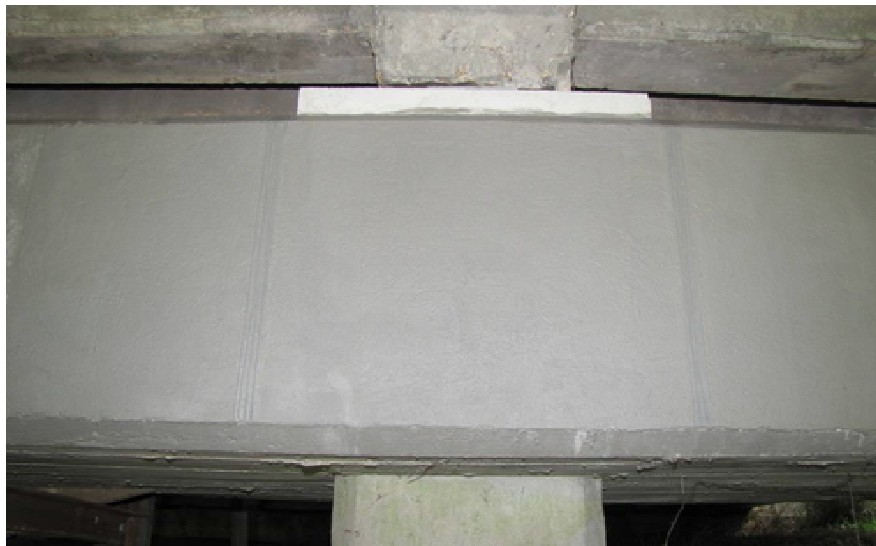
**Figure 12**  
**Final coating with short carbon fiber composite**

After the completion of the fiber composite placement, the entire bent was coated with inorganic polymer and short carbon fibers composite, shown in Figure 12. This coating's self-cleaning capability provides pleasant aesthetics and decreases the likelihood of surface deterioration of both repaired surface and the original concrete surface. The coating will also provide extra protection for carbon fibers against abrasion due to the flow of debris from the deck of the bridge. Note that the coating also has a very high abrasion resistance.

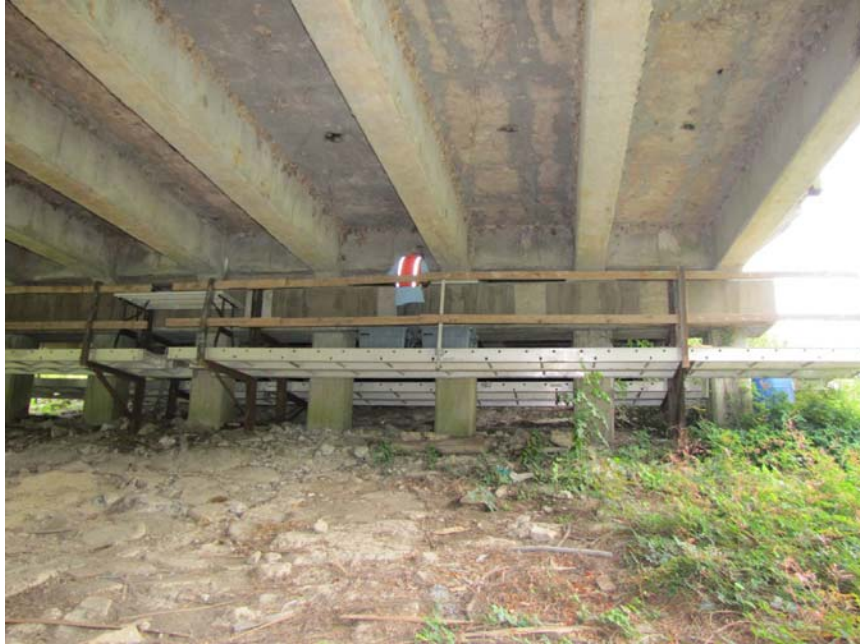
**Figure 13**  
**Appearance of the pier cap after initial major repair**

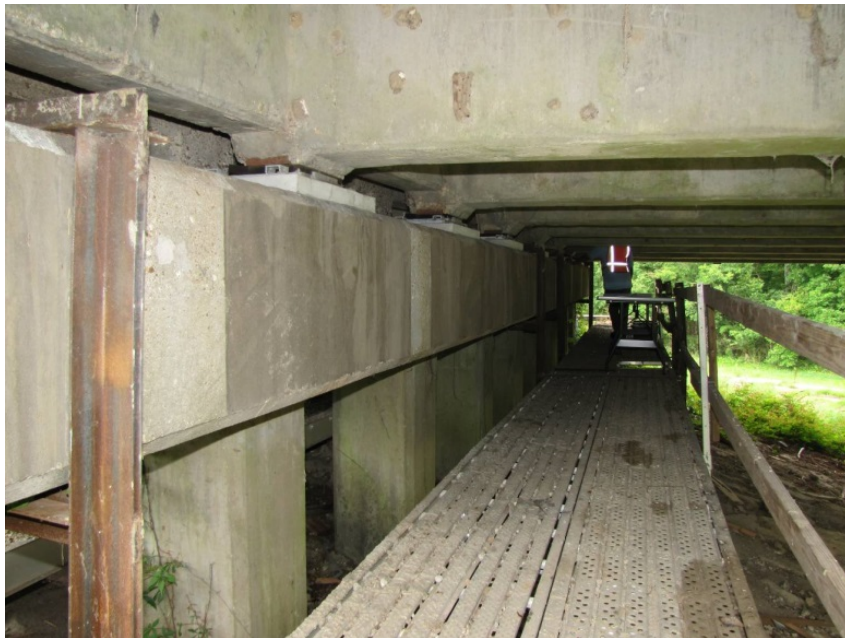
**Figure 14**  
**Surface after cleaning with water**

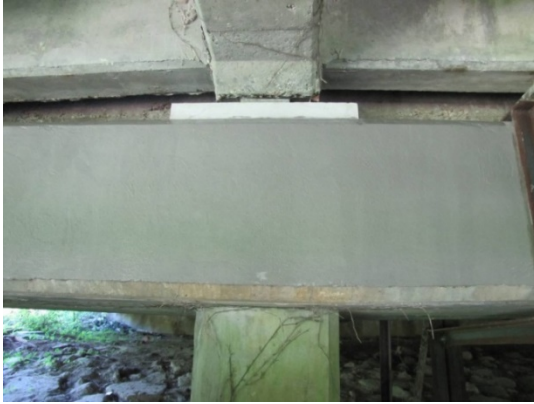
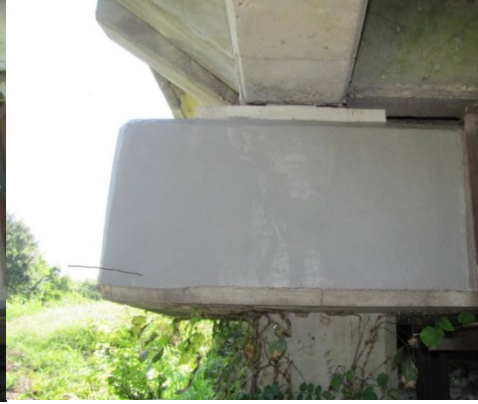
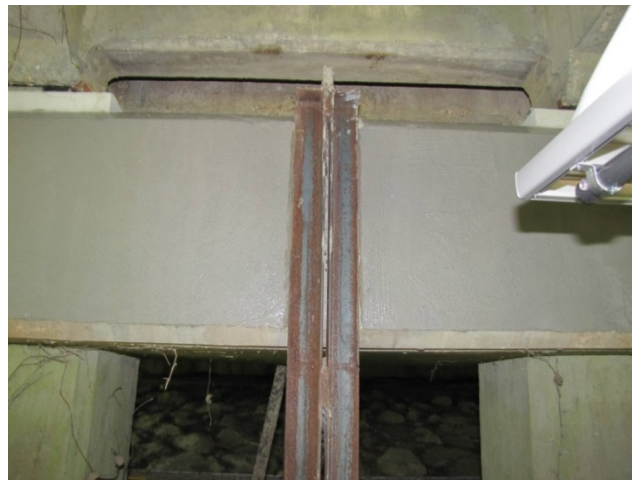
View of interior pile cap at bearing plate

View of pile cap at exterior column

View of pile cap between columns

**Figure 15**  
Appearance after initial (first) coat

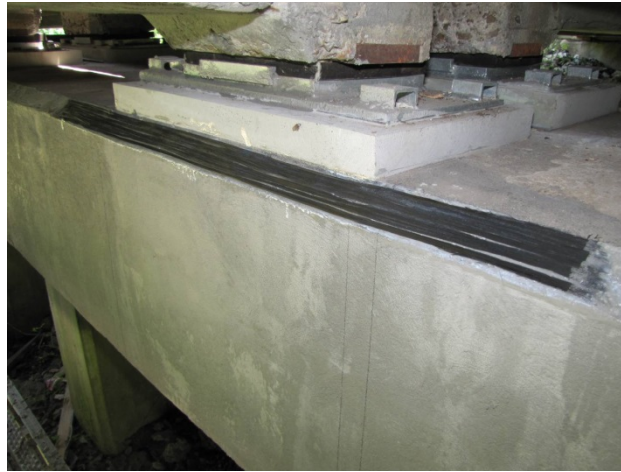
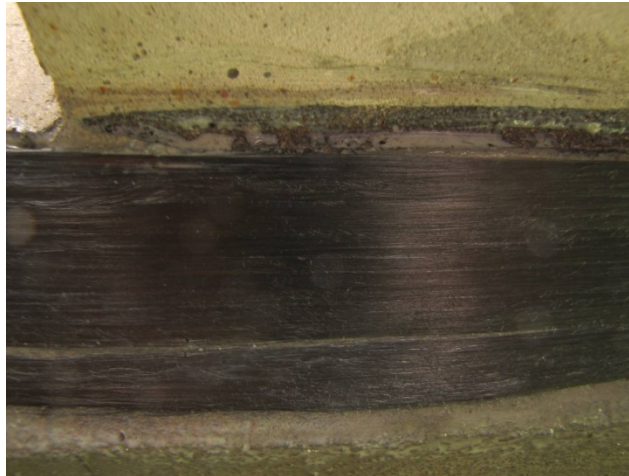
**Top view of carbon fiber placement parallel to pile cap span**

**Close-up view of carbon fiber tows**

**Figure 16**  
**Placement of tows parallel to bearing plate**

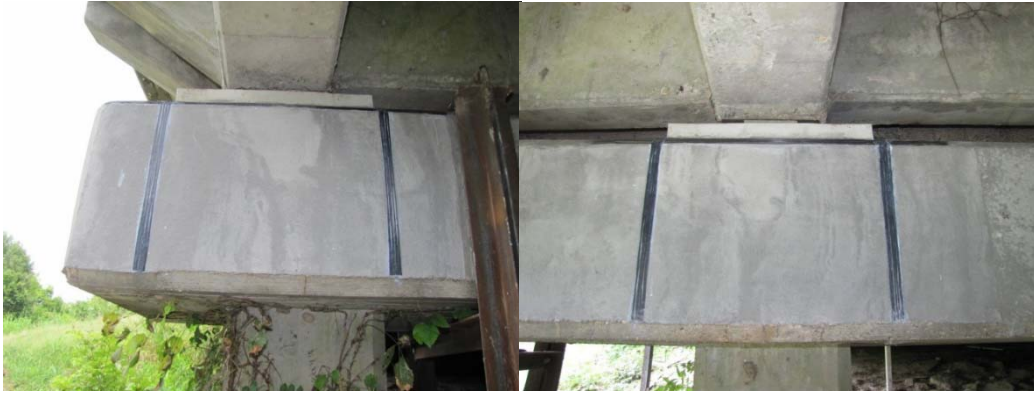
(a)  
View of carbon fiber tows in vertical direction at exterior column

(b)  
View of carbon fiber tows in vertical direction at interior column

**Figure 17**  
Placement of vertical tows

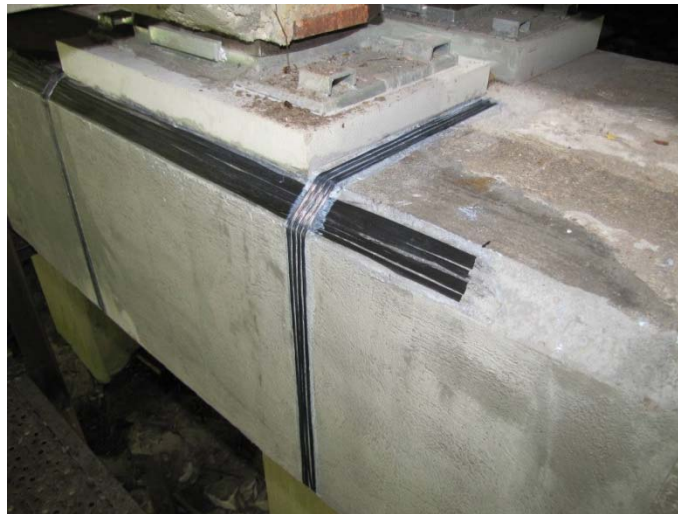
**Figure 18**  
Detail of horizontal and vertical tows junction

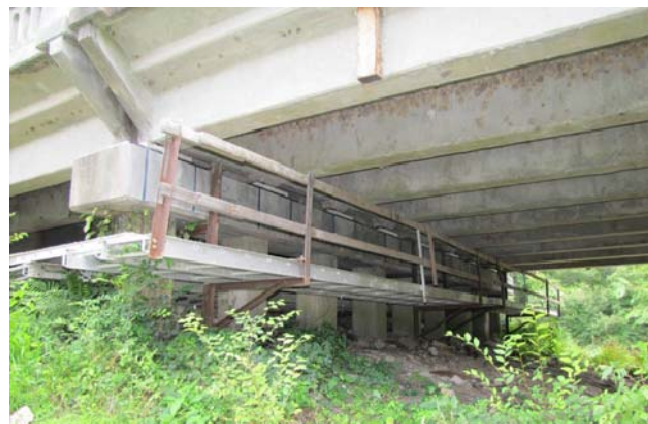
**Figure 19**  
View of entire bent after placement of tows

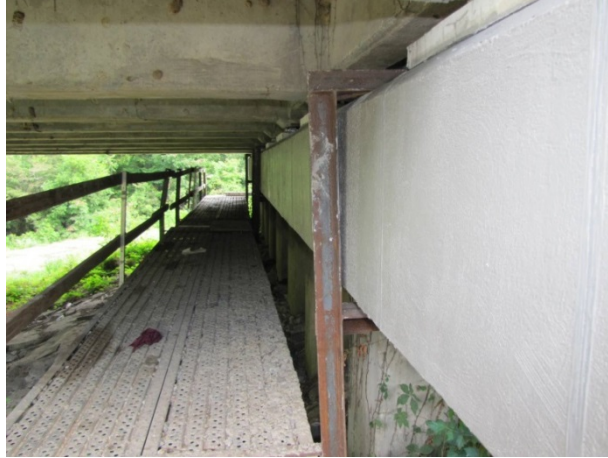
**Figure 20**  
**Appearance after the completion of second coat**

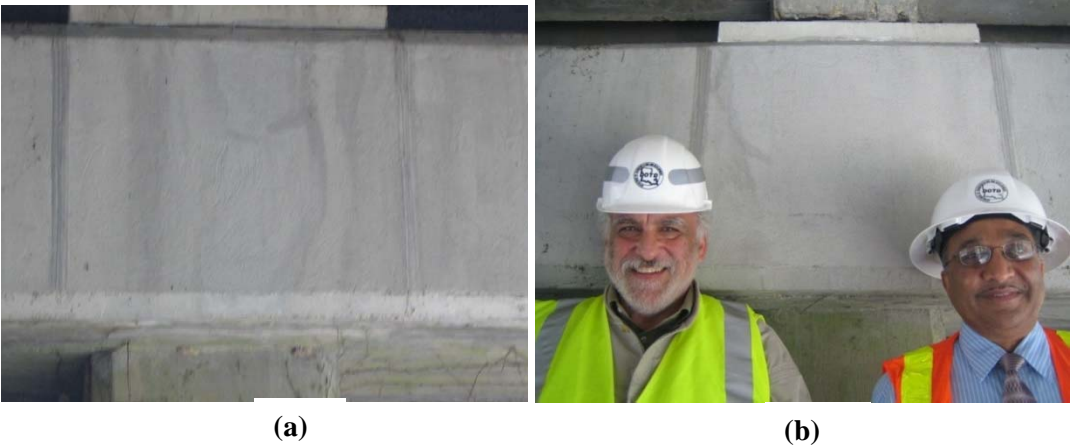
The rehabilitation work is performing well. The high modulus carbon composite used for confinement is well bonded and there is no sign of any damage or deterioration. The top fiber composite coating is also performing well. Pictures of both composites presented in Figures 22 to 25 show the status of the rehabilitation work.

**Figure 22**  
**View of high modulus confinement composite: continuous carbon tows can be seen on both sides of the bearing plate**

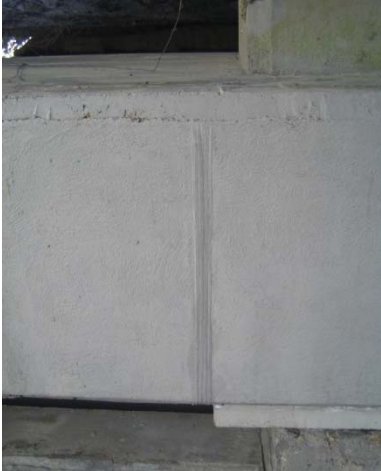
**Figure 23**  
**Close up of carbon tows**

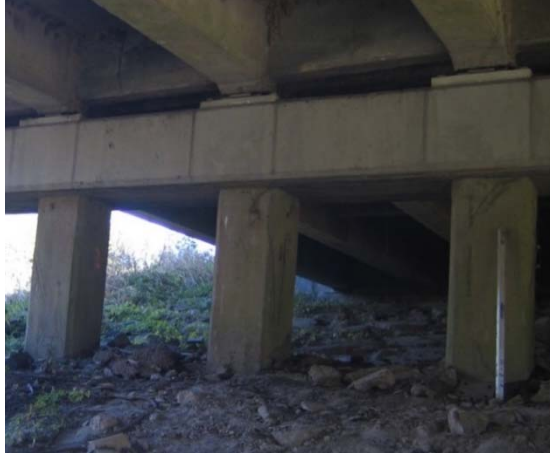
**Figure 24**  
**View of the overall structure**

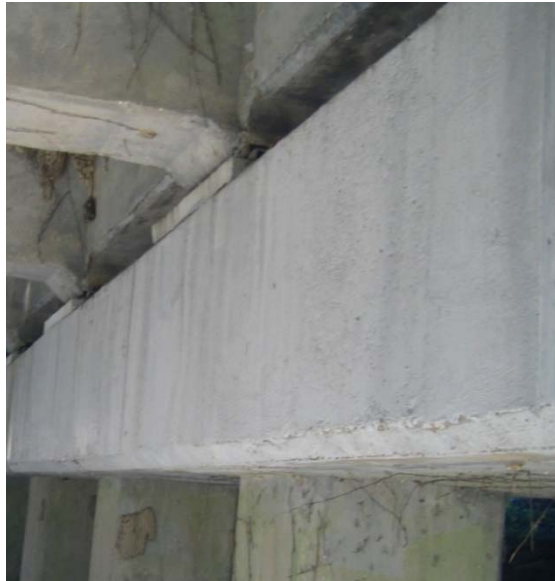
**Figure 25**  
**Close up of short fiber composite coating**

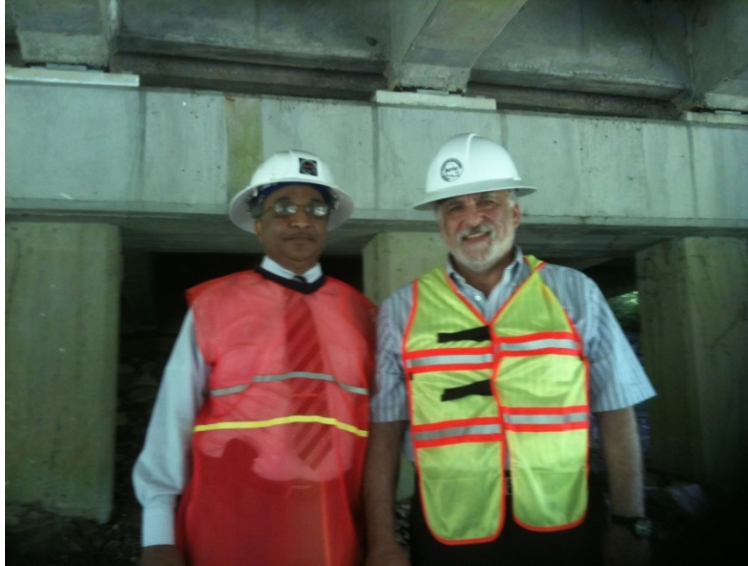
**Figure 26**

The rehabilitation work is performing well. The high modulus carbon composite used for confinement is well bonded and there are no signs of any damage or deterioration. The top fiber composite coating is also performing well. Pictures of both composite-coatings presented in Figures 26 to 30 show the status of the rehabilitation work.

**View of high modulus confinement composite: Continuous carbon tows can be seen on both sides of the bearing plate; the patch above Professor Gopu (left) is the non-coated control surface**

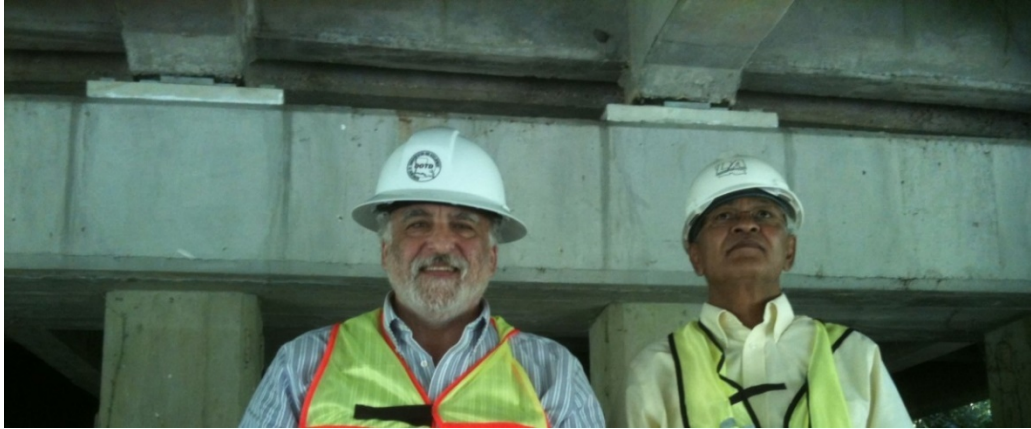
**Figure 28**  
**View of center part of the structure**

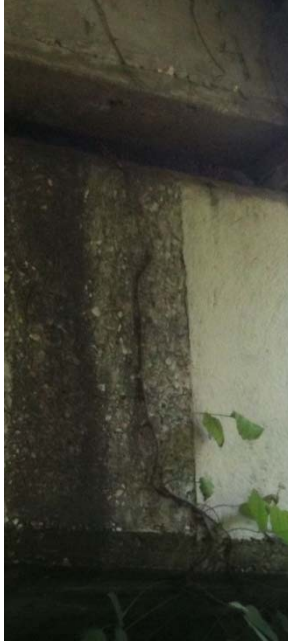
**Figure 30**  
**Self-Cleaning Property: Close-up of coated (on right) and non-coated (on left) surface highlights self-cleaning**

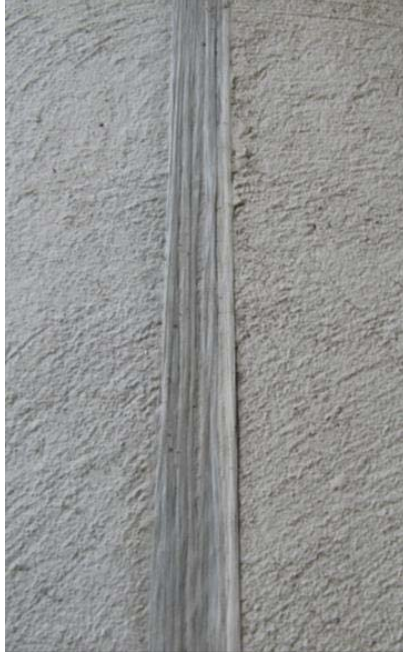
**Figure 32**  
**Close-up of carbon tows**

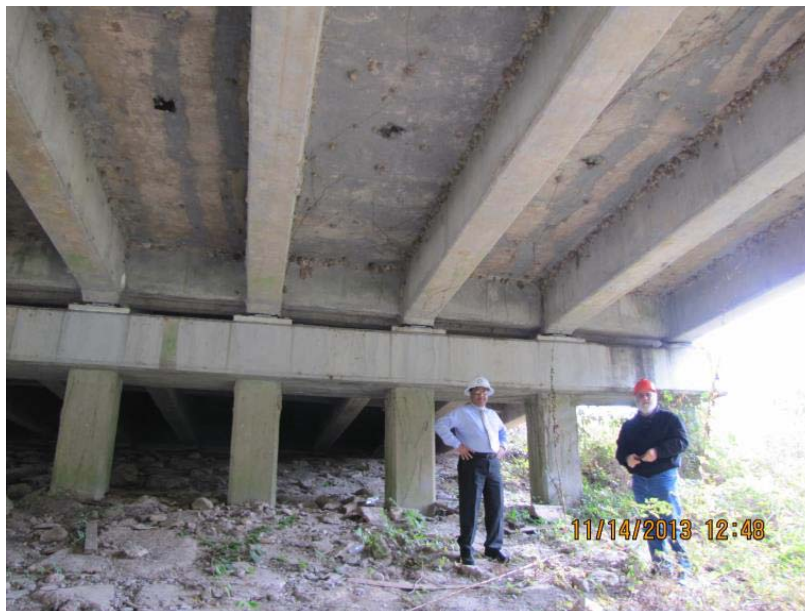
**Figure 33**  
**Overall view: Note the debris buildup on the un-coated right side of the structure**

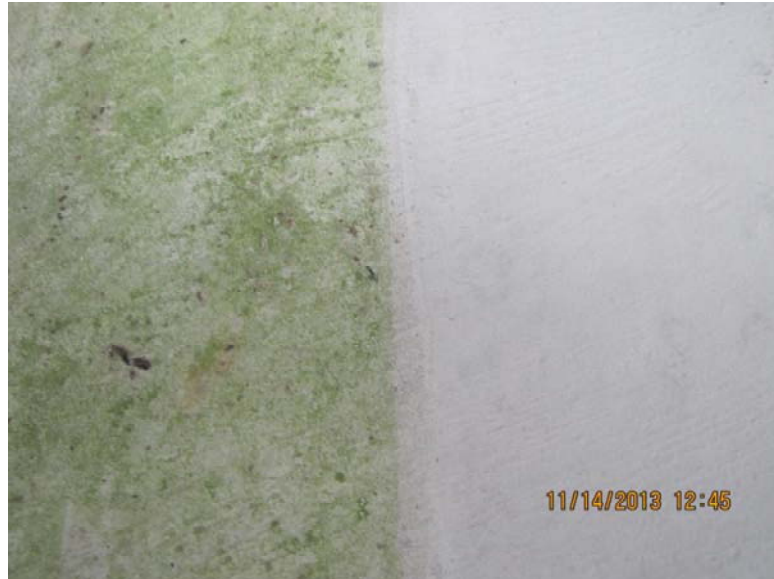
**Figure 34**  
**Self-cleaning property: close-up of coated (on right) and non-coated (on left) surface highlights self-cleaning**

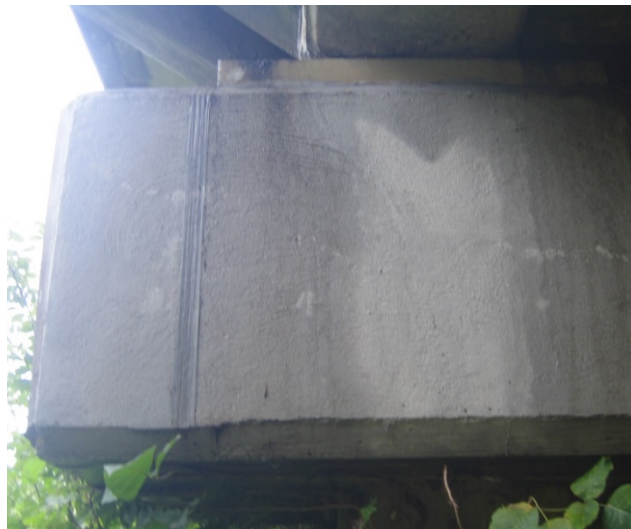
The fourth and the final inspection was performed on June 27, 2014, approximately two years after the initial application. As in the case of previous inspections, the repair is performing very well with no distress. The self-cleaning and abrasion properties are demonstrated. The status of the repair, presented in Figures 35 to 39, supports the aforementioned observations.

**Figure 35**  
**View of high modulus confinement composite: Continuous carbon tows can be seen next to the bearing plate**

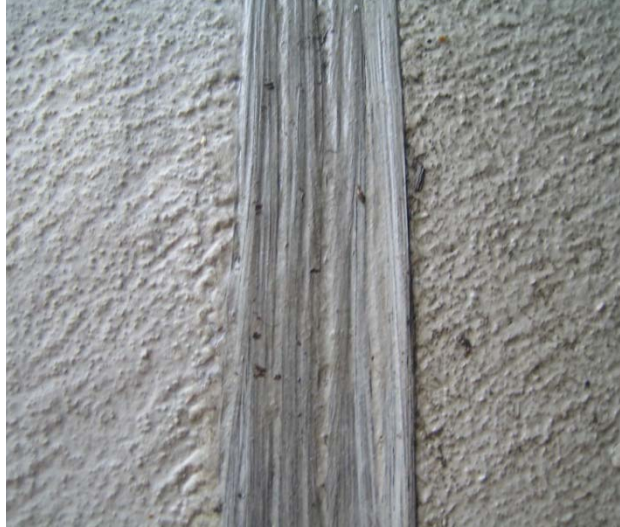
**Figure 36**  
**Close-up of carbon tows**

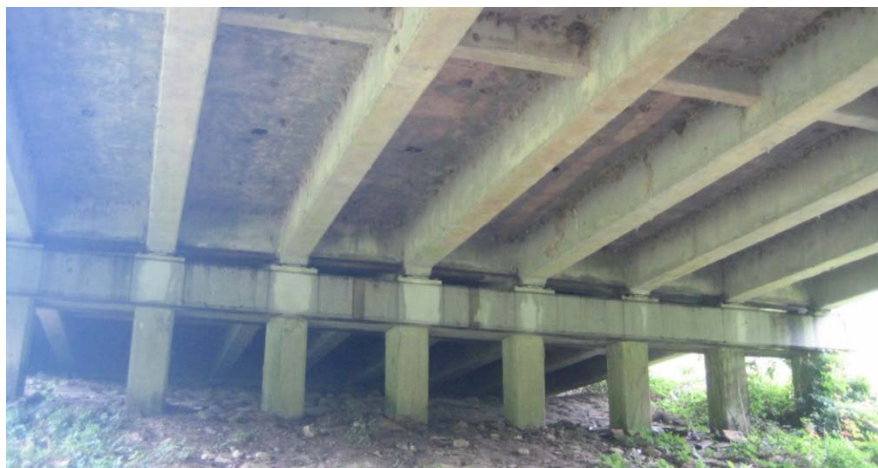
**Figure 38**  
**Overall view: Note the debris buildup on the un-coated right side of the structure**
