Evaluation of High Friction Surface Locations in Kansas

David A. Meggers, P.E.

*Kansas Department of Transportation
Bureau of Research*

Final Report

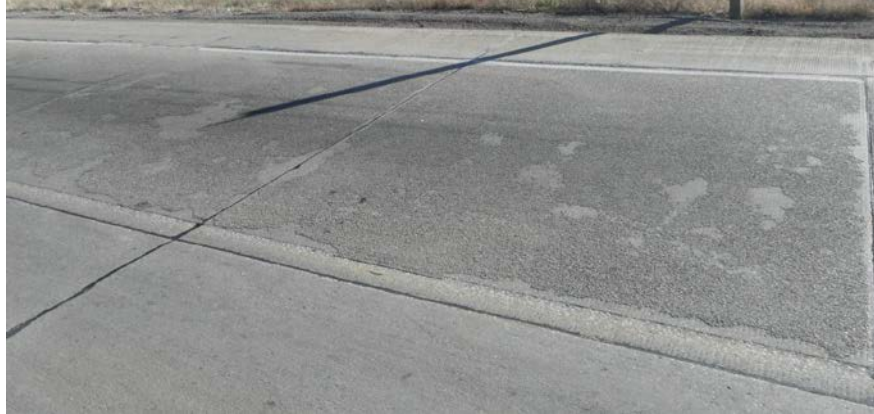
Figure 1: I-35/I-635 Ramp Overlay Condition

The I-35/I-635 (concrete) application was also reviewed in the fall of 2013 and was found to have significant wear. A large amount of the material has either worn off or peeled off (see Figure 1). Similar to the asphalt surface of K-5, the material is peeling along joints and reflective cracks.

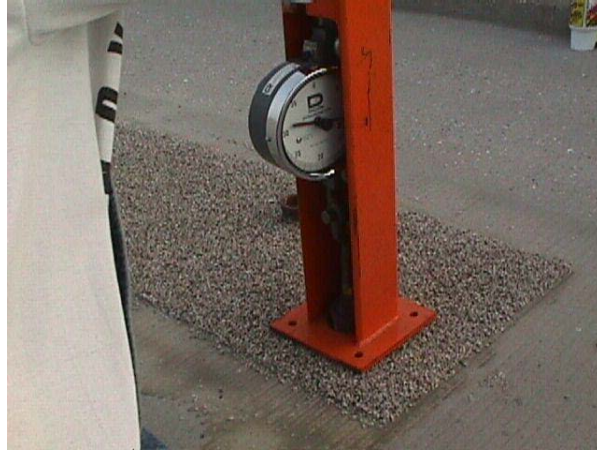
Figure 2: Example of Field Pull-Off Test

HFS to pavement bond was tested at the three remaining locations using ASTM C1583 (2013). Sampling was performed in the field by drilling a 2-inch diameter core to a depth of 1 inch. The top of the sample is cleaned and dried, and a 2-inch diameter pipe cap is bonded to the sample with 5-minute epoxy. The epoxy is allowed to cure and a frame is placed over the sample with an attached dynamometer to determine force at failure (Figure 2). Results of the bond tests for the three remaining applications are shown in Tables 5, 6, and 7.

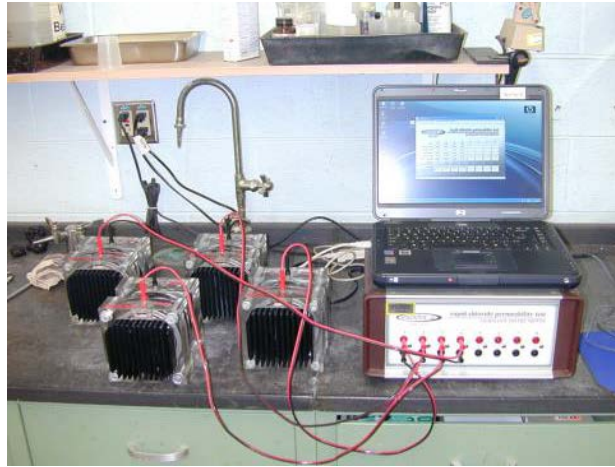
Figure 3: Rapid Chloride Permeability Equipment

Rapid chloride permeability testing was performed according to ASTM C1202 (2012). Three cores 4 inches in diameter were removed to a depth of at least 6 inches from each of the three HFS locations remaining in service. RCP was performed on the top 2 inches of each core with the HFS intact. RCP was also performed on the second 2 inches of the cores to determine the permeability of the substrate paving material. The RCP testing indicated that the HFS surfaces did afford some level of protection to the pavements. See Figure 3 for equipment set up.
