**ALTERNATIVE AGGREGATES AND MATERIALS FOR HIGH  
FRICTION SURFACE TREATMENTS**

Final Report  
Project BDR74-977-05

Performed in cooperation with the  
Florida Department of Transportation  
and the  
Federal Highway Administration

Published May 2016

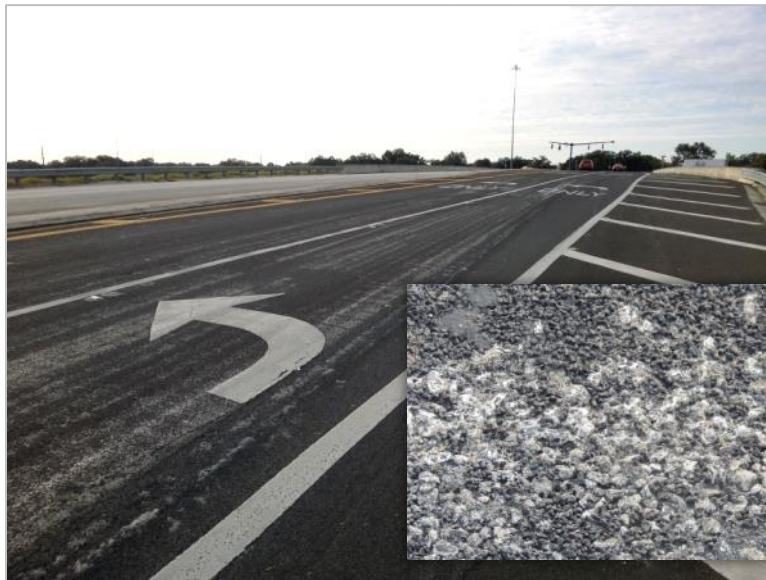
**Figure 2.6 – Aggregate loss over uneven texture (Memorial Blvd to I-4)**

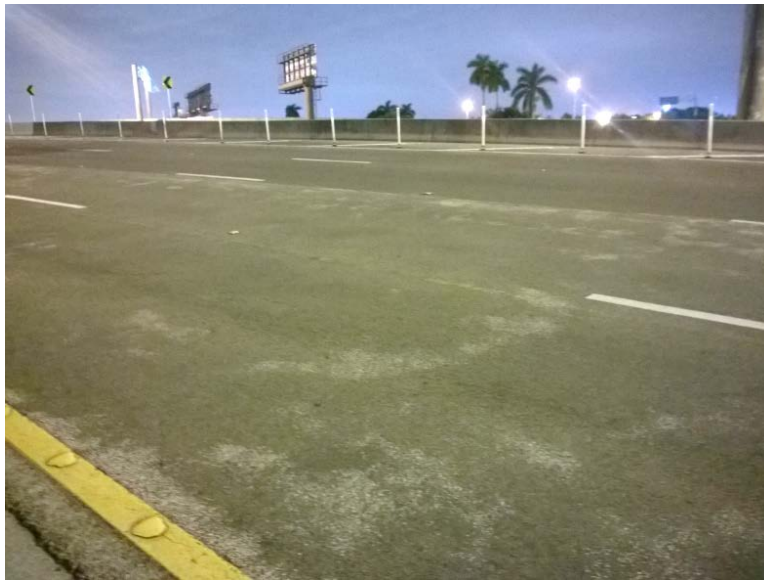
**Figure 2.8 – Aggregate loss over OGFC (FLL Airport)**

To avoid this problem, surface preparation practices described in the *Best Practices* section should be followed. If applying over an OGFC, the superelevated curves should be completely treated to prevent water from infiltrating beneath the HFST.

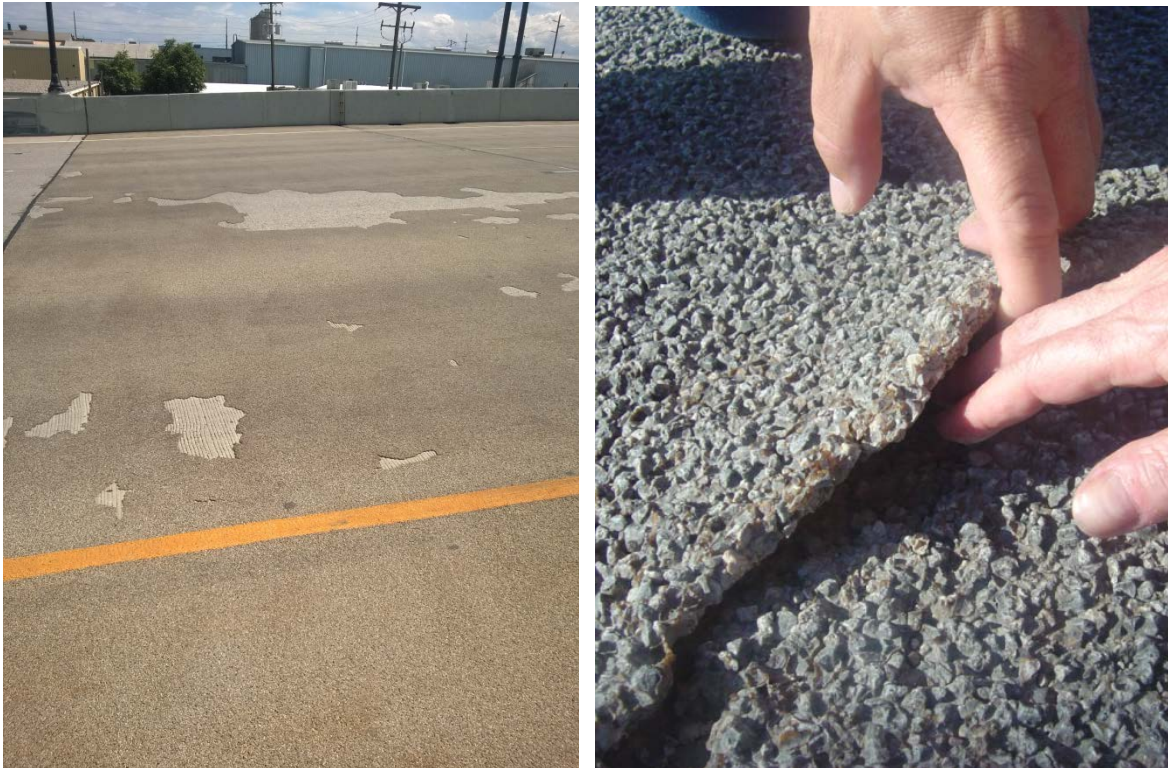
**Figure 2.9 – Delamination: Bridge deck and a double layer HFST**

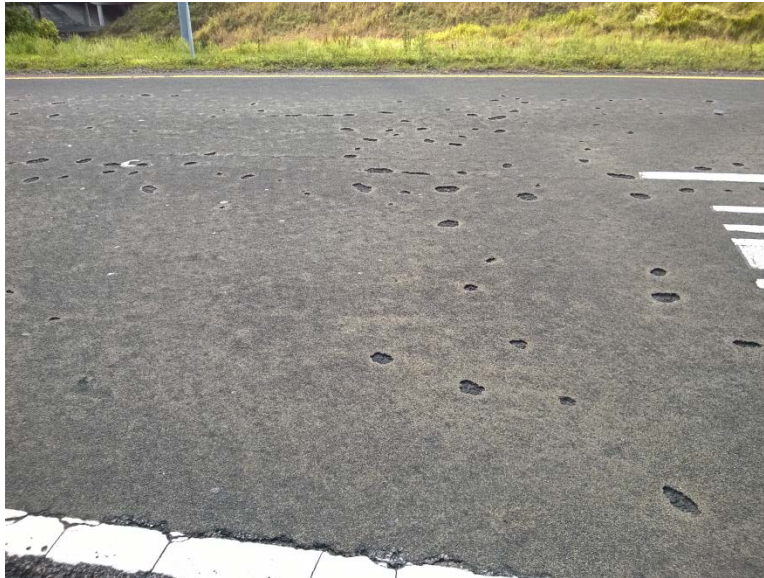
In the case of two Florida sections (Tampa-I-275 to US 60 and Brandon-US-60 to NB I-75), an inexperienced contractor rented an epoxy mixing truck from the HFST vendor. The equipment malfunctioned and could not completely mix the two epoxy components. After 3 years, the project is covered by localized failures (Figure 2.10). On both projects, the HFST was applied over OGFC. As the aggregate and binder delaminated, moisture collected in the OGFC, stripped the aggregate, and created potholes under traffic. Other examples of uncured binder failure are shown in Figure 2.11 and Figure 2.12.

**Figure 2.10 – Widespread localized failures due to poor binder mixing (US 90 – I-75 NB)**

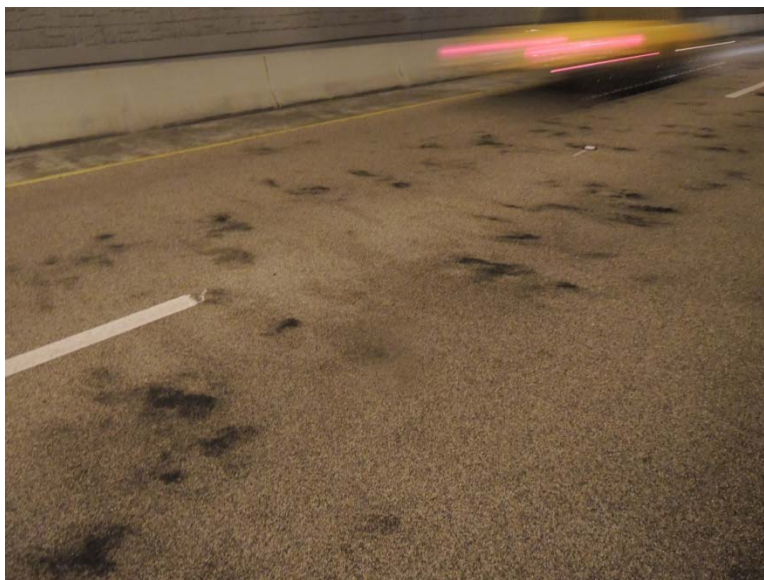
**Figure 2.11 – Soft blotchy areas shortly after construction (I-95 ramp)**

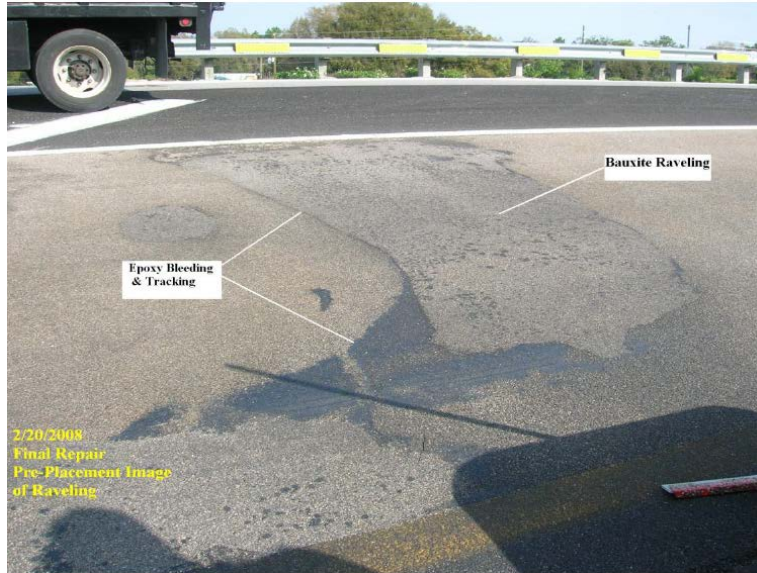
**Figure 2.12 – Result of incorrect proportioning: aggregate loss, epoxy bleeding, and epoxy tracking (Polk Co. Parkway to I-4)**

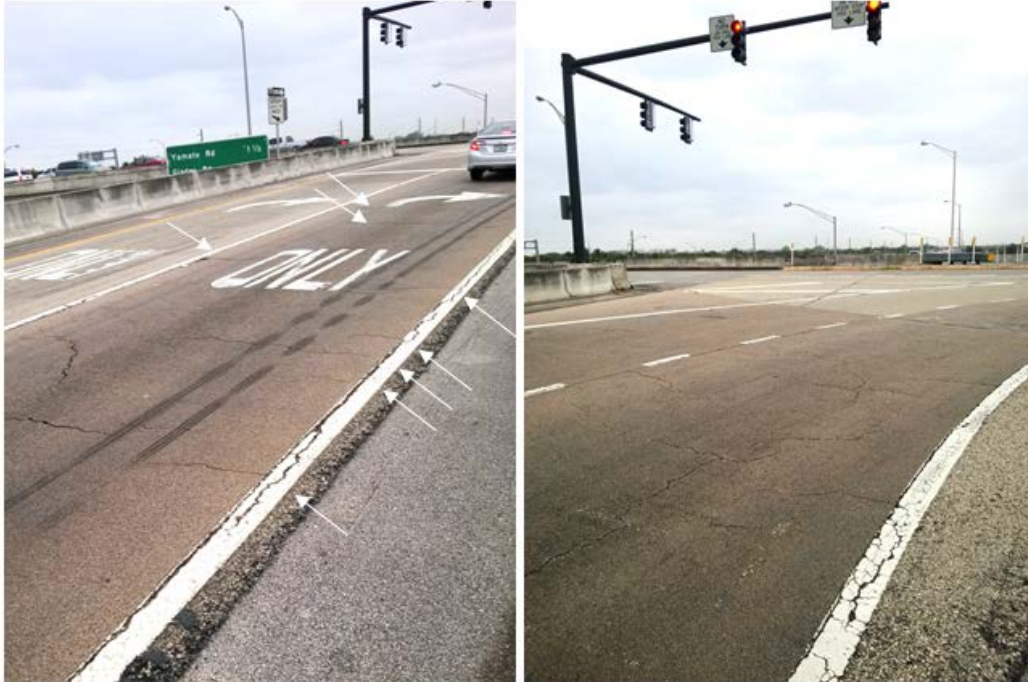
The exact mechanism is not proven but theorized in Figure 2.14. As a vehicle turns, brakes, and accelerates, the tires generate shear forces on the pavement surface. There is also a small amount of slipping that occurs, especially when turning. On an aggressive high-friction surface, the amount of slipping is reduced, and as a consequence, the shear stress between the tire and surface increases. These higher shear stresses can accelerate the deterioration of weak substrates.

**Figure 2.13 – Substrate tearing at an approach (transverse) and around curve (random) (Boca Raton-I-95 to Congress)**

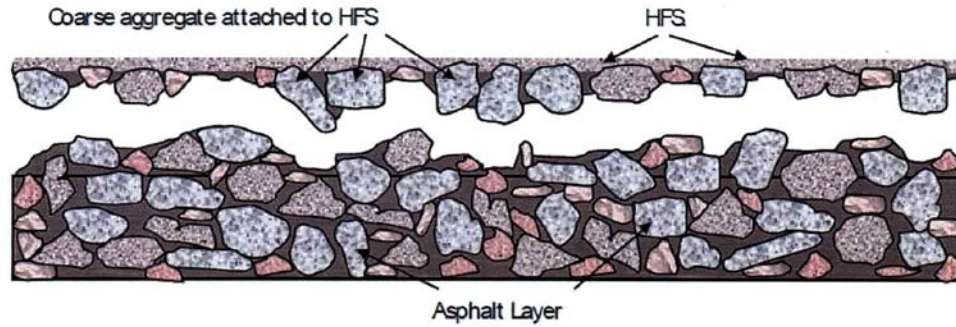
Stripping may first look like a delamination failure, except that the actual location of failure is in the substrate, and not at the HFST bond interface (Figure 2.15). Moisture at the time of construction, or moisture that later infiltrates, becomes trapped beneath the HFST and can strip the asphalt under traffic and high temperatures. Waters (28) investigated HFST failures in New Zealand and found that most cases were a failure within the top 20 mm of the asphalt substrate. This stripping condition is worsened by the previously described mechanism of higher shear stress.

**Figure 2.15 – Cohesive failure (28)**

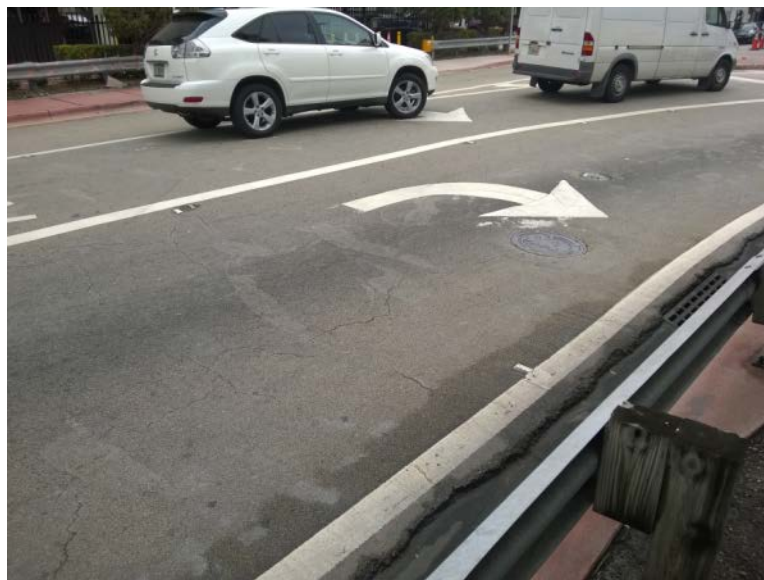
The last substrate-failure mechanism is thermal incompatibility. This type of failure is observed as surface cracking in roughly circular patterns. If the cracked area is removed, the failure in the substrate is in the shape of an inverted cone. (29) This is caused by (1) a difference in thermal coefficients, (2) a difference in layer stiffness (resistance to bending) and (3) low tensile strength of the substrate. The thermal coefficient for typical epoxy is  $25 \text{ to } 36 \text{ E}^{-6} \text{ inch}/(\text{inch} \cdot ^\circ\text{F})$ . (30). This property for asphalt is unknown, but will be measured in later laboratory testing. With temperature changes, the epoxy layer and asphalt layer expand and contract at different rates, generating thermal stress. If this stress exceeds the substrate strength, then the substrate will fail. One particular epoxy was more susceptible to this problem than other epoxies because it was stiffer and would not flex under these stresses. The project in Figure 2.16 used this epoxy. This product is not in general use anymore.

**Figure 2.16 – Random cracking likely from thermal incompatibility (Miami Beach-SR A1A)**

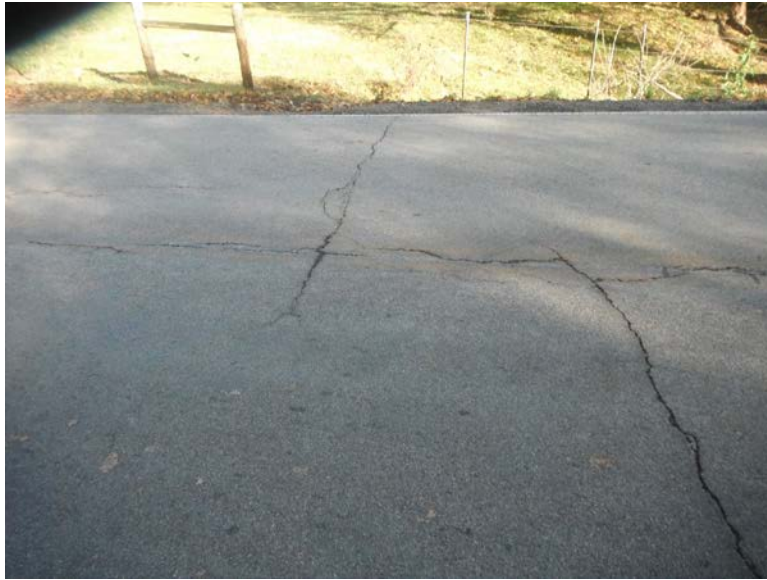
Epoxy has some flexibility and generally resists brittle cracking under traffic. Most observed cracking, if not associated with substrate failure, is reflective cracking. Existing cracks will propagate into the HFST under traffic loads or thermal cycling. (Figure 2.17) Two such examples are projects in North Carolina and Colorado. Reflective cracking here was combined with stripping.

**Figure 2.17 – Reflective cracking**

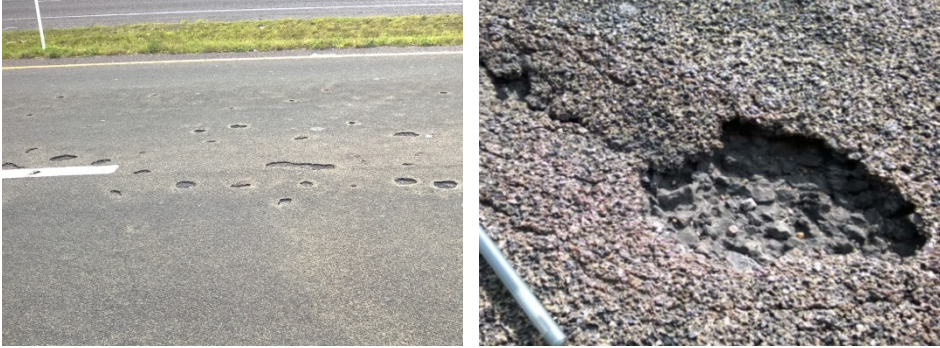
Project	Distress	Failure Mechanism	Example
<p><b>US 60 to I-75</b></p>	<p>Small random potholes</p>	<p>Uncured binder failure (inadequate mixing).  Stripping within substrate.</p>

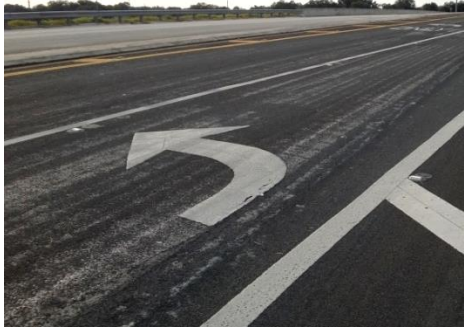
<p><b>Mem. Blvd Ramp</b></p>	<p>Raveling (limited)</p>	<p>Inadequate film thickness (inconsistent texture on existing surface).</p>

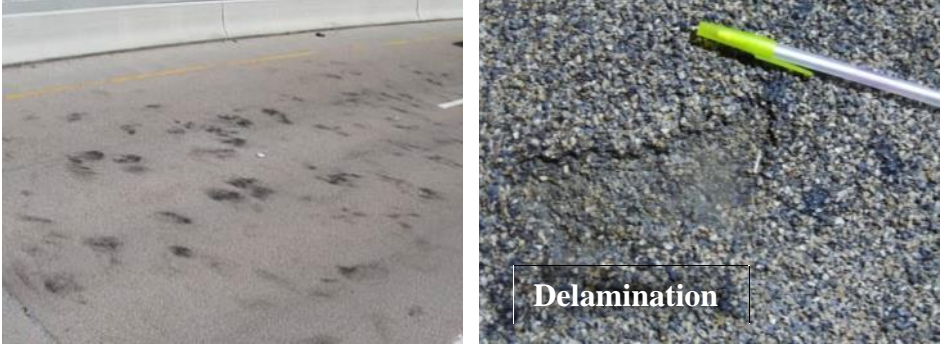
<p><b>I-95 and Ramp</b></p>	<p>None on bridge  Splotches and delaminations on ramp</p>	<p>-  Uncured binder failure (inadequate mixing from equipment malfunction).</p>

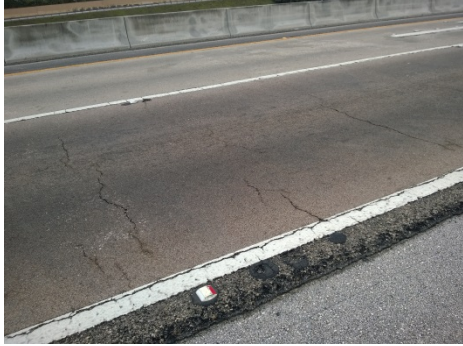
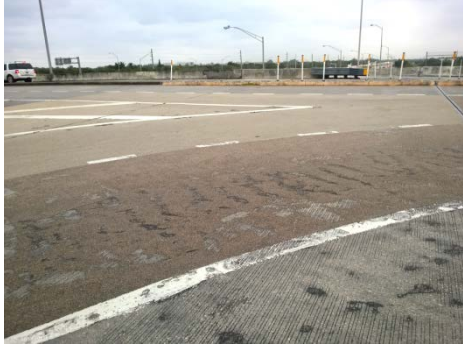
Project	Distress	Failure Mechanism	Example	
<p><b>I-95 to Congress</b></p>	<p>Transverse and random cracking</p>	<p>Substrate tearing.</p>

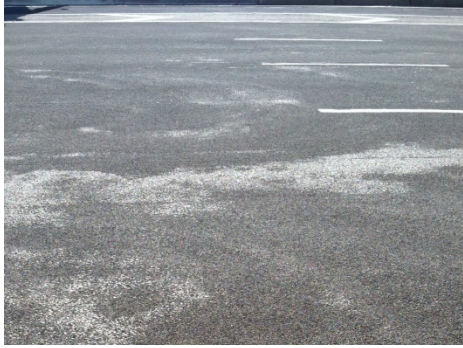
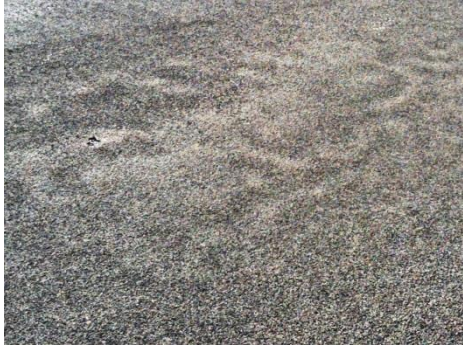
<p>Raveling over concrete</p>	<p>Likely no shot blasting. Likely single-lift.</p>		
<p><b>FLL Ramp</b></p>	<p>None on bridge</p>	<p>-</p>

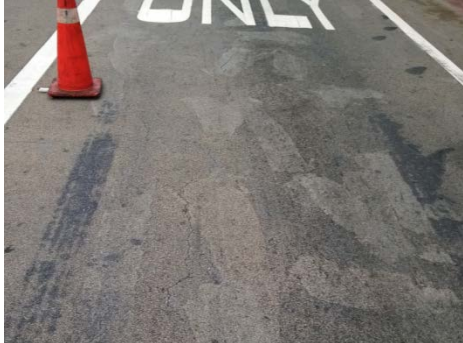
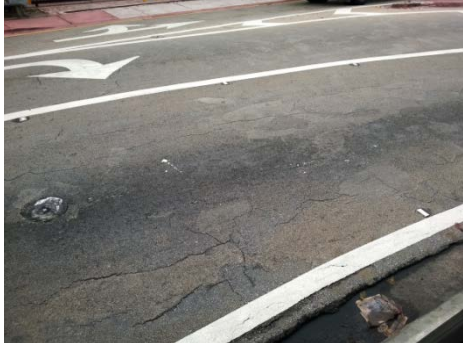
<p>Raveling over FC-5</p>	<p>Inadequate film thickness (poor application).</p>		
	<p>Irregular depressions</p>	<p>Unknown. Possible stripping of weak substrate.</p>		
<p><b>SR A1A</b></p>	<p>Splotchy texture</p>	<p>Subsequent HFST patches.</p>

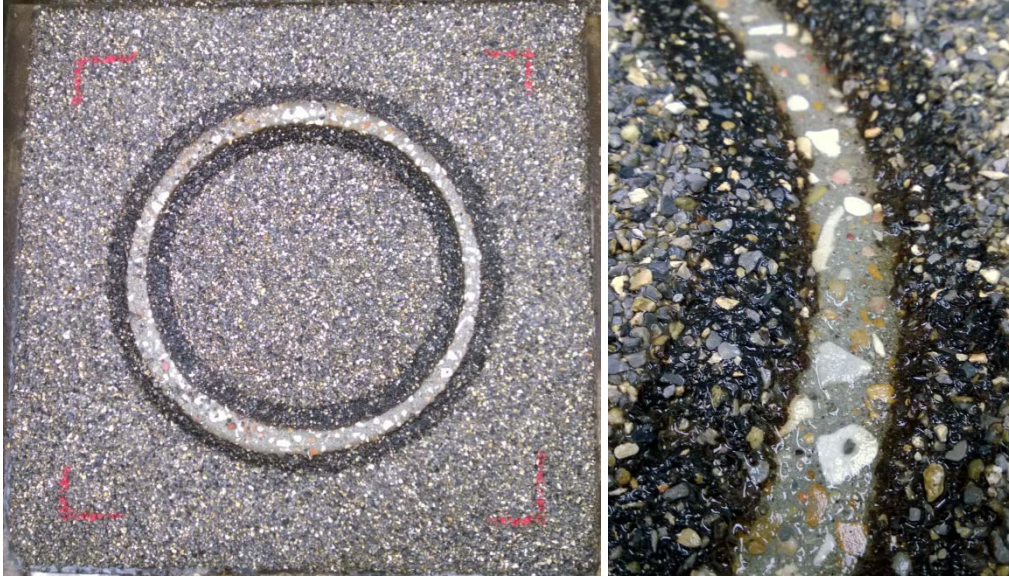
**Figure 5.16 – Failure of Binder C sample at 140°F**

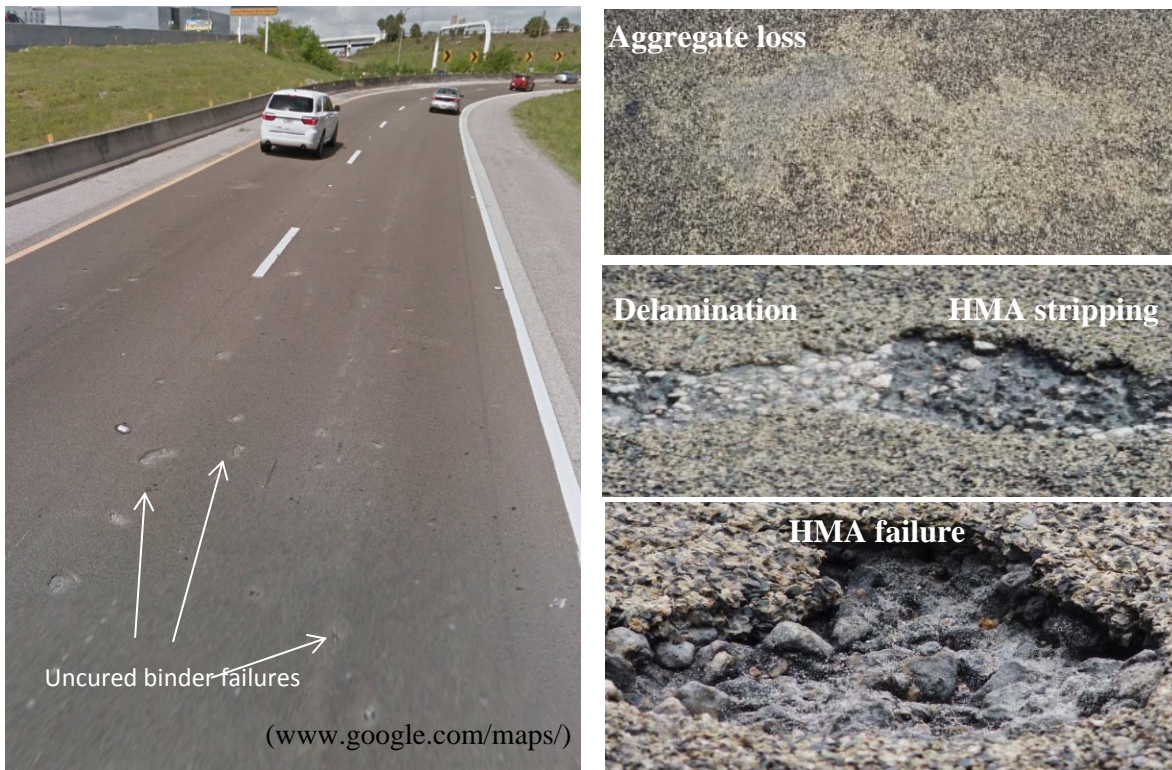
**Figure C.3 – Failed locations on HFST (2014)**

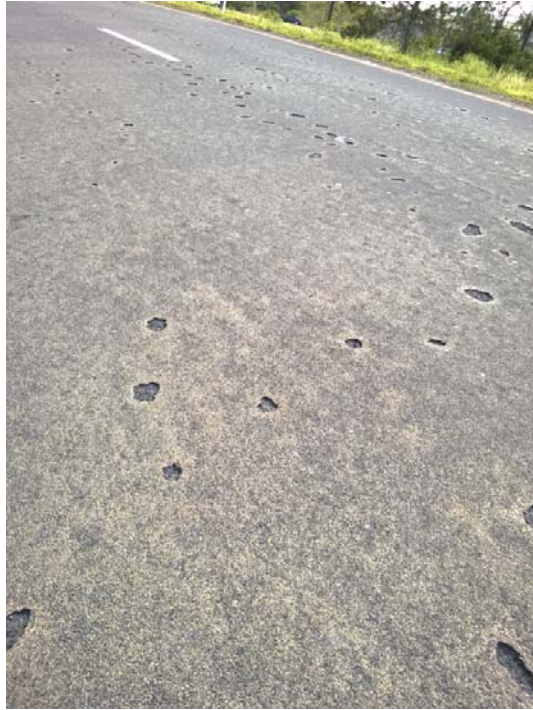
**Figure C.6 – Uncured binder failure and potholing.**

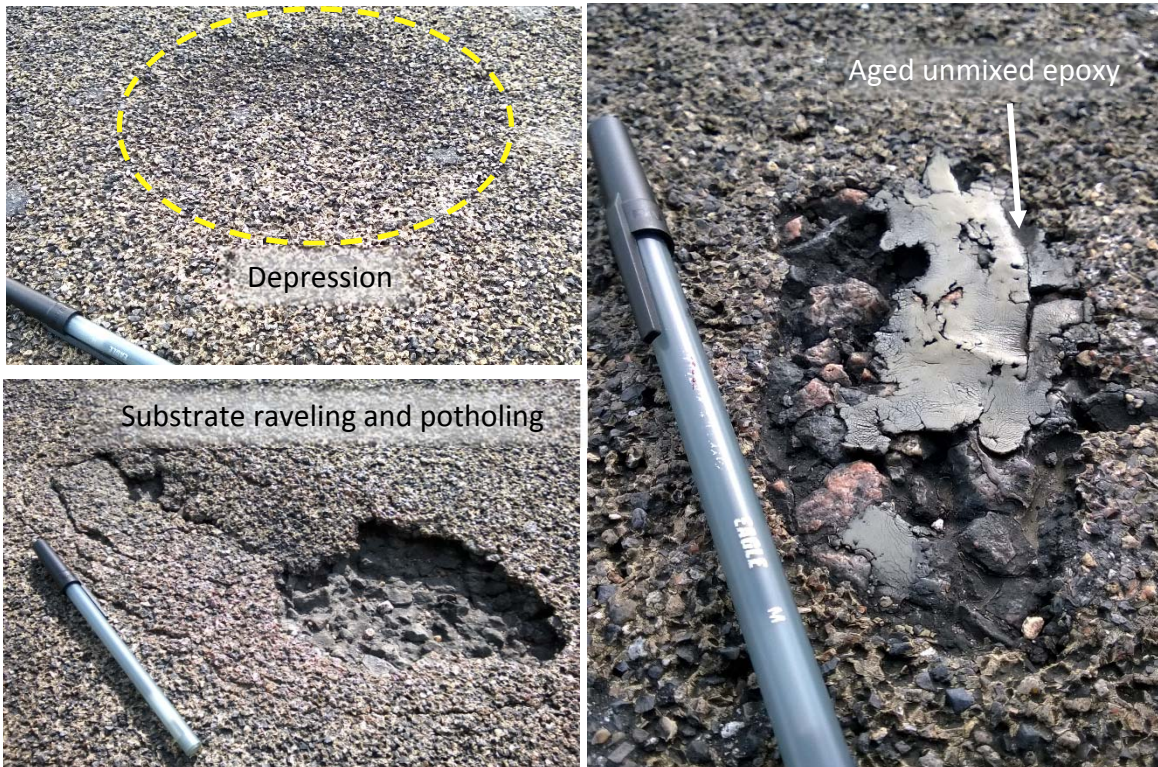
**Figure C.7 – Stages of HFST failure.**

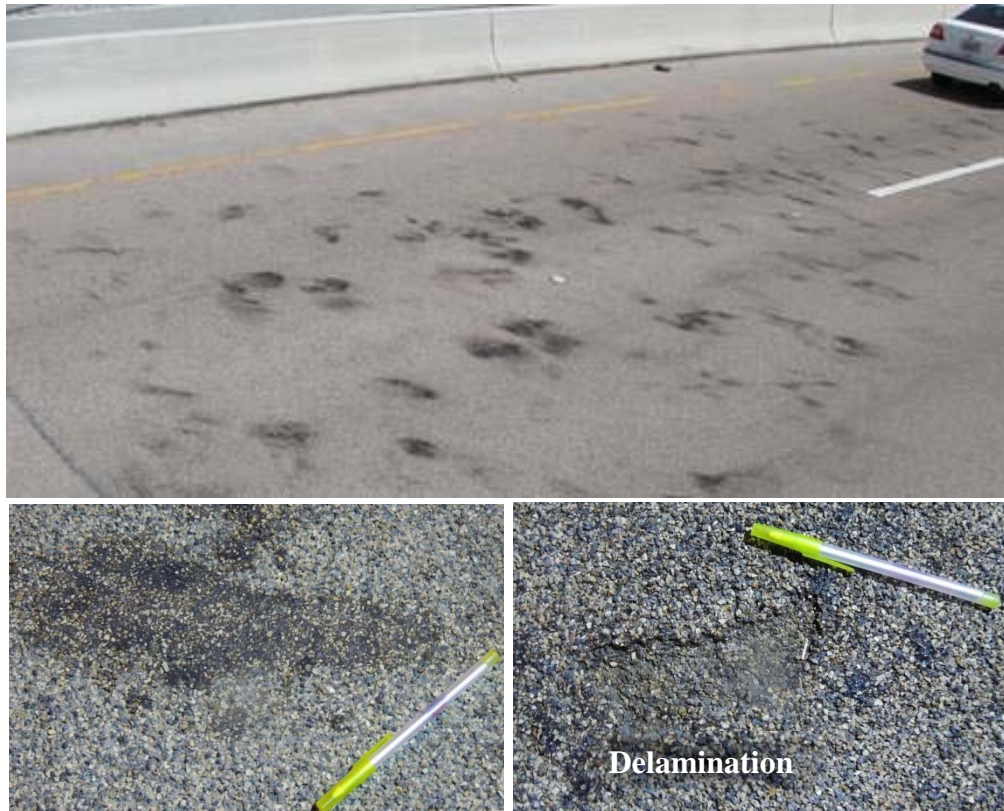
**Figure C.16 – Splotchy areas on southbound exit ramp.**

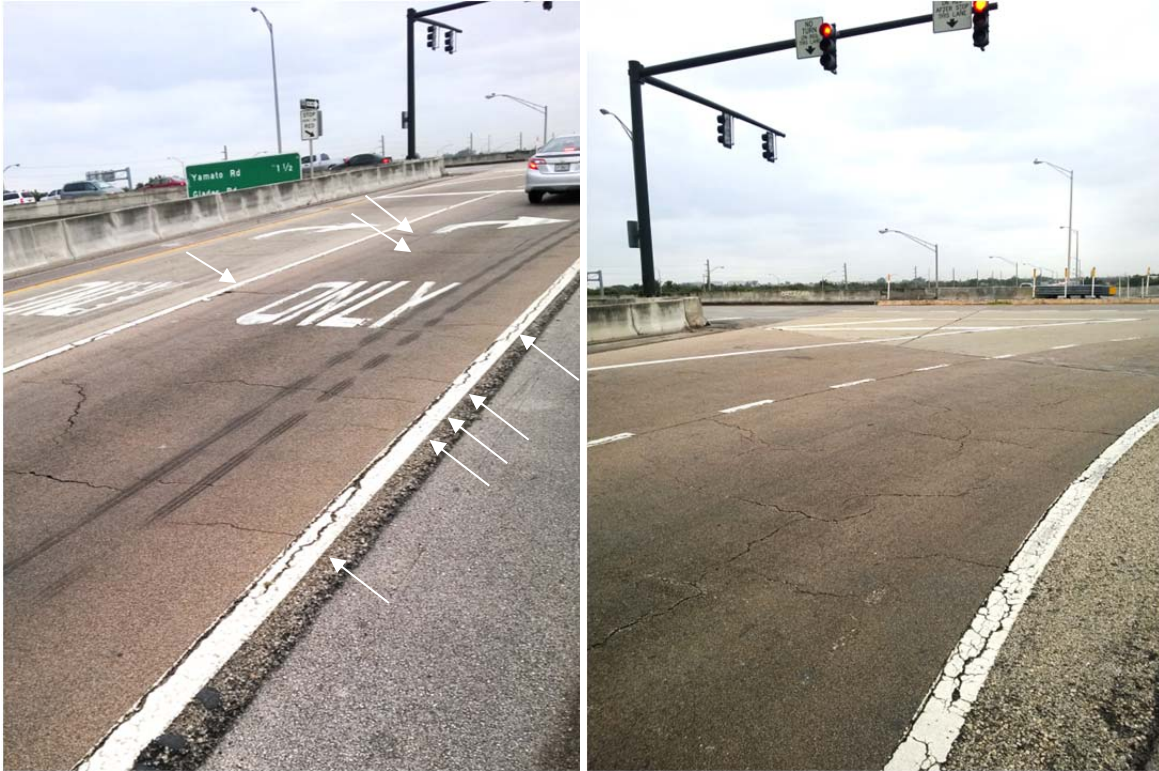
**Figure C.21 – Distress near stop bar over OGFC: a) transverse and b) random cracking.**

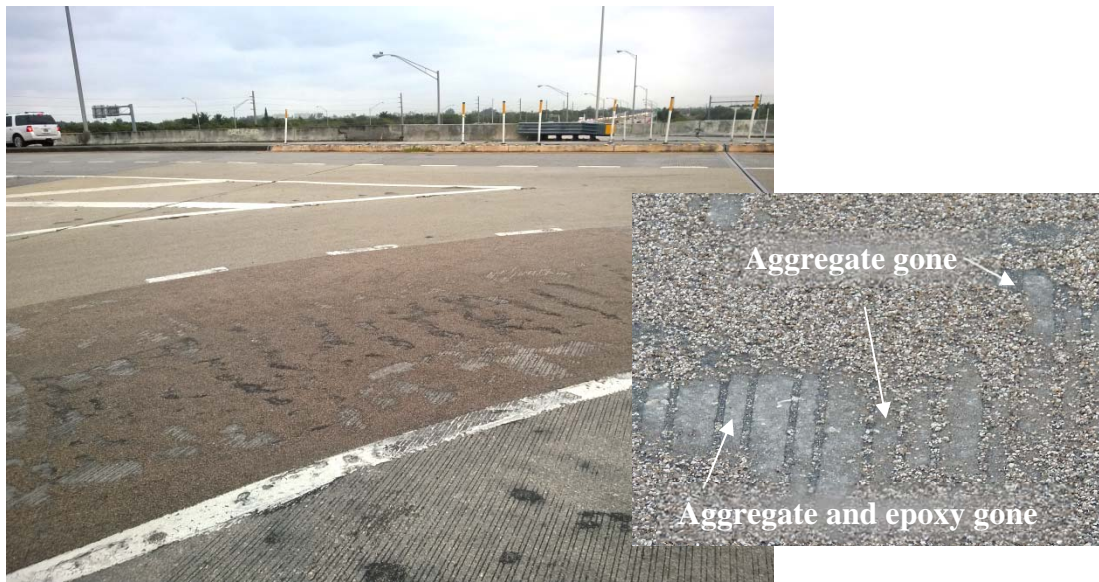
**Figure C.22 – Wearing away of HFST around the curve over concrete.**

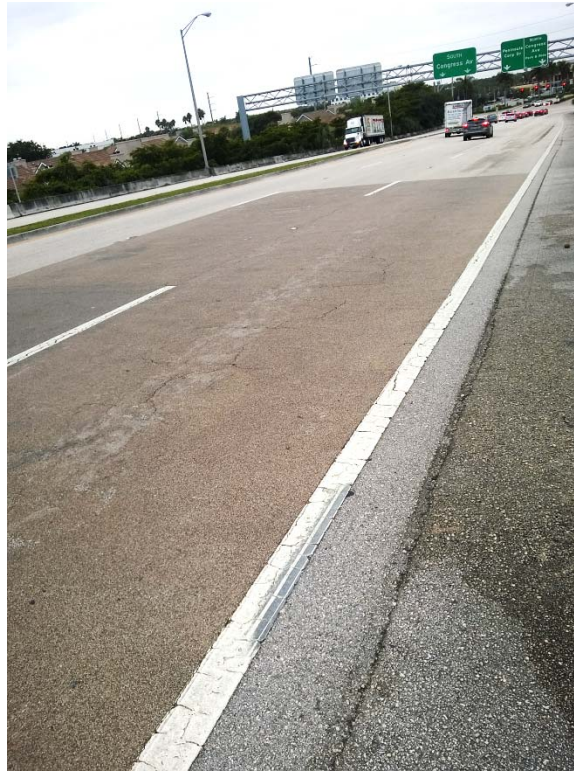
**Figure C.23 – Random cracking of HFST after the curve and over HMA.**

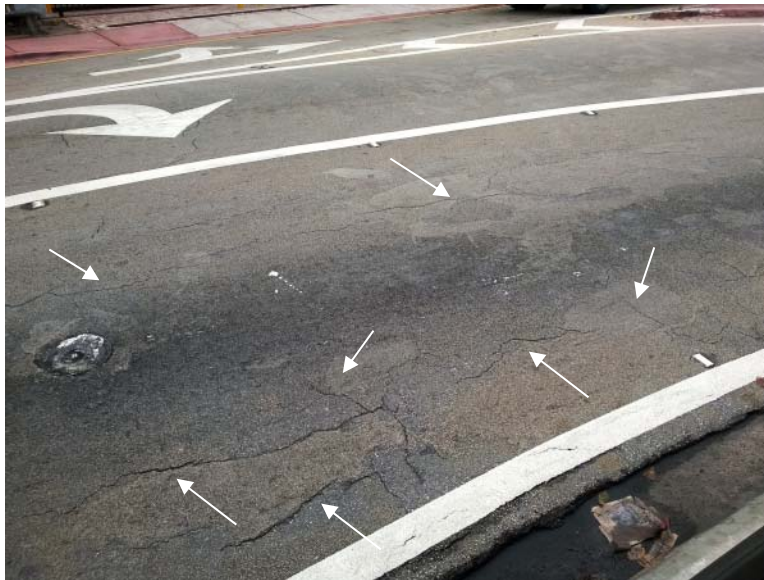
**Figure C.27 – Random cracking (likely thermal incompatibility).**

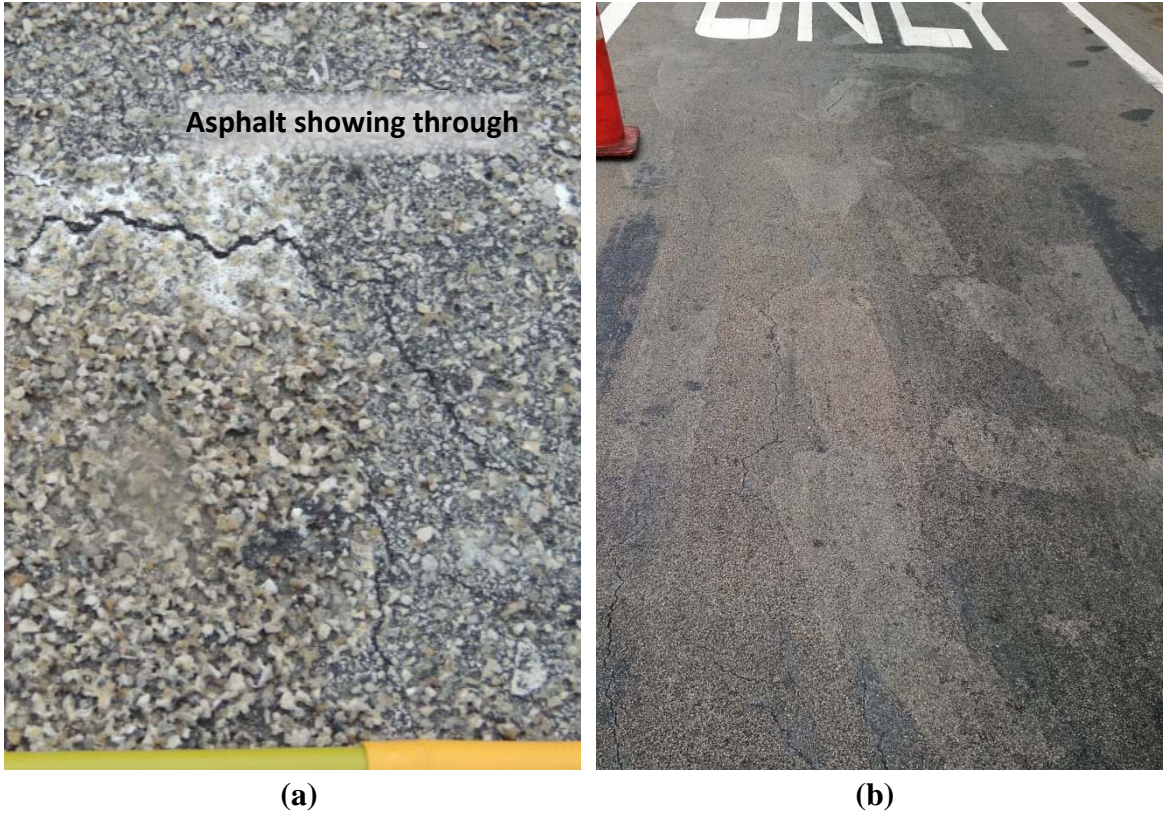
Figure C.28 – Other distress: a) raveling and b) subsequent HFST patching.
