Field Testing of Hand-Held Infrared Thermography, Phase II TPF-5(247) Final Report

Project No. TPF-5(247)

Field Testing of Hand-Held Infrared Thermography, Phase II

Final Report Volume II: New Technologies

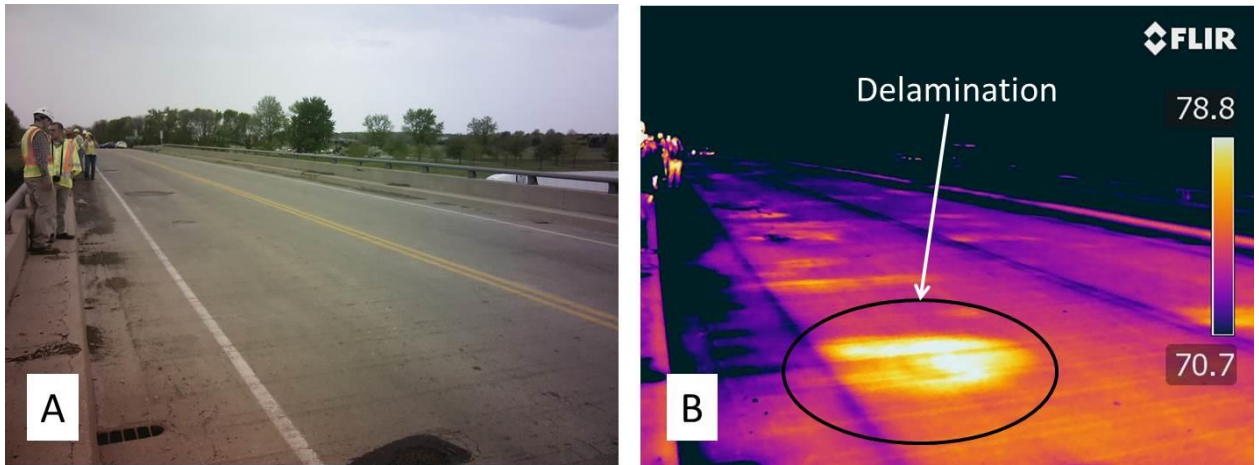
Infrared thermography (IR) offers a potential solution to these inspection challenges. IR cameras produce images of the surface temperature distribution over a large area and can produce these images from distances of 100 ft. or more from the surface being imaged. For example, thermal images of a bridge deck can be produced from a position along the roadside without the use of traffic control. For the soffit (i.e., underside) portion of the bridge, IR images can be produced from positions on the ground below the bridge. The IR images reveal subsurface damage in the concrete, which is manifested as temperature variation at the surface of the concrete. The subsurface damage is typical in reinforced concrete structures and is commonly known as delamination. The delamination is produced by the expansion of the reinforcing steel in the concrete as a result of corrosion processes. The reinforcing bars are placed in a manner such that when multiple bars are corroding, cracking in the concrete joins between the bars. This results in a horizontal crack parallel to the surface of the concrete that is subsurface (i.e., a delamination). Figure 1 shows an image captured by an infrared camera that shows an example of the detection of subsurface delamination in a concrete bridge deck. Figure 1A shows a photograph (visual image) of the area of the deck imaged using an infrared camera (Figure 1B). As shown in the visual image, the deck appears to be intact and in good condition. Figure 1B shows the IR image of a bridge deck that reveals an area of deck that is hotter than the surrounding areas. This area is a subsurface delamination; other delaminations are also shown farther away in the image. The image is captured from a standing position on the shoulder of the roadway while the roadway remained open to traffic. The subsurface delamination shown in Figure 1B was verified by sounding the area.

Figure 1. Photograph of a bridge deck (A) and an IR image of the same deck area showing a subsurface delamination (B).

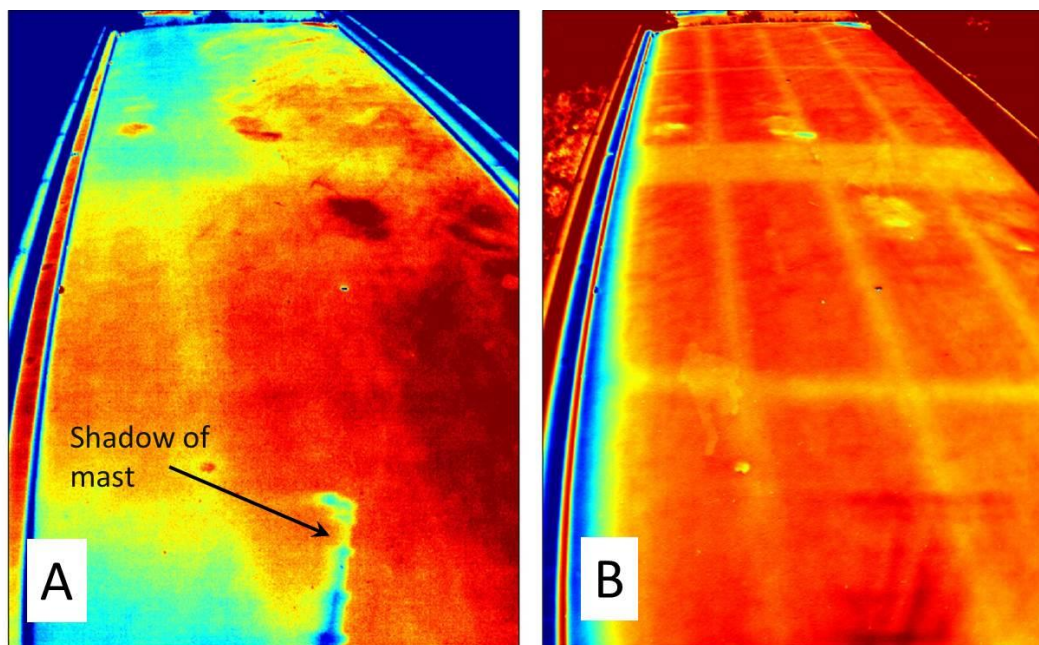
The resulting image can be compared to an image captured using the traditional approach of analyzing the radiant flux of IR energy emitted by the concrete. For example, Figure 7 compares a traditional IR image, taken at a time of maximum thermal contrast for the subsurface delamination in the bridge deck, with the image using the IR-UTD technology. Note that Figure 7A, which shows a typical thermal image of surface temperature on the deck, has significant variations across the surface due to uneven heating of the deck and changes in surface material properties. Additionally, the data displayed in Figure 7A were captured at the optimum time showing the greatest thermal contrast between the delaminated and sound areas of bridge deck. This result would only be obtained by an inspector using a hand-held camera if the inspection were done at the optimum time, which is difficult to determine particularly if the depth of the damage in the concrete is not known. Figure 7B, showing the IR-UTD data obtained from processing the transient thermal data over a longer time interval, provides much better signal-to-noise ratio, more clearly defined extent of the delaminations, and also shows the internal diaphragms and webs of the bridge. Color variations within the individual delaminations correspond to depth variations of the damage, as the initially subsurface delamination extends toward the surface of the deck which is the typical progress of a delamination from subsurface damage to a spall in the concrete deck.

Figure 7. Image of a concrete deck showing A) traditional thermal image and B) IR-UTD image showing the delaminations in the bridge deck.

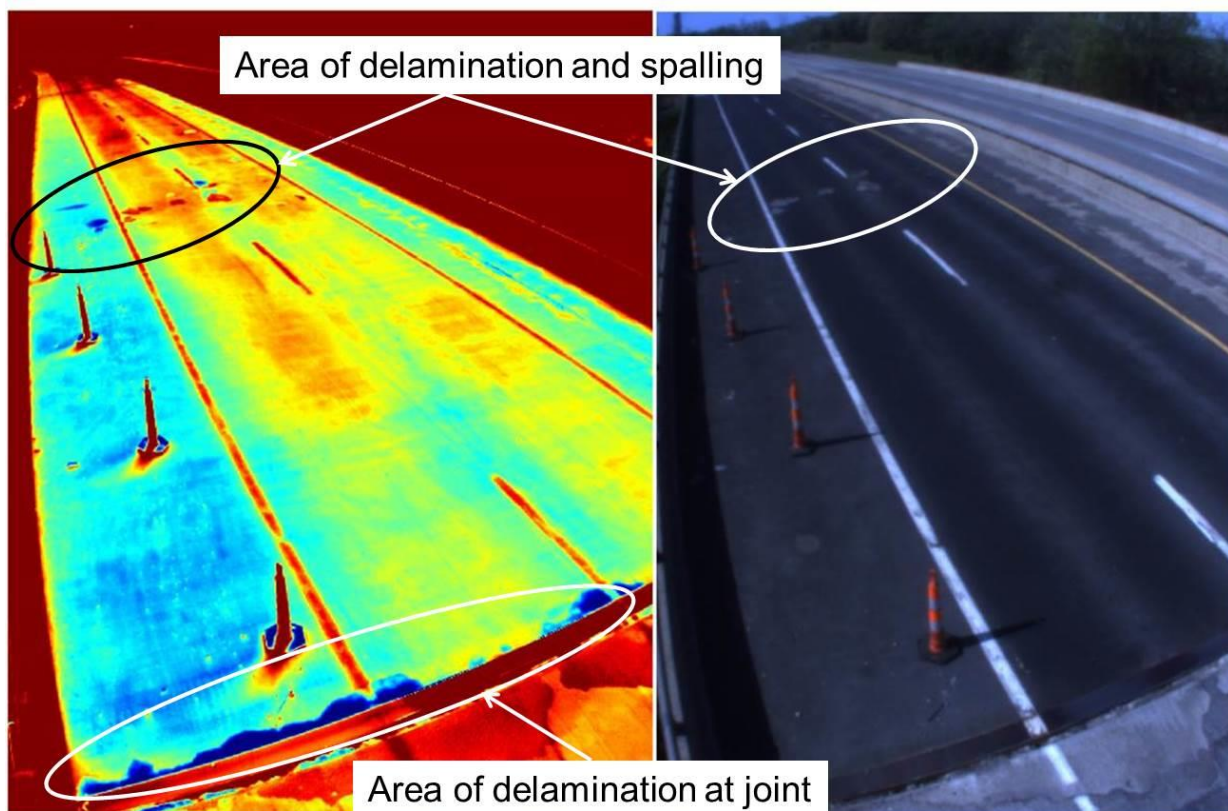
Figure 13 shows both the processed IR-UTD data and the visual camera image captured by the IR-UTD camera positioned on top of the mast. In the IR-UTD image, the spalled areas of the bridge deck are shown as dark red areas. Delaminations in the deck are shown as dark

blue areas. These data indicated delamination adjacent to the joint and adjacent to spalling in the bridge deck. The spalling of the bridge deck is apparent in the visual image.

Figure 13. Side by side image of the infrared image (left) next to the visual image (right) of the Providence Road Bridge.

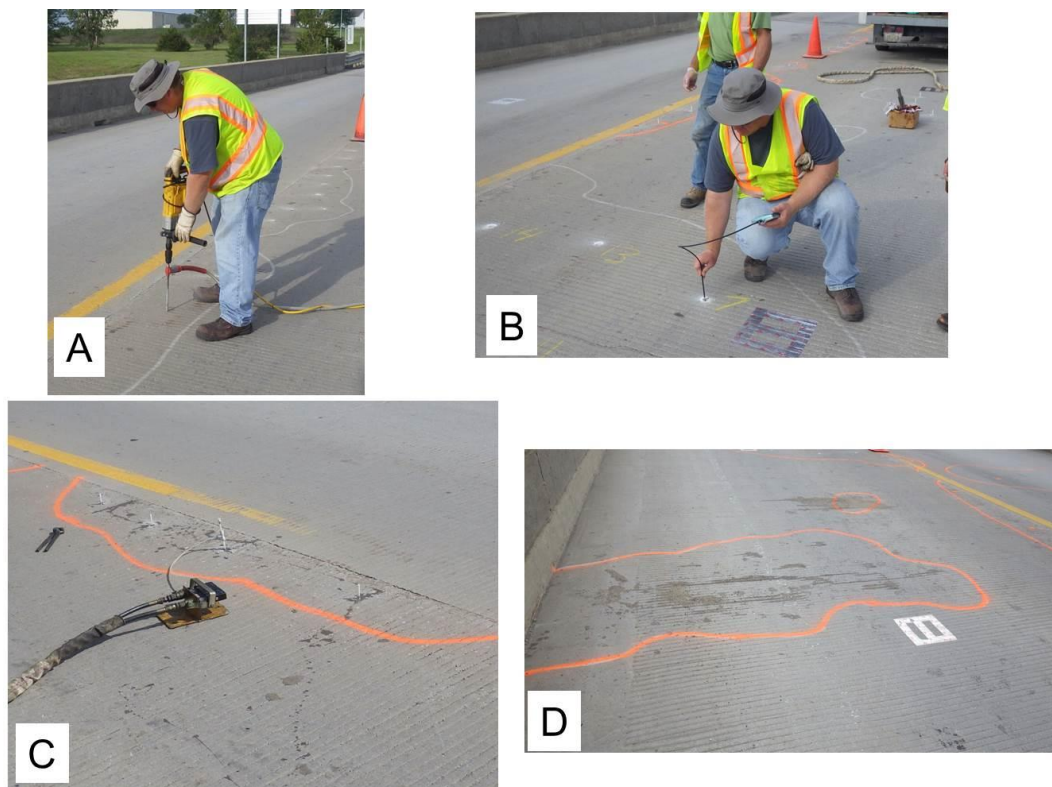
from the hole. Frequently some epoxy material remains on the surface of the deck due to spillage, as shown in Figure 22D.

Figure 22. Photographs showing the process of epoxy injection on the Iowa Bridge deck showing (A) hole drilling, (B) measuring the delamination depth using a borescope, (C) injection of epoxy materials into a subsurface delamination, and (D) the deck surface after injection is complete.

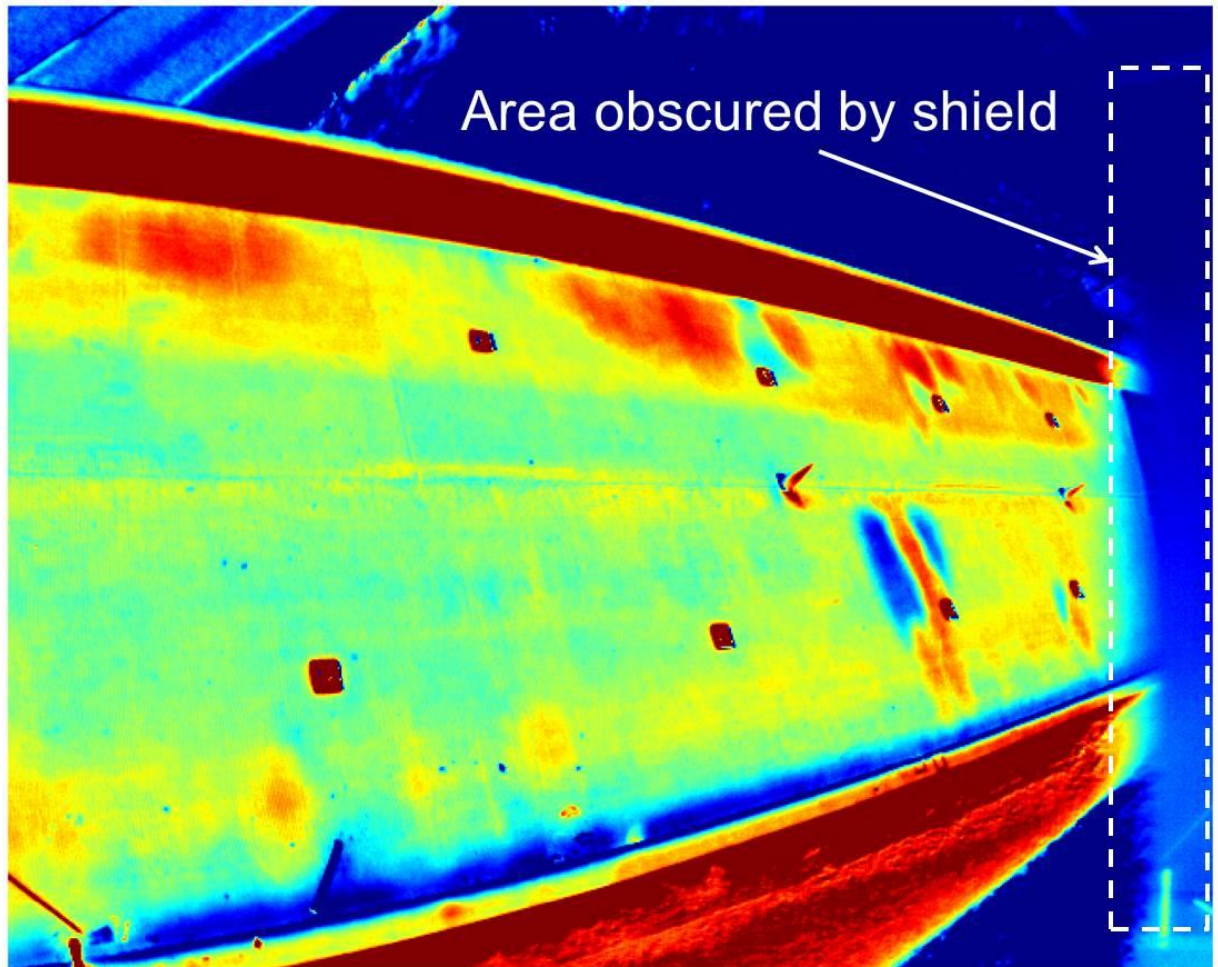
Figure 26. IR-UTD from the Iowa Bridge showing areas of delamination in the deck.

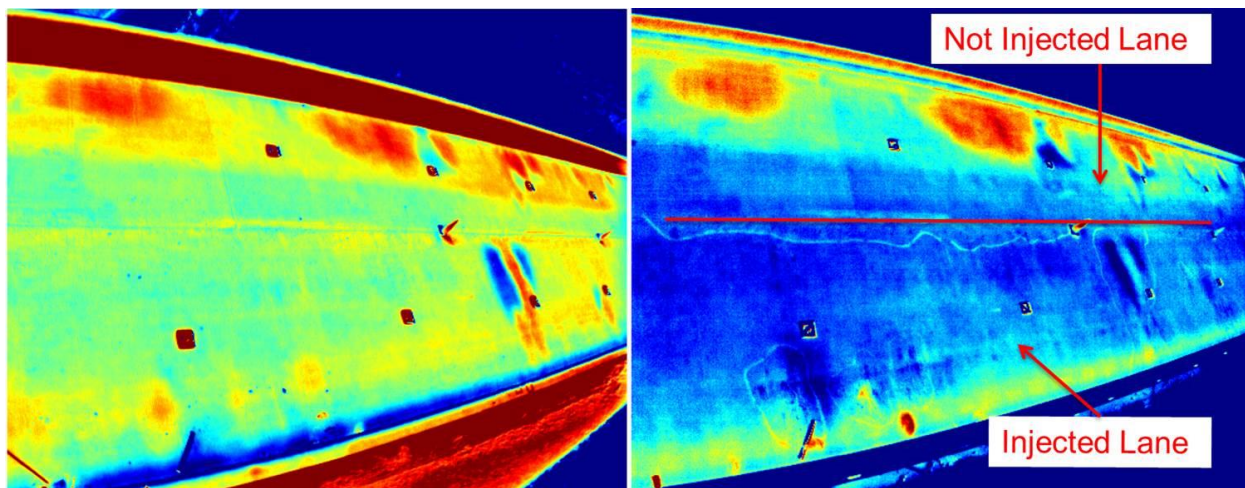
Figure 31. IR-UTD images showing delaminations prior to epoxy injection (left) and after epoxy injection (right).

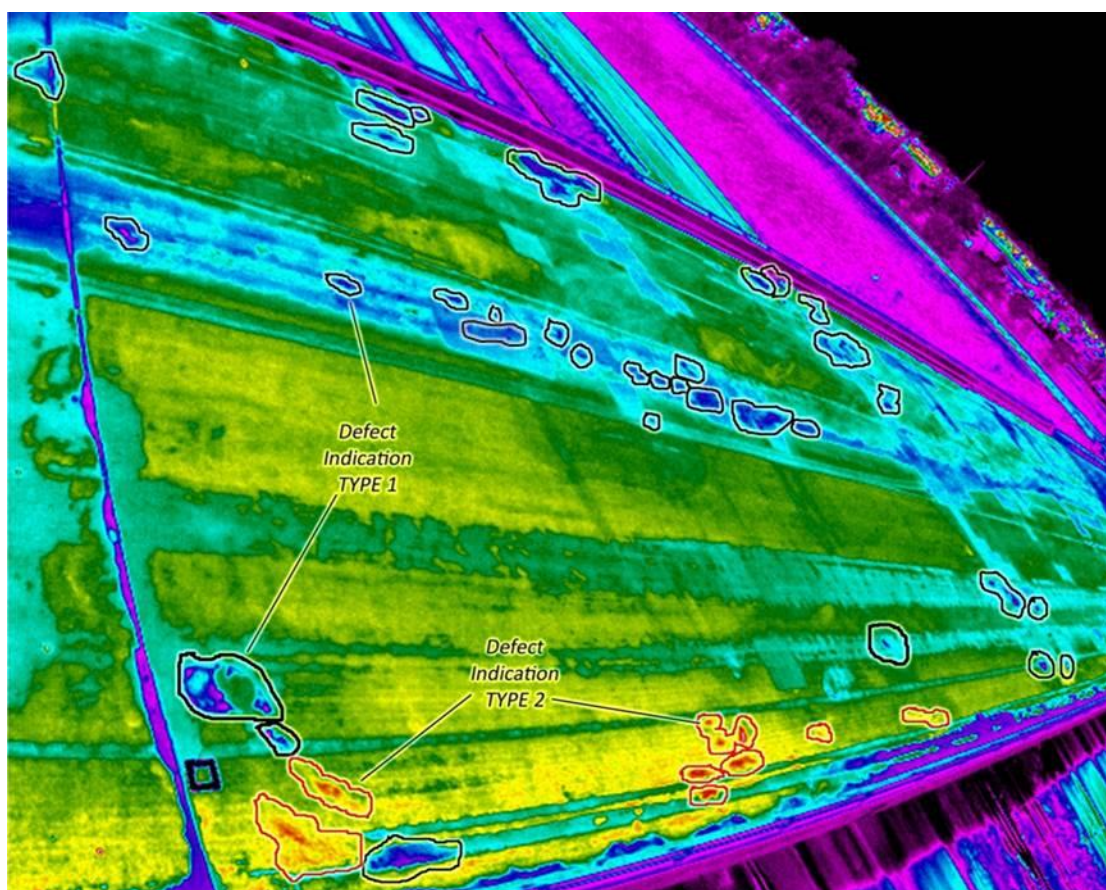
Figure 37. IR-UTD processed data from process period 2 showing defect indications with manual outlines.

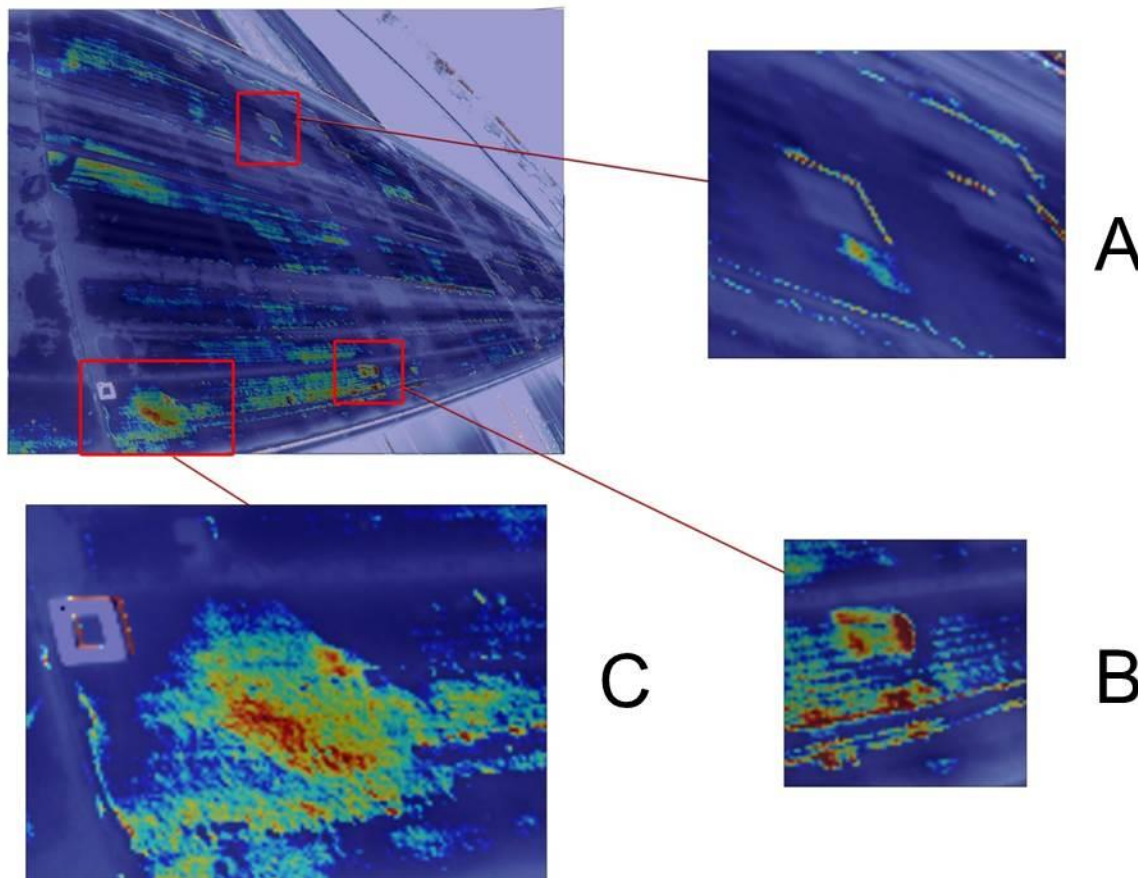
Figure 38. IR-UTD processed data from process period 1 showing entire image (top left) and three separate close-up images of defect indications (bottom left, top right, bottom right).

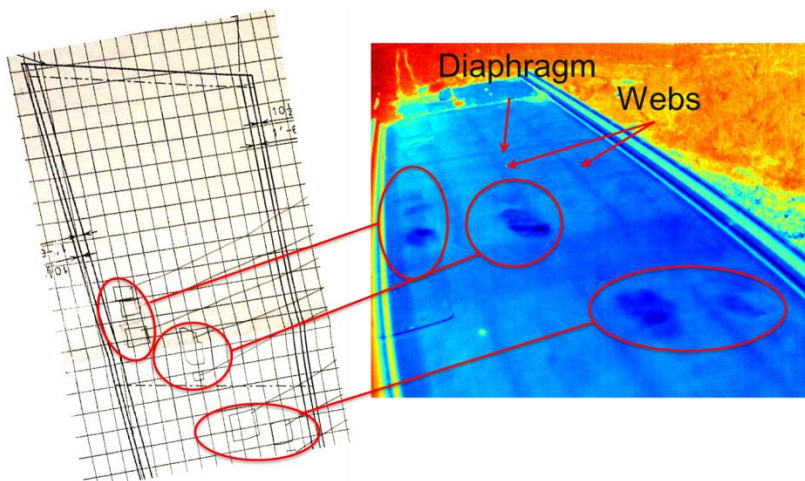
Figure 40. Image of chain drag results (left) and IR-UTD data from Test 1 (right).

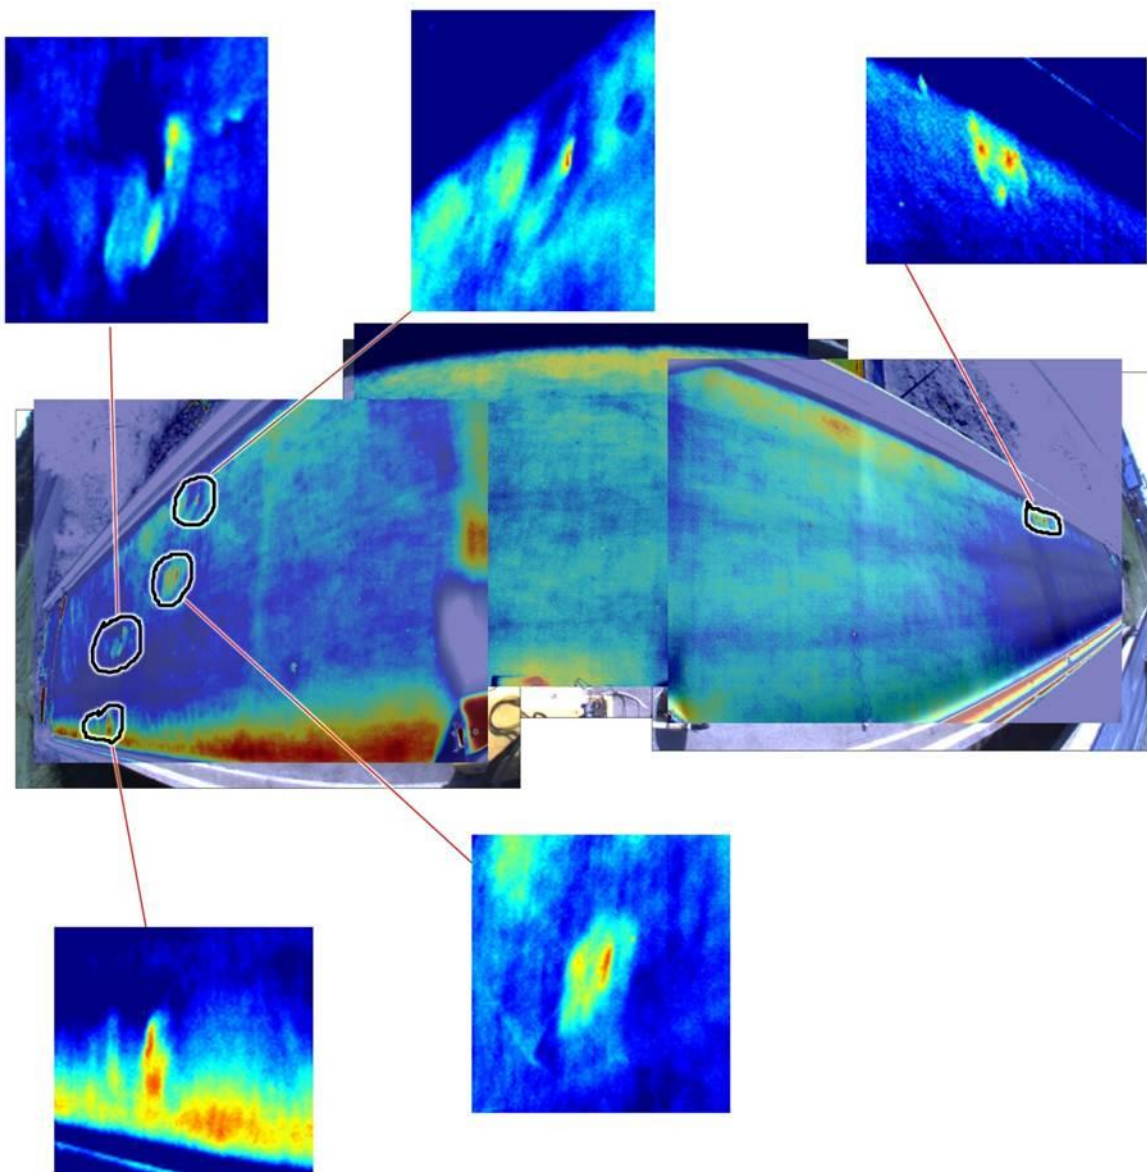
Figure 43. Measurement of three spans showing defect indications.

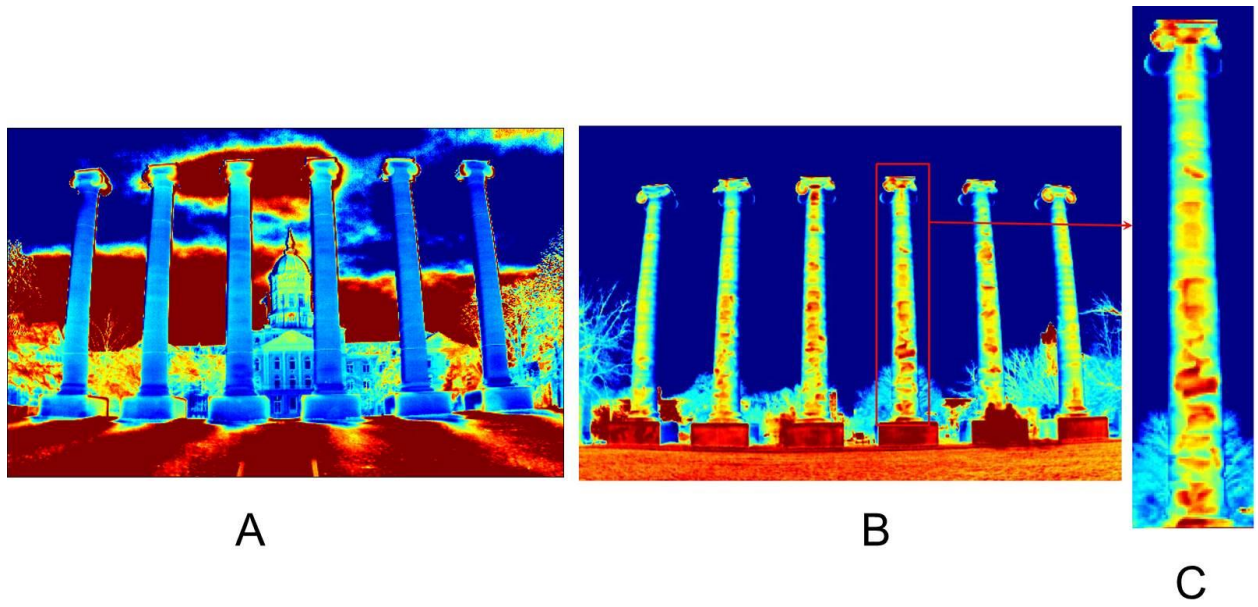
Figure 52. IR-UTD images of the columns on the MU campus showing (A) the undamaged side of the columns, (B) the damaged side of the columns, and (C) an expanded view of one of the columns.

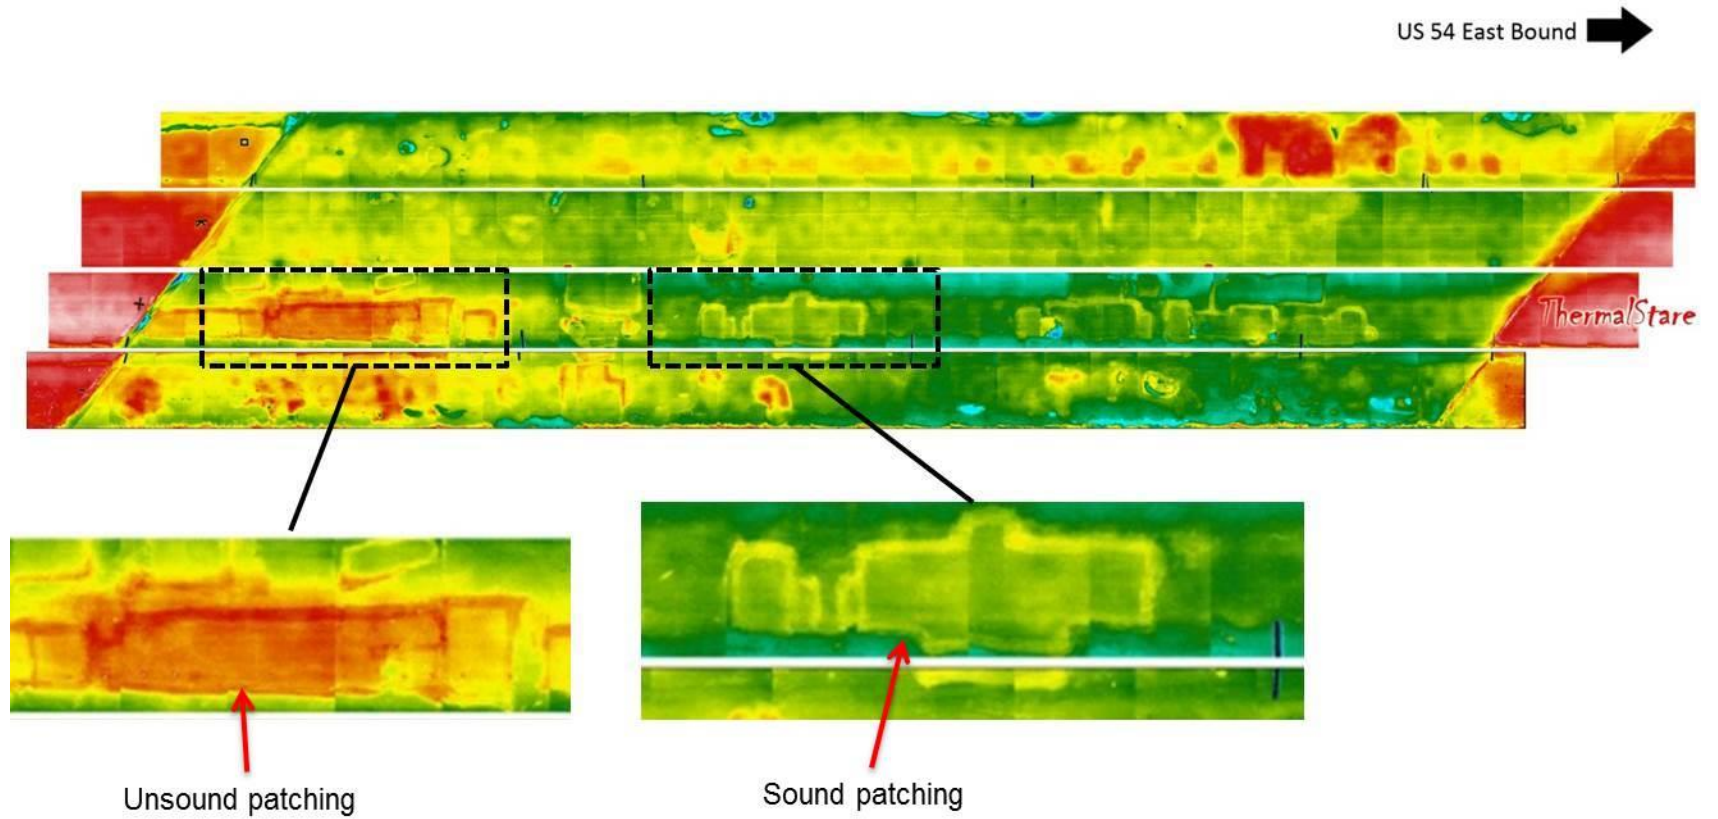
Figure 58. Plan view image showing sound and unsound patch areas.
