Repair of Distortion-Induced Fatigue Damage in Bridge No. 135-87 (043SB and 044NB) Using Newly-Developed Strengthening Schemes

Report Number: KS-16-06 • Publication Date: August 2016

The University of Kansas

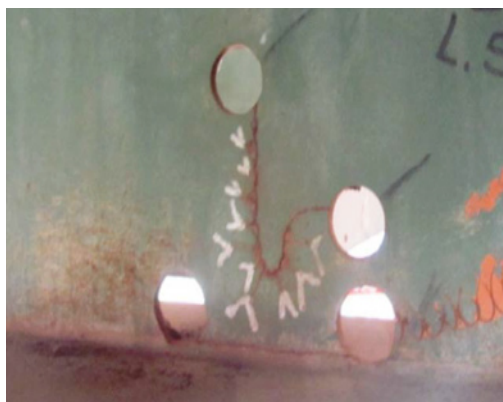
A steel girder twin bridge structure located near Park City, Kansas, has experienced extensive distortion-induced fatigue cracking in its web-gap regions. Due to the bridge's skewed, staggered configuration, the majority of these cracks have occurred in the bottom web-gap region. The bridge was previously the subject of a series of detailed finite element analyses that investigated the effectiveness of several types of retrofits in repairing its distortion-induced fatigue cracks. One of these retrofits, the “angles-with-plate” retrofit, was developed and tested at the University of Kansas as a new retrofitting technique aimed at providing a more economical and easy-to-install distortion-induced fatigue cracking repair. The retrofit is made up of a pair of angles and a backing plate that connect the cross-frame connection plate and girder web in order to stiffen the web-gap region. Results from the finite element analyses determined that the angles-with-plate retrofit was the most effective and economical choice for repairs in the bridge, and plans were made for its installation.

Example of the Types of Cracks Occurring in Kansas Bridges
