Louisiana Transportation Research Center

Technical Assistance Report 16-03TA-C

Evaluation of Cores from Jefferson Highway Near Airline Highway

Petrographic Investigation of Concrete Cores Extracted from Cracked
Pavement Slabs on Jefferson Highway in Baton Rouge, Louisiana
(RE: LTRC Project 16-1TA-C)

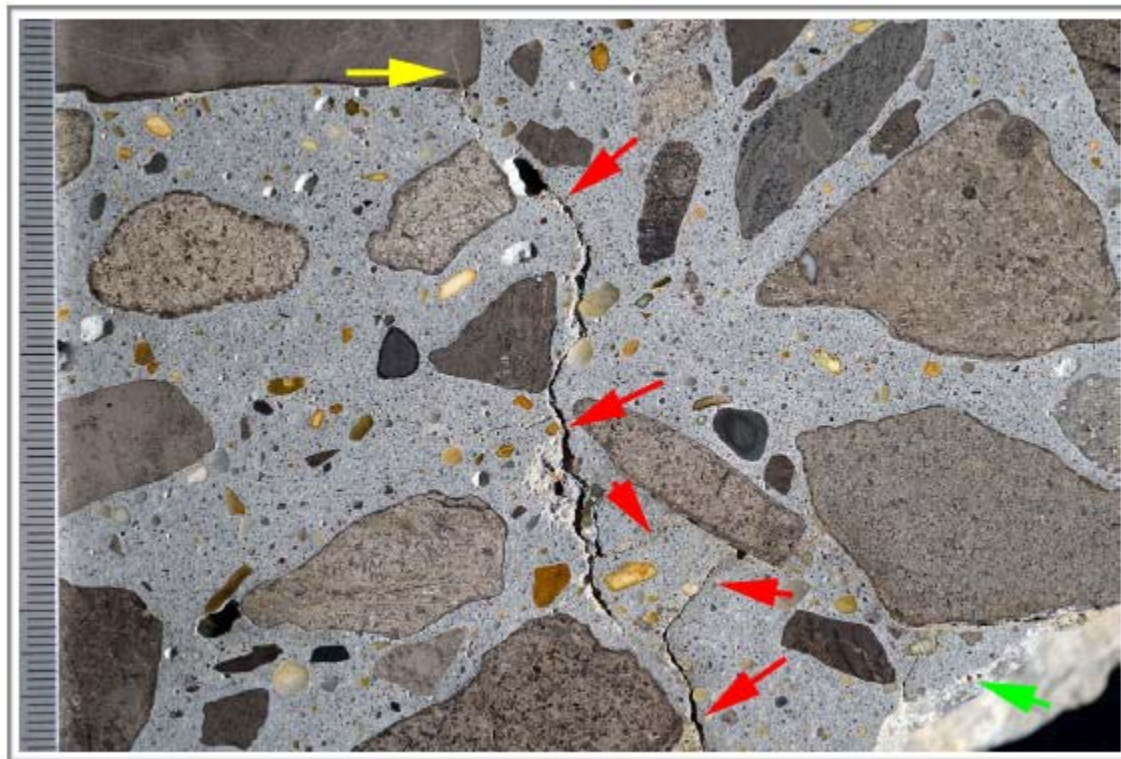
Core 2 showed ACR cracking as evidenced in Figure 4. Note the yellow arrow shows the crack originating in the dolomitic limestone particle and extending outward throughout the core structure with the red arrows. The scale at the left is in mm.

Figure 4
Section of Core 2 showing ACR cracking originating at a dolomitic limestone particle and extending outward in the paste and concrete structure

Being that the evidence strongly indicates that this pavement section is affected by ACR, possible remedies include continued patching efforts and a full-depth replacement of the affected section since ACR cannot be mitigated with an overlay.

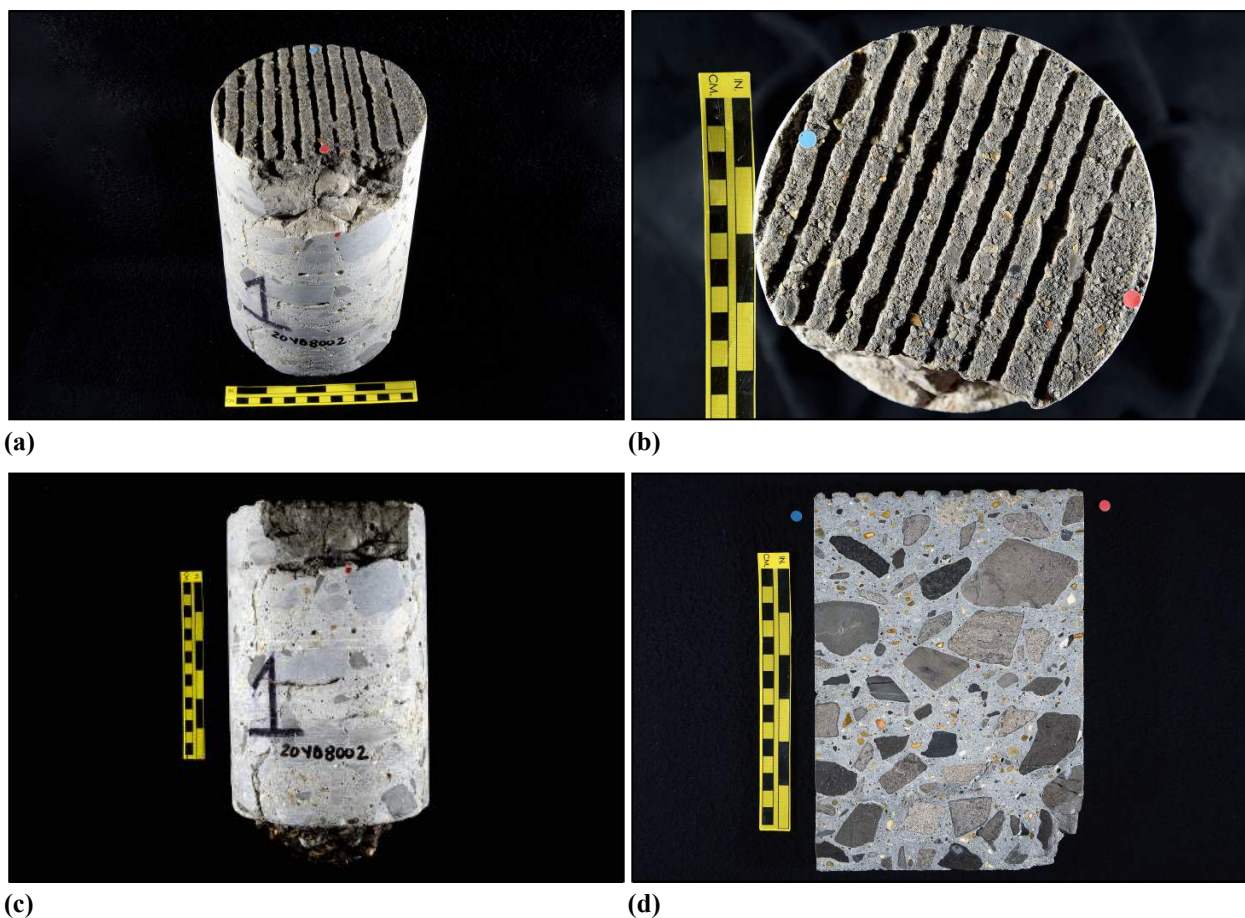
Figure 1. Photographs of Core 1. (a) Oblique view of the top and side of the core. (b) View of the top surface of the core. (c) View of the side of the core; note spalled area. (d) View of the polished surface of the core. Note that both sides of the core were polished. The yellow scale bar is ~ 150 mm (6 in.) long.

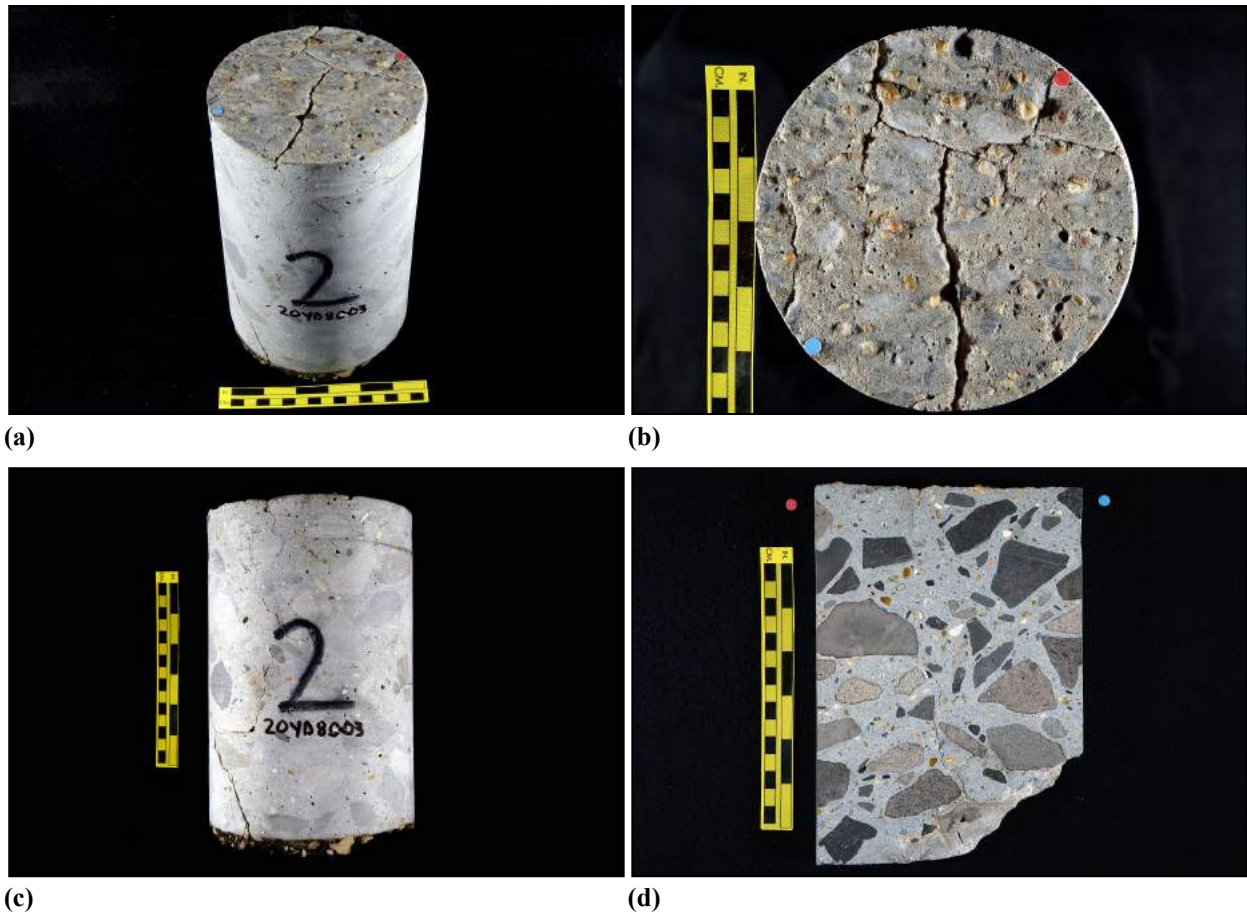
Figure 2. Photographs of Core 2. (a) Oblique view of the top and side of the core. (b) View of the top surface of the core. (c) View of the side of the core. (d) View of the polished surface of the core. Note that both sides of the core were polished. The yellow scale bar is ~ 150 mm (6 in.) long.

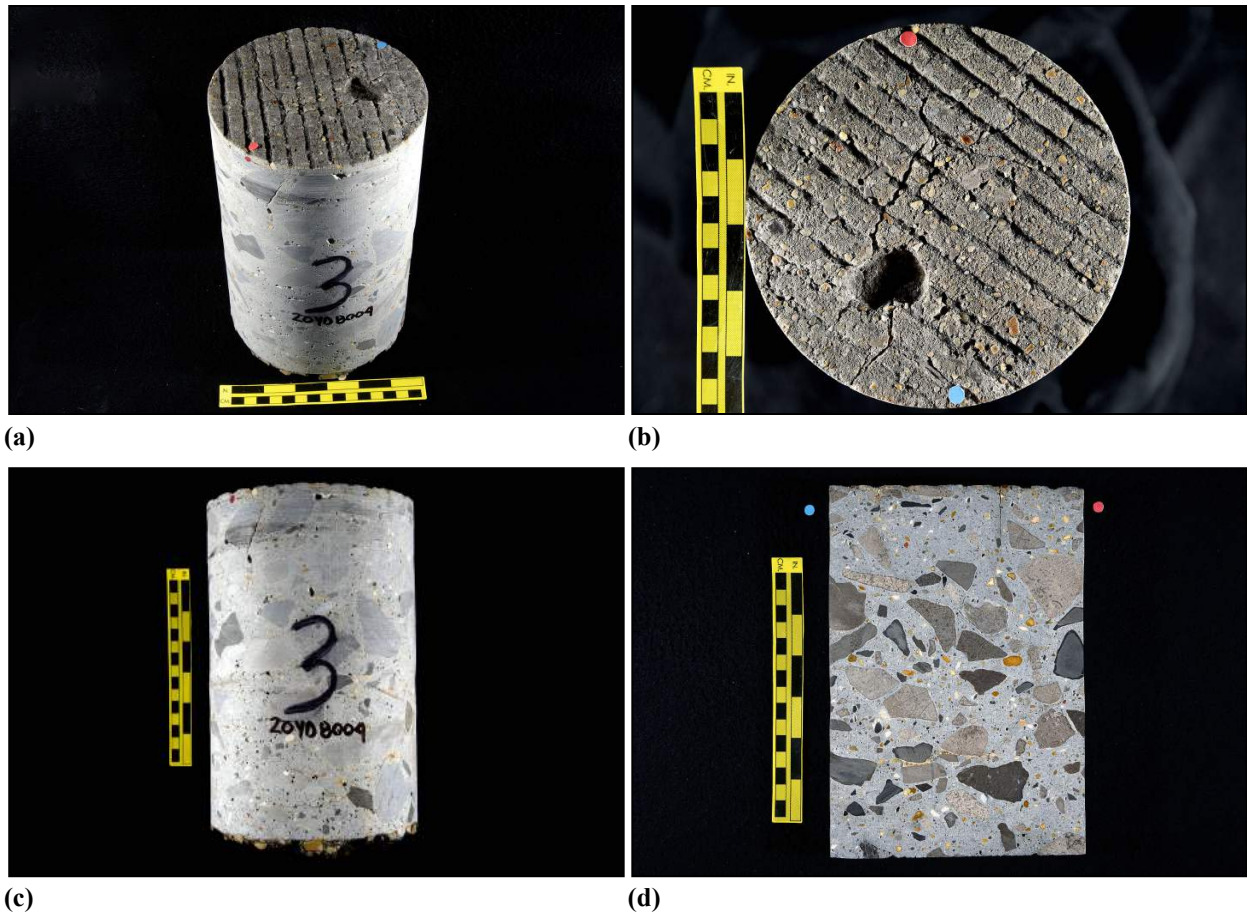
Figure 3. Photographs of Core 3. (a) Oblique view of the top and side of the core. (b) View of the top surface of the core. Note large pit. (c) View of the side of the core. (d) View of the polished surface of the core. Note that both sides of the core were polished. The yellow scale bar is ~ 150 mm (6 in.) long.

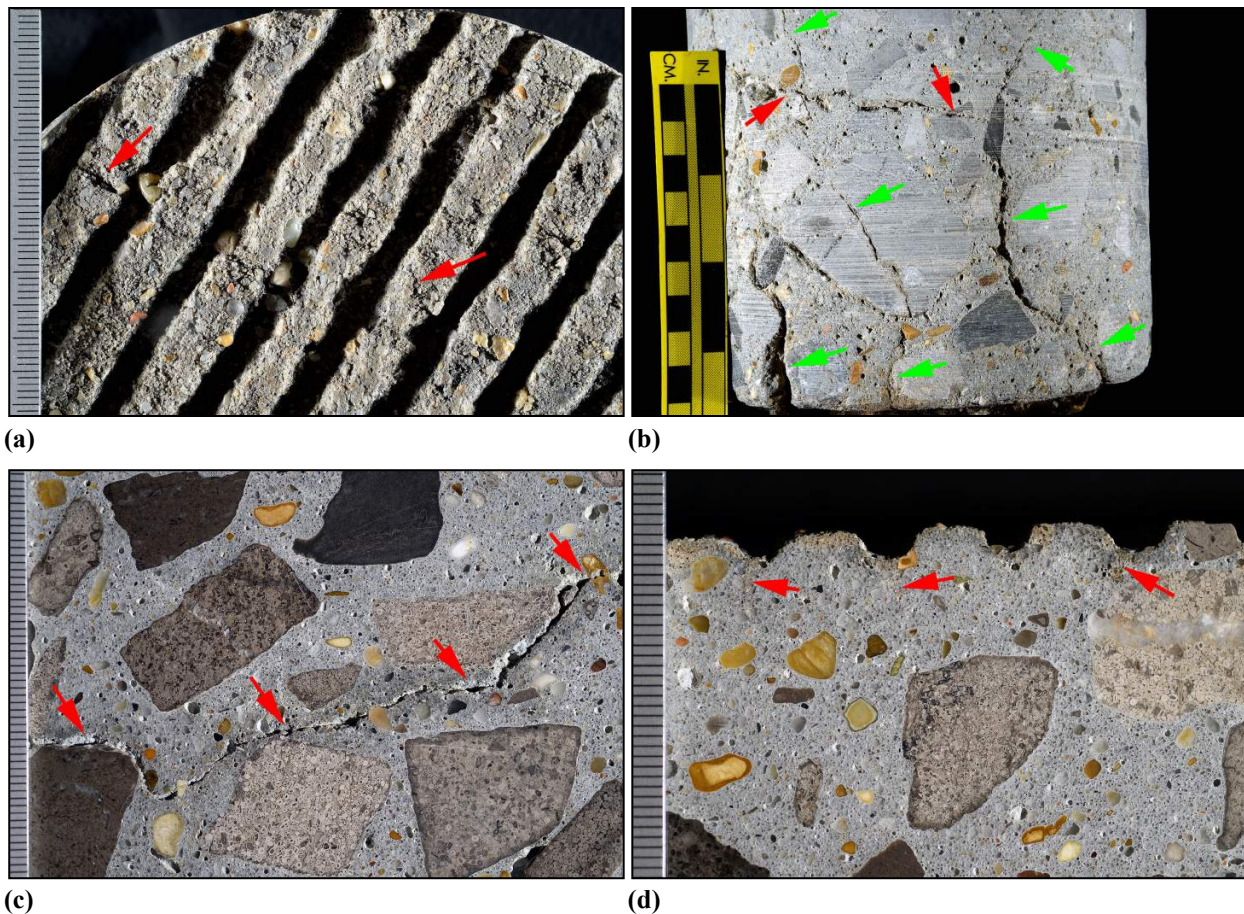
Core 1 Core 1 shows cracks up to 250 μm (10 mil) wide that cut across the the top surface and cracks up to 1.5 mm (60 mil) wide and 70-200 mm (2 $\frac{3}{4}$ - 8 in.) long on the side of the core. On the polished surface major sub-horizontal cracks up to 2 mm (80 mil) wide that cut across the full width of the core were observed at 75 mm (3 in.), 110 mm (4 $\frac{3}{8}$ in.) and 145 mm (5 $\frac{3}{4}$ in.) below the top surface. Some of the cracks contain deposits of ASR gel and ettringite was observed along segments of the cracks. Microcracking was relatively minor in the core. Several microcracks cut sub-vertically from the top surface to 6 mm ($\frac{1}{4}$ in.). Minor microcracking was observed in reaction rims in some coarse aggregate particles. Occasional microcracks filled with gel cut from limestone particles into the paste (see section on AAR below for more detail).

Figure 8. Photographs of cracking in Core 1. (a) Linear cracks (red arrows) on the top surface. (b) Sub-vertical cracks (green arrows) and sub-horizontal cracks (red arrows) near the bottom of the core. (c) Sub-horizontal crack (red arrows) about 75 mm (3 in.) below the top surface. (d) Sub-vertical microcracks (red arrows) at the top of the core. Scale in millimeters in all photos except (b).

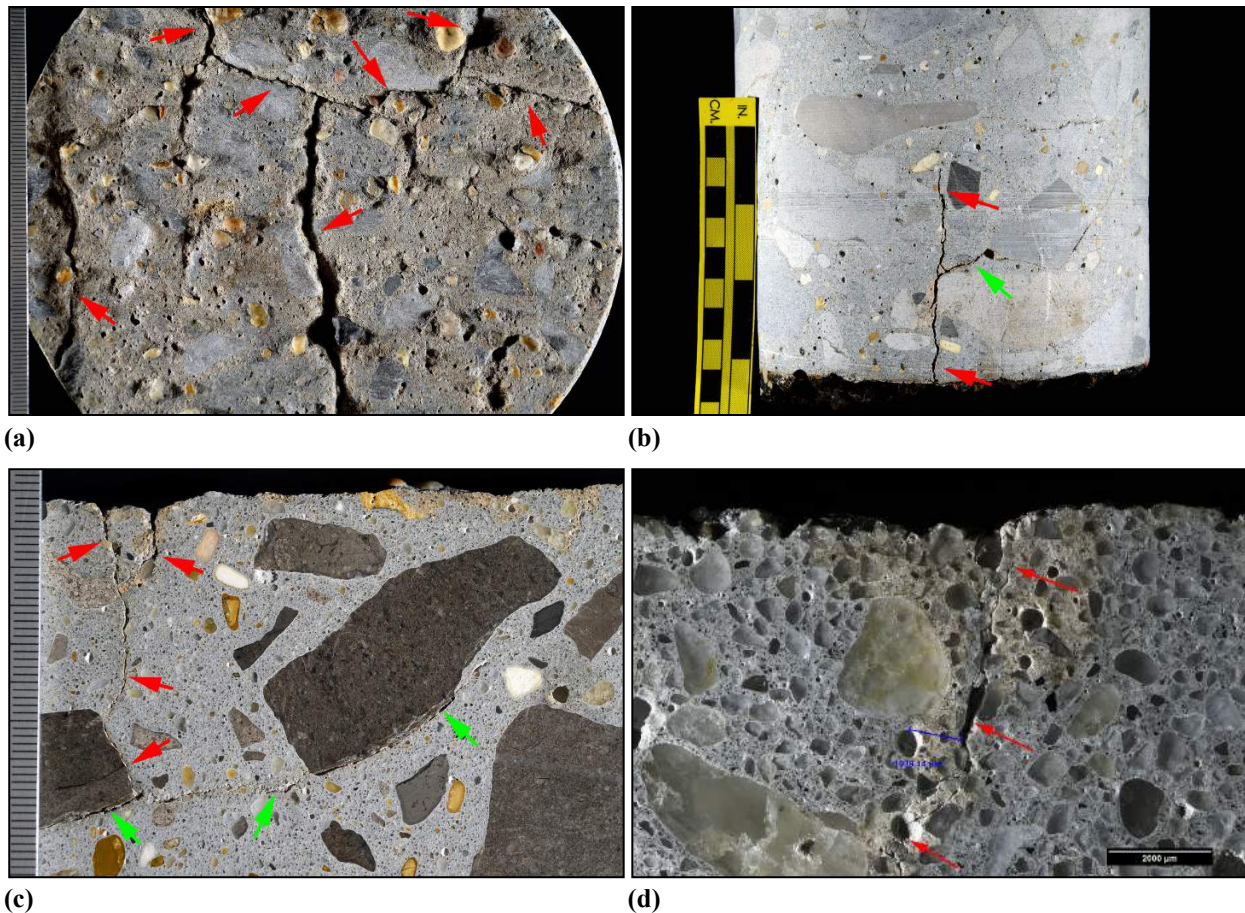
Core 2 Core 2 shows cracks up to 750 μm (30 mil) wide that cut across the the top surface and cracks up to 500 μm (20 mil) wide and 75-200 mm (3 - 8 in.) long on the side of the core. On the polished surface sub-vertical cracks up to 500 μm (20 mil) wide cut from the top surface where they intersect sub-horizontal cracks ~ 38 mm (1 $\frac{1}{2}$ in.) below the top surface. A hairline crack cuts sub-vertically from the top surface through a chert particle where it terminates in a dolomitic aggregate particle at ~ 15 mm ($\frac{5}{8}$ in.). These cracks show minor discoloration of the paste along their walls but are generally free of secondary deposits. A crack ranging from 250 μm (10 mil) to 2 mm (80 mil) wide cuts from the bottom surface to 100 mm (4 in.). Deposits of ettringite and ASR gel were observed along segments of the crack. Several microcracks ranging up to 100 μm (4 mil) wide cut sub-vertically from the top surface to depths of 3-6 mm ($\frac{1}{8}$ - $\frac{1}{4}$ in.). These microcracks lack secondary deposits. Fine peripheral microcracks less than 25 μm (1 mil) wide were observed in occasional particles of limestone.

Figure 9. Photographs of cracking in Core 2. (a) Linear cracks (red arrows) on the top surface. (b) Sub-vertical crack (red arrows) and sub-horizontal crack (green arrow) near the bottom of the core. (c) Sub-horizontal crack (green arrows) and sub-vertical cracks red arrows near the top of the core. (d) Reflected light photomicrograph of a sub-vertical microcrack (red arrows) at the top of the core. Scale in millimeters in (a) and (c).

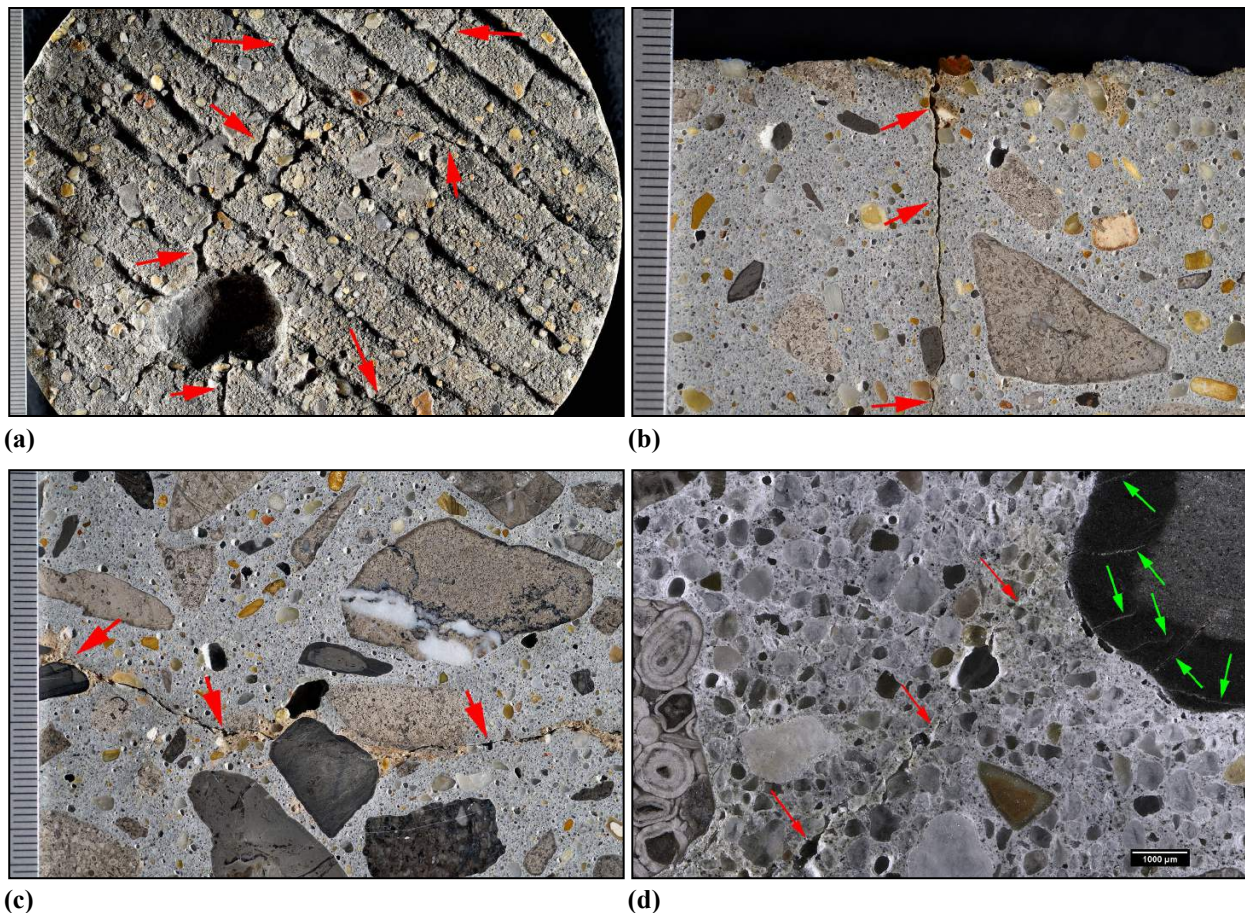
Core 3 Core 3 shows cracks up to 250 μm (0 mil) wide that cut across the the top surface and cracks up to 500 μm (20 mil) wide and 160 mm (6 $\frac{1}{4}$ in.) long on the side of the core. On the polished surface sub-vertical cracks up to 500 μm (20 mil) wide cut from the top surface 50-70 mm (2-2 $\frac{3}{4}$ in.). Several sub-horizontal cracks were observed that range up to 750 μm (30 mil) wide and cut up to the full width of the polished slab. Several sub-vertical microcracks up to 100 μm (4 mil) wide cut to depths of 3-6 mm ($\frac{1}{8}$ - $\frac{1}{4}$ in.). These cut around aggregates and are free of secondary deposits. Extensive microcracking was observed in reaction rims in dolomitic aggregate particles. Most of these are less than 25 μm (1 mil) wide. Occasional microcracks cut from these aggregate particles into the paste; these are mostly free of secondary deposits but some contain deposits of ettringite.

Figure 10. Photographs of cracking in Core 3. (a) Linear cracks (red arrows) on the top surface. (b) Sub-vertical crack (red arrows) at the top of the core. (c) Sub-horizontal crack (red arrows) about 165 mm (6 $\frac{1}{2}$ in.) below the top surface. (d) Reflected light photomicrograph of dolomitic limestone particle with peripheral microcracks (green arrows) and hairline crack cutting through the paste (red arrows) about 110 mm (4 $\frac{3}{8}$ in.) below the top surface.

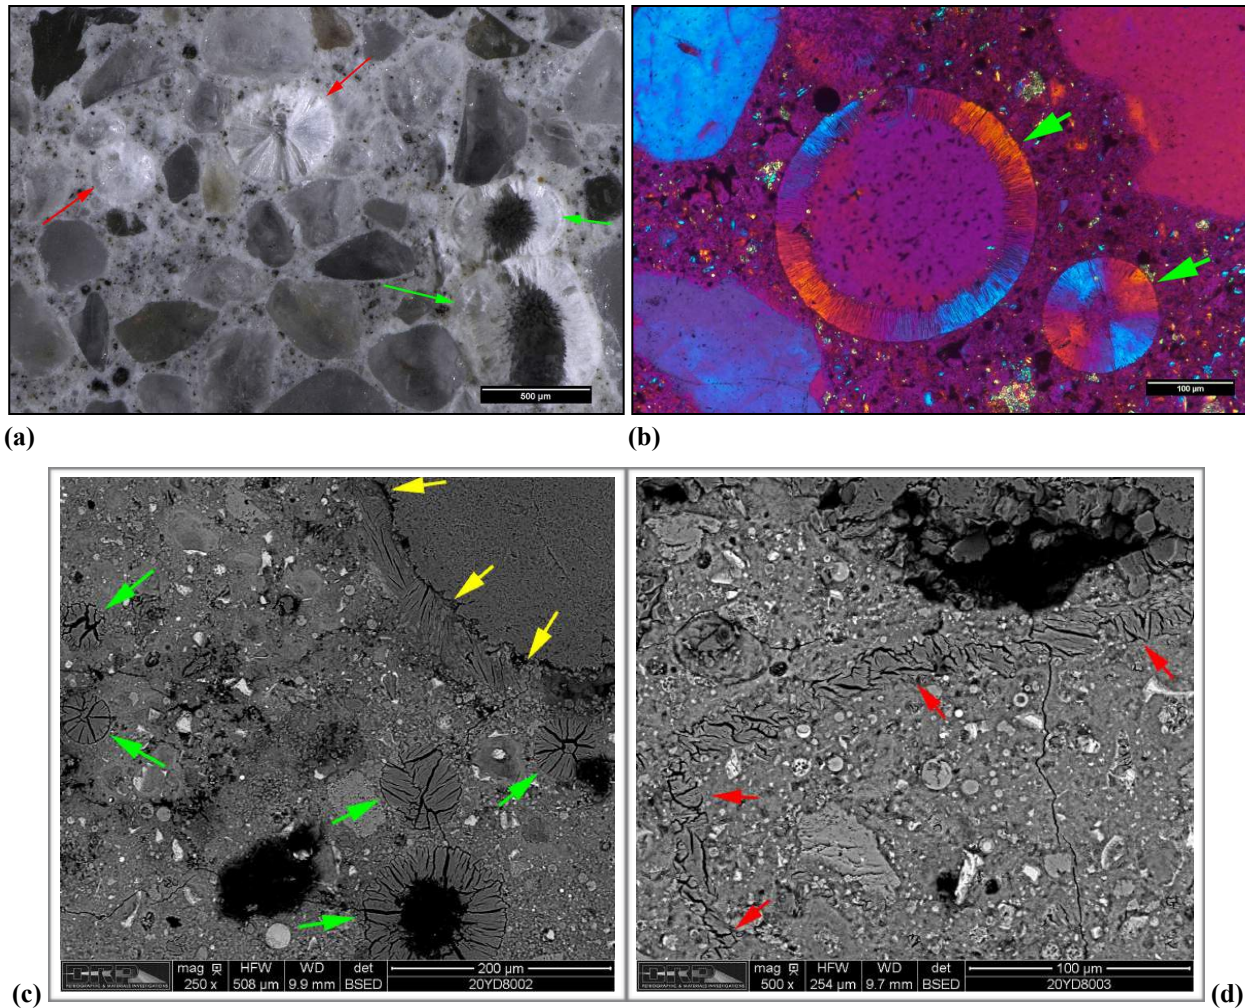
3.7 Secondary Deposits—Ettringite Ettringite was observed in all three cores but is more abundant in Core 1 and Core 3 than in Core 2. The ettringite occurs primarily in air voids but was also observed lining and filling segments of cracks and microcracks as well as discrete deposits in the paste (**Figure 12**). No cracking or microcracking due to ettringite mineralization was observed.

Figure 12. (a) Reflected light photomicrograph of the polished surface of Core 1 showing ettringite filling air voids (red arrows) and lining air voids (green arrows). (b) Cross-polarized transmitted light photomicrograph of thin section from Core 3 showing voids lined and filled with ettringite (green arrows). (c) BSE micrograph of polished surface from Core 1 showing voids with ettringite (green arrows) and ettringite in the interfacial transition zone (yellow arrows) between an aggregate particle and the paste. (d) BSE micrograph of the polished surface from Core 2 showing microcrack filled with ettringite (red arrows).

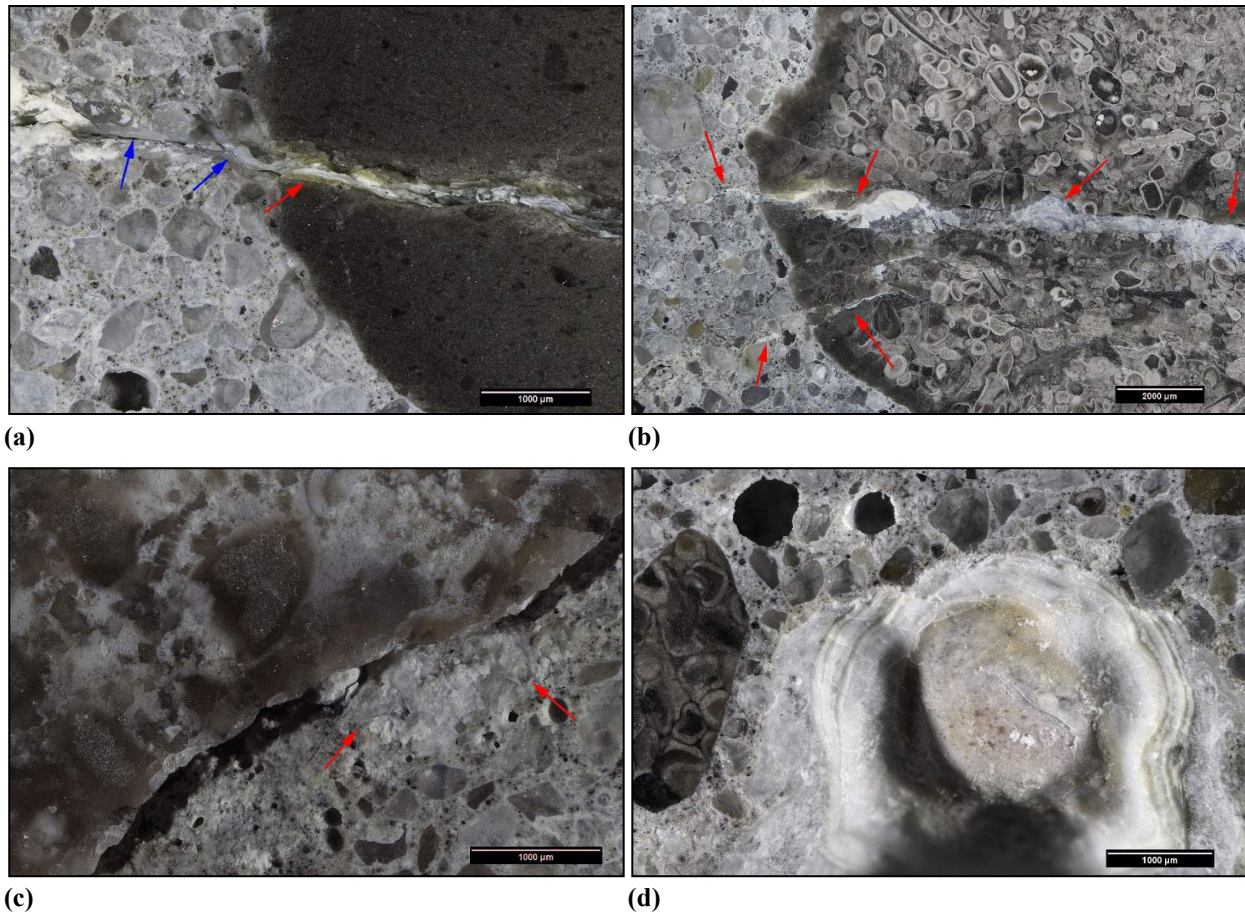
3.7 Secondary Deposits—ASR Gel Deposits of gel were observed in all three cores (**Figure 13**) but they are most abundant in Core 1, followed by Core 3 and are relatively scarce in Core 2. In all three cores analysis of gel compositions by EDS indicated they consist primarily of calcium and silicon. This indicates the gels are fairly mature, as calcium tends to diffuse into gels over time. This also suggests that the concrete shows evidence of alkali cycling, which may promote continued AAR. The reactive components in these cores primarily involves fossiliferous and oolitic limestones, which also contain interstitial quartz and chert, some of which is chalcedonic. Minor reaction was also observed with chert particles in the fine aggregate.

Figure 13. Reflected light photomicrographs of the polished surfaces of (a), (b) Core 1 and (c), (d) Core 3 showing deposits of ASR gel. In (a) the red arrow indicates white gel in a dolomitic limestone particle about 110 mm (4 3/8 in.) below the top surface and the blue arrows indicate translucent gel in the paste. In (b) the red arrows show deposits of gel about 150 mm (6 in.) below the top surface. In (c) the red arrows show a deposit of gel in the ITZ of a limestone particle about 90 mm (3 1/2 in.) below the top surface. (d) Laminated gel deposit in void about 135 mm (5 3/8 in.) below the top surface. All of these deposits were analyzed by EDS and found to consist primarily of calcium and silicon (see Appendices for details).

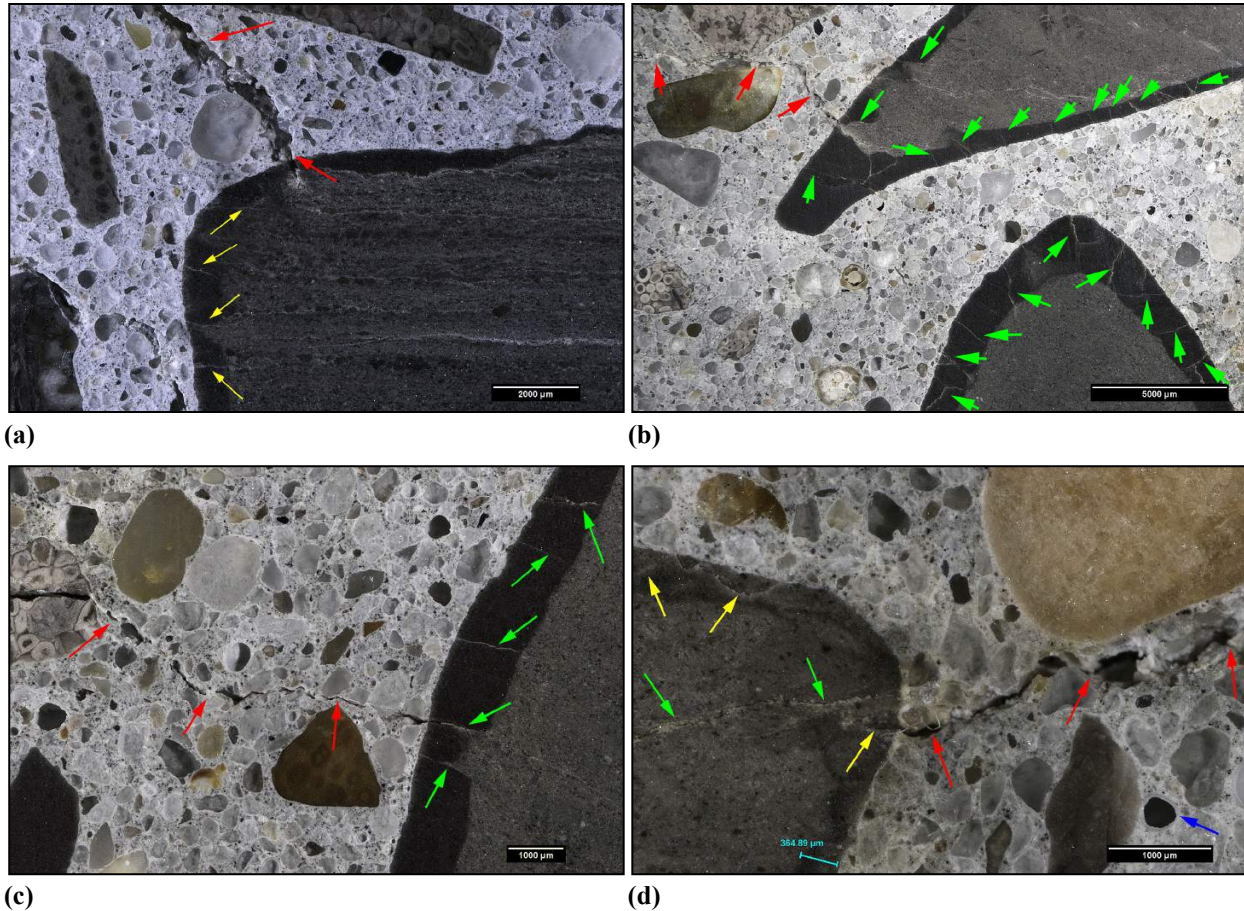
3.8 Alkali-Carbonate Reaction All three cores show evidence of ACR but it is most advanced in Core 3, where numerous limestone particles show peripheral microcracking in reaction rims. The cores show and cracks and microcracks that cut from particles of dolomitic limestone into the paste (**Figure 14**). The reactive components involve the dark brown dolomitic limestone observed in the coarse aggregate.

Figure 14. Evidence of ACR. (a) Reflected light photomicrograph of polished surface of Core 2 showing limestone particle with peripheral microcracks (yellow arrows) and crack (red arrows) that cuts from the particle and into the paste about 65 mm (2 ½ in.) below the top surface. **(b)-(c)** Reflected light photomicrographs of the polished surface of Core 3 showing peripheral microcracks (green arrows) in dolomitic limestone particles about **(b)** 80 mm (3 ⅛ in.) and **(c)** 85 mm (3 ⅜ in.) below the top surface. Red arrows show cracks that cut from the particle into the paste. **(d)** Reflected light photomicrograph of polished surface of Core 3 showing peripheral microcracks (yellow arrows) in dolomitic limestone particle about 165 mm (6 ½ in.) below the top surface. The green arrows highlight a sub-horizontal microcrack in the particle, the red arrows show a crack that cuts from the particle into the paste. The blue bar measures the width of a reaction rim and the blue arrow indicates a void lined by ettringite.

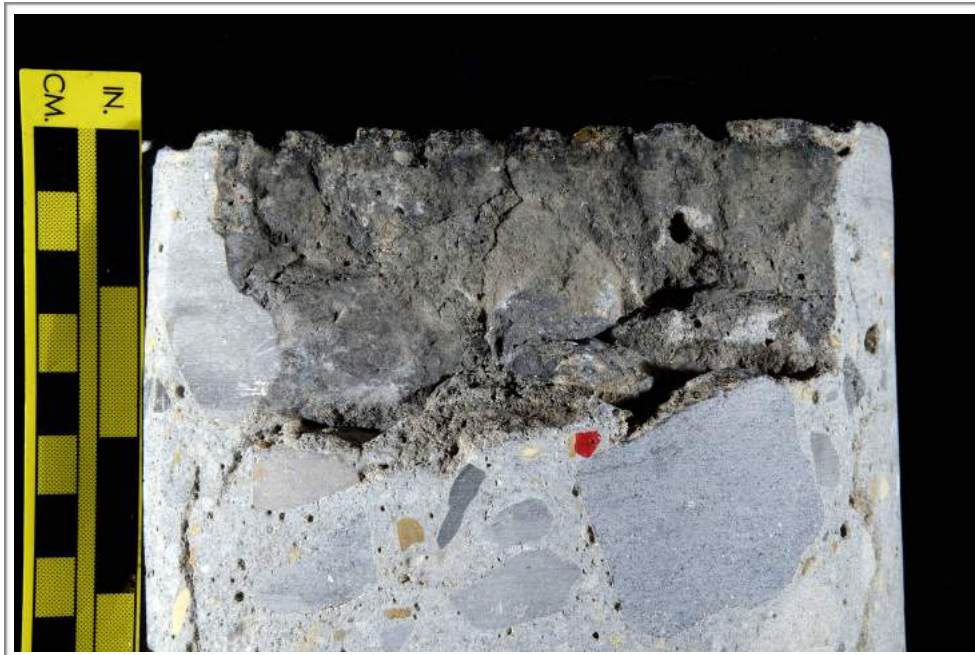
Figure A4. Photograph of top of core showing missing section.

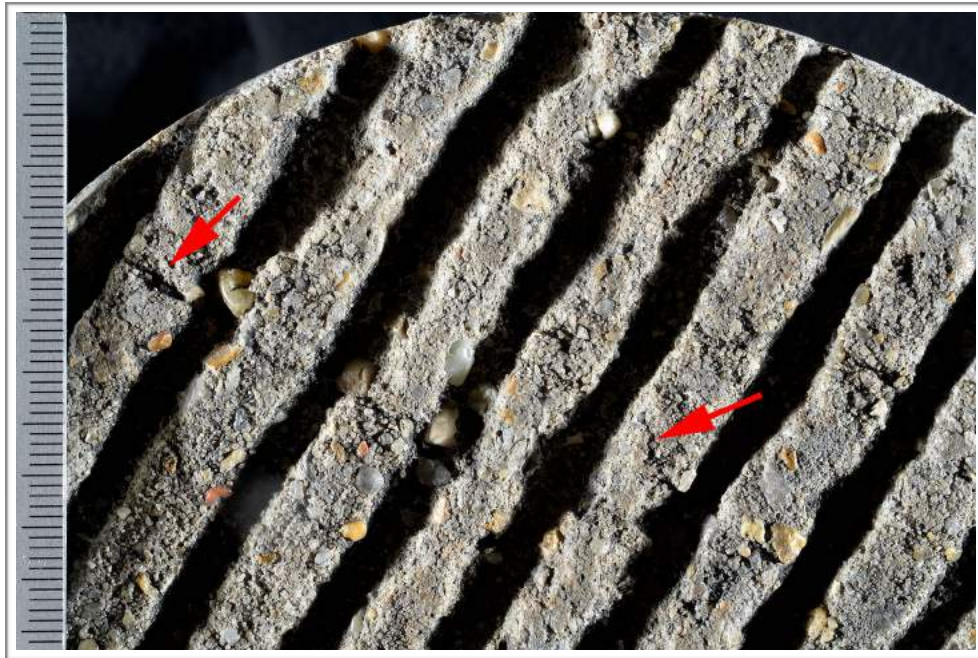
Figure A5. Photograph of the top surface showing linear cracks (red arrows). Scale in millimeters.

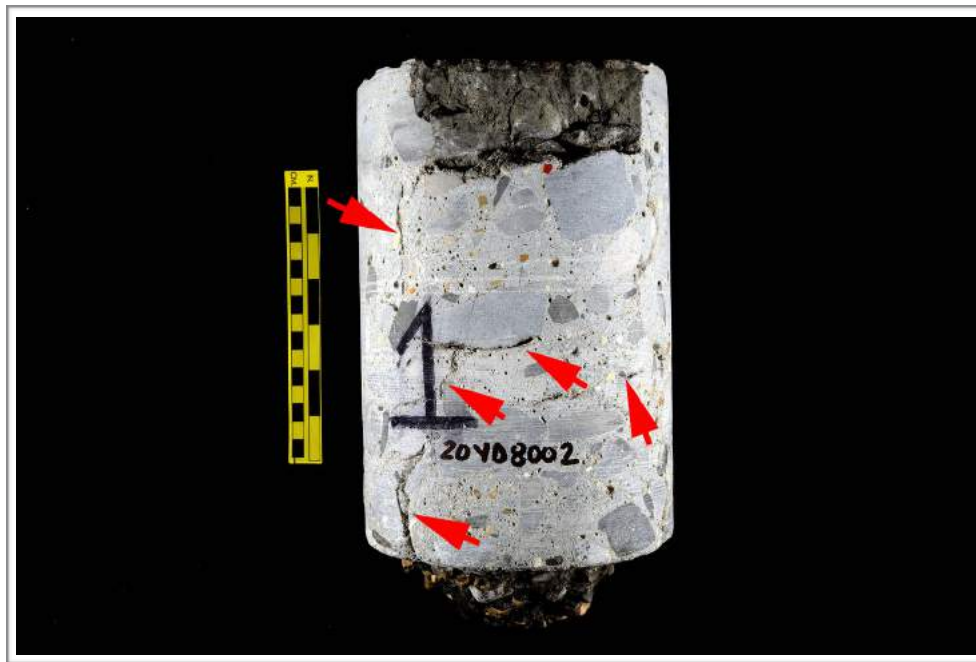
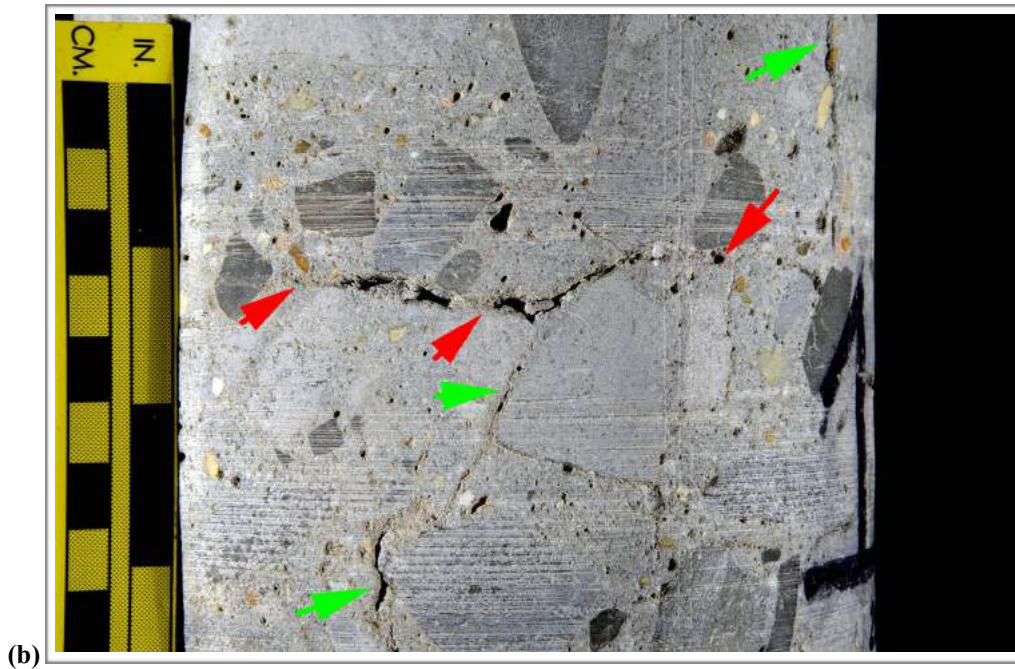
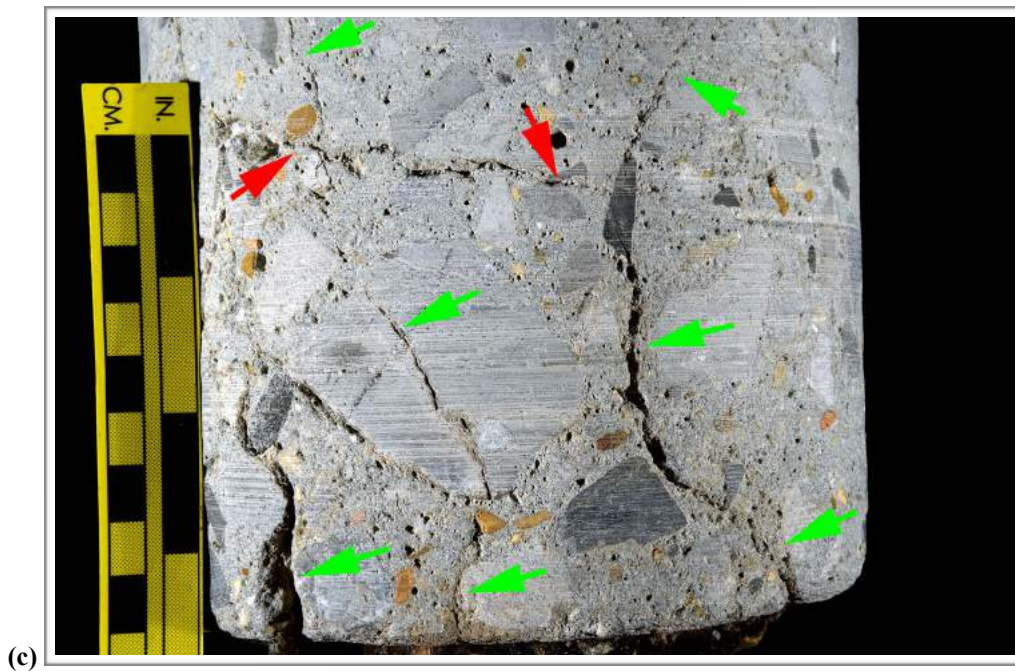
Figure A6. (a) Photograph of the side of the core showing overview of cracks (red arrows). The yellow scale is ~ 150 mm (6 in.) long.

Figure A6 (cont'd). Photographs showing cracks on the side of the core. The red arrows indicate sub-horizontal cracks and the green arrows indicate sub-vertical cracks.

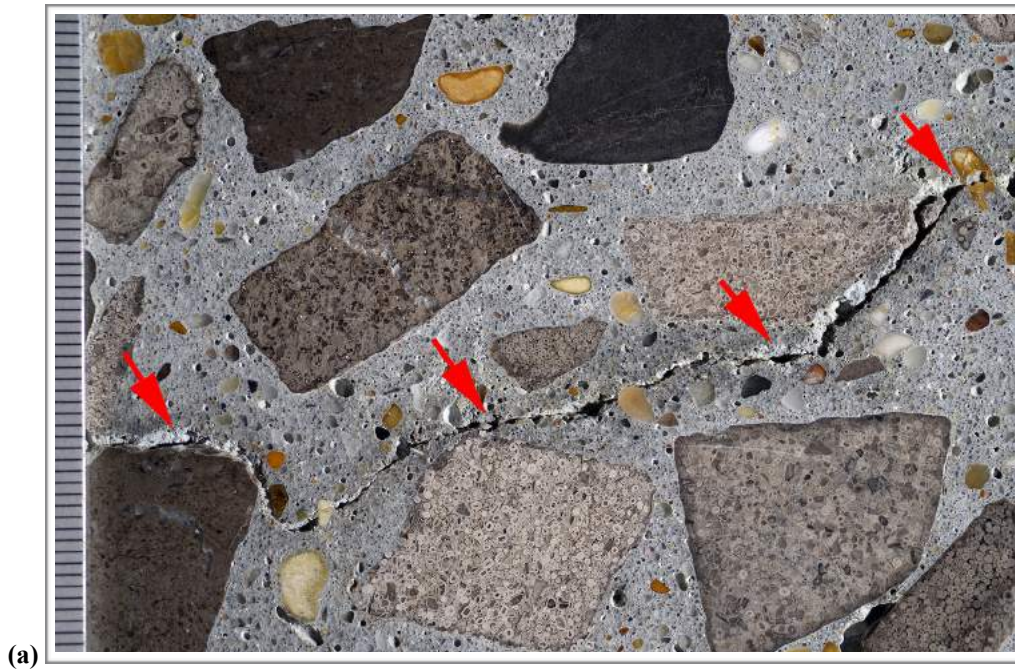
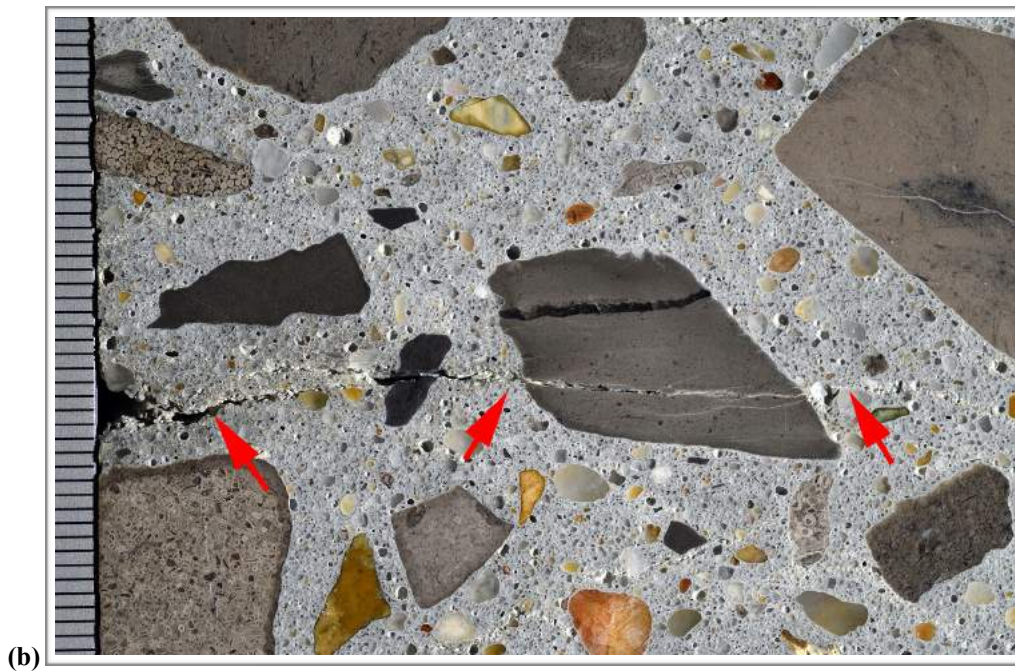
Figure A7. Photographs of the polished surface showing sub-horizontal cracks (red arrows) at (a) 75 mm (3 in.) and (b) 110 mm (4 3/8 in.) below the top surface.

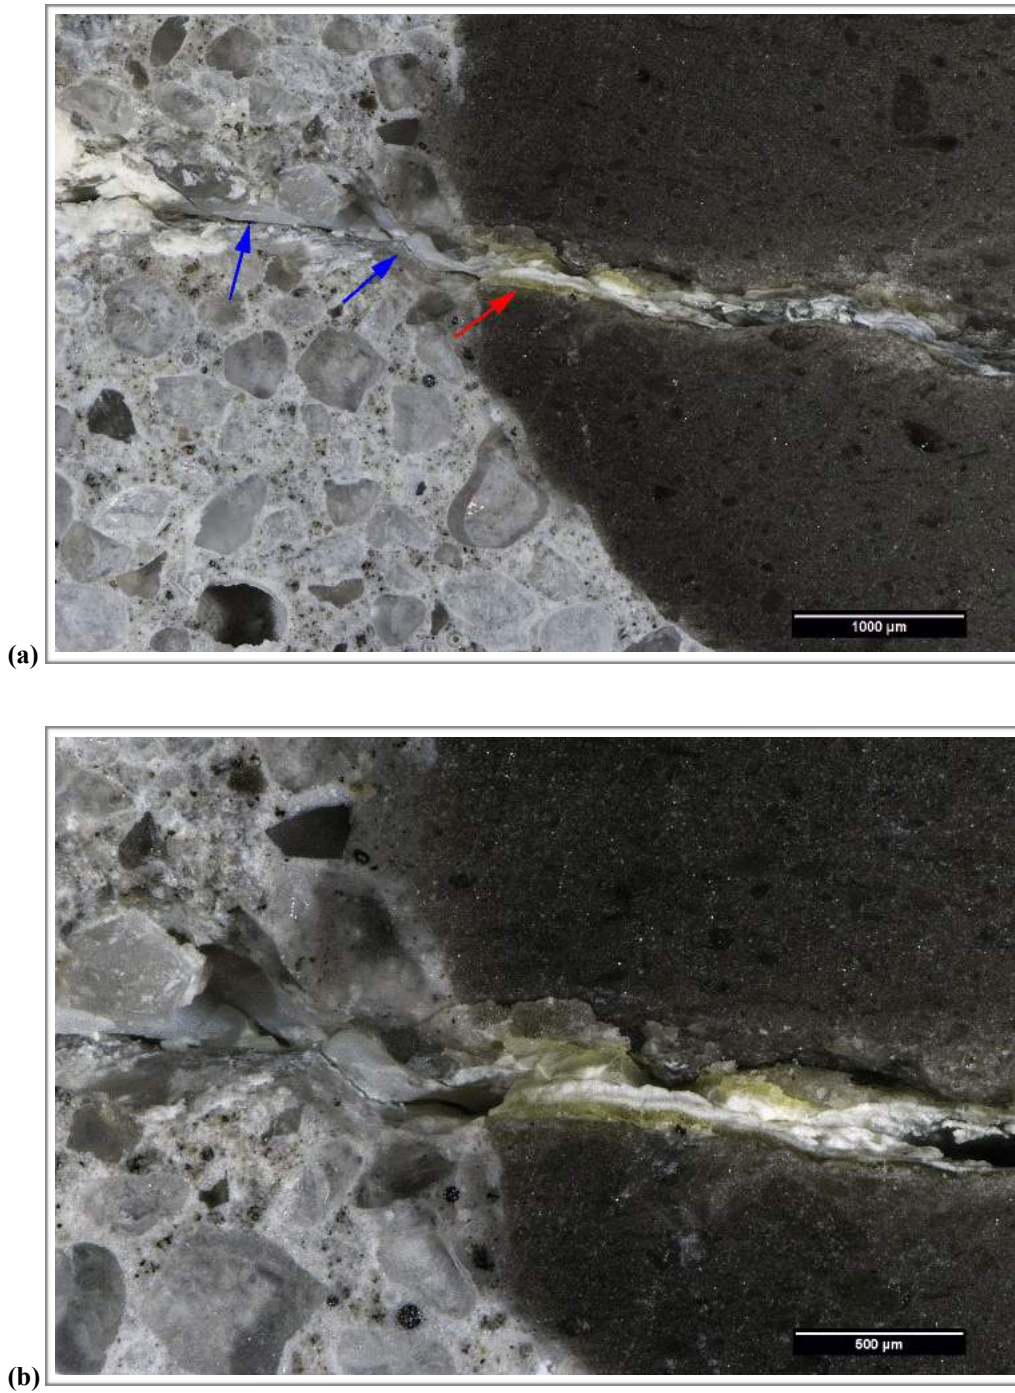
Figure A8. Reflected light photomicrographs of polished surface showing detail of gel in microcrack about 110 mm (4 3/8 in.) below the top surface.

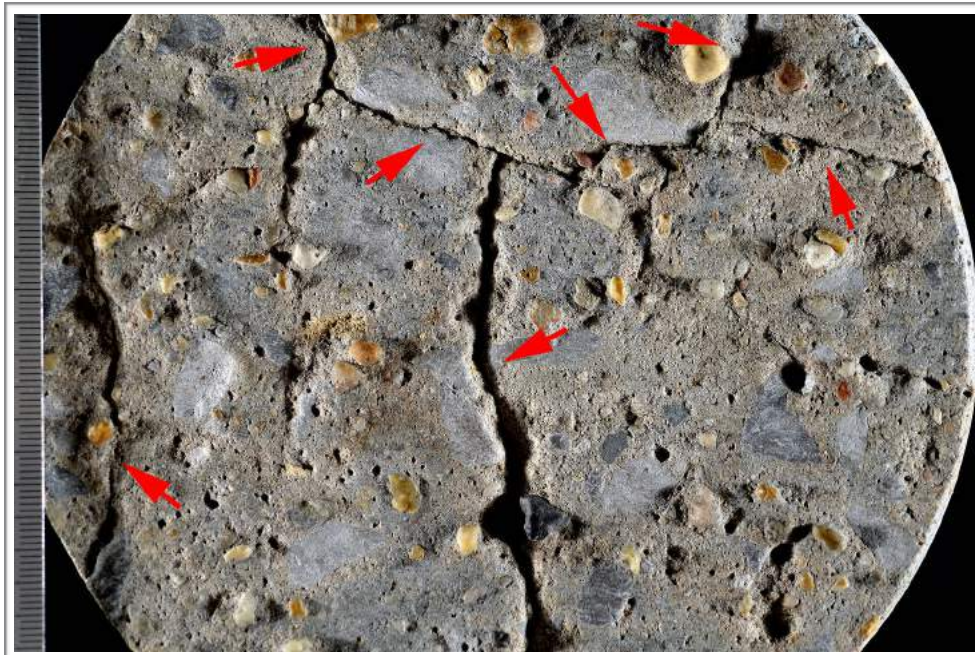
Figure B4. Photograph of top of core showing cracks (red arrows); scale in millimeters.

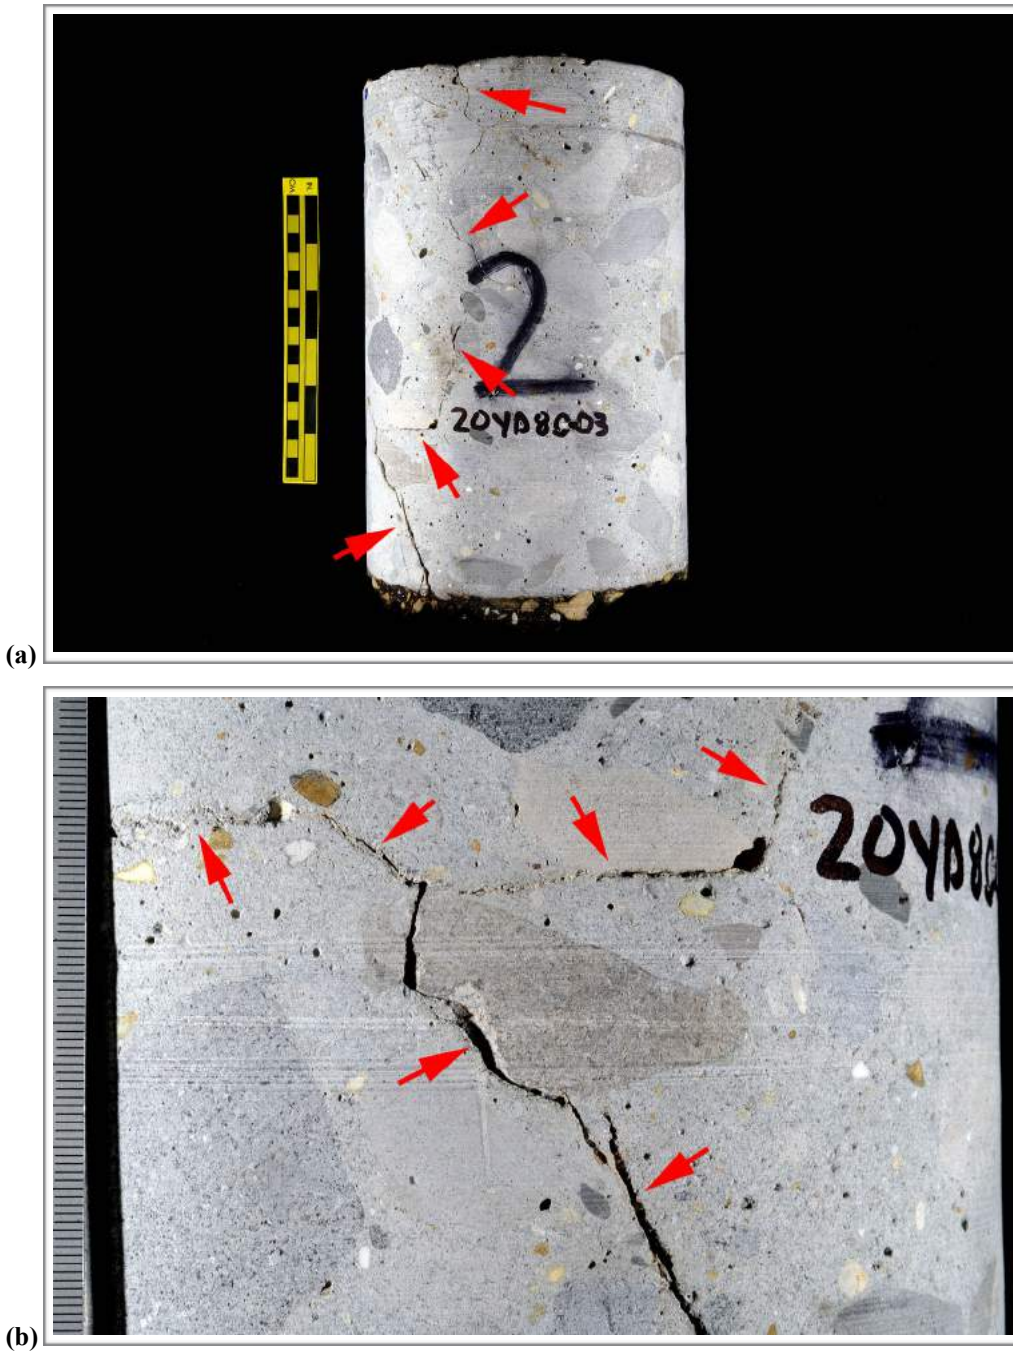
Figure B5. Photographs of the side of the core showing (a) overview and (b) detail of cracks (red arrows). The yellow scale is ~ 150 mm (6 in.) long.

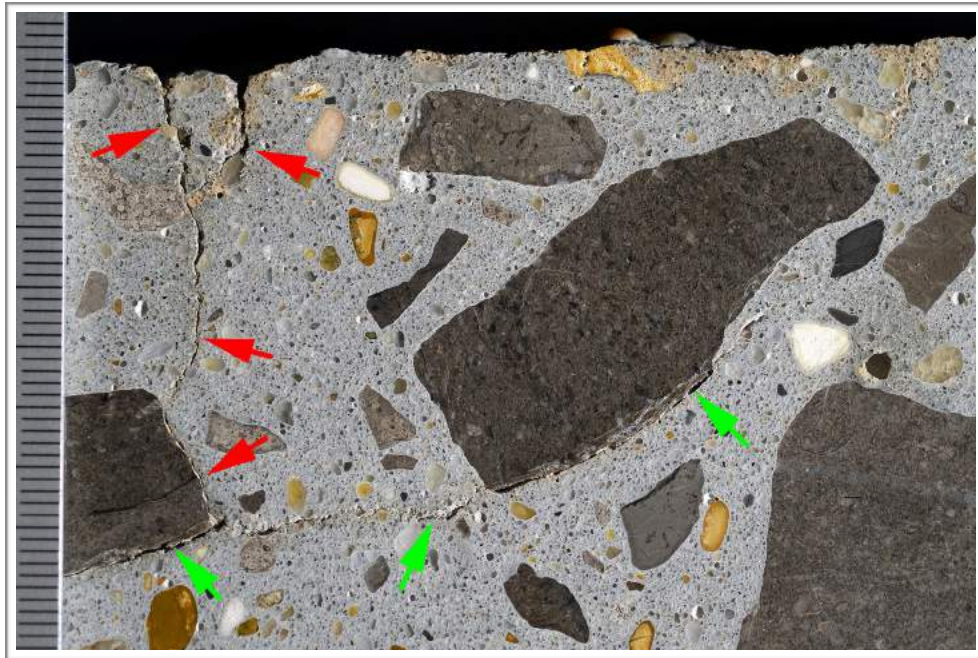
Figure B6. Photograph of polished surface showing sub-vertical crack (red arrows) at the top of the core and the sub-horizontal crack (green arrows) where it terminates.
