Louisiana Transportation Research Center

Technical Assistance Report 16-03TA-C

Evaluation of Cores from Jefferson Highway Near Airline Highway

Petrographic Investigation of Concrete Cores Extracted from Cracked
Pavement Slabs on Jefferson Highway in Baton Rouge, Louisiana
(RE: LTRC Project 16-1TA-C)

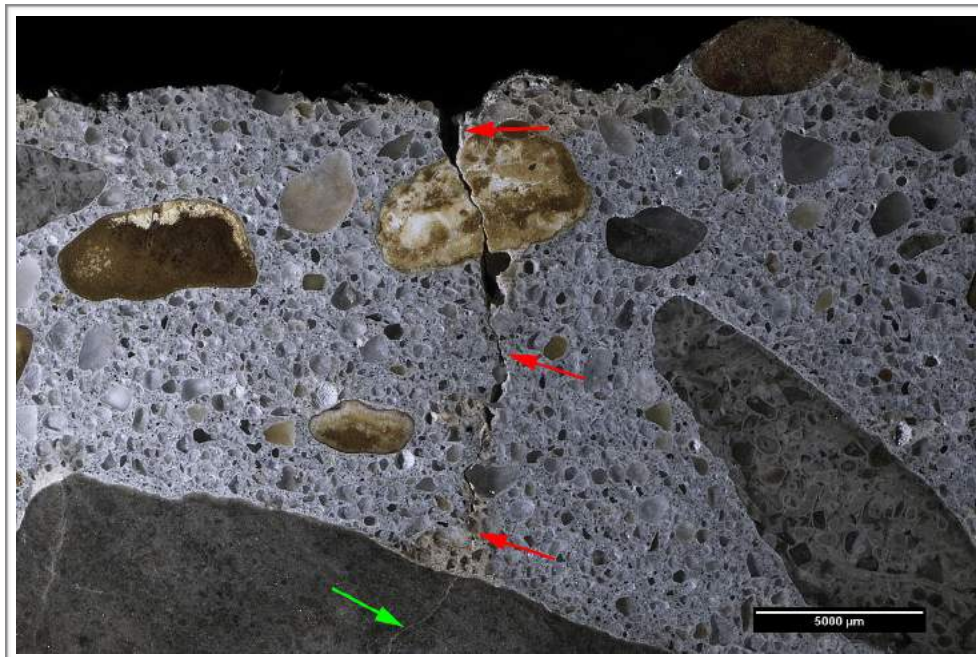
Figure B7. Reflected light photomicrograph of the top surface showing hairline crack (red arrows) that cuts sub-vertically from the top surface to a limestone particle with an internal microcrack (green arrow).

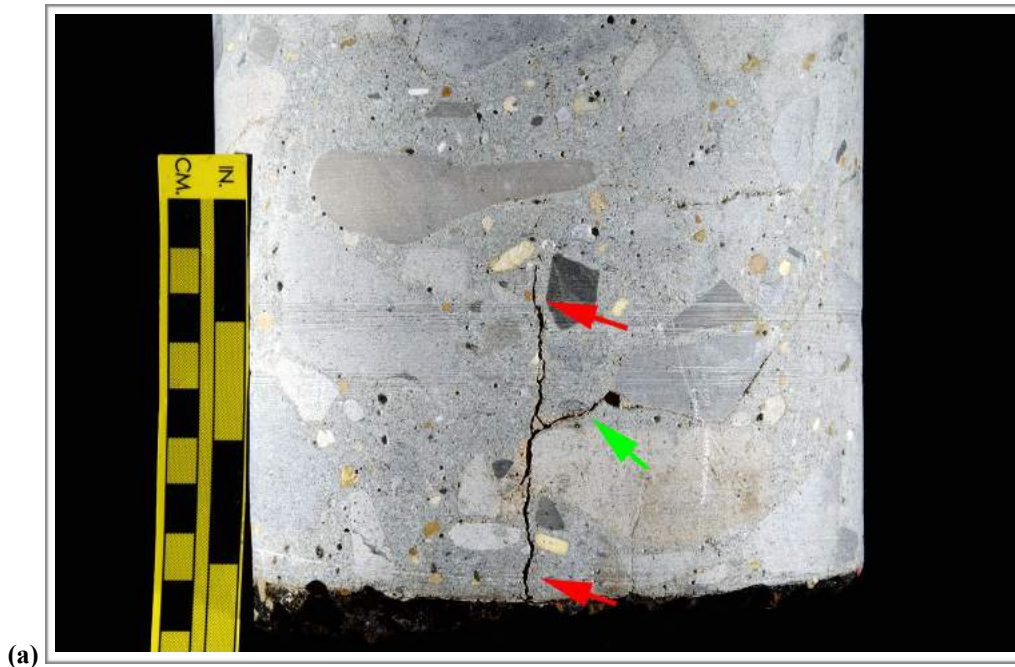
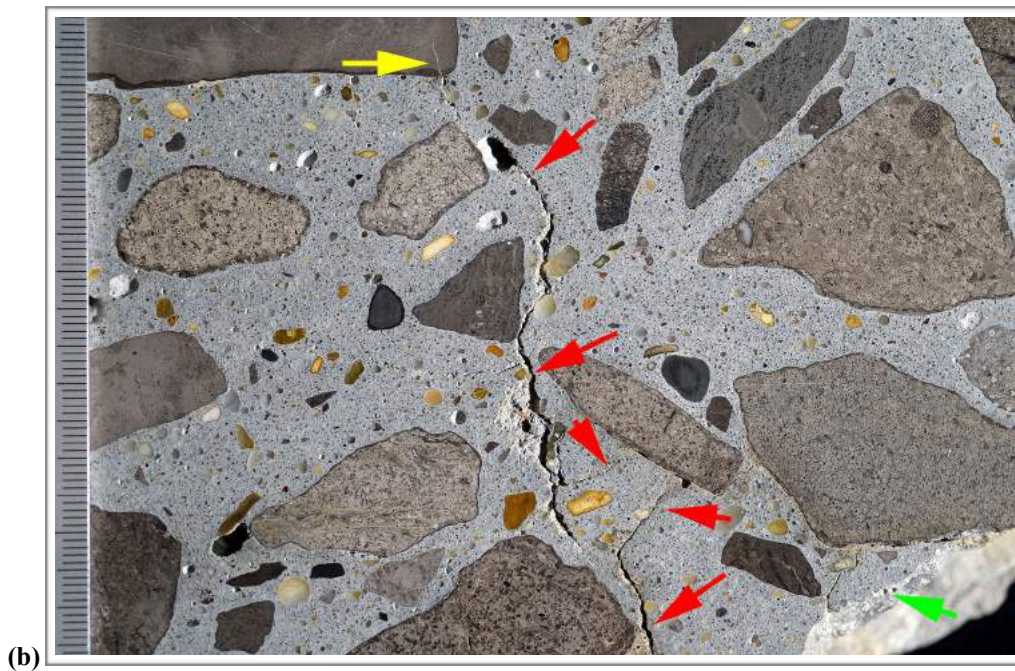
Figure B8. Photographs of the (a) side of the core and (b) the polished surface showing cracks (red arrows) at the bottom of the core (green arrow in (b)). In (b) the yellow arrow highlights a hairline crack in a dolomitic limestone particle and the scale is in millimeters.

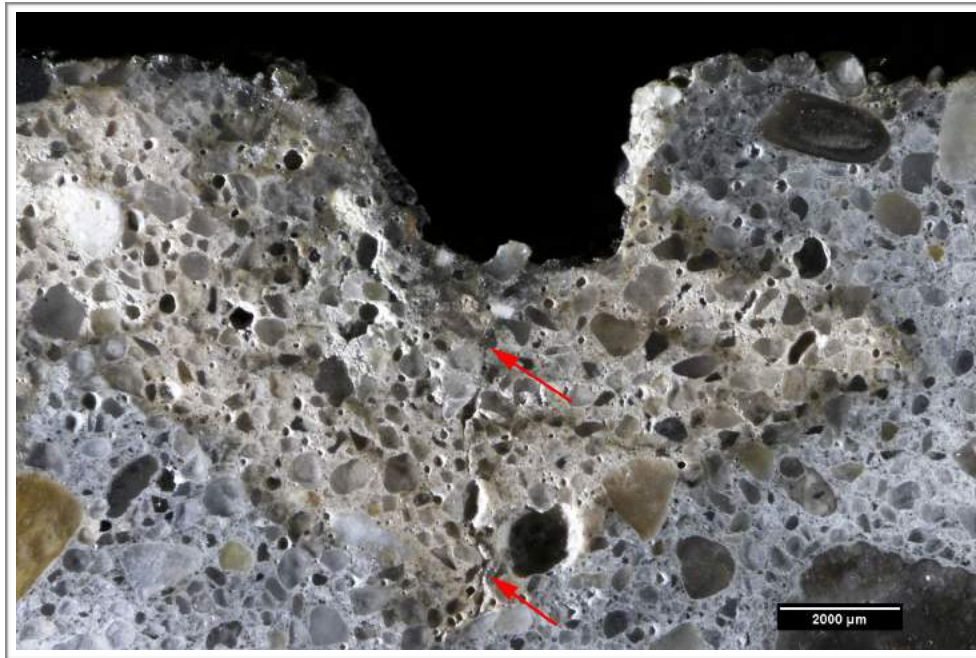
Figure B9. Reflected light photomicrograph of the polished surface showing sub-vertical microcrack (red arrows) at the top of the core. Note the discoloration of the paste around the microcrack, which is typical of carbonation.

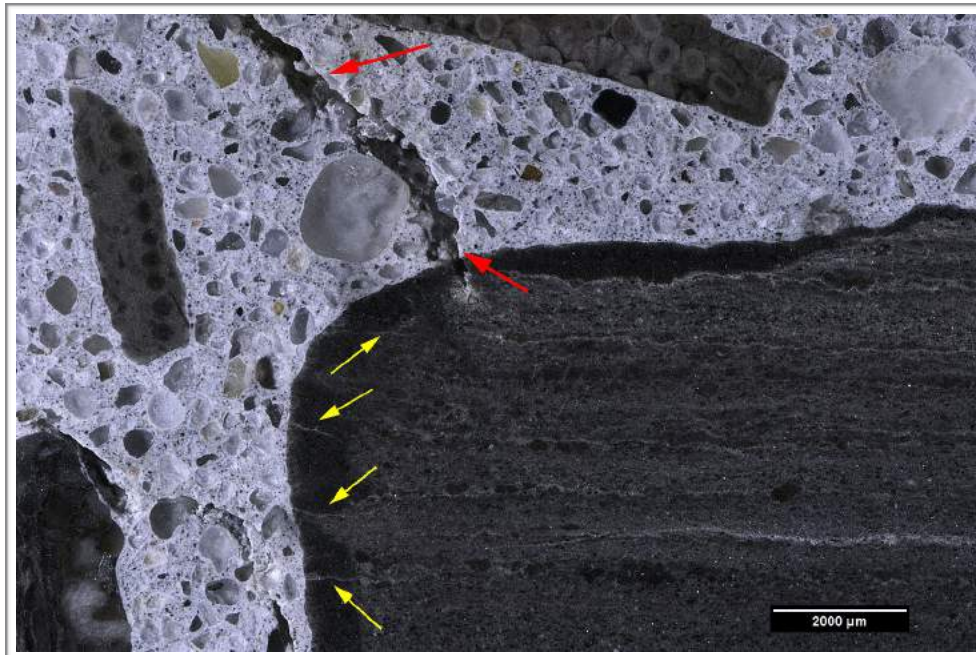
Figure B10. Reflected light photomicrograph of the polished surface showing microcracks (yellow arrows) in a reaction rim of a dolomitic limestone particle and a crack (red arrows) cutting from particle into the paste.

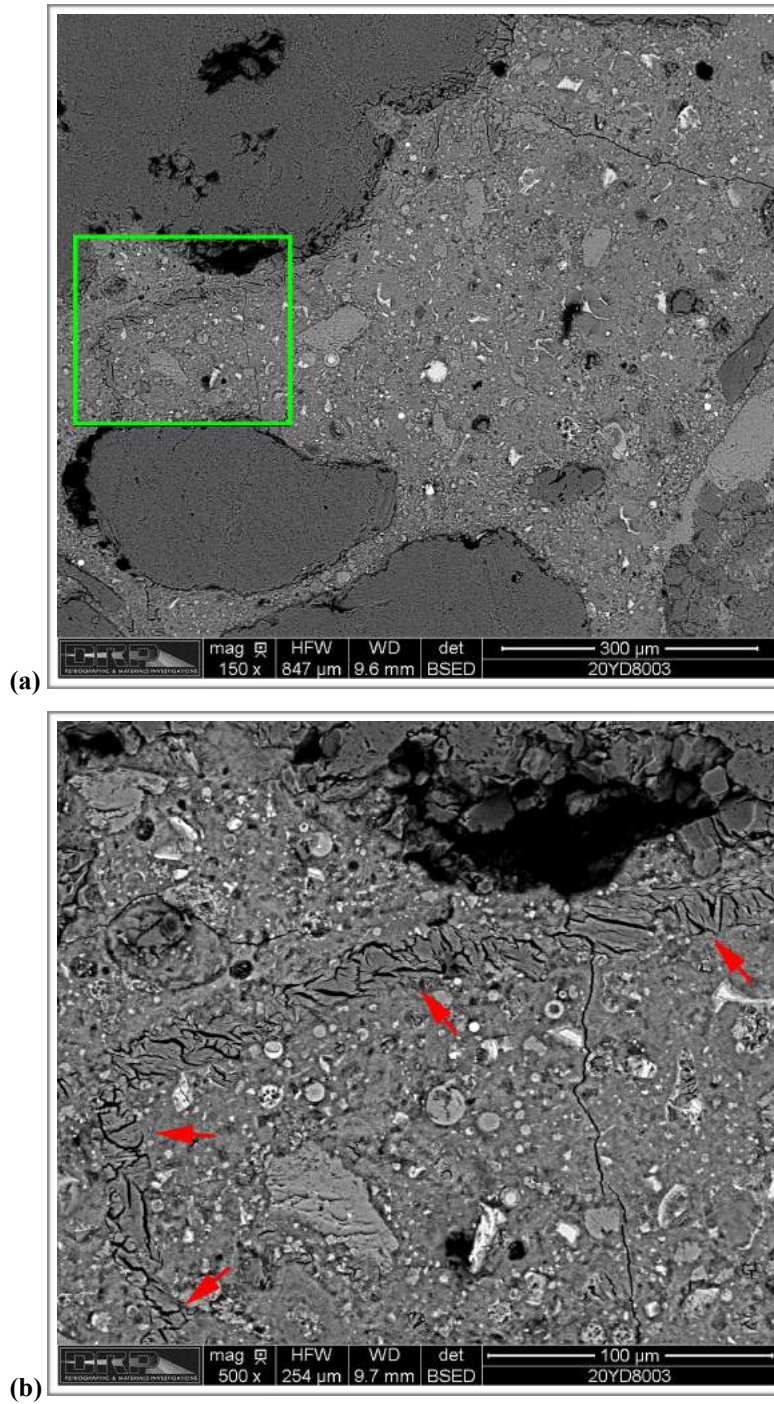
Figure B20. BSE micrographs showing (a) overview and (b) detail of microcrack with ettringite (red arrows) in the paste.

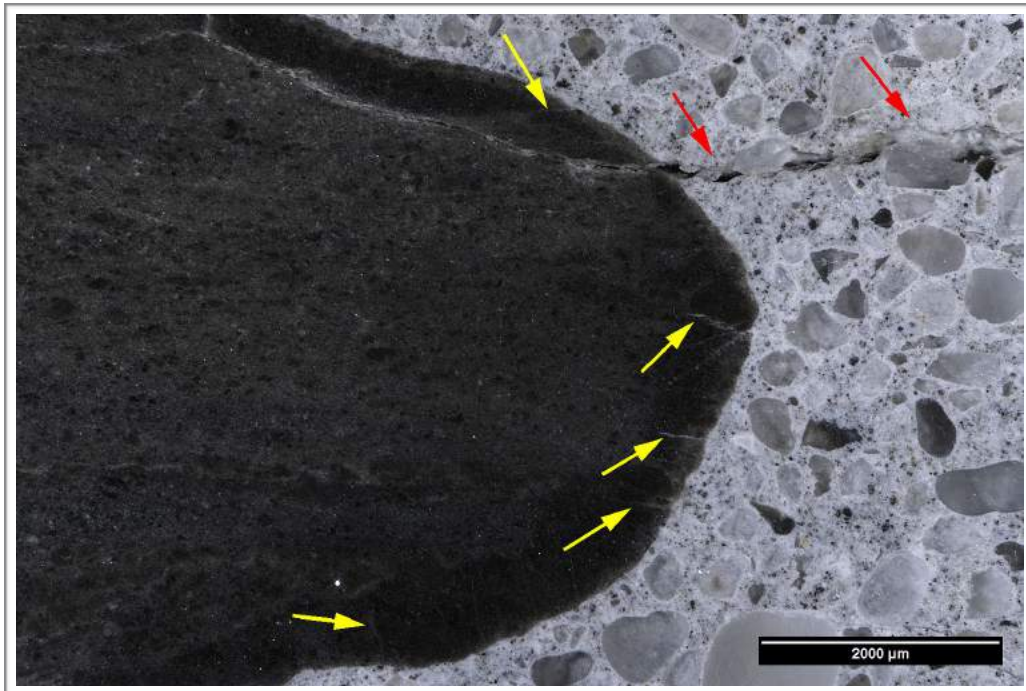
Figure B21. Reflected light photomicrograph of the polished surface showing hairline crack (red arrows) cutting from dolomitic limestone particle with microcracks in reaction rim (yellow arrows).

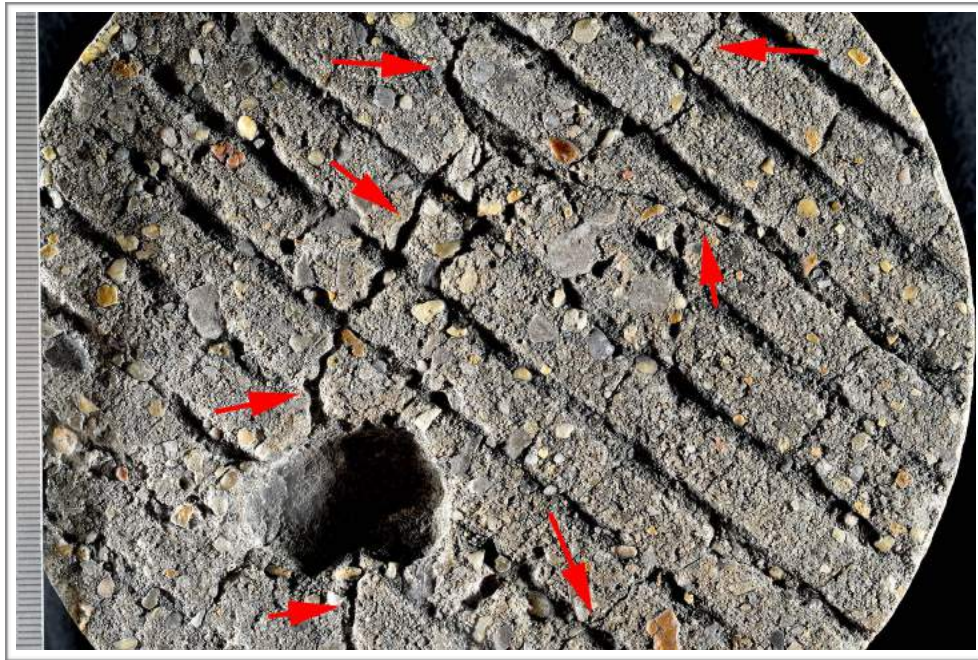
Figure C5. Photograph of the top surface showing overview of cracks (red arrows). Scale in millimeters.

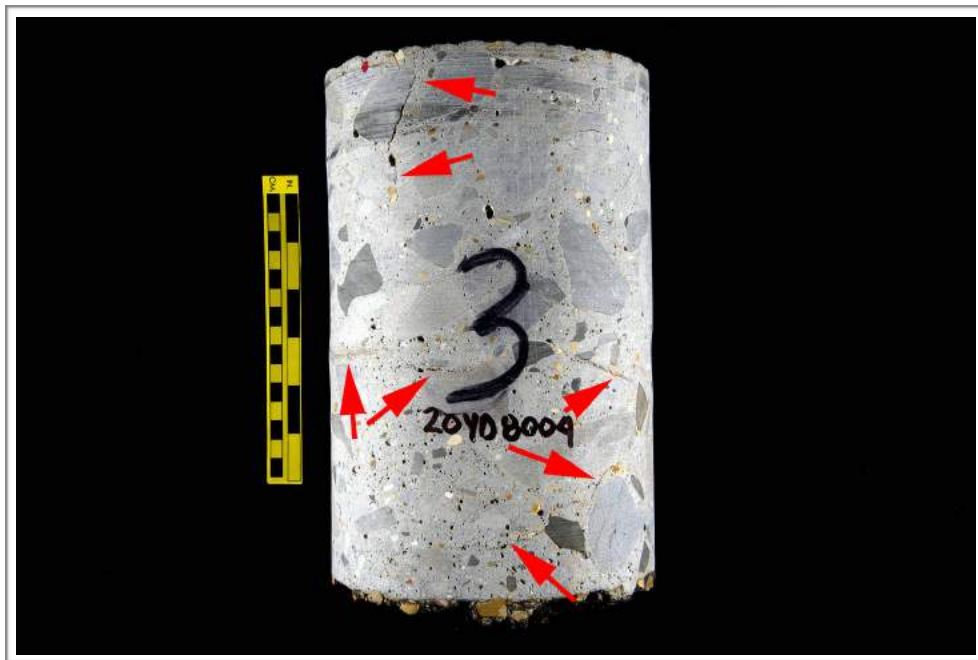
Figure C6. Photograph of the side of the core showing overview of cracks (red arrows). The yellow scale is ~ 150 mm (6 in.) long.

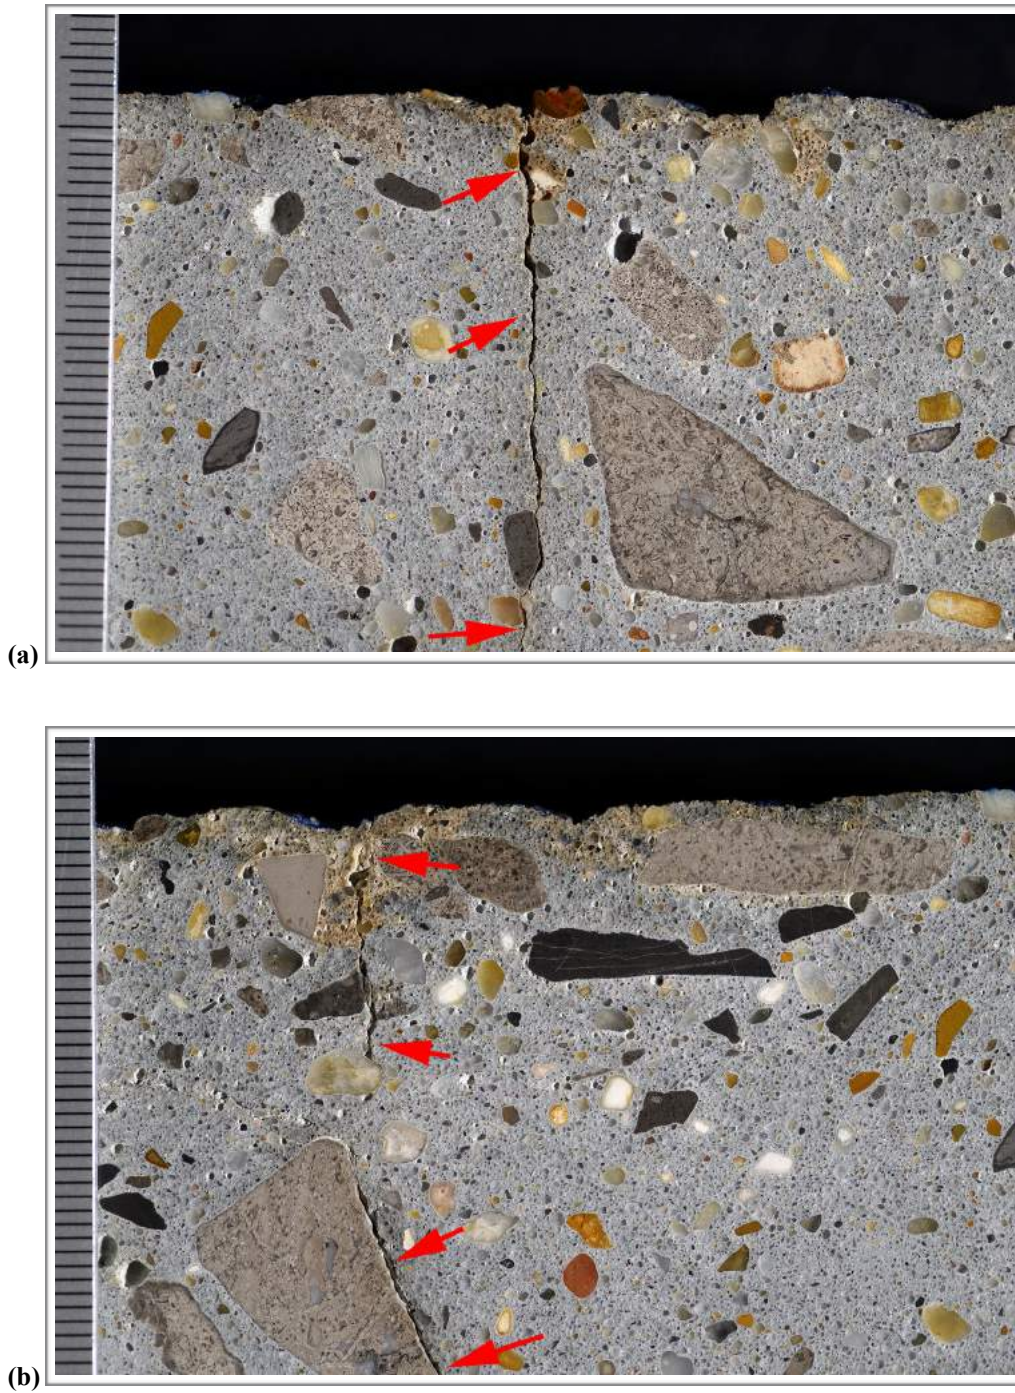
Figure C7. Photographs of the polished surface showing sub-vertical cracks at the top of the core. Scale in millimeters in both photos.

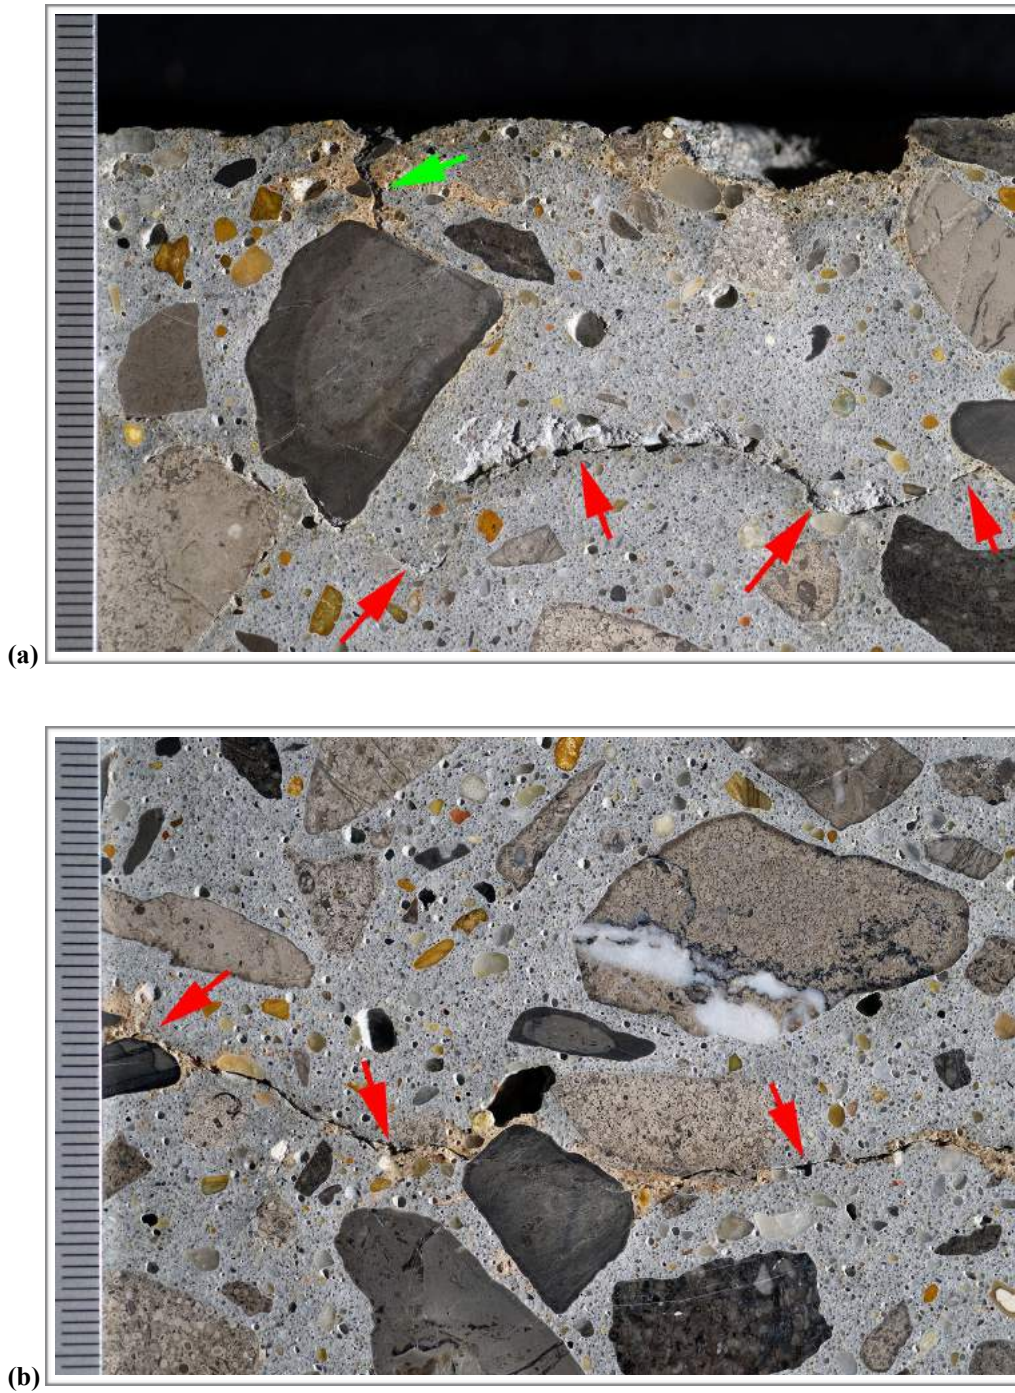
Figure C8. Photographs of the polished surface showing sub-horizontal cracks (red arrows). Scale in millimeters in both photos. The green arrow in (a) indicates sub-vertical crack.

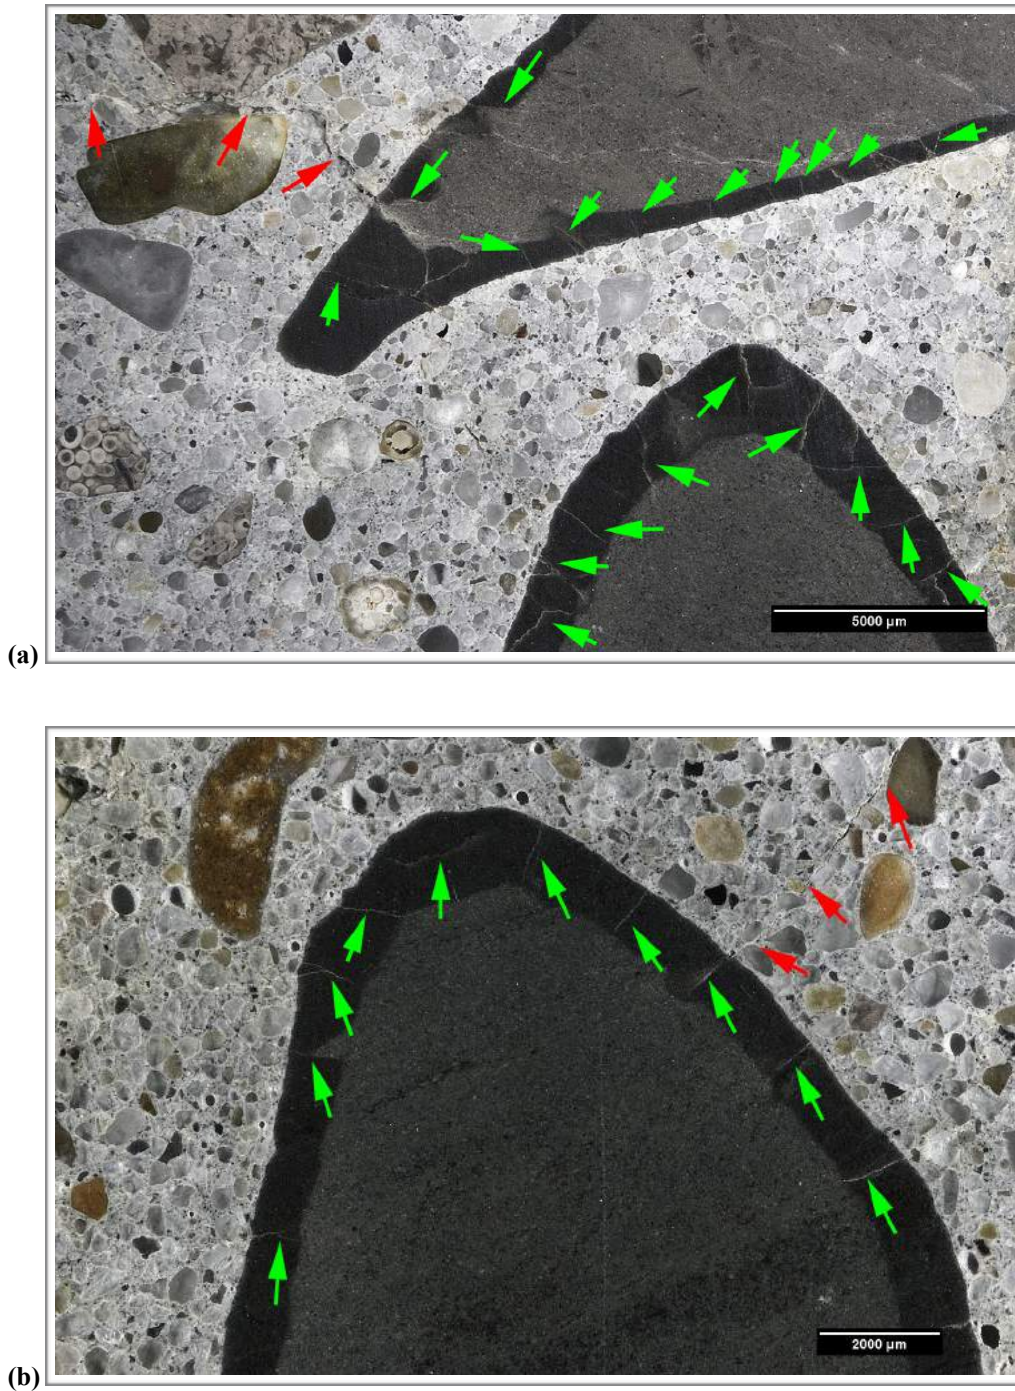
Figure C9. Reflected light photomicrographs of the polished surface showing (a) overview and (b) detail of peripheral microcracking (green arrows) in dolomitic limestone particles about 80 mm (3 1/8 in.) below the top surface. The red arrows in both photos indicate microcracks that cut from the limestone into the paste.
