**MDOT RC-1617B**

**Evaluation of Bridge Decks Using  
Non-Destructive Evaluation (NDE)  
at Near Highway Speeds  
for Effective Asset Management  
– Pilot Project**

**FINAL REPORT**

Michigan Department of Transportation

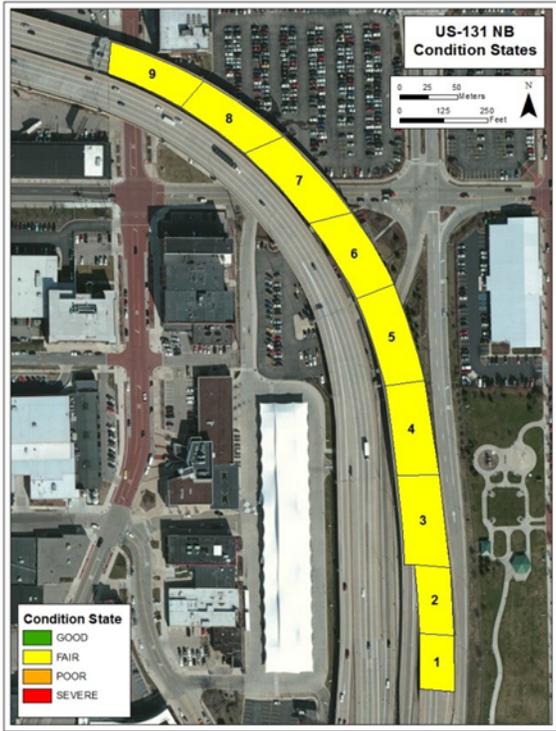
**Figure 1: Summary of condition state per span at US-131 northbound.**

Location:		Area Cond. State 1 (ft <sup>2</sup> ) GOOD	Area Cond. State 2 (ft <sup>2</sup> ) FAIR	Area Cond. State 3 (ft <sup>2</sup> ) POOR	Area Cond. State 4 (ft <sup>2</sup> ) SEVERE
<b>US131</b>	<b>Area of Span (ft<sup>2</sup>)</b>				
Span 1	7,642	7,629	13	0	0
Span 2	9,318	9,299	19	0	0
Span 3	15,456	15,451	5	0	0
Span 4	14,872	14,865	7	0	0
Span 5	15,120	15,105	15	0	0
Span 6	13,711	13,675	36	0	0
Span 7	15,524	15,489	35	0	0
Span 8	12,647	12,643	4	0	0
Span 9	11,635	11,601	34	0	0
<b>Total</b>	<b>115,926</b>	<b>115,757 (99.85%)</b>	<b>168 (0.15%)</b>	<b>0 (0%)</b>	<b>0 (0%)</b>

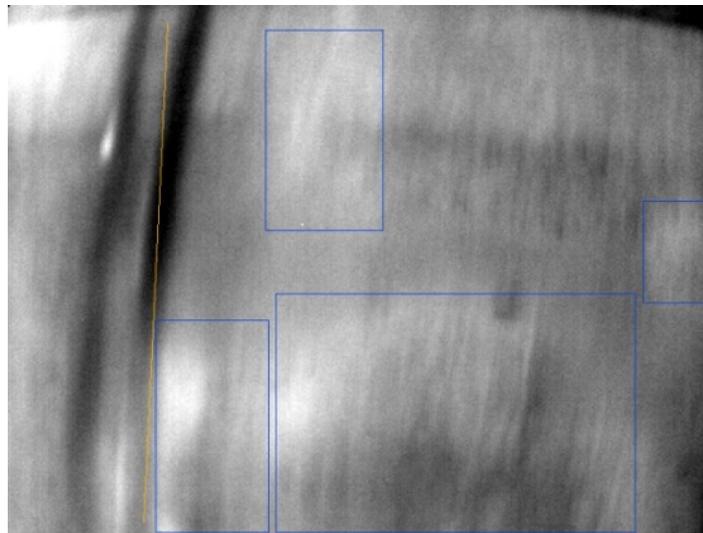
**Figure 4: Passive thermal imagery was processed and analyzed for the detection of potential delaminations (blue boxes).**

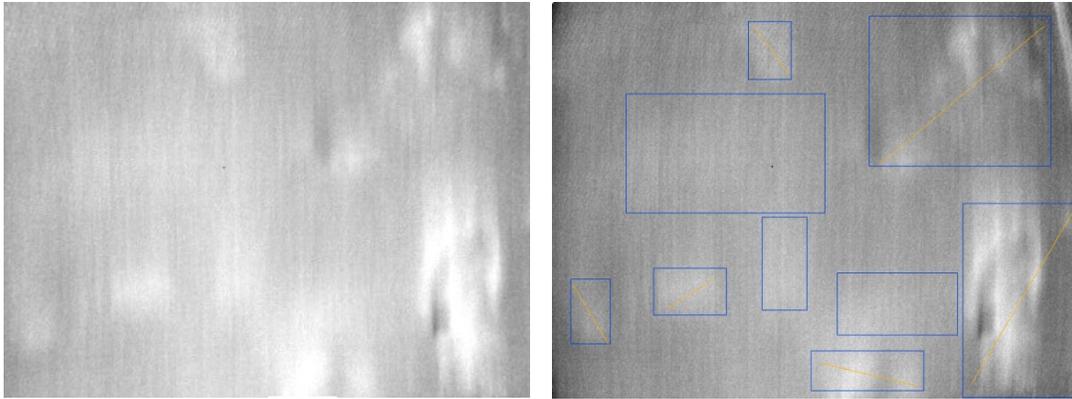
**Figure 7: Raw thermal imagery (left) and thermal imagery processed to highlight areas of potential delamination (right).**

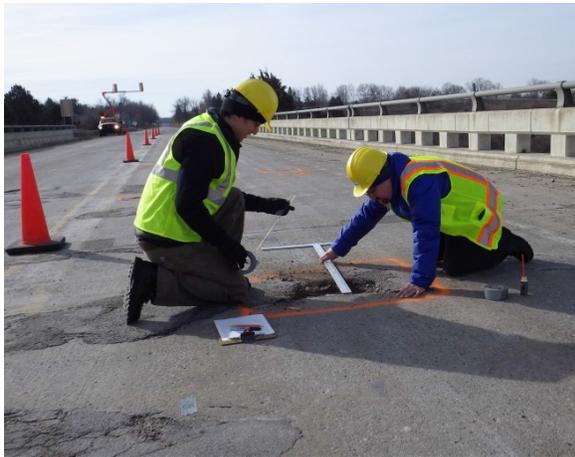
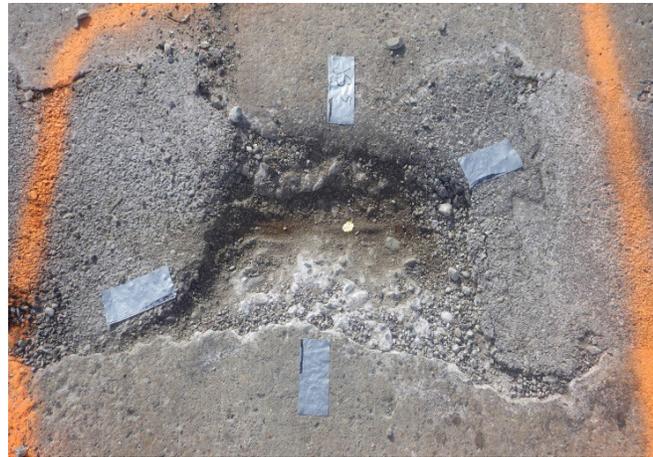
**Figure 12: Manual measurements the length, width, and depth of spall and patch features on the bridge deck.**

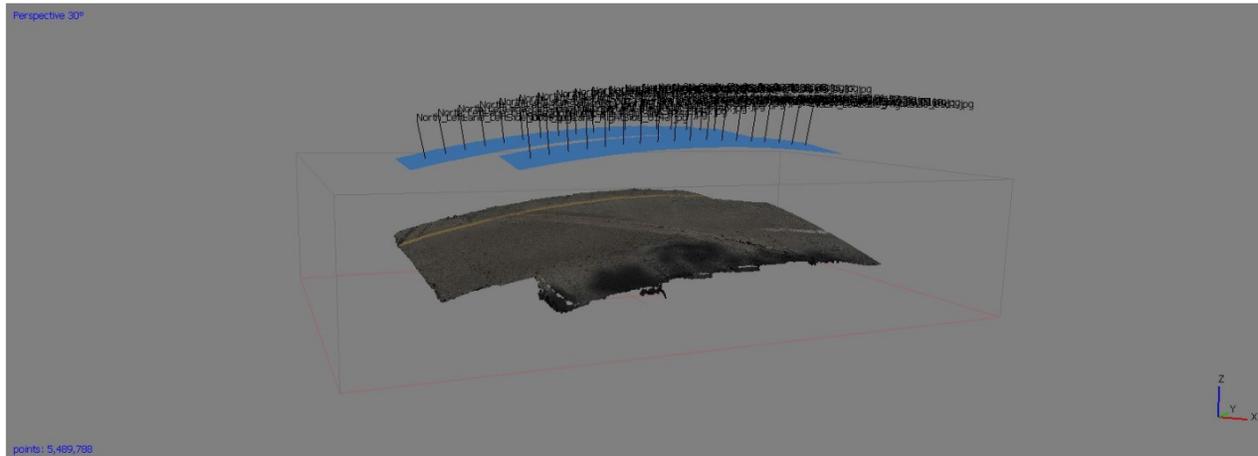
with few distresses. The resulting models would be severely distorted and not of sufficient quality to make reliable and accurate measurements (Figure 15). Because the RED Epic imagery was unable to be processed into an orthoimage and DEM, the imagery was mosaicked and georeferenced to the high-resolution base maps layer within ArcGIS. While this process is more time consuming, it provided a high-resolution base layer for manually georeferencing the thermal imagery and spalls.

**Figure 15: Example of I-75 point cloud demonstrating the reconstruction challenges encountered.**
