**Federal Railroad
Administration**

Locomotive Fuel Vapor Reclamation System Field Evaluation and Cost-Benefit Analysis

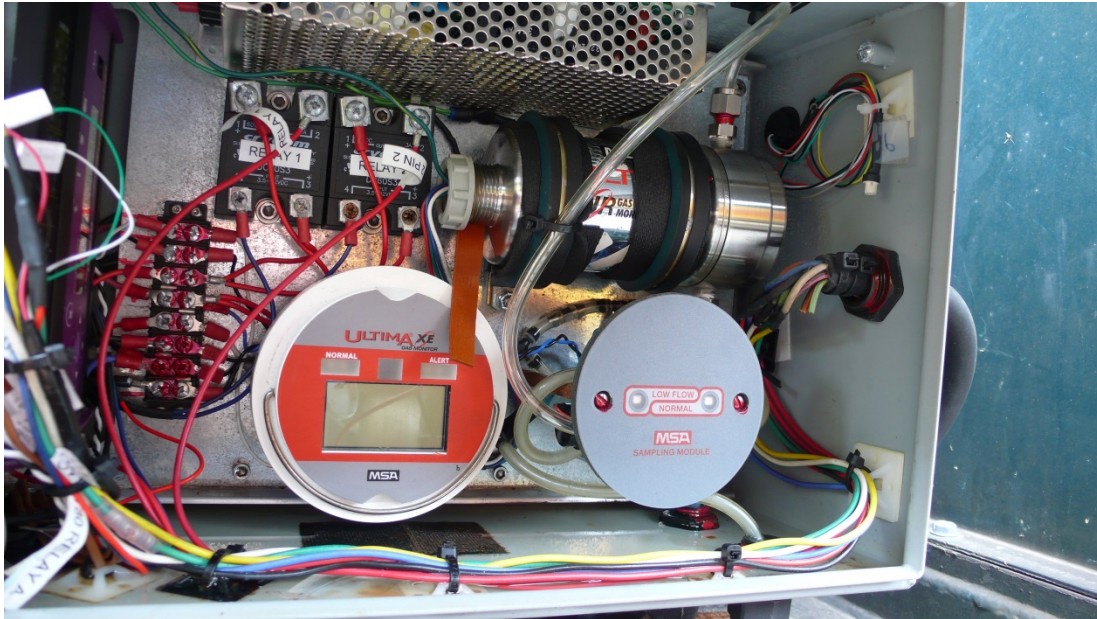
Upon examining the installed DVRU, QNA detected a lack of power inside the electronics control box. The inside of the box was flooded with water, which shorted the power supply, thus rendering the DAQ and the data communication module non-functional. The vapor suction fan and the chiller were in working condition which derived 110 V DC power separately through an inverter. The team observed liquid diesel fuel dripping out drop by drop from the CFMU collector tank overflow port. This could have happened due to the long term diesel vapor condensation by the condenser over the five months period when both the vapor suction fan and the chiller unit circulating the chilled coolant to and from the condenser were fully operational, but the fuel level sensors and the fuel pump within the CFMU were non-functional due to power supply cutoff within the electronics control box. A further reason could be due to the tank overfill under pressure that could push-up past the ball valve and accumulate some fuel in the fan and condenser manifolds.

Figure 20 shows the inside status of the DVRU electronics control box with all power indicators in the MSA vapor sampling pump, its display unit off, and the damp bottom inside wall of the box, including the evidence of rusting due to pressurized water ingress. It was believed that despite using an electronics box enclosure certified to meet NEMA-4X standard, water could have entered inside the box during the power wash that was given to the DVRU-installed BNSF9674 before it left the BNSF Topeka yard for revenue service. QNA was not made aware of the power wash procedure or schedule prior to or during the DVRU installation.

Figure 20. Inside view of the electronics control box with power cut off

Because of the very little time available, it was not possible for the QNA engineers to repair, replace and test all components of the DVRU at Mandan to make it fully functional and to install an additional water-proof cover to effectively protect the electronics control box against future pressurized water ingress. To retrieve the residual recorded data from the Data Taker, QNA personnel brought the unit back to QNA. Further, the team switched off the inverter to shut down the fan and the chiller unit until the whole DVRU system could be checked and powered 'ON' at a BNSF Maintenance Depot.

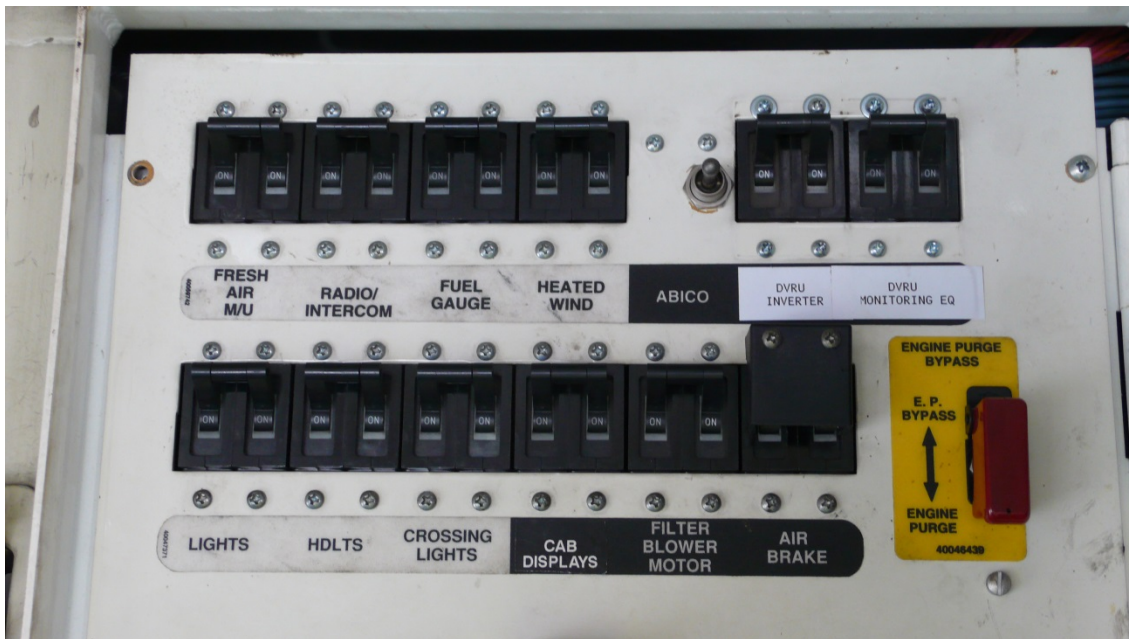
The DVRU switches, both for the inverter and the monitoring equipment were found still ‘ON’ as shown in Figure 21, and the chiller unit was still functioning normally at its preset temperature of 40 °F as shown in Figure 22.

Figure 21. Main switch board showing status of DVRU-specific switches

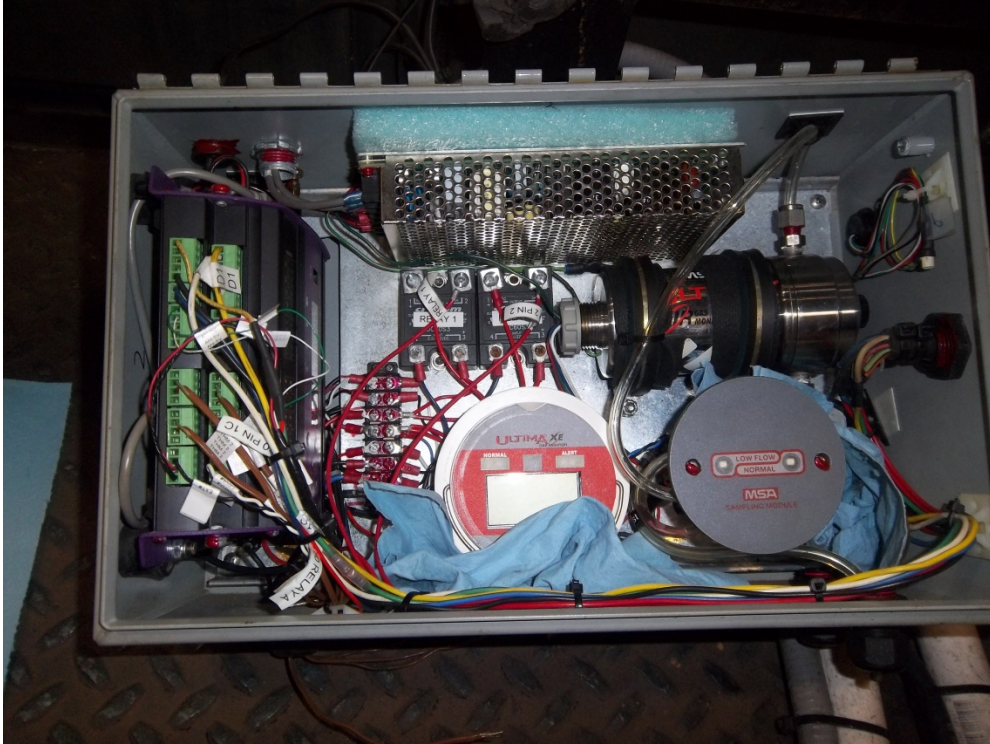
Figure 23. Water clean-up of the electronics control box at Glendive

With prior notification from BNSF regarding the availability of SD70 BNSF9674, the QNA team check-listed all items necessary for repair or replacement in the DVRU to make it operational. QNA carried out the DVRU maintenance work at Glendive. On opening the cover of the electronics control box, the team found it contained water, which had to be removed using paper towels as shown in Figure 23. Because of the vulnerable location of the 74 V DC to 12 V DC converter within the electronics box, the QNA team shifted the new converter to a location at the back of the electrical panel inside the cab. They replaced the old Data Taker as well as a SIM card with a newer version supporting a more efficient data communication module connecting to a cellphone network (AT&T/Rodgers). The new version Data Taker installed inside the control box is shown in Figure 24. It was powered by a cable running from the converter which was shifted to the cab to avoid getting shorted by water spray.

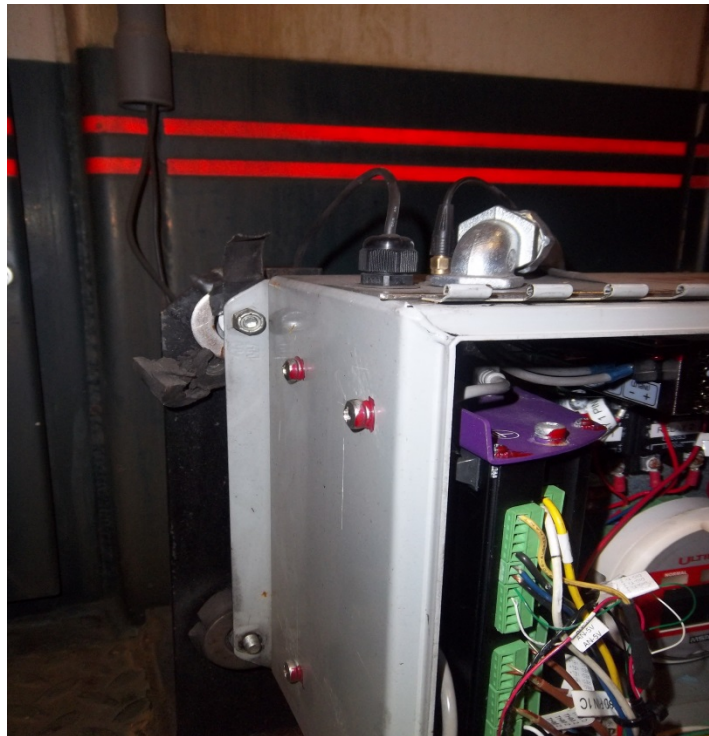
Figure 24. New Data Taker module installed inside the electronics control box

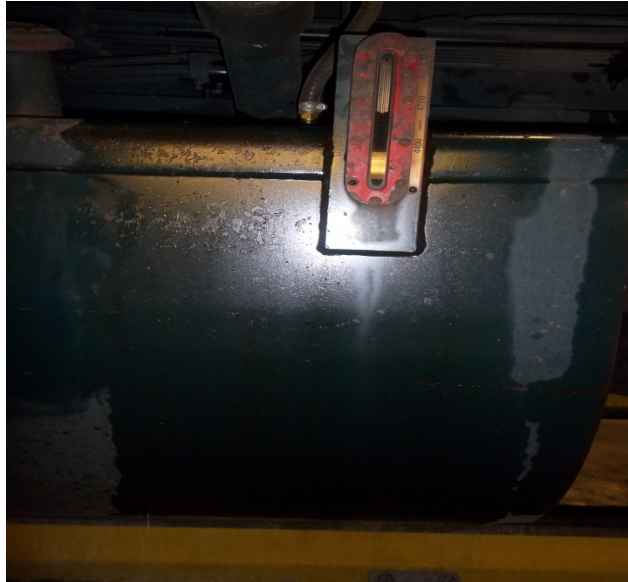
The QNA team observed evidence of fuel overfilling during refueling despite clear instructions on the placard and decals to the contrary. The pressurized fuel overfill had likely caused the flooding of the tubing in MSA vapor sampling line. Figure 25 shows the fuel overflow marks on the tank sidewall and the diesel fuel inside the MSA tubing is shown in Figure 26.

Figure 25. Evidence of fuel overflow during tank refueling

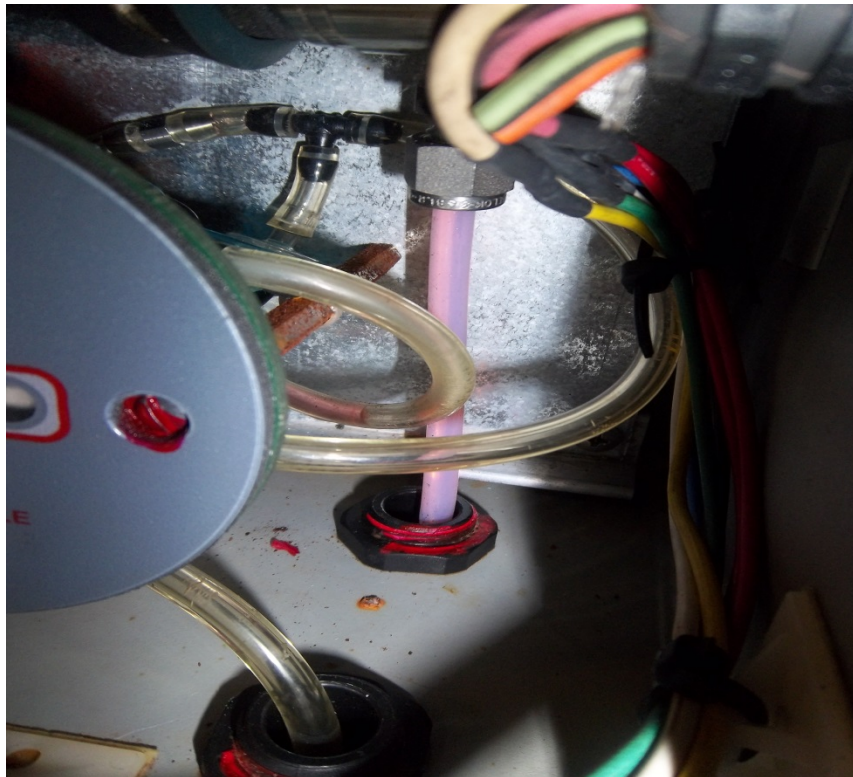
Figure 26. Overfilled diesel fuel in MSA vapor sampling tubing inside electronics box

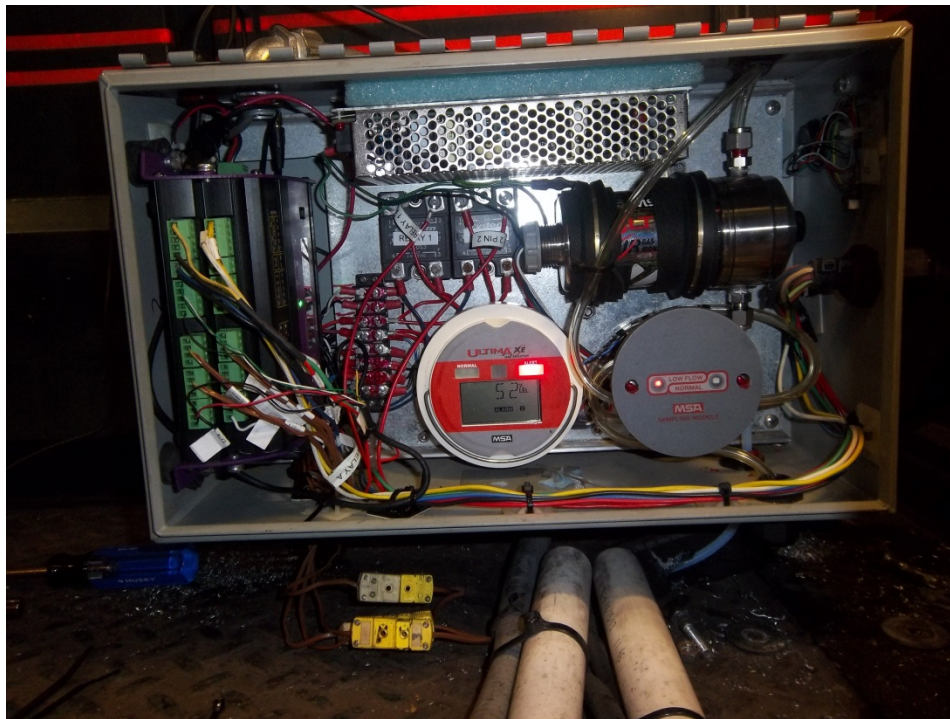
Figure 27. Powered electronics control box following maintenance at Glendive

On completion of the cleanup and maintenance of the electronics control box, as well as setting up the converter within the cab, the QNA team powered up the DVRU electronics control box and confirmed the sensors and display units were functional, as seen in Figure 27. They also watched the pump of the Condensed Fuel Measuring Unit (CFMU) start pumping fuel from its container with the Data Taker indicating 227 mL of fuel pumped out. Next, they cleaned up the collected dirt from the vapor suction fan and the chiller surfaces and tested their functionality by switching 'ON' the inverter located within the cab. The BNSF electrician who was present near the main switch board found the switchgear fittings were loose and tightened them prior to switching 'ON' the inverter. For some unknown reason, at powering 'ON', the inverter got instantly burnt. QNA team tried to locate a replacement inverter at Glendive, but in vain. Just to ascertain if the fan and the chiller got adversely affected during the inverter burning process, they isolated them from the inverter and then powered them separately from a different source to check their functionality. Figure 28 shows the power cables drawn from a different source to the chiller unit for its functional test. Fortunately, both the fan and the chiller were found to be fully functional. They installed an additional waterproof plastic cover to protect the electronics box against a power wash hazard in the absence of QNA team.

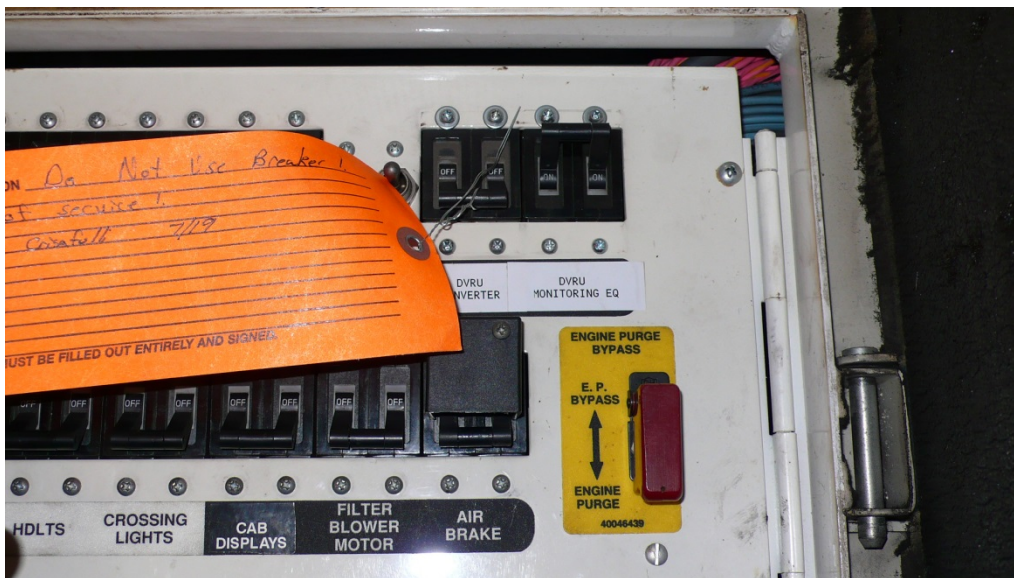
Figure 29. Switchboard display of placard not to switch on the inverter

In the absence of a replacement inverter, a warning placard was placed on the switch board not to attempt switching 'ON', while the switches for the DVRU equipment monitoring were left 'ON', as shown in Figure 29. Prior to departing the BNSF yard at Glendive, Montana, QNA team was informed that they will be contacted again with the schedule for the replacement of the inverter.

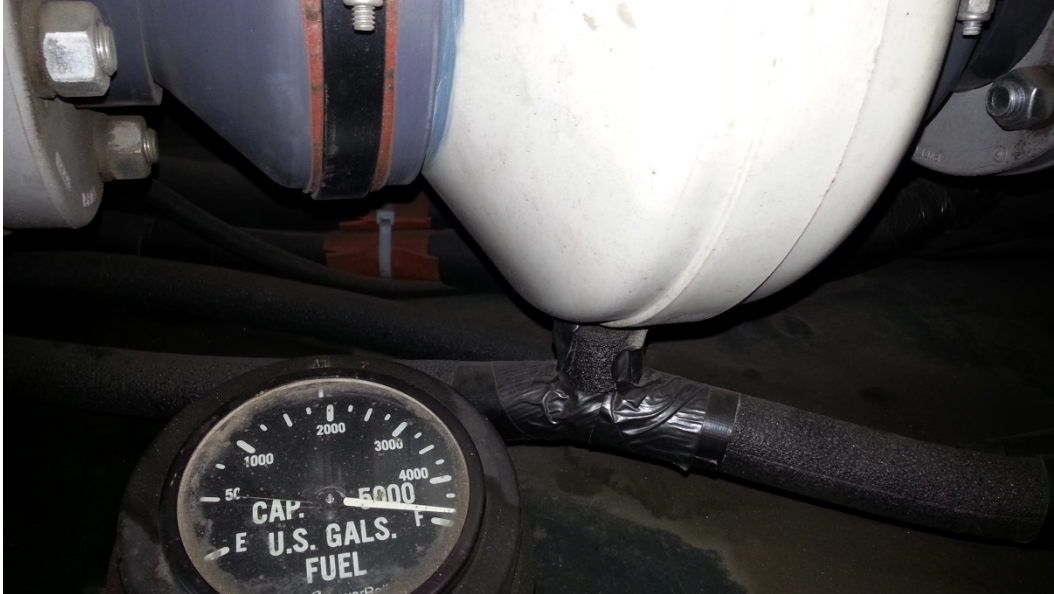
It is observed from Figure 33 that the vapor inlet and outlet temperatures, as well as the fuel temperature variations with time, show nearly identical trend as that of the ambient temperature. The FAR variation data show a nominal value of around 10 to 20 percent LEL for low speed operation of the locomotive. There is a sharp rise in FAR value to about 45 percent LEL, which is accompanied by a drop in ambient temperature from 62 to 32 °F and the fuel temperature dropped from 73 to 45 °F. Since FAR magnitude normally does not rise without rise in fuel temperature, this is suggestive of a refueling of the tank including an over-fill that could force some fuel into the tubing of MSA vapor sampling pump. The tank overfill may be substantiated by the fact that the QNA team found the tank fuel gage reading close to tank full (F) mark, as shown in Figure 34; although it is common practice of the railroads not to refuel a tank above 4,500 gallons to allow vapor space and venting.

Figure 34. Locomotive # 9674 tank fuel gage showing a nearly full tank

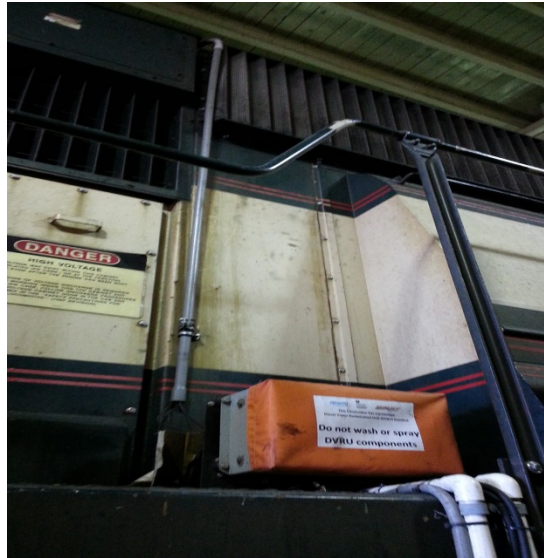
Figure 35. Waterproof cover reinstalled over the electronics control box

The resumed data plots to the right of Figure 33 show almost identical variation of the vapor outlet temperature with that of ambient. However, the fuel temperature and the FAR show very small variations at around 10 percent LEL, which are indicative of the locomotive’s low speed operation or idling in the yard. When the QNA team arrived at Glendive in the afternoon, they found BNSF9674 idling in the yard. They also found the electronics control box undisturbed with its additional waterproof cover intact with instructions on it. After the data download, they again shut the electronics control box and reinstalled the additional waterproof cover over it as shown in Figure 35.
