# EFFECTIVENESS OF ASPHALT PENETRATING SEALERS IN EXTENDING NEW ASPHALT PAVEMENT LIFE

The Office of Pavement Engineering  
Ohio Department of Transportation

January 2017

1. Report No. FHWA/OH-2017/3	2. Government Accession No.	3. Recipient's Catalog No.	
4. Title and Subtitle Effectiveness of Asphalt Penetrating Sealers in Extending New Asphalt Pavement Life		5. Report Date January 2017

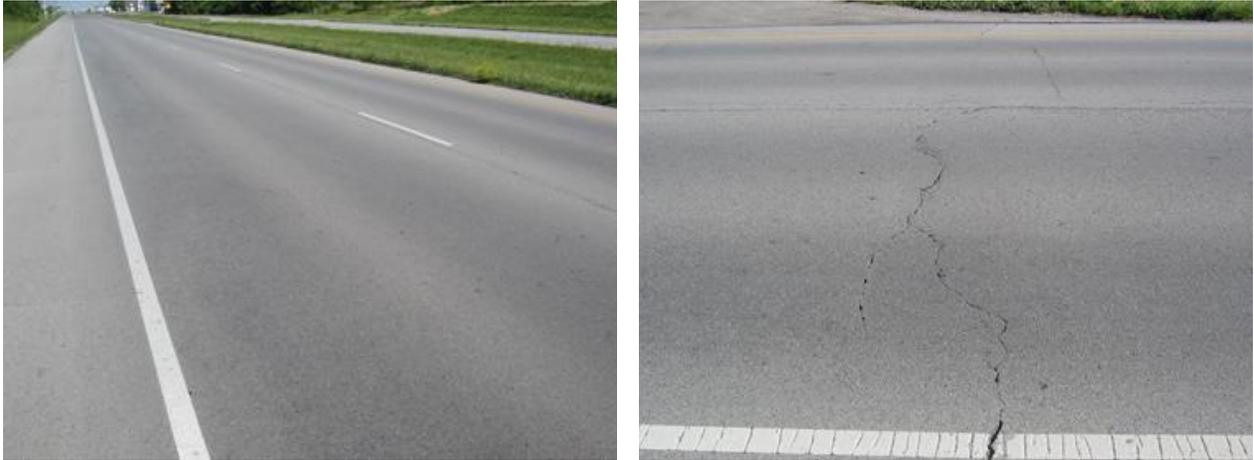
**Figure 25. Project US-40, Springfield, Eastbound Lane: Photograph showing Typical Cracking Distress along Control Test Section, Summer of 2016**

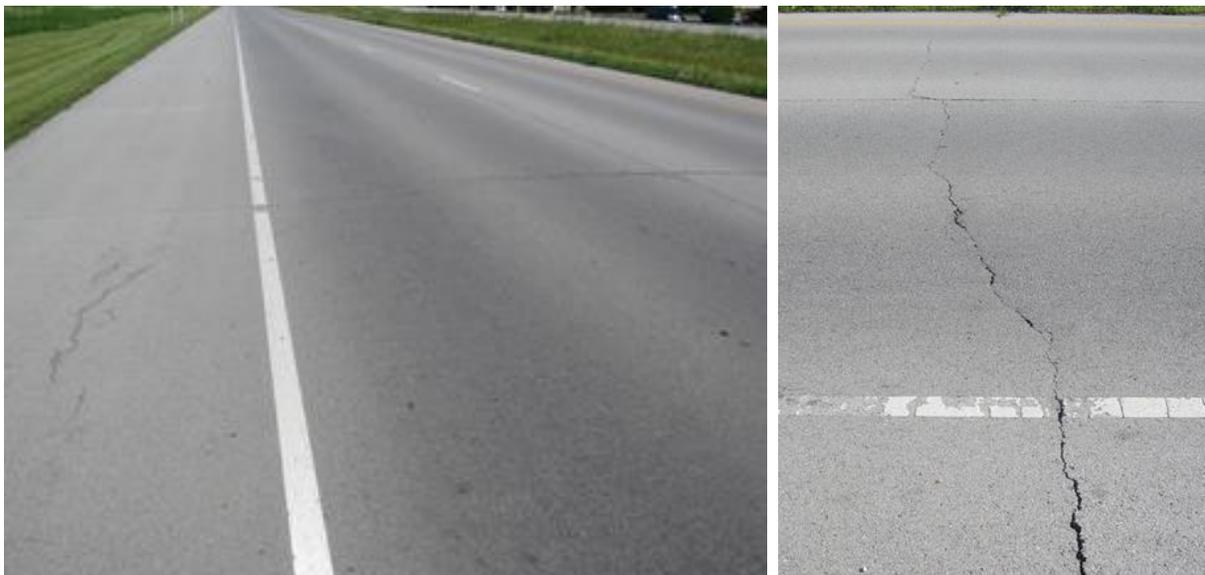
**Figure 26. Project US-40. Springfield, Eastbound Lane: Photograph showing Typical Cracking Distress along Replay Test Section, Summer of 2016**

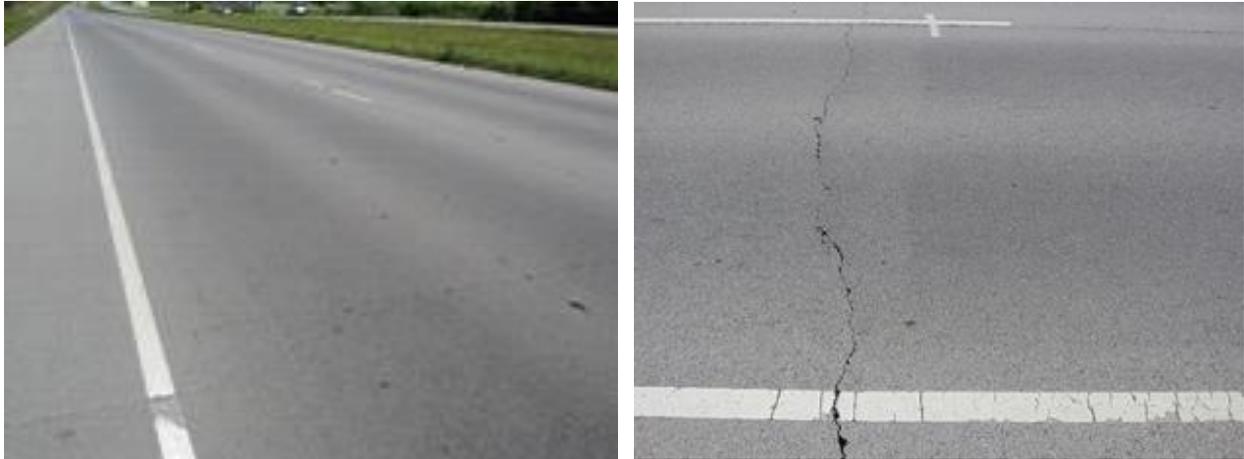
**Figure 27. Project US-40, Springfield, Eastbound Lane: Photograph showing Typical Cracking Distress along Reclamite Test Section, Summer of 2016**

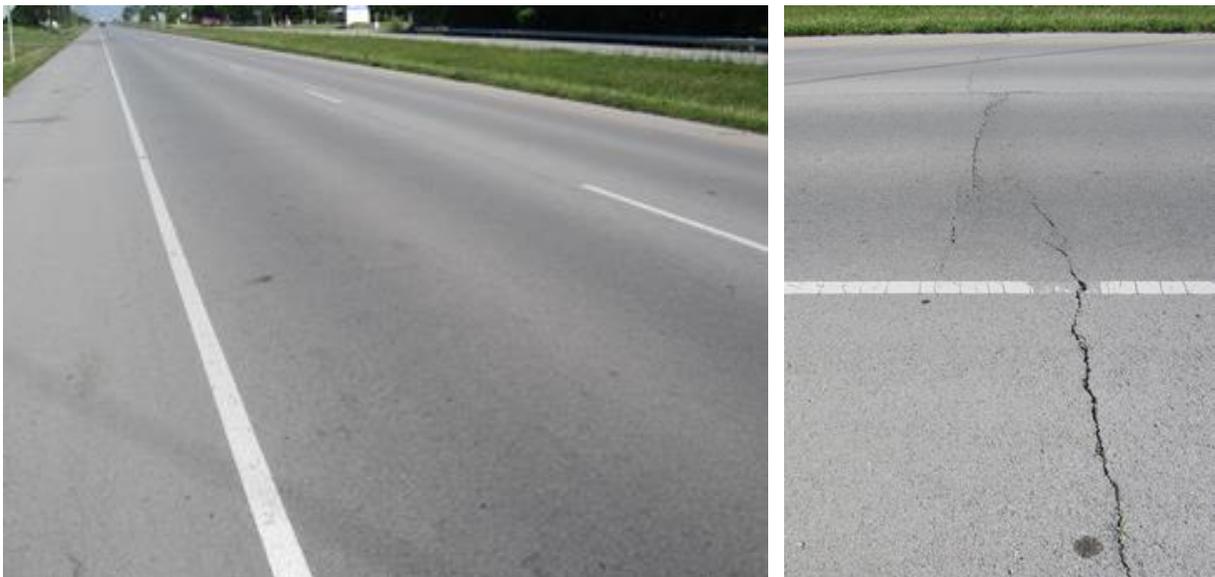
**Figure 28. Project US-40, Springfield, Eastbound Lane: Photograph showing Typical Cracking Distress along Biorestor Test Section, Summer of 2016**

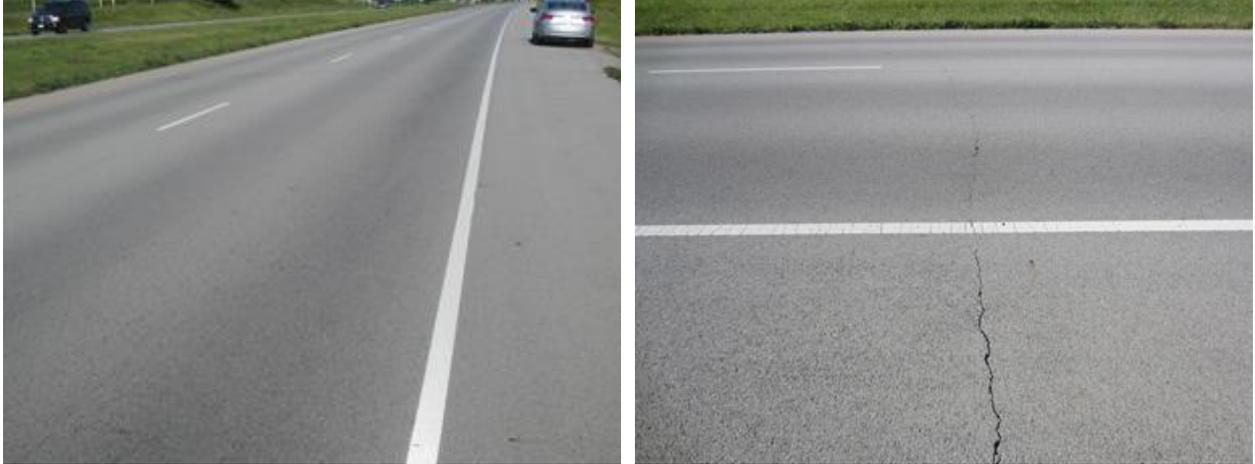
**Figure 29. Project US-40, Springfield, Westbound Lane: Photograph showing Typical Cracking Distress along Control Test Section, Summer of 2016**

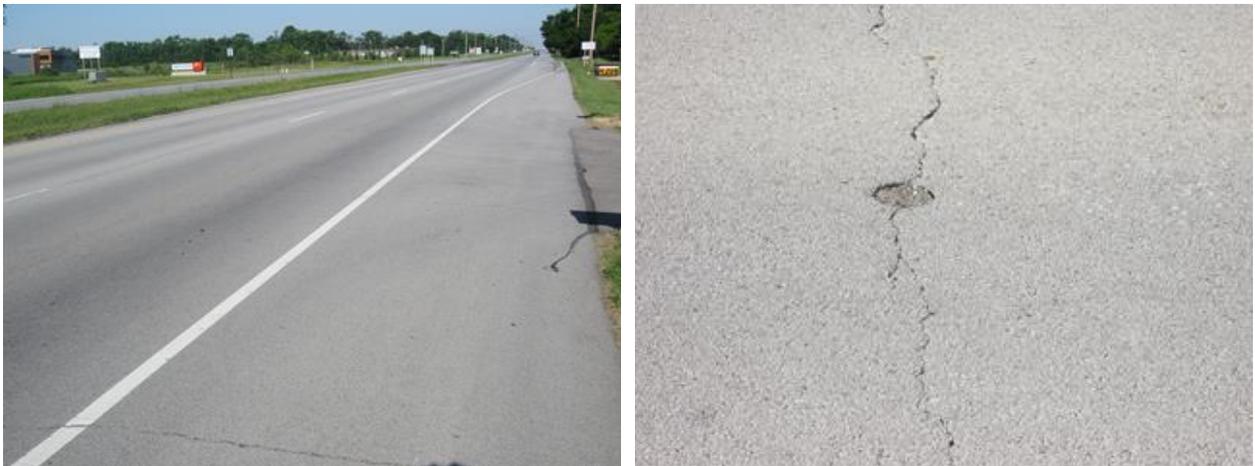
**Figure 30. Project US-40, Springfield, Westbound Lane: Photograph showing Typical Cracking Distress along Replay Test Section, Summer of 2016**

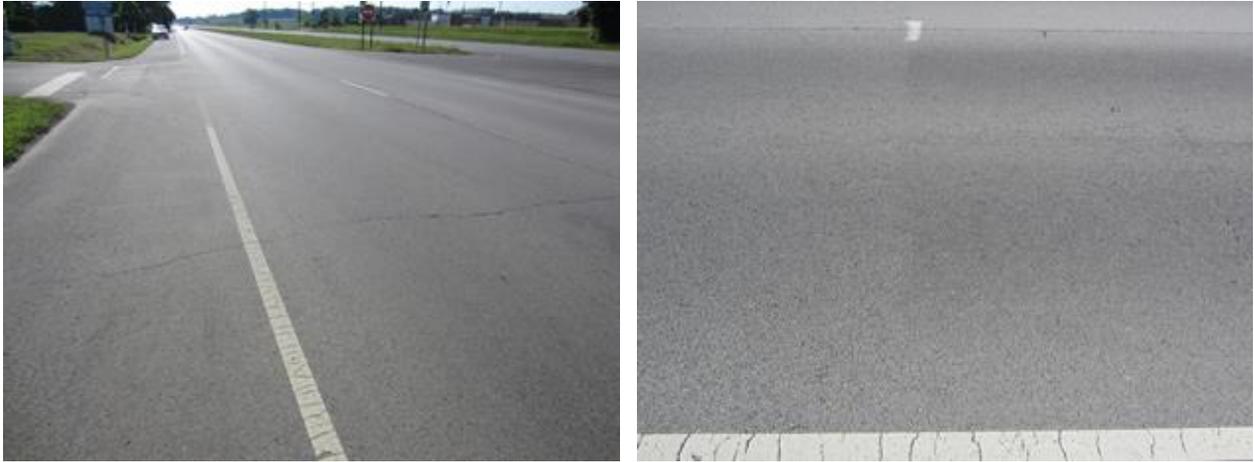
**Figure 31. Project US-40, Springfield, Westbound Lane: Photograph showing Typical Cracking Distress along Reclamite Test Section, Summer of 2016**

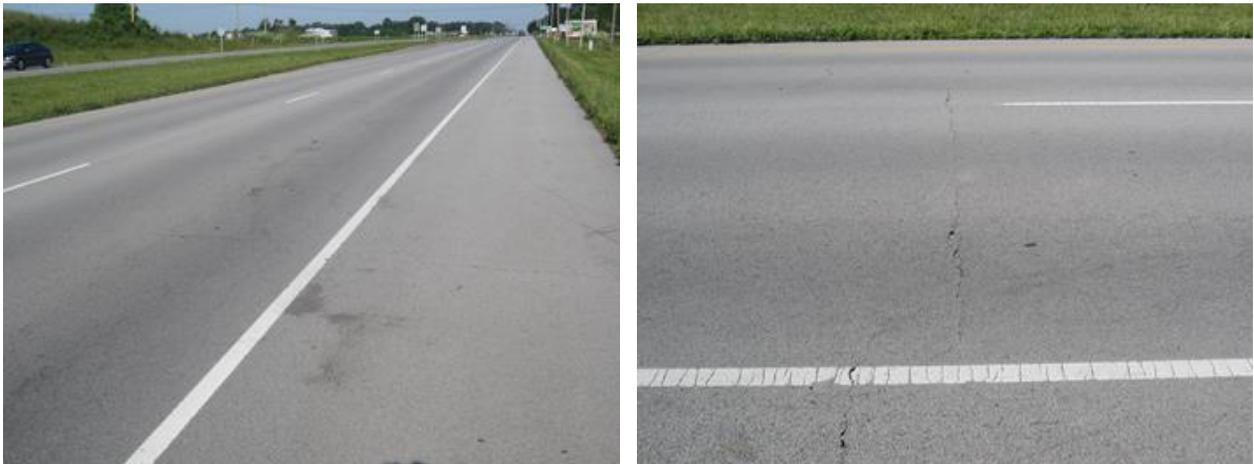
**Figure 32. Project US-40, Springfield, Westbound Lane: Photograph showing Typical Cracking Distress along Biorestor Test Section, Summer of 2016**

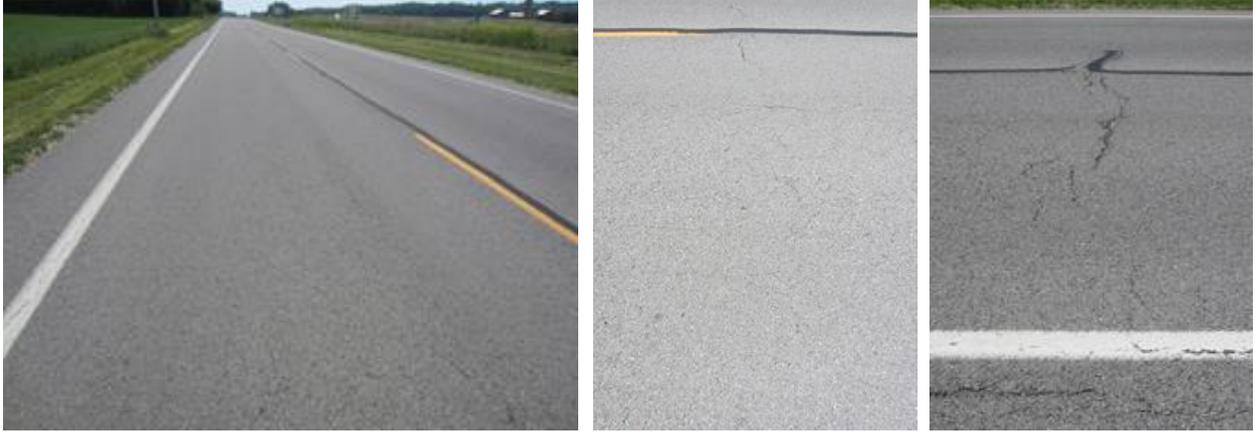
**Figure 35. Project SR-292/A, East Liberty: Photograph showing Typical Cracking Distress along Control Test Section, Summer of 2016**

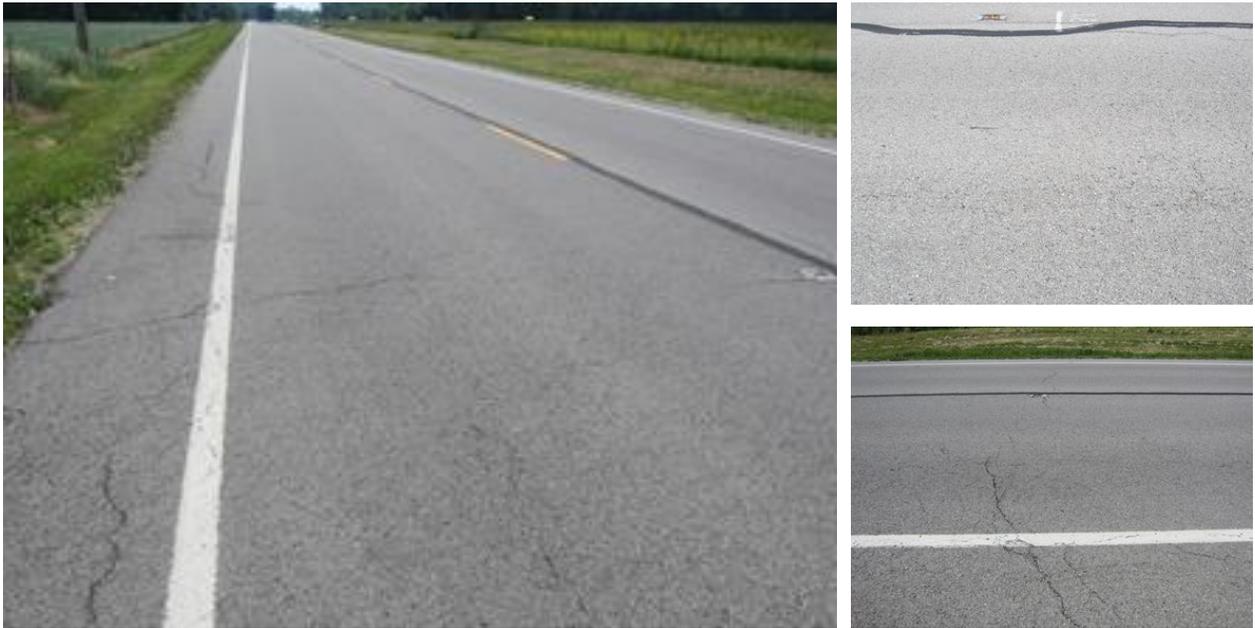
**Figure 36. Project SR-292/A, East Liberty: Photograph showing Typical Cracking Distress along Replay Test Section, Summer of 2016**

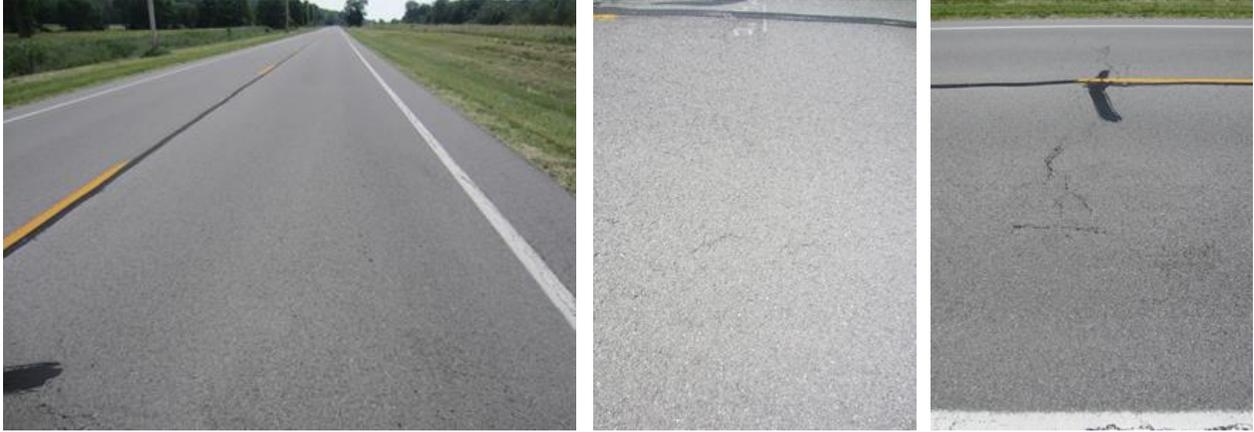
**Figure 37. Project SR-292/A, East Liberty: Photograph showing Typical Cracking Distress along Reclamite Test Section, Summer of 2016**

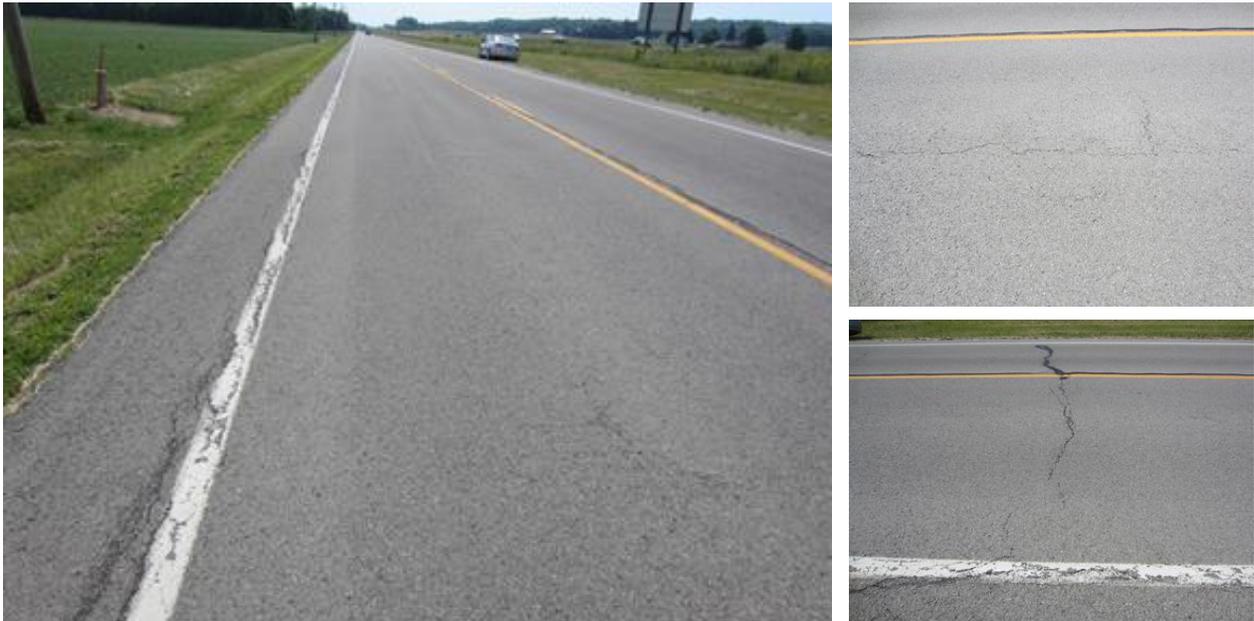
**Figure 38. Project SR-292/A: Photograph showing Typical Cracking Distress along Biorestor Test Section, Summer of 2016**

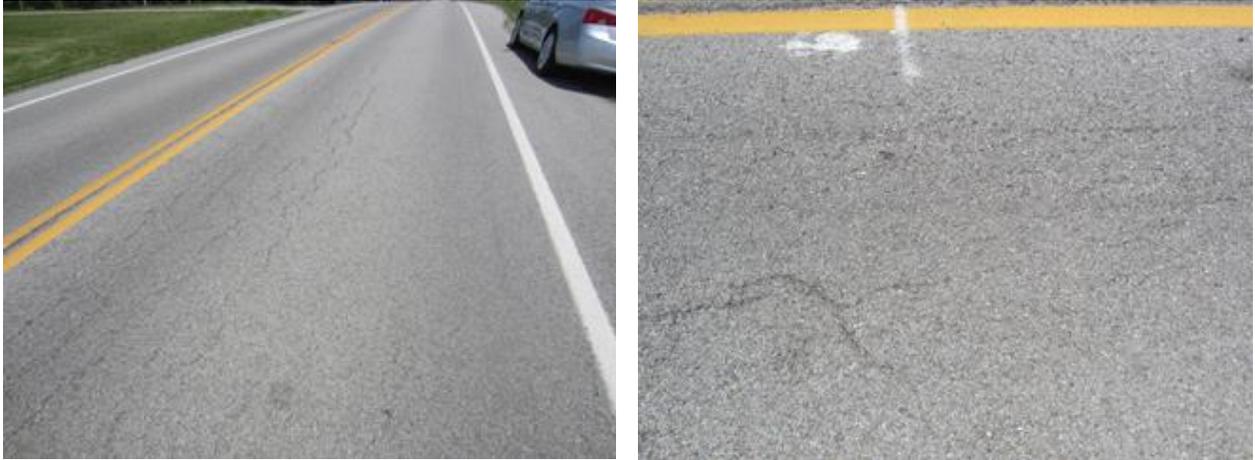
**Figure 42. Project SR-292/B, East Liberty: Photograph showing Typical Cracking Distress along Control Test Section, Summer of 2016**

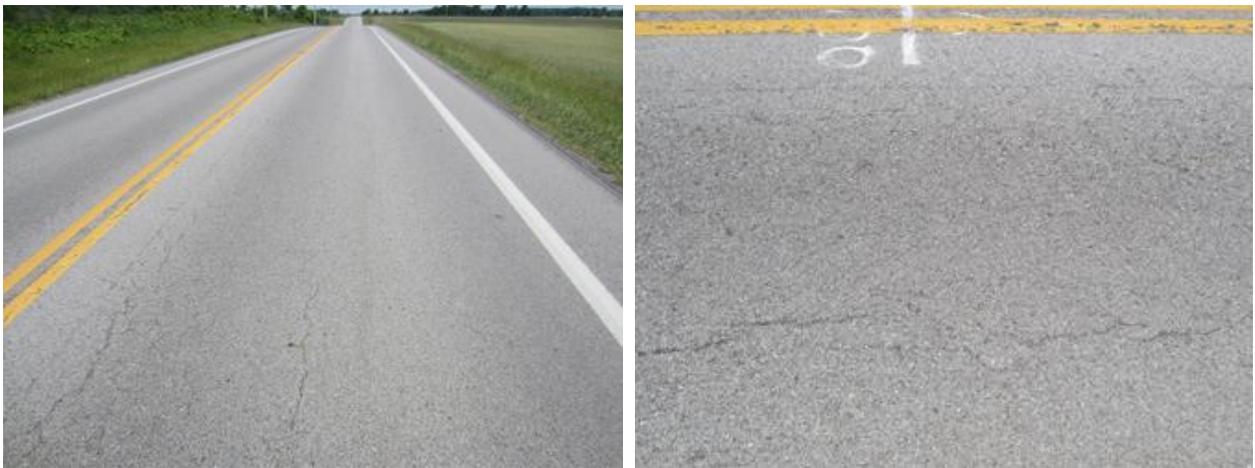
**Figure 43. Project SR-292/B, East Liberty: Photograph showing Typical Cracking Distress along Replay Test Section, Summer of 2016**

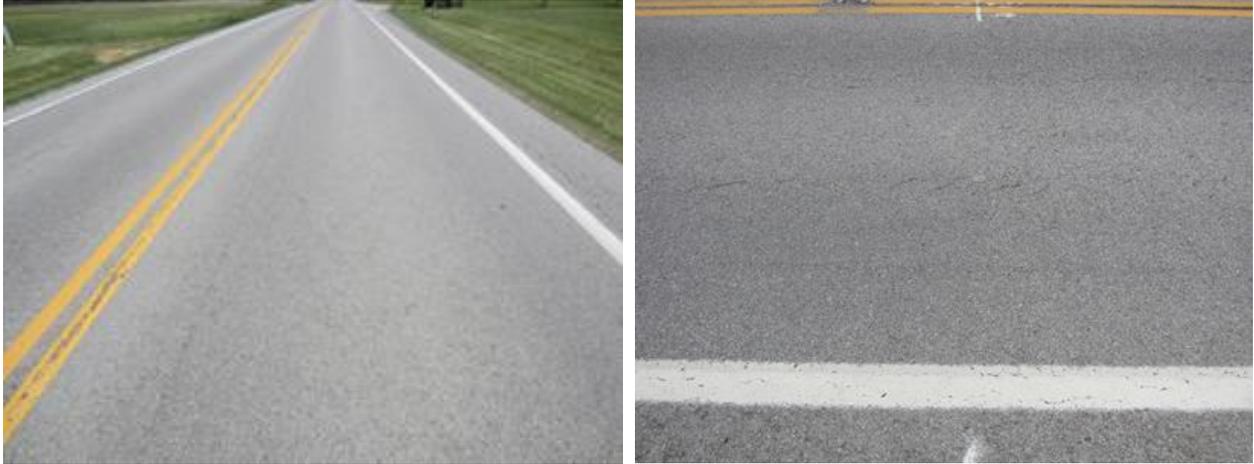
**Figure 44. Project SR-292/B, East Liberty: Photograph showing Typical Cracking Distress along Reclamite Test Section, Summer of 2016**

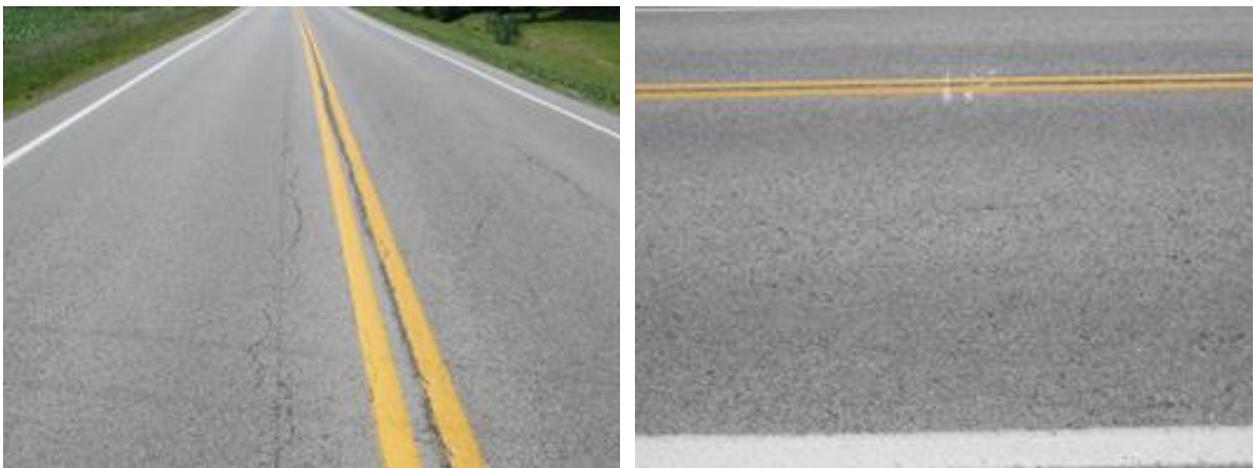
**Figure 45. Project SR-292/B, East Liberty: Photograph showing Typical Cracking Distress along Bioresator Test Section, Summer of 2016**

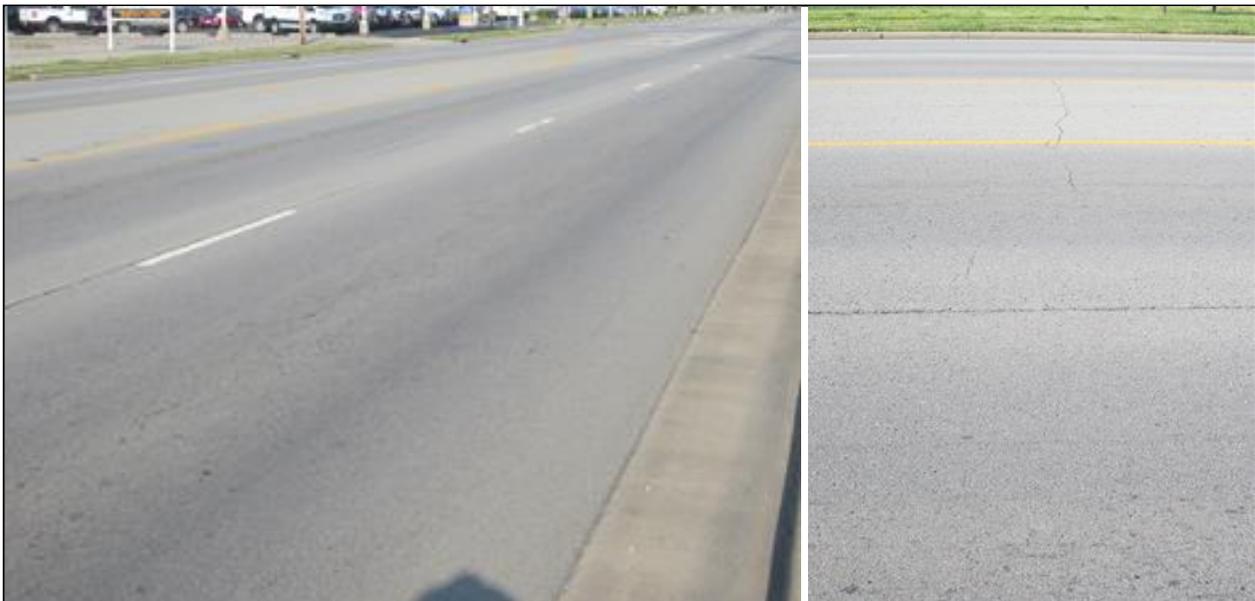
**Figure 49. Project SR-47, Sydney, Westbound Lane: Photograph showing Typical Cracking Distress along Control Test Section, Summer of 2016**

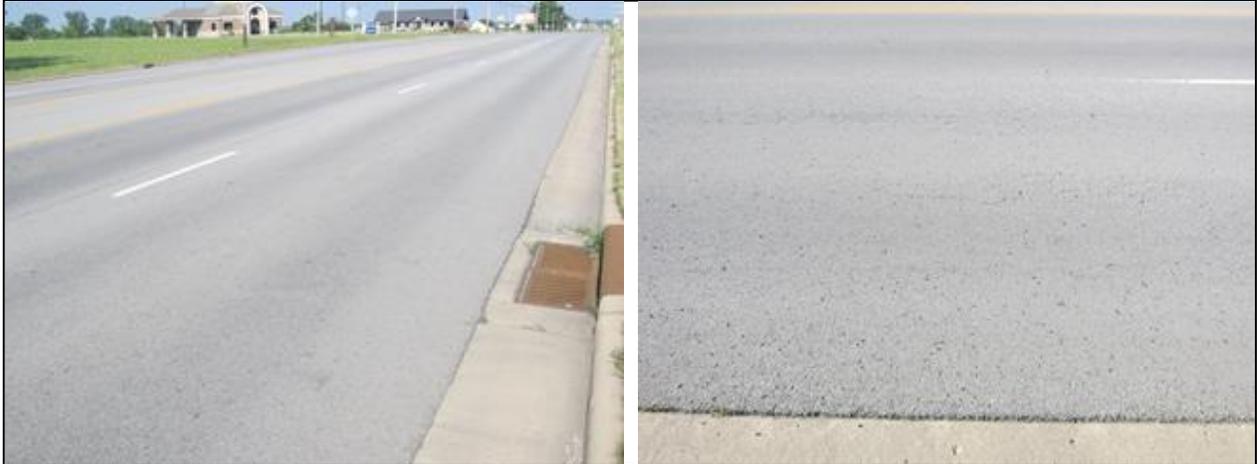
**Figure 50. Project SR-47, Sydney, Westbound Lane: Photograph showing Typical Cracking Distress along Replay Test Section, Summer of 2016**

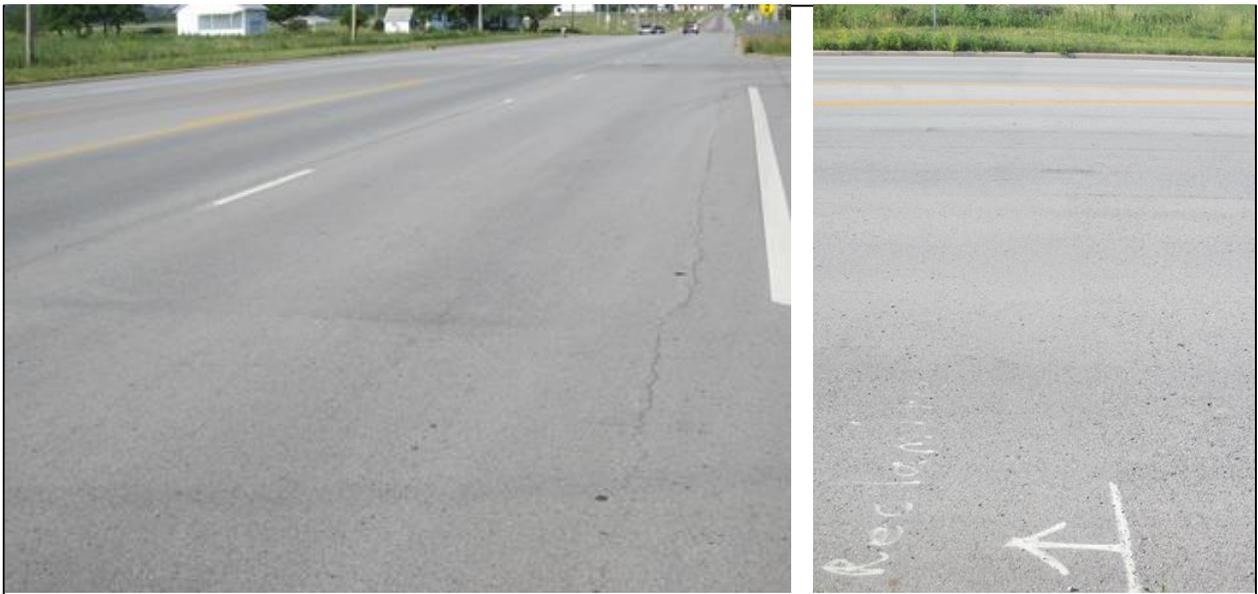
**Figure 51. Project SR-47, Westbound Lane: Photograph showing Typical Cracking Distress along Reclamite Test Section, Summer of 2016**

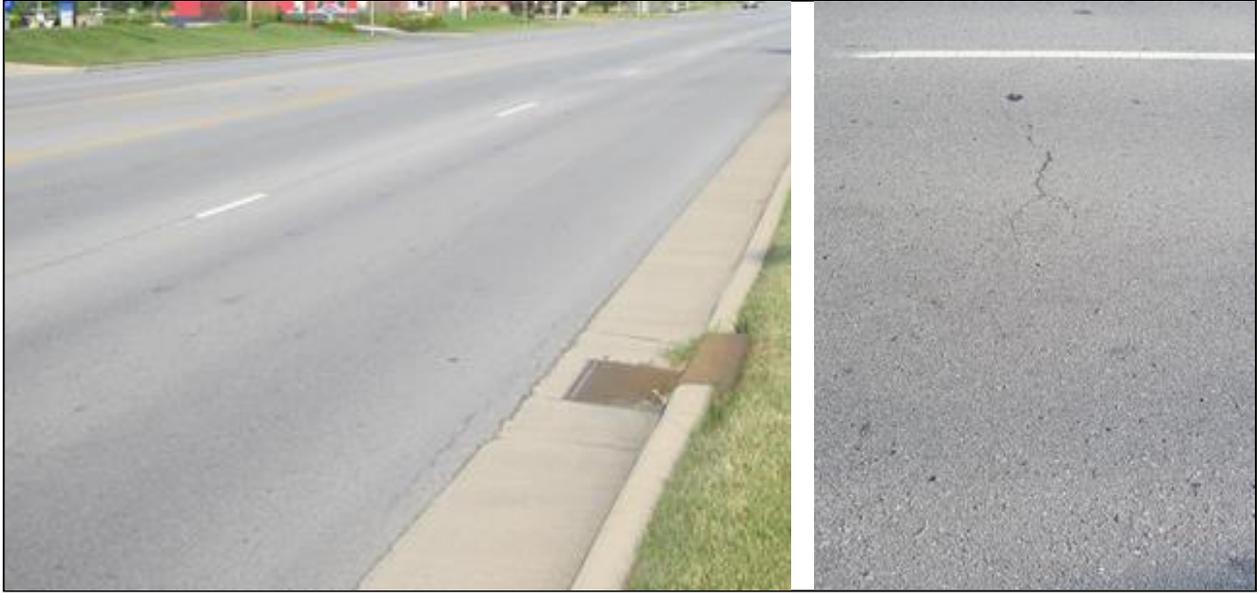
**Figure 52. Project SR-47, Sydney, Westbound Lane: Photograph showing Typical Cracking Distress along Biorestor Test Section, Summer of 2016**

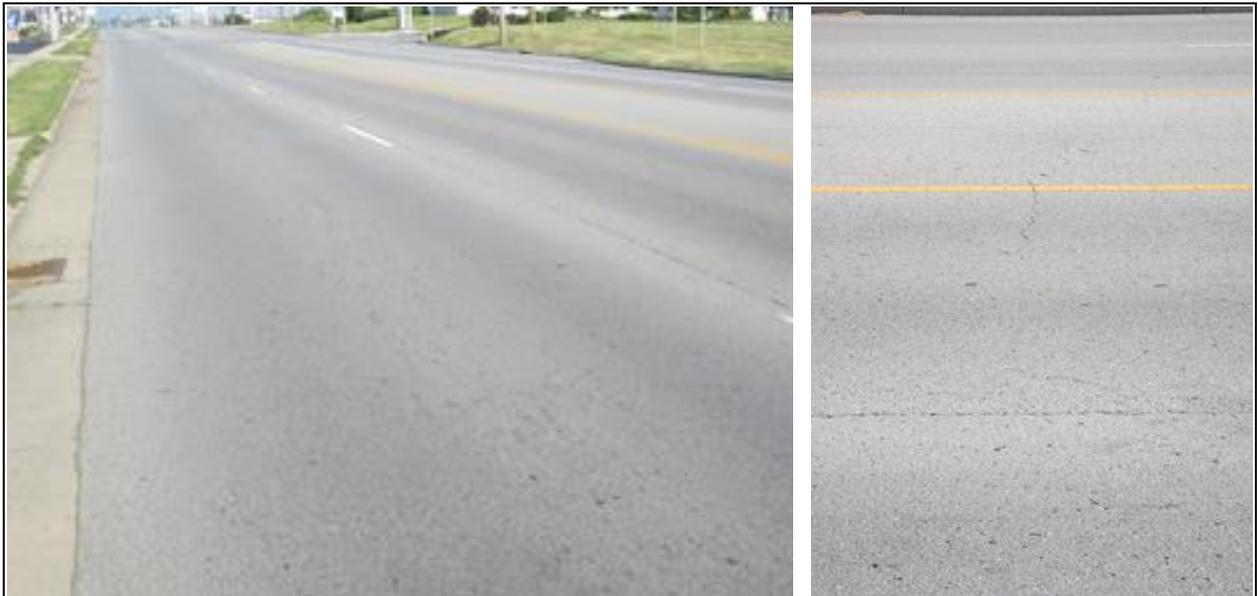
**Figure 53. Project SR-47, Sydney, Eastbound Lane: Photograph showing Typical Cracking Distress along Control Test Section, Summer of 2016**

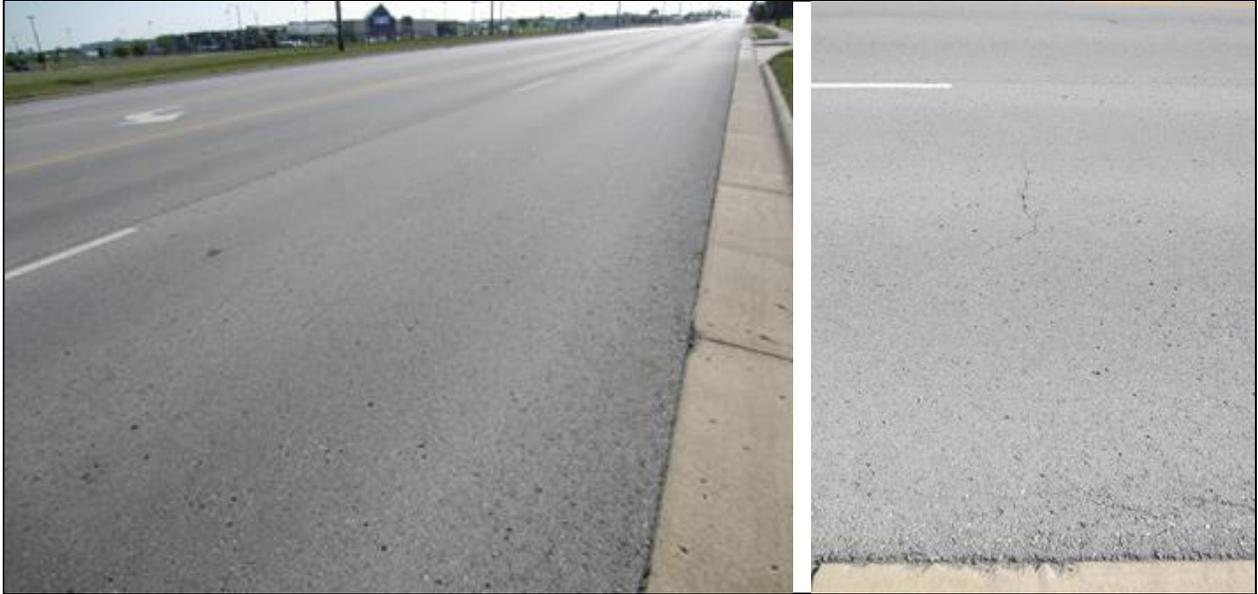
**Figure 54. Project SR-47, Sydney, Eastbound Lane: Photograph showing Typical Cracking Distress along Replay Test Section, Summer of 2016**

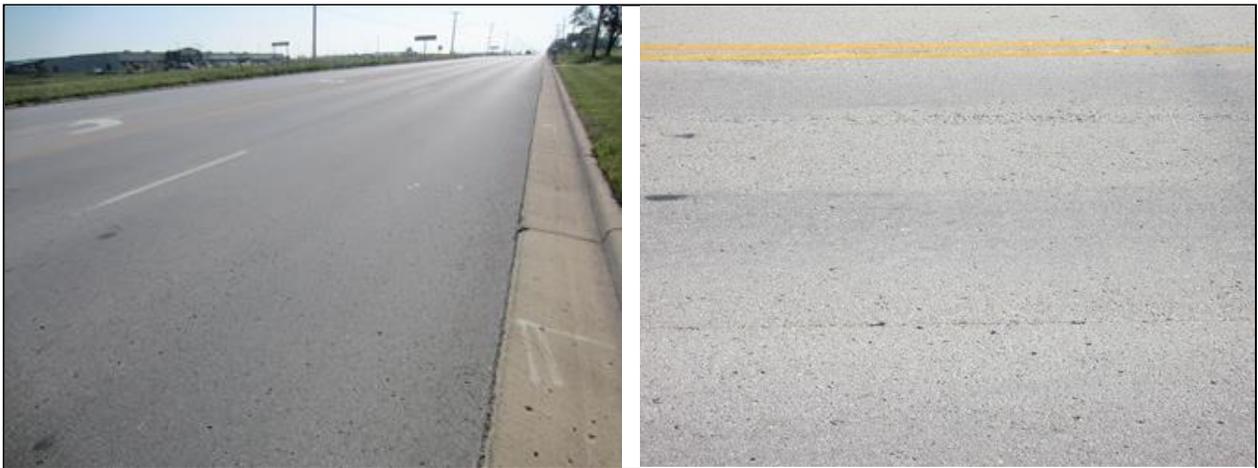
**Figure 55. Project SR-47, Eastbound Lane: Photograph showing Typical Cracking Distress along Reclamite Test Section, Summer of 2016**

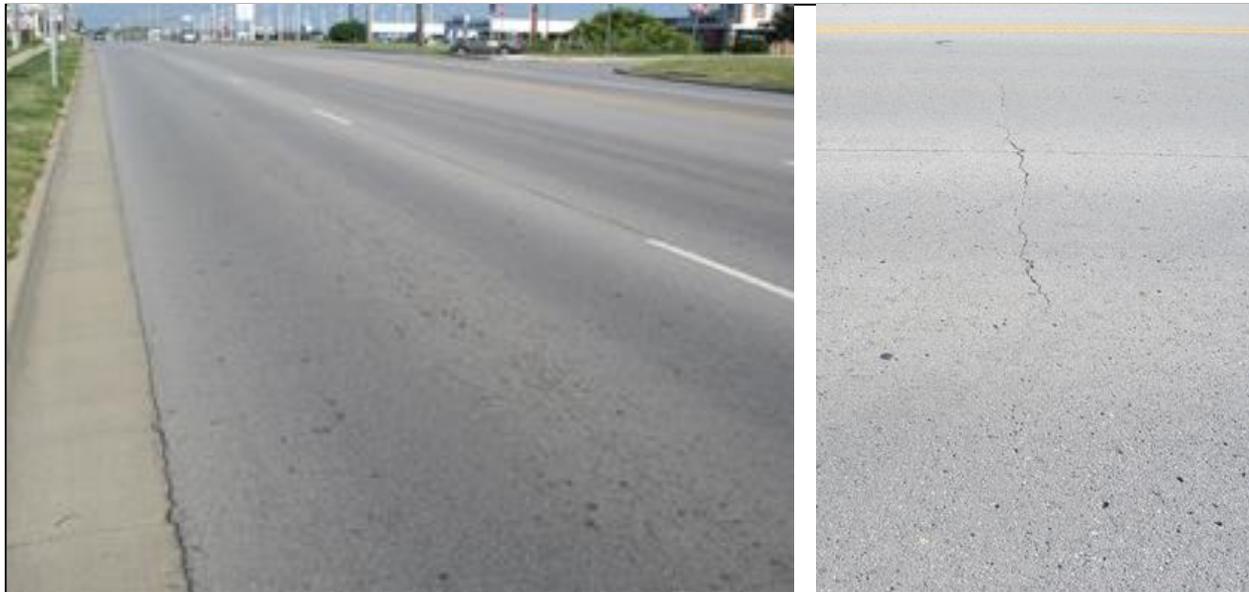
**Figure 56. Project SR-47, Sydney, Eastbound Lane: Photograph showing Typical Cracking Distress along Biorestor Test Section, Summer of 2016**

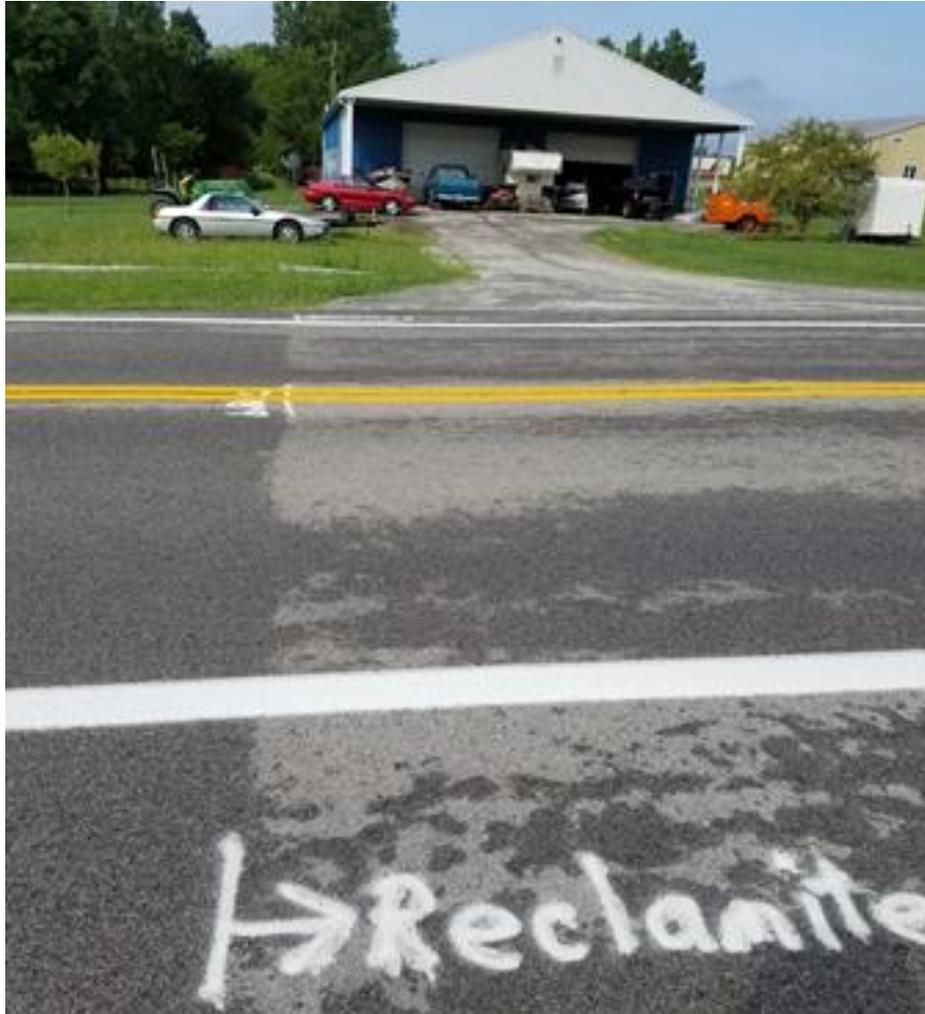
**Figure 84. Surface of Reclamite Test Section of the SR 292/B Project Shortly after Rain in Comparison to the Untreated Surface (Control Section)**

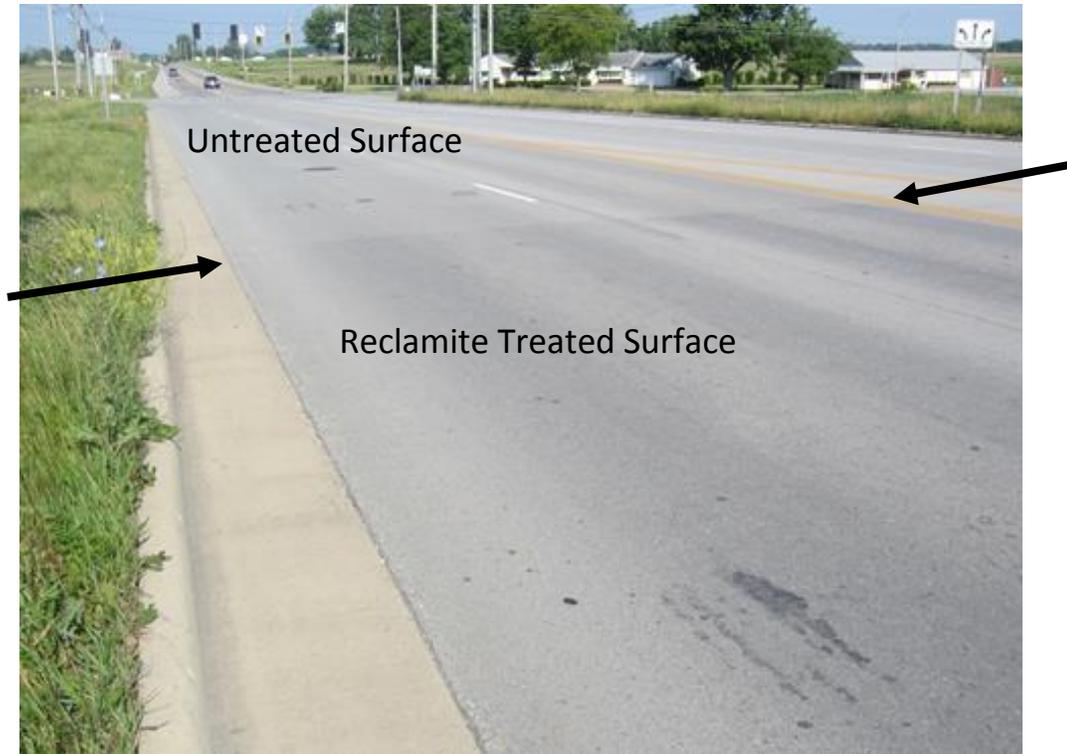
**Figure 85. Transition between the Untreated and Reclamite Section Showing the Difference in Color of the Surface for the SR 47 Project; Photograph taken in 2016**

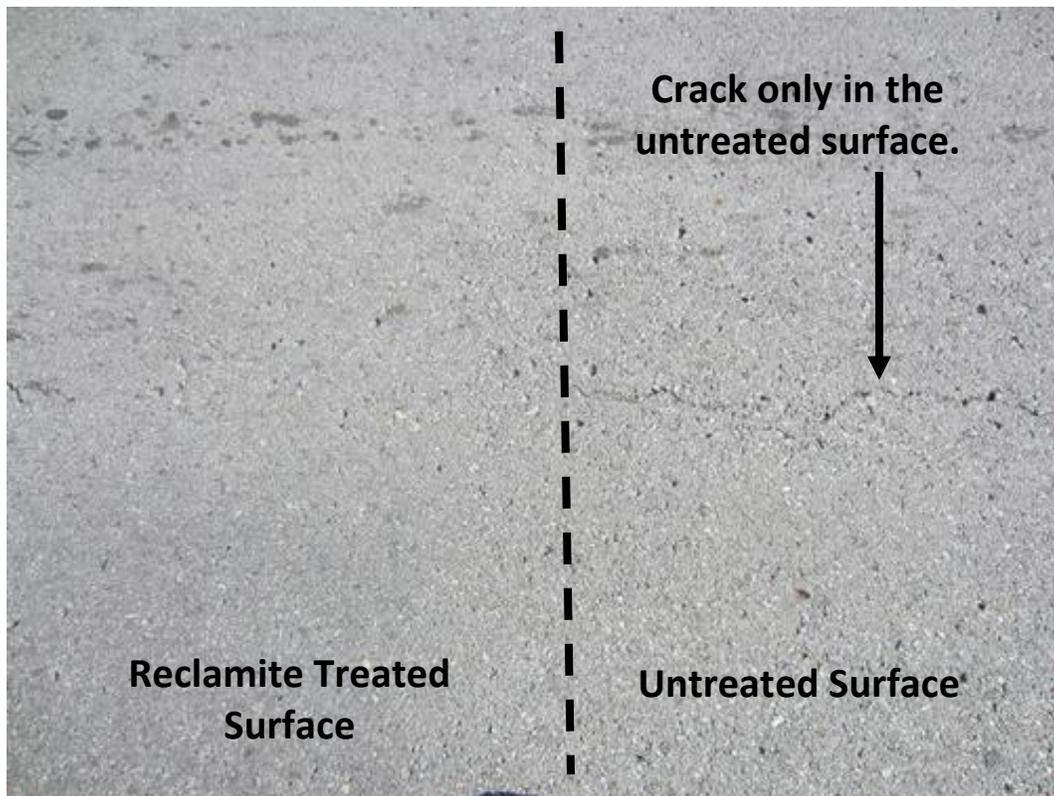
**Figure 86. Crack Visible in the Untreated Surface and not Visible in the Reclamite Treated Surface of SR 47 Project**
