# Evaluation of Partial Depth Pavement Repairs on Routes Heavily Traveled by Amish Horse and Buggies

*Prepared for:*  
The Ohio Department of Transportation,  
Office of Statewide Planning & Research

State Job Number 135316

*Final Report*

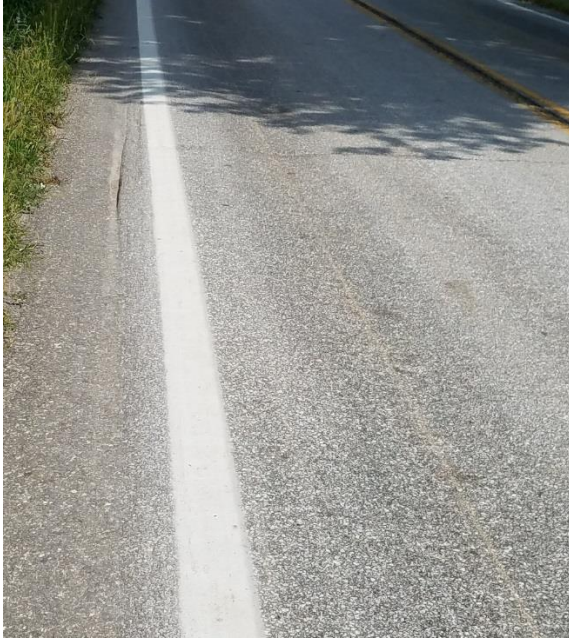
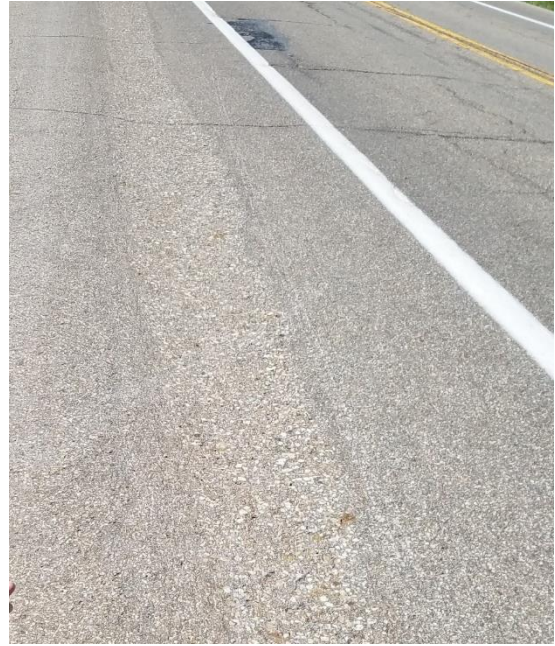
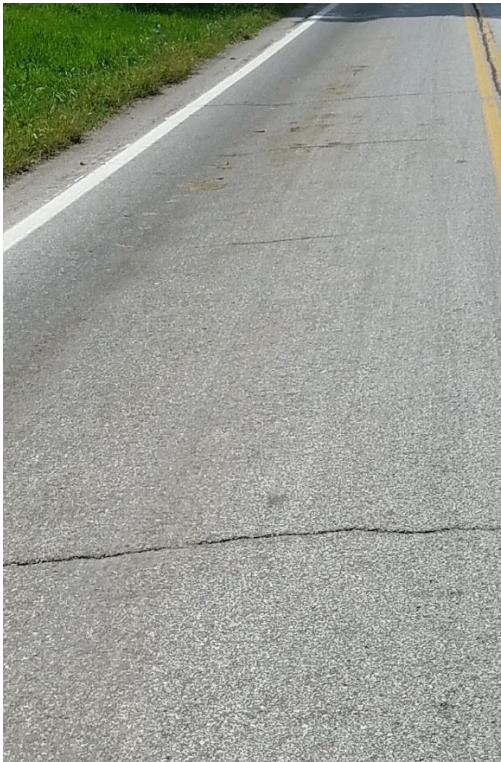
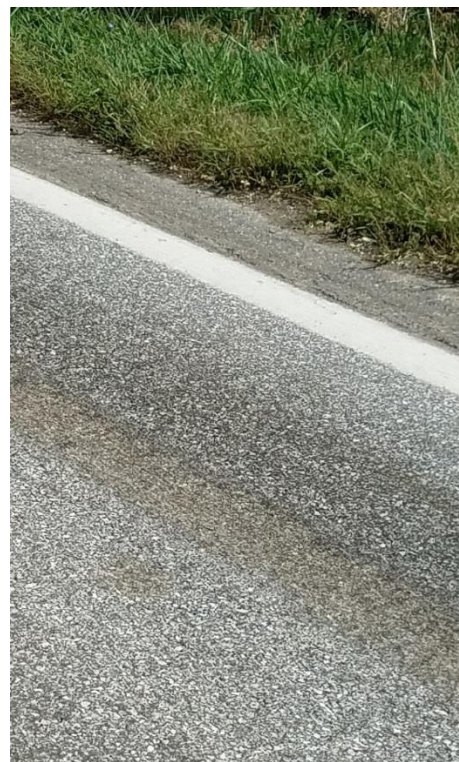
- The main distress in repairs on Amish buggy routes was rutting of the surface layer(s). Some of the aggregates in surface mixes within the top 2.5 inches were cracked, which resulted from the high stress intensity due to the Amish buggy traffic.

Figure C.1 Pictures of Damage in partial depth repair on Amish Buggy Routes

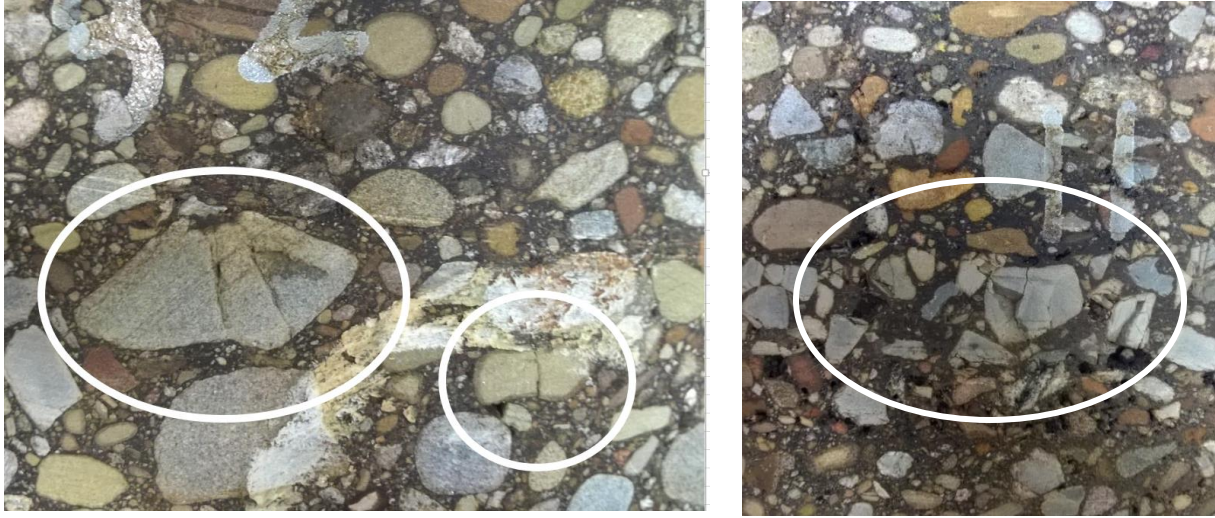
Analysis of repair cycles for routes with or without buggy traffic was performed. This analysis included examining full depth core samples that were obtained from different locations of repaired roadways with heavy Amish buggy traffic to determine the cause of the rutting problem in these roadways. Stress Analysis was also conducted using KENLAYER software to determine the distribution of stresses that develop within the pavement structure due to Amish buggy traffic.

Figure C.2 Pictures of Cores Obtained from the Repairs on Amish Buggy Routes

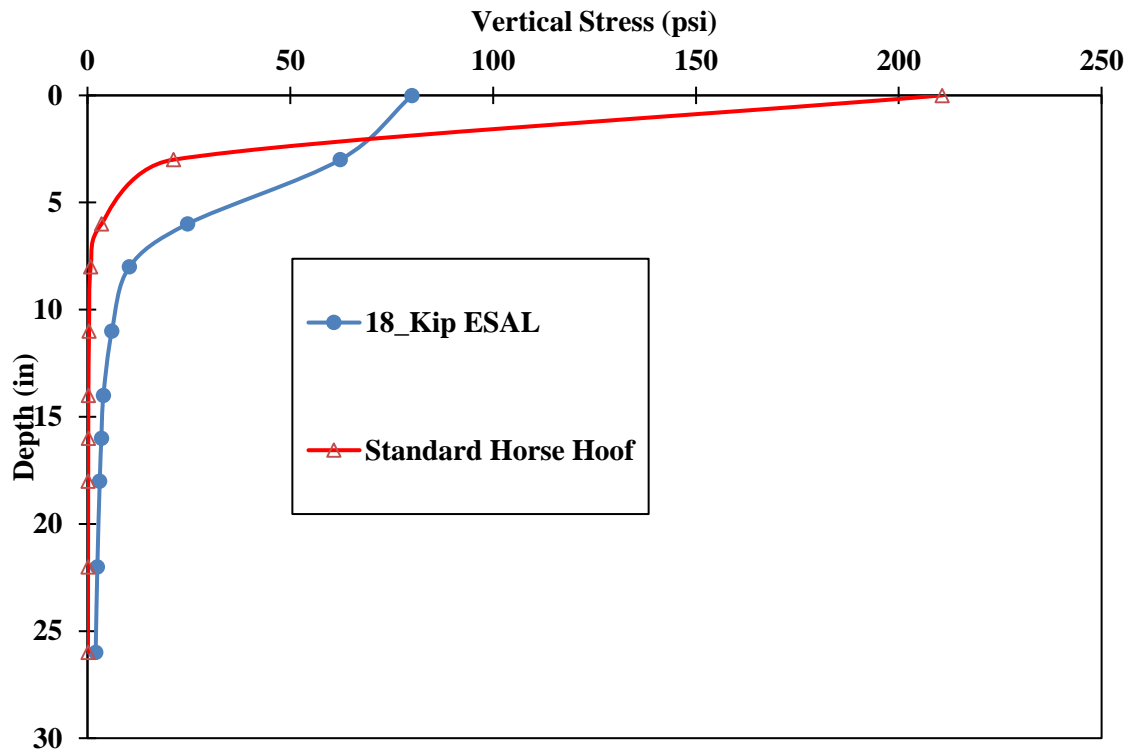
Figure C.3 Vertical Stress Distribution
