## **MASH TL-4 EVALUATION OF THE TXDOT TYPE C2P BRIDGE RAIL**

### **Test Report 9-1002-15-2 Rev.1**

**TEXAS A&M TRANSPORTATION INSTITUTE  
COLLEGE STATION, TEXAS**

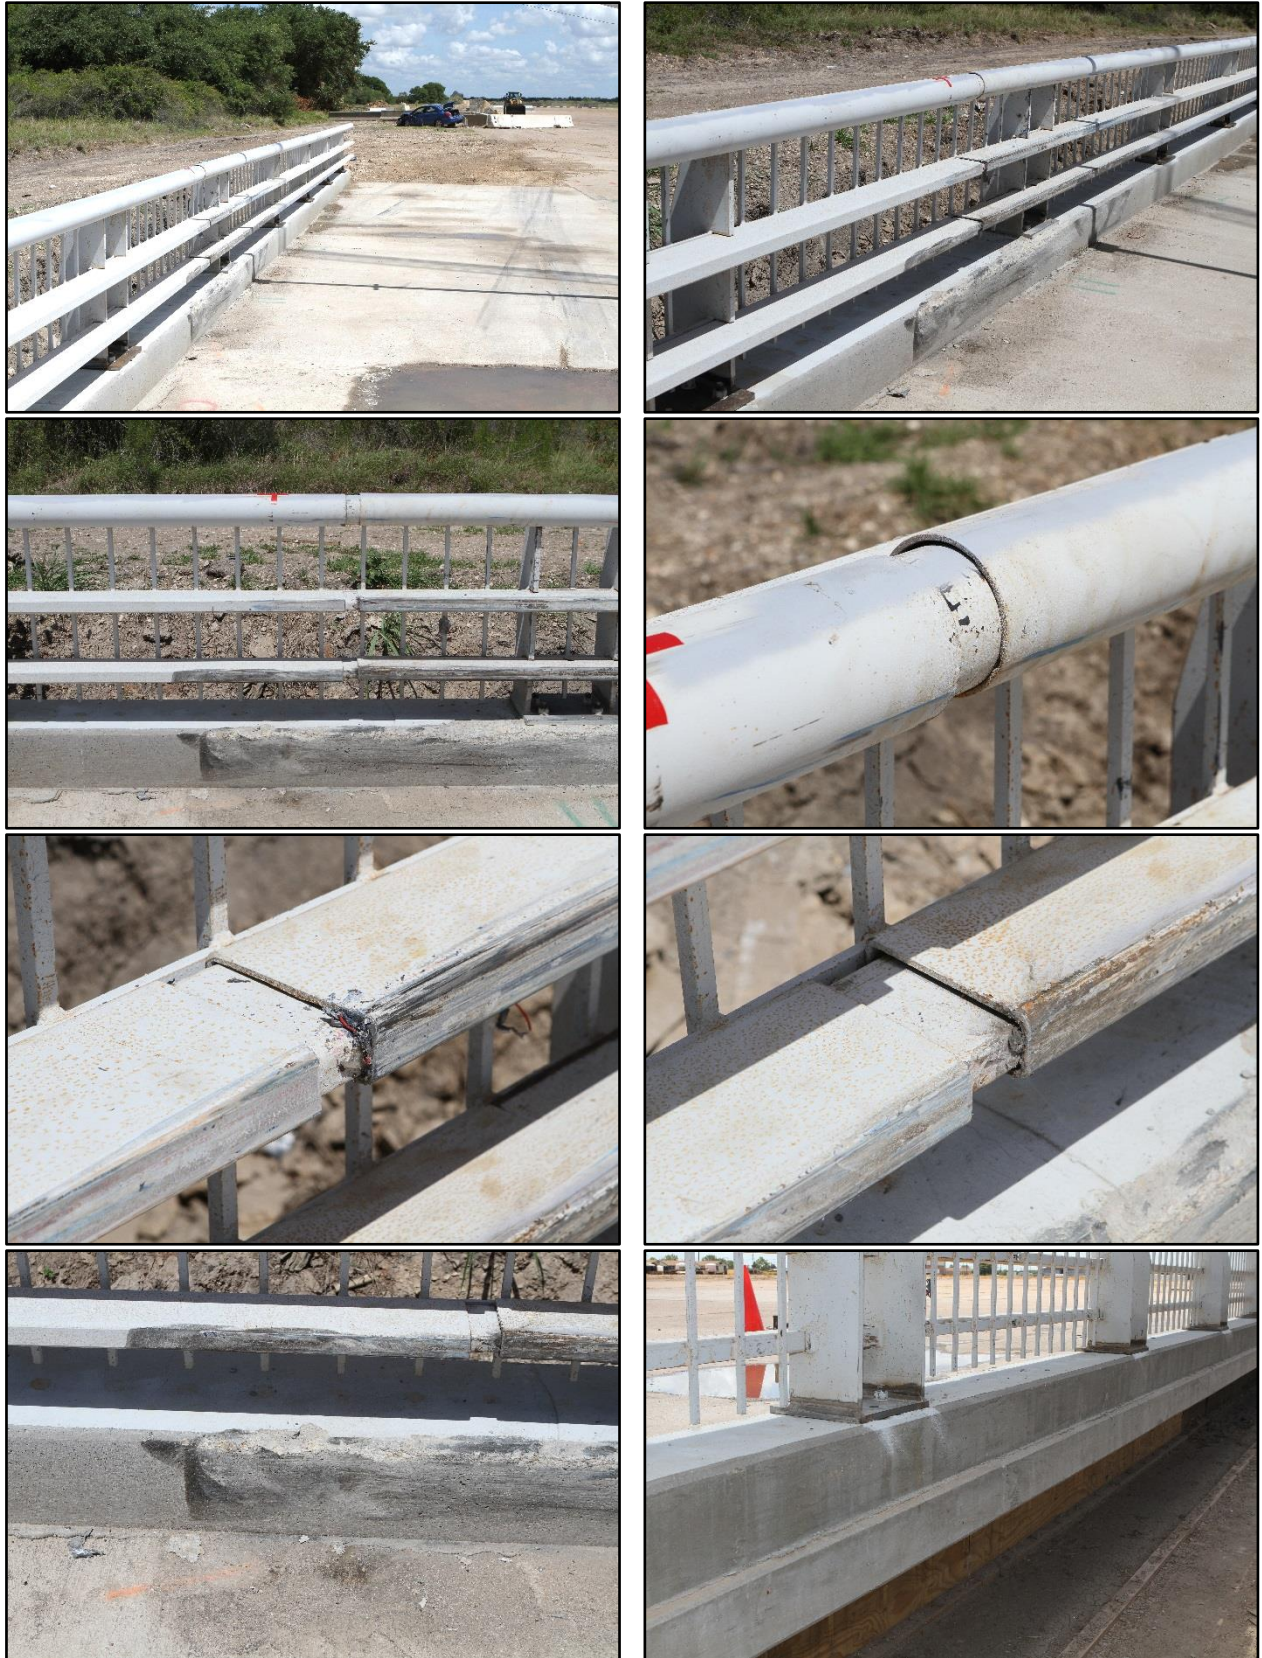
**Figure 5-3. TxDOT Type C2P Bridge Rail after Test No. 490026-4-1.**

Figure 5-3 shows the damage to the TxDOT Type C2P Bridge Rail. The traffic face of the bridge rail was marred and scuffed, as was the traffic face and top of the curb. Working width was 14.0 inches. Maximum dynamic deflection during the test was 0.8 inch, and there was no notable maximum permanent deformation after the test.

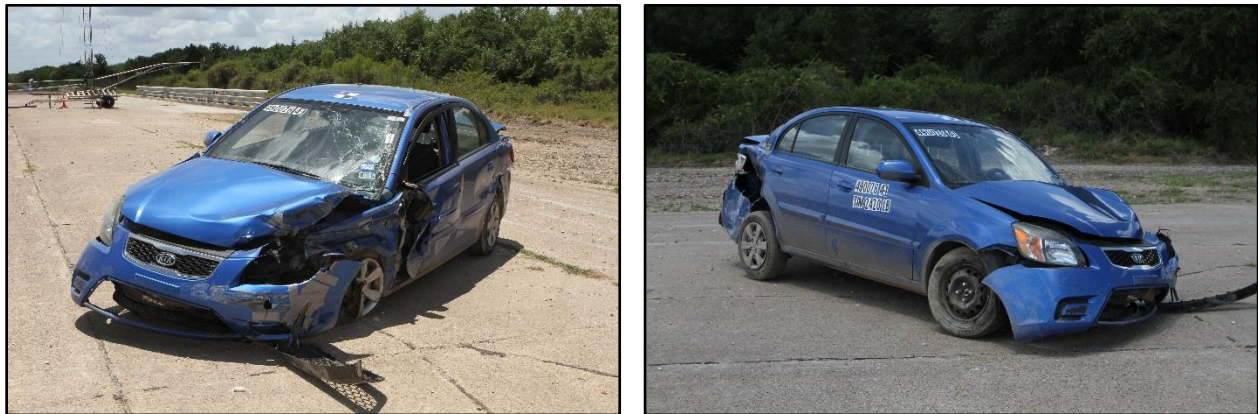
**Figure 5-4. Test Vehicle after Test No. 490026-4-1.**

Figure 5-4 shows the damage sustained by the vehicle. The front bumper, hood, left front tire and rim, left front strut and tower, left front fender, left front door and window glass, left rear door, left rear quarter panel, and rear bumper were damaged. The windshield was cracked in the left lower corner, and cracks radiated upward and toward the center, and deformation of the windshield was significantly less than 3 inches. Maximum exterior crush to the vehicle was 13.0 inches in the side plane at the left front corner at bumper height. Maximum occupant compartment deformation was 4.0 inches in the left front firewall area near the toe pan. Figure 5-5 shows the interior of the vehicle. Tables C-2 and C-3 in Appendix D1 provide exterior crush and occupant compartment measurements.

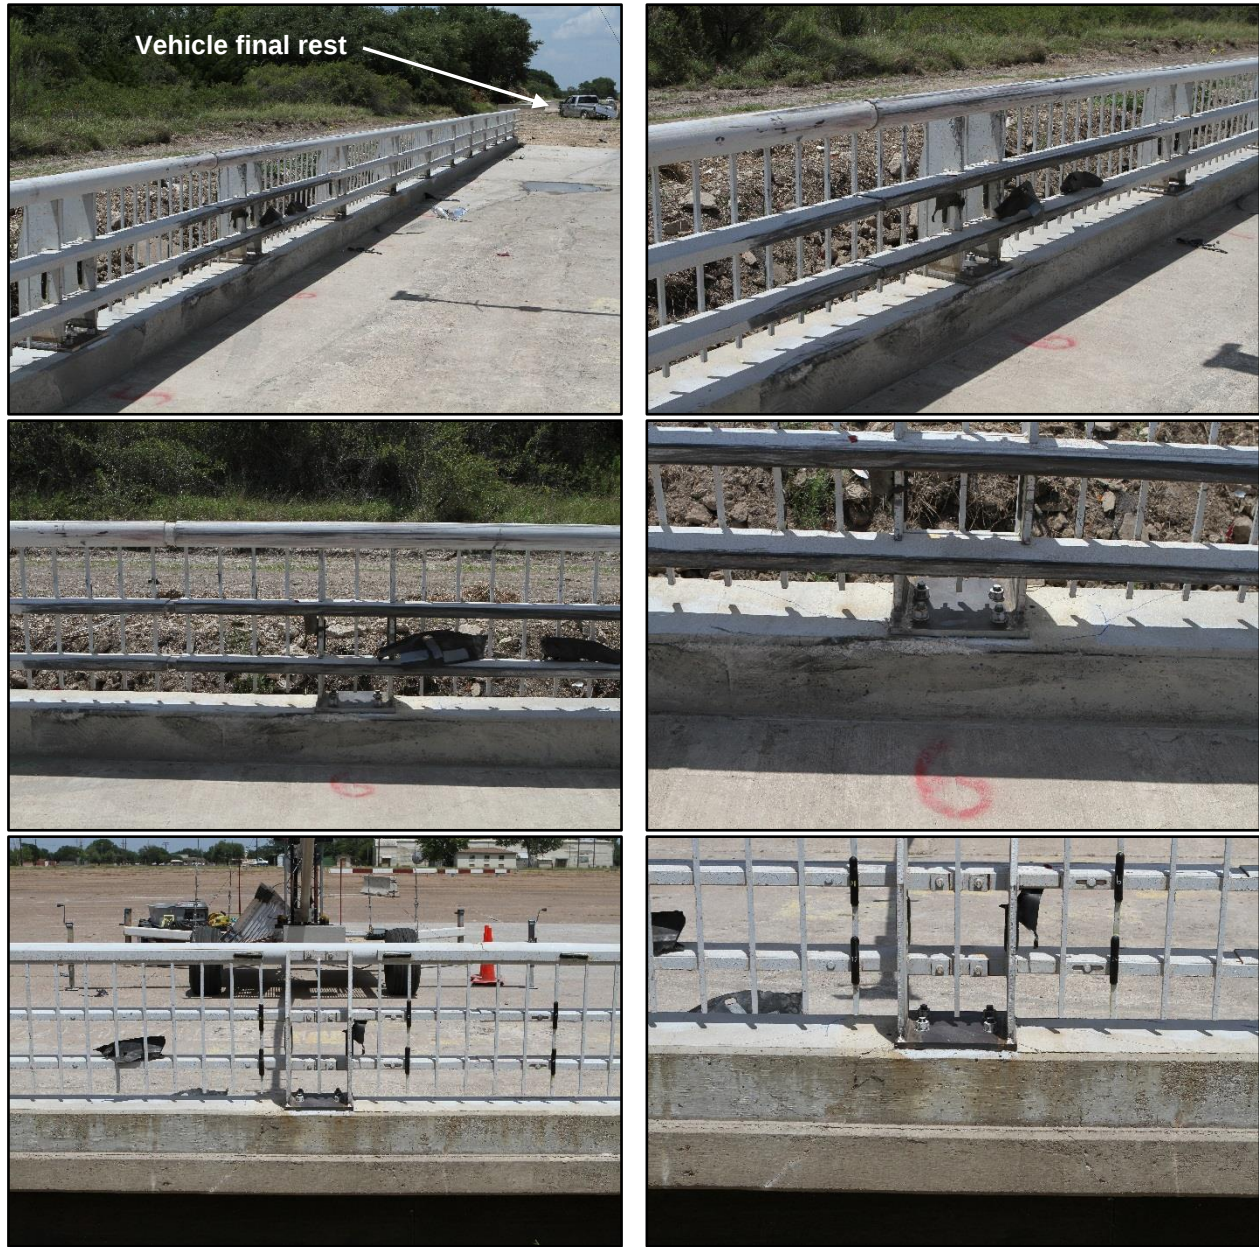
**Figure 6-3. TxDOT Type C2P Bridge Rail after Test No. 490026-4-2.**

Figure 6-3 shows the damage to the TxDOT Type C2P Bridge Rail. No damage to the posts was noted. Small cracks in the curb radiated from the anchor bolts at post 5, and larger cracks radiated from the anchor bolts at post 6. Working width was 14.0 inches. Maximum dynamic deflection during the test was 2.5 inches, and maximum permanent deformation was 1.4 inches.

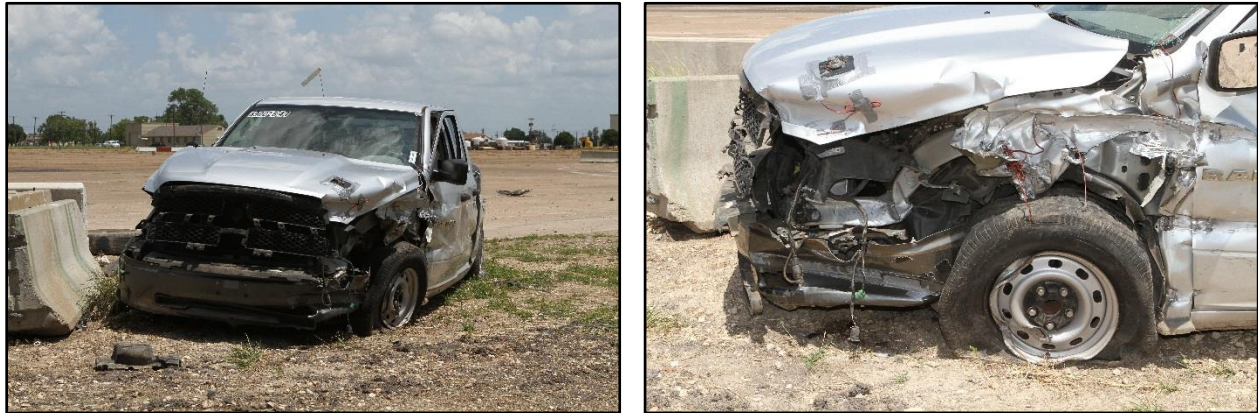
**Figure 6-4. Test Vehicle after Test No. 490026-4-2.**

Figure 6-4 shows the damage sustained by the vehicle. The front bumper, grill, hood, left front tire and rim, left upper and lower A-arms, left front fender, left front door and window glass, left rear door, left rear cab corner, left rear exterior bed, left rear tire and rim, left rear bumper, and left rear tailgate were damaged. The windshield sustained stress cracks radiating from the lower left corner of the A-pillar, and there was no deformation to the windshield. Maximum exterior crush to the vehicle was 13.0 inches in the side plane at the left front corner at bumper height. Maximum occupant compartment deformation was 2.25 inches in the instrument

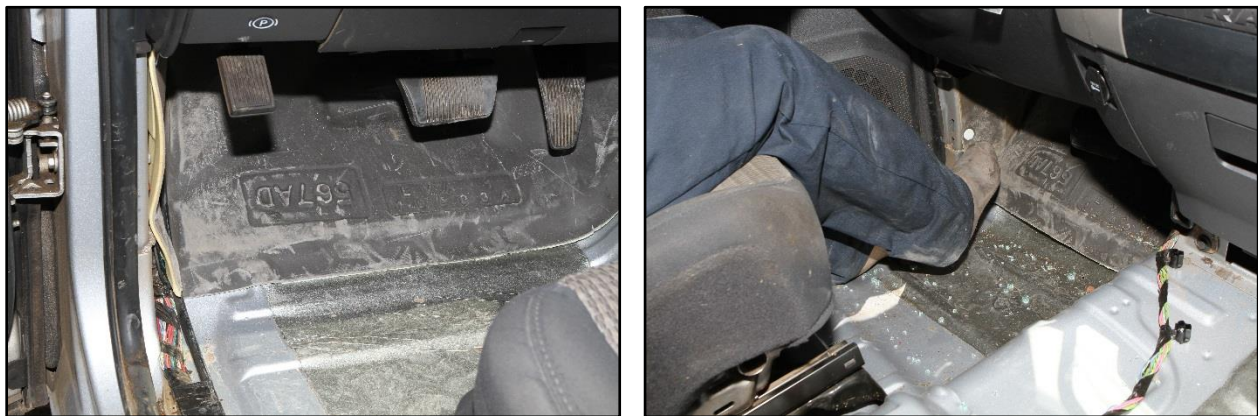
**Figure 6-5. Interior of Test Vehicle for Test No. 490026-4-2.**

panel area. Figure 6-5 shows the interior of the vehicle. Tables E-3 and E-4 in Appendix E1 provide exterior crush and occupant compartment measurements.

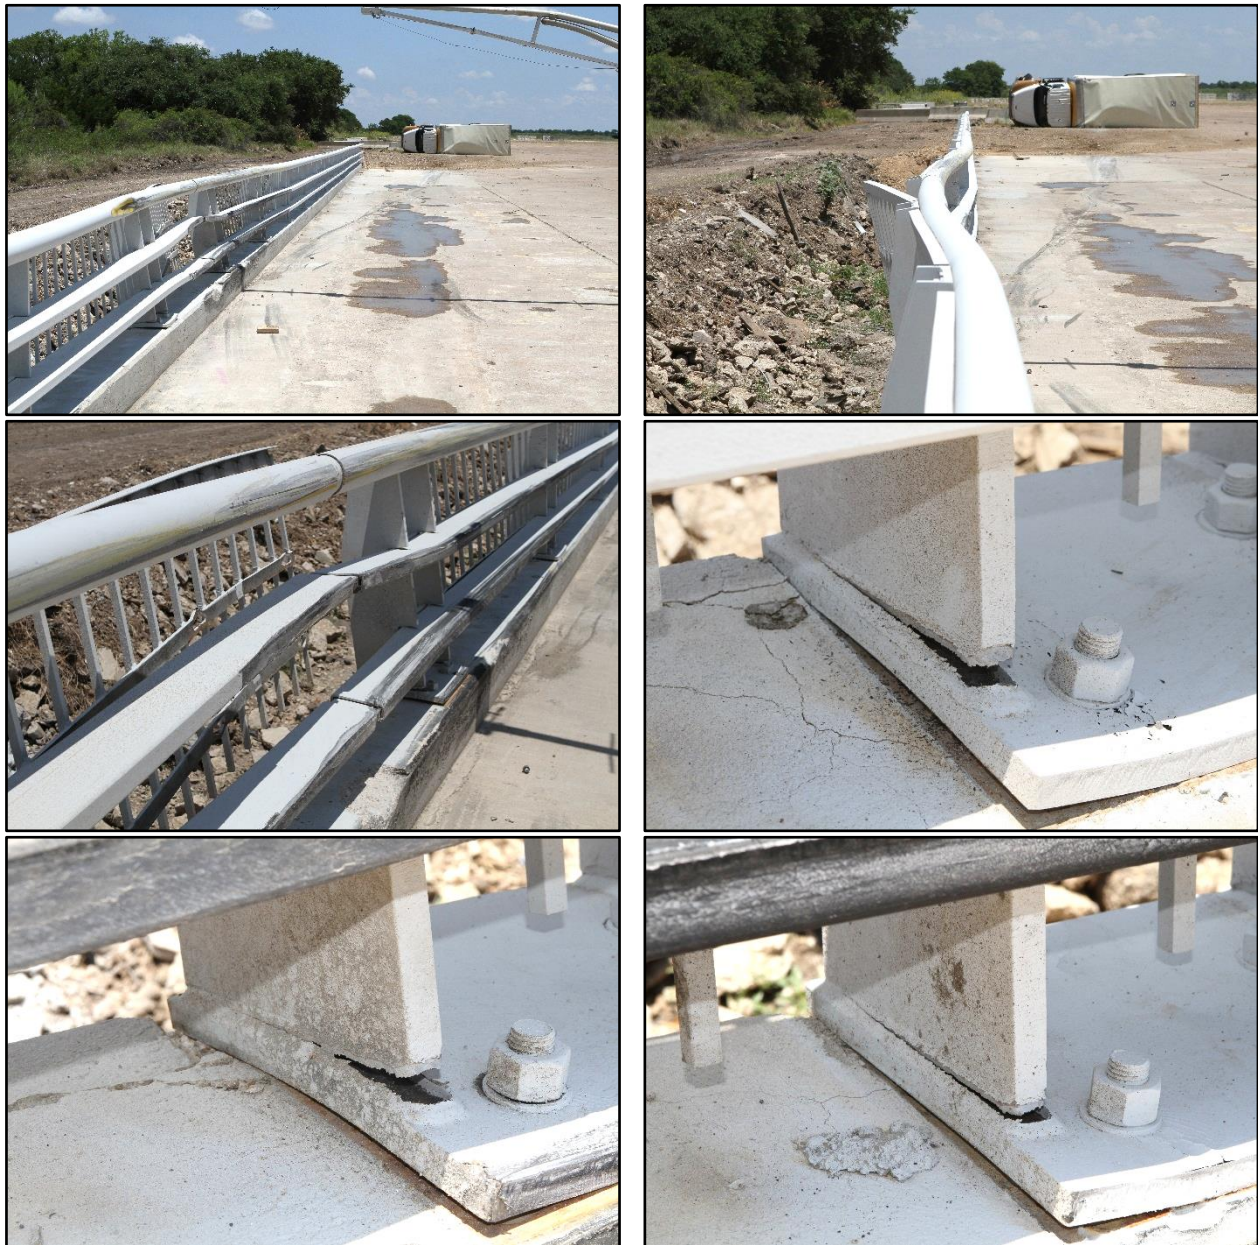
**Figure 7-3. TxDOT Type C2P Bridge Rail after Test No. 490026-4-3.**

Figure 7-3 shows the damage to the TxDOT Type C2P Bridge Rail. The welds failed at the base plates of post 5, 6, and 7. It was determined that the welds were not constructed correctly by the fabricator. After the welds failed at Posts 5, 6, and 7, the post plates rotated toward the field side 10 degrees, 13 degrees, and 7 degrees, respectively. The picket section between posts 5 and 6 released at the center and downstream locations but remained attached to the rail. Cracks radiated through the curb at posts 3 and 4, through the curb and deck at posts 5, 6, and 7, and through the curb at post 8. Working width was 62.3 inches. Maximum dynamic deflection during the test was 11.4 inches. Maximum permanent deformation as 7.25 inches at the joint between posts 5 and 6.

Results: The TxDOT Type C2P Bridge Rail contained and redirected the 10000S vehicle. Although the welds partially failed on several posts in the impact region (due to incorrect weldment by the fabricator), the vehicle did not penetrate, underride, or override the installation. Maximum dynamic deflection during the test was 11.4 inches. (PASS)

The first test was test 3 with the single unit truck (*MASH* 4-12), followed by test 2 with the pickup truck (*MASH* 4-11), and finally test 1 with the small car (*MASH* 4-10). During test 3, the base plate welds failed at posts 5, 6, and 7 (refer to Section 7.5). Prior to test 2, the base plates for all 15 posts used for the remaining two tests were removed and new base plates of the same design were welded to the posts.

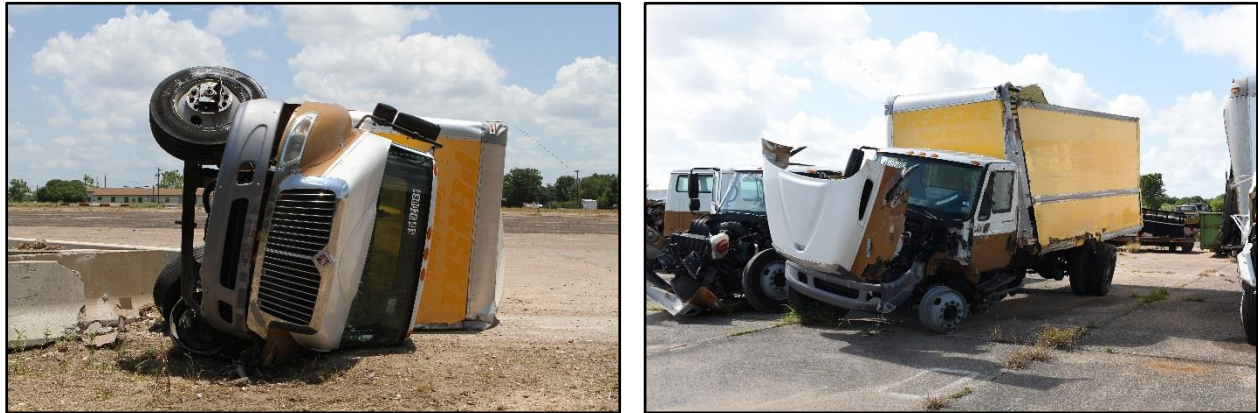
**Figure 7-4. Test Vehicle after Test No. 490026-4-3.**

Figure 7-4 shows the damage sustained by the vehicle. The front bumper, hood, left front tire and rim, left battery box, left steps, left door and vent glass, left side of the cargo box, left rear outer tire and rim, and roof were damaged. The windshield sustained stress cracks during the test, and there was no deformation to the windshield. Maximum exterior crush to the vehicle was 14.0 inches in the side plane at the left front corner at bumper height. No occupant compartment deformation was noted. Figure 7-5 shows the interior of the vehicle.

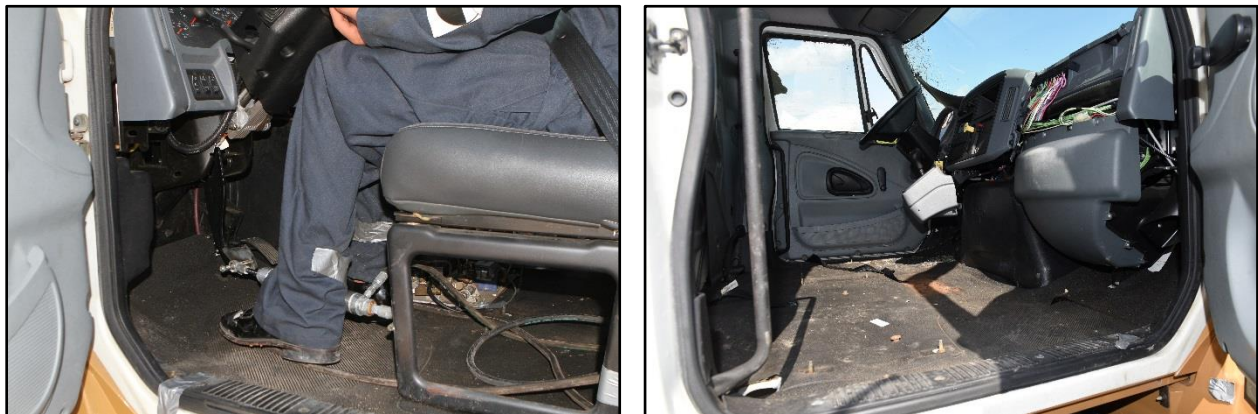
**Figure 7-5. Interior of Test Vehicle for Test No. 490026-4-3.**

No deformation or intrusion into the occupant compartment occurred. (PASS)
