ULTRASONIC IMAGING FOR CONCRETE INFRASTRUCTURE CONDITION ASSESSMENT AND QUALITY ASSURANCE

Research Report No. FHWA-ICT-17-007

A report of the findings of
ICT PROJECT R27-146
Ultrasonic Imaging for Concrete Infrastructure
Condition Assessment and Quality Assurance

Illinois Center for Transportation
April 2017

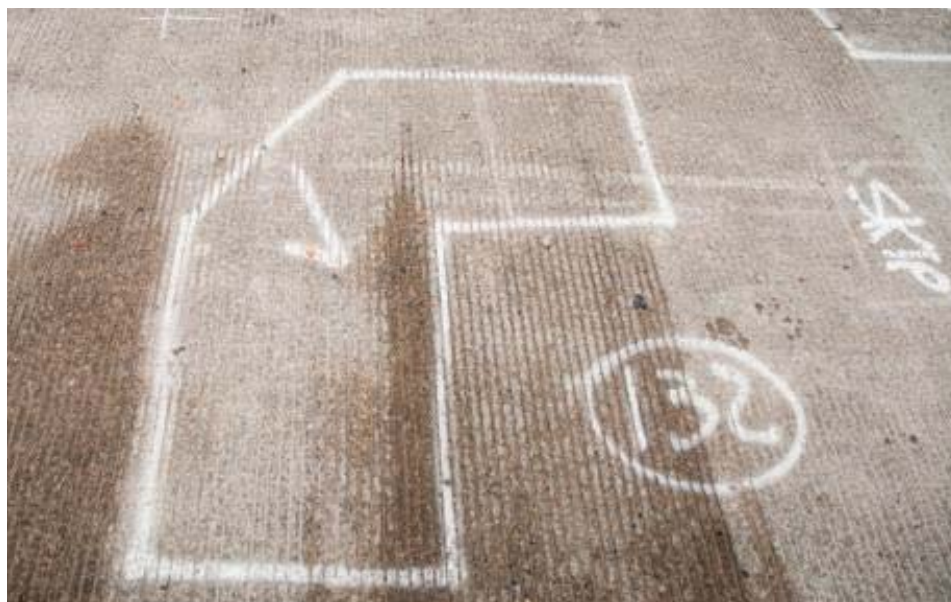
Figure 43: Sounding estimate of the I-55 bridge deck delamination 132.

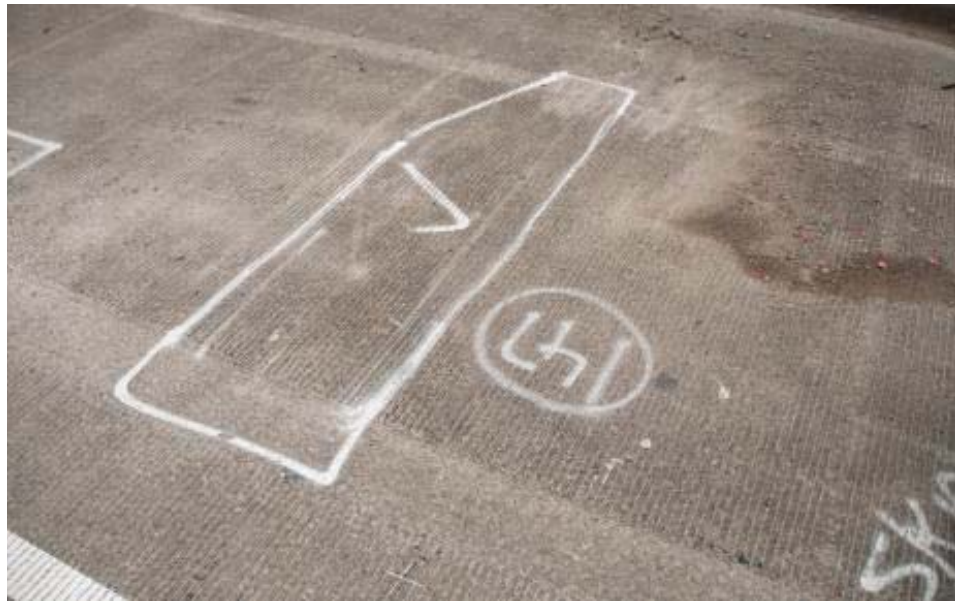
Figure 44: Sounding estimate of the I-55 bridge deck delamination 147.

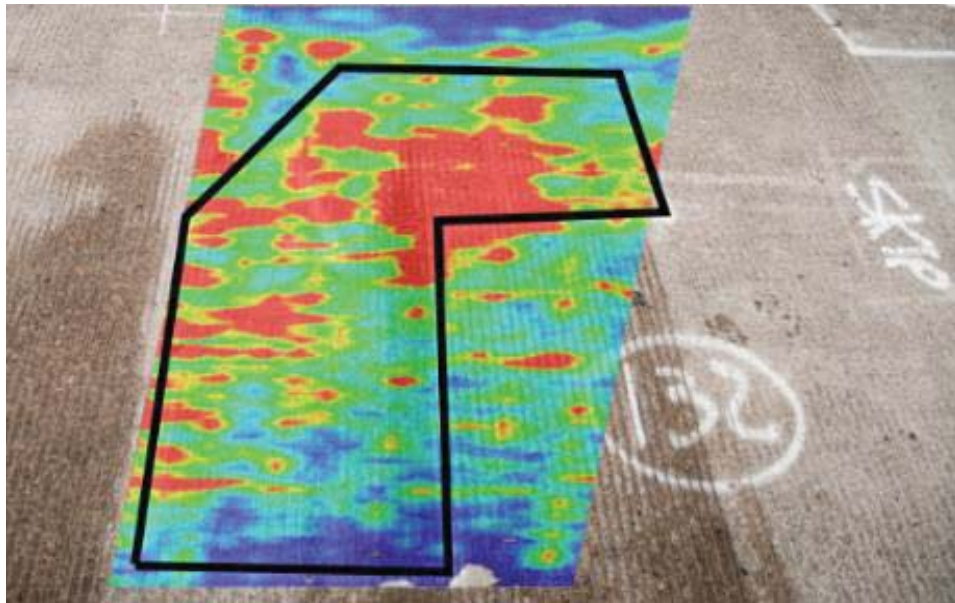
Figure 45: Near-surface reflectors in range 0 to 150 mm (0 to 5.9 in.) for the I-55 bridge deck delamination 132.

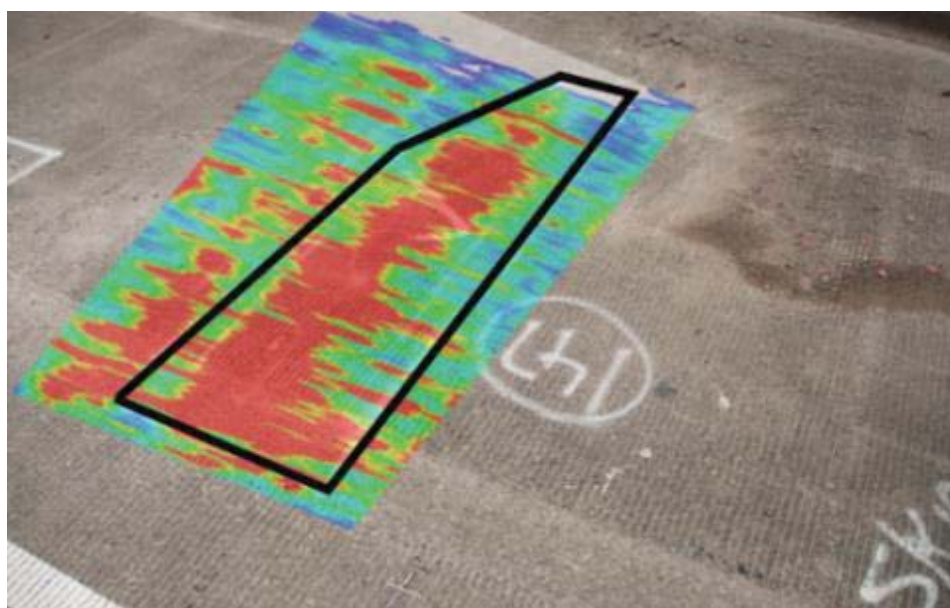
Figure 46: Near-surface reflectors in range 0 to 150 mm (0 to 5.9 in.) for the I-55 bridge deck delamination 147.

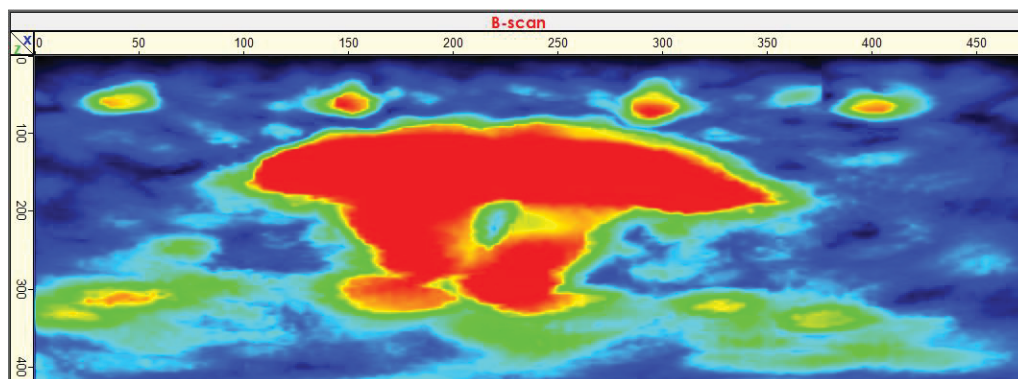
Figure 51: Double box girder scanned from bottom. Orientation perpendicular to bridge traffic flow, significant visual signs of corrosion.
Units of the plot are in millimeters, 1 in. = 25.4 mm.

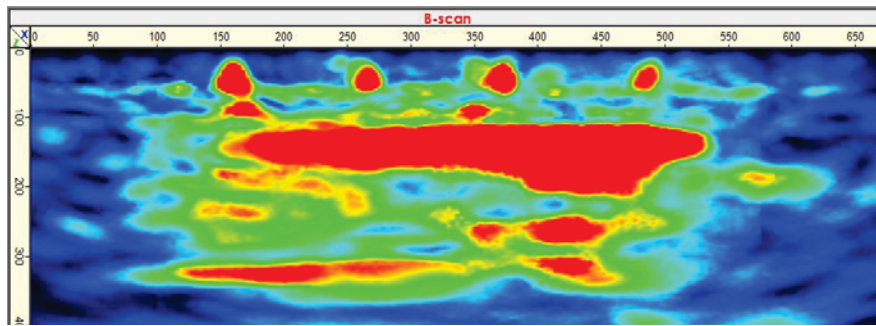
Figure 52: Double box girder scanned from bottom. Orientation parallel to bridge traffic flow, significant visual signs of corrosion. Units of the plot are in millimeters, 1 in. = 25.4 mm.

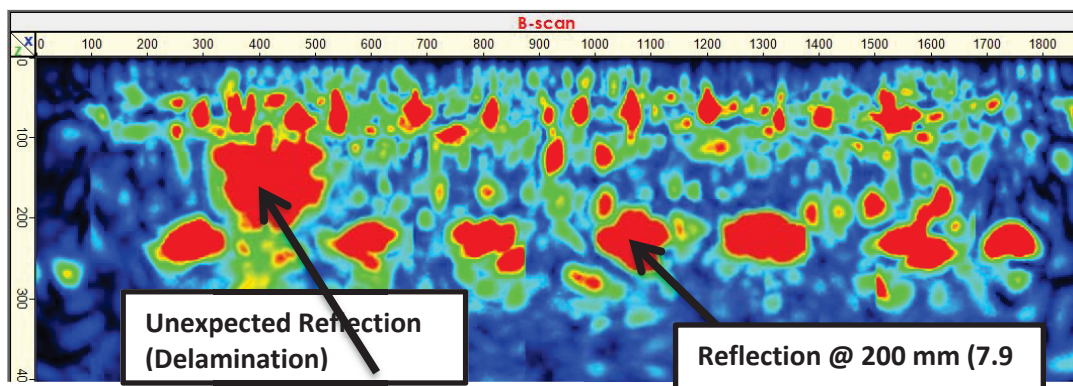
Figure 53: Double box girder scanned from bottom. Orientation parallel to bridge traffic flow, various levels of visual signs of corrosion. Unexpected reflection occurs at a zone with no visual corrosion. Units of the plot are in millimeters, 1 in. = 25.4 mm.

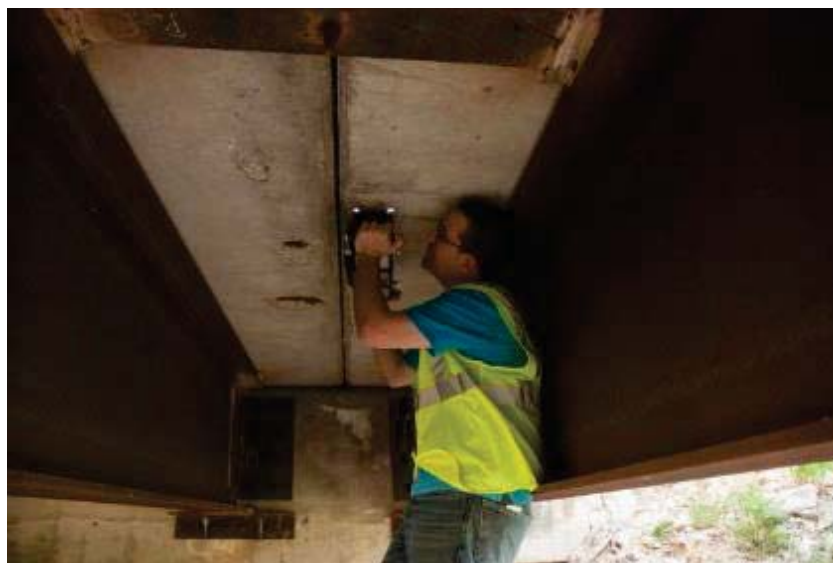
Figure 54: Photograph of visually corroded scan location and testing method.

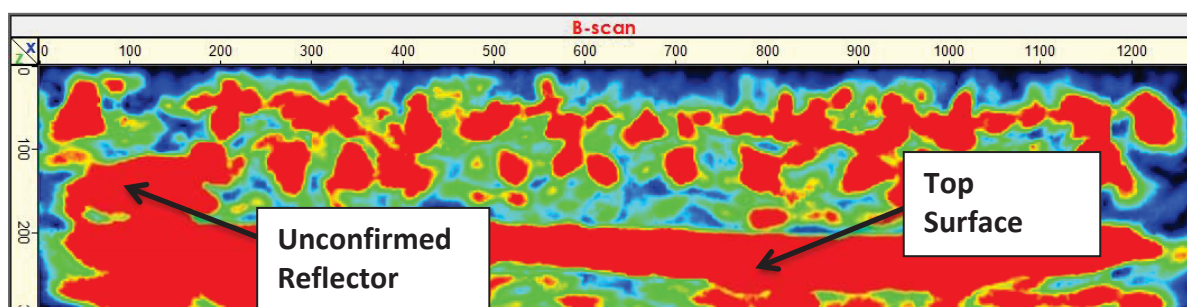
Figure 65: Underside of northbound lanes under asphalt deterioration (perpendicular to top traffic flow). Units of the plot are in millimeters, 1 in. = 25.4 mm.

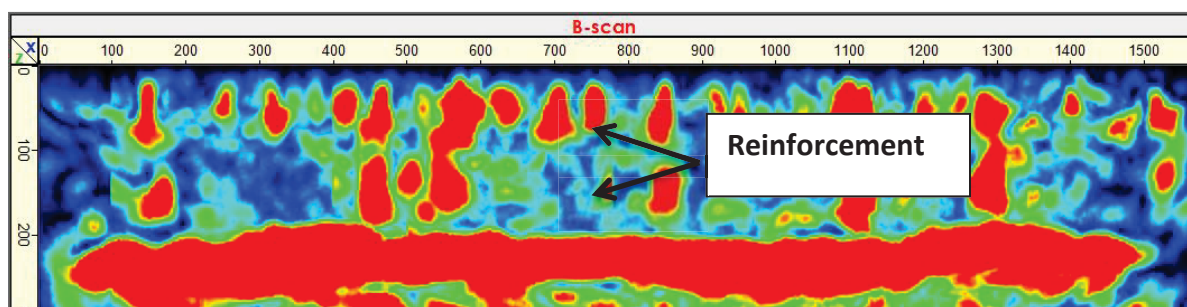
Figure 66: Underside of northbound lanes under asphalt deterioration (parallel to top traffic flow). Units of the plot are in millimeters, 1 in. = 25.4 mm.

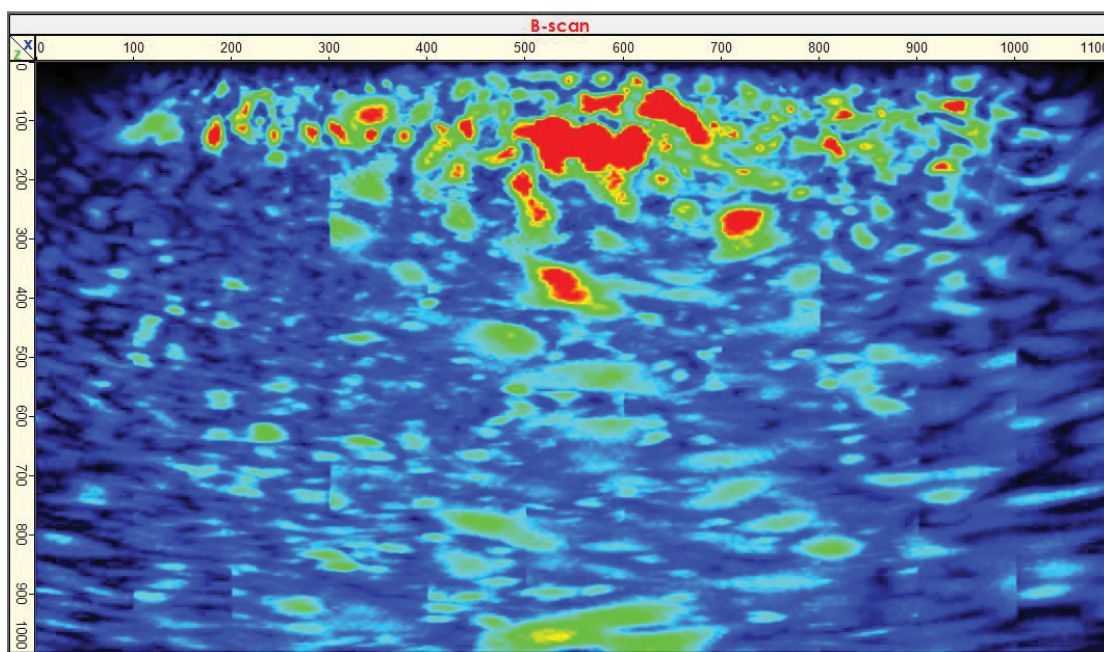
Figure 89a: Repaired pier cap, fiber reinforced between 300 to 800 mm (11.8 to 31.5 in.); horizontal. Units of plot are in millimeters, 1 in. = 25.4 mm.

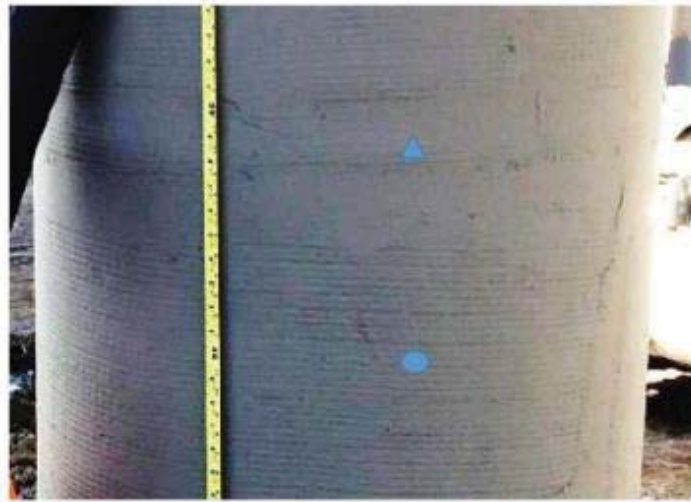
Figure 89b: Northwest side of FRP-wrapped column, 1 m (3.28 ft) diameter. Triangle in region of smooth epoxy coating, Circle in region of coarse epoxy coating. Ruler in plot is in inches, 1 in. = 25.4 mm.

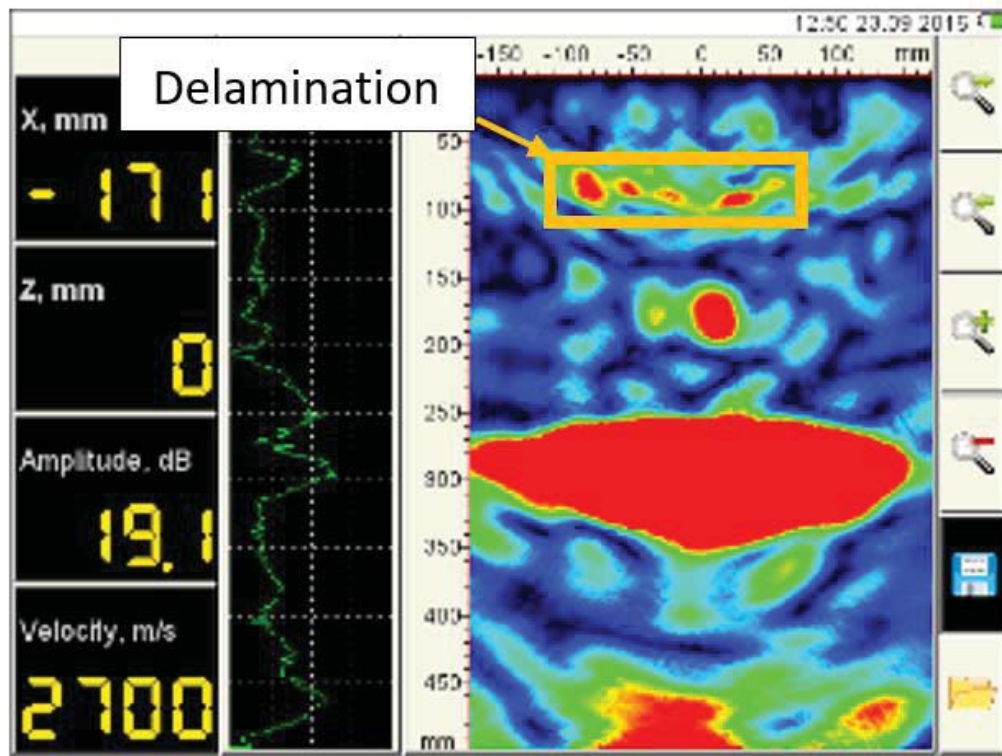
Figure 99: Stadium Drive B-scan showing potential voids/delamination and misaligned dowel bar and slab depth at 290 mm(11.4 in.). Units of the plot are in millimeters, 1 in. = 25.4 mm.

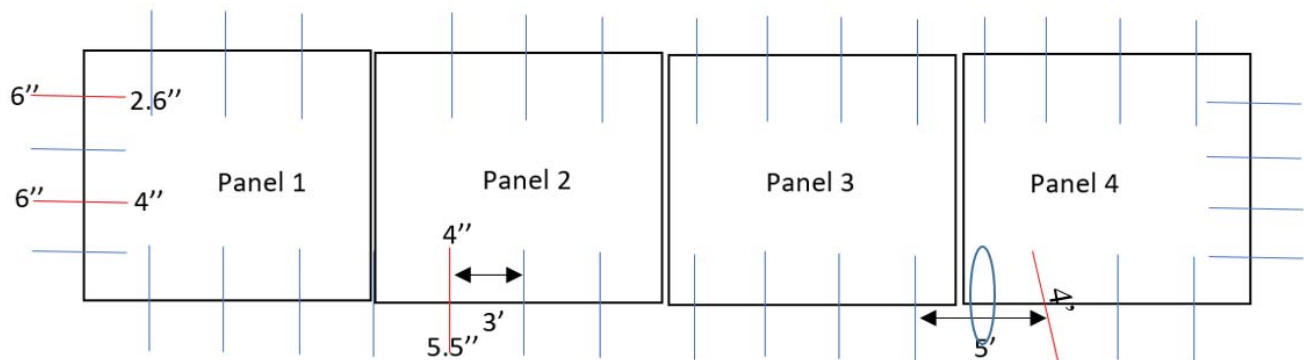
Figure 100: Reinforcements location in inspected panels (red = misaligned bars; \emptyset = missing bar). Plot is in units of inches, 1 in. = 25.4 mm.

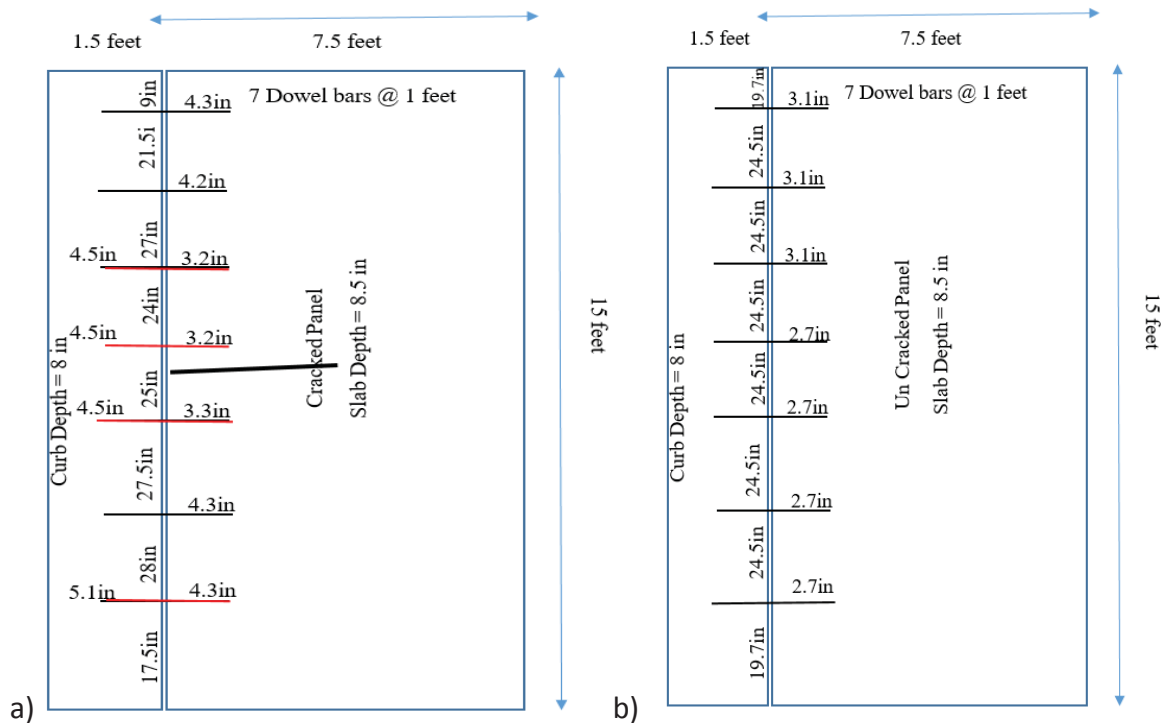
Figure 111: Rebar scheme: (a) cracked panel; (b) uncracked panel on John Street extension.
Unit conversions: 3.28 ft = 1 m, 1 in. = 0.025 m.
