Design Considerations for Embankment Protection During Road Overtopping Events

Jeffrey D. G. Marr, Principal Investigator

St. Anthony Falls Laboratory

Final Report 2017-21

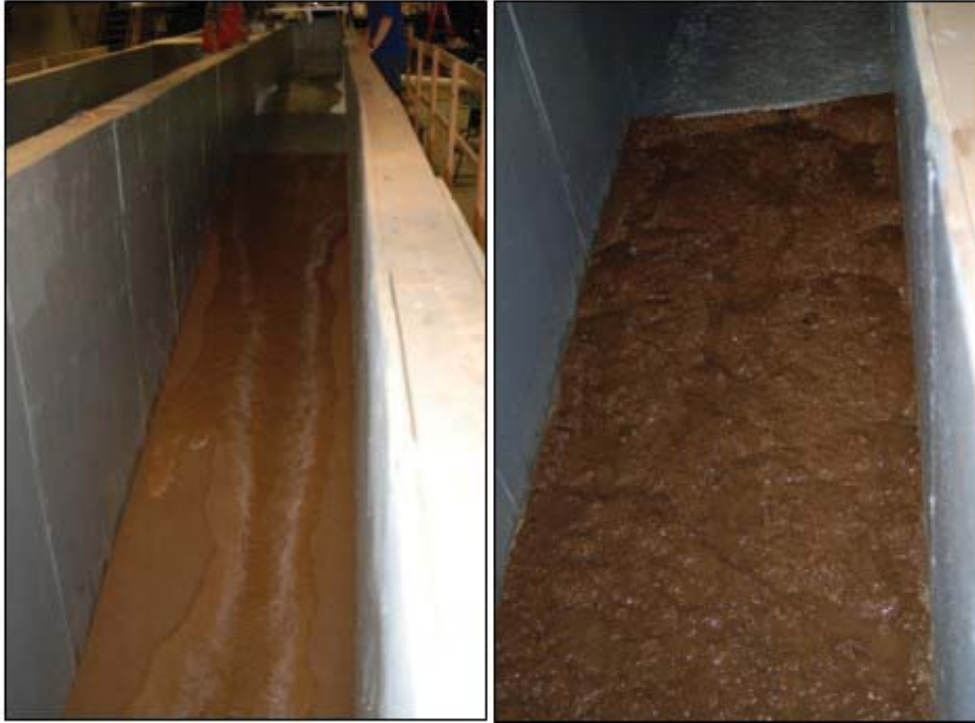
Figure 4.8. (Left) Initiation of flow on 6H:1V slope looking upstream. (Right) Erosion began immediately with incisional channels forming on slope.

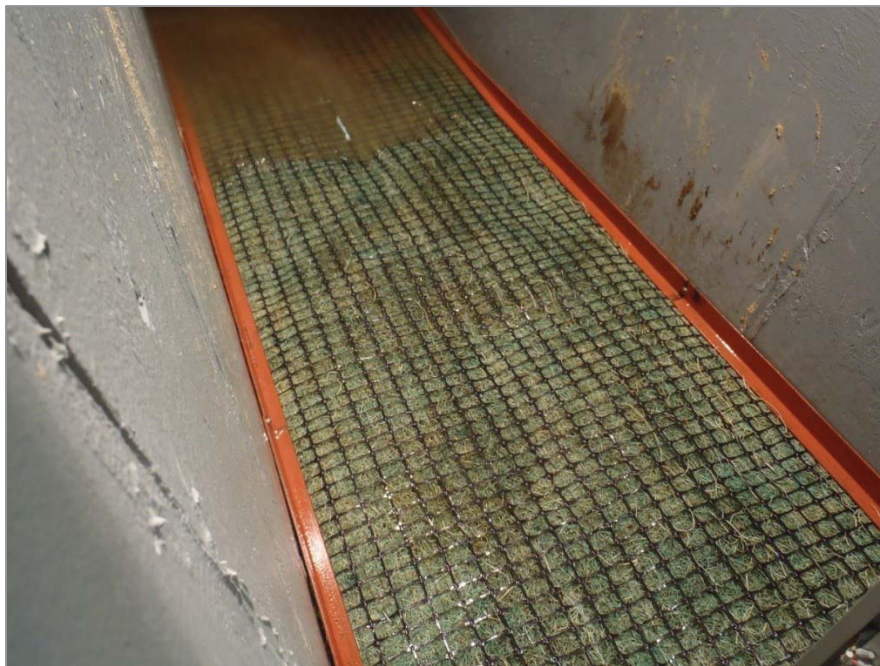
Figure 4.30. Image of early sign of erosion as a depression 75% of the way down slope caused water to separate from bed. Image is looking downstream near toe of slope with tail-water still draining.

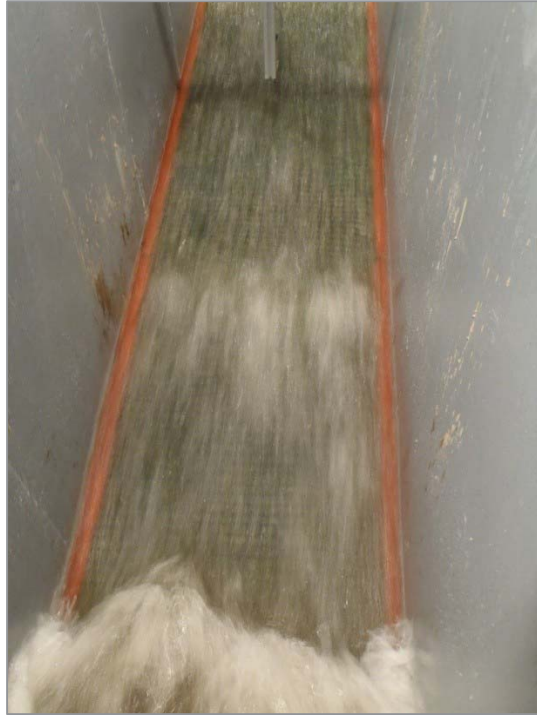
Figure 4.31. Flow on slope becoming aerated because of the increasing depth of erosion and separation of the geogrid from the soil. The image shows the formation of a hydraulic jump at bottom of the slope.

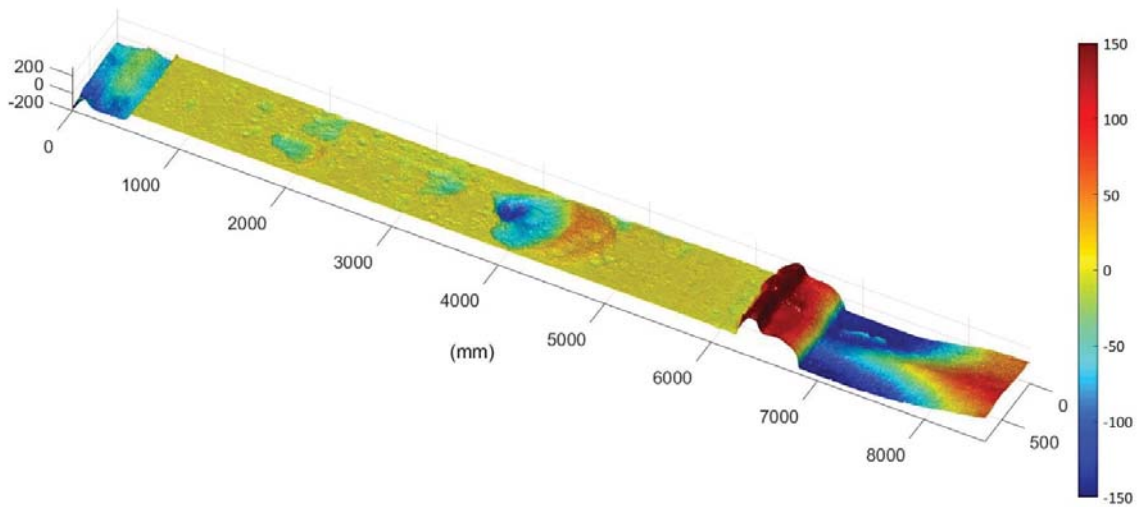
Figure 4.35. Topographic difference plot of final bare soil condition vs. initial bare soil condition. Erosional areas are easily identified here because the ECB covering was removed for the scan.

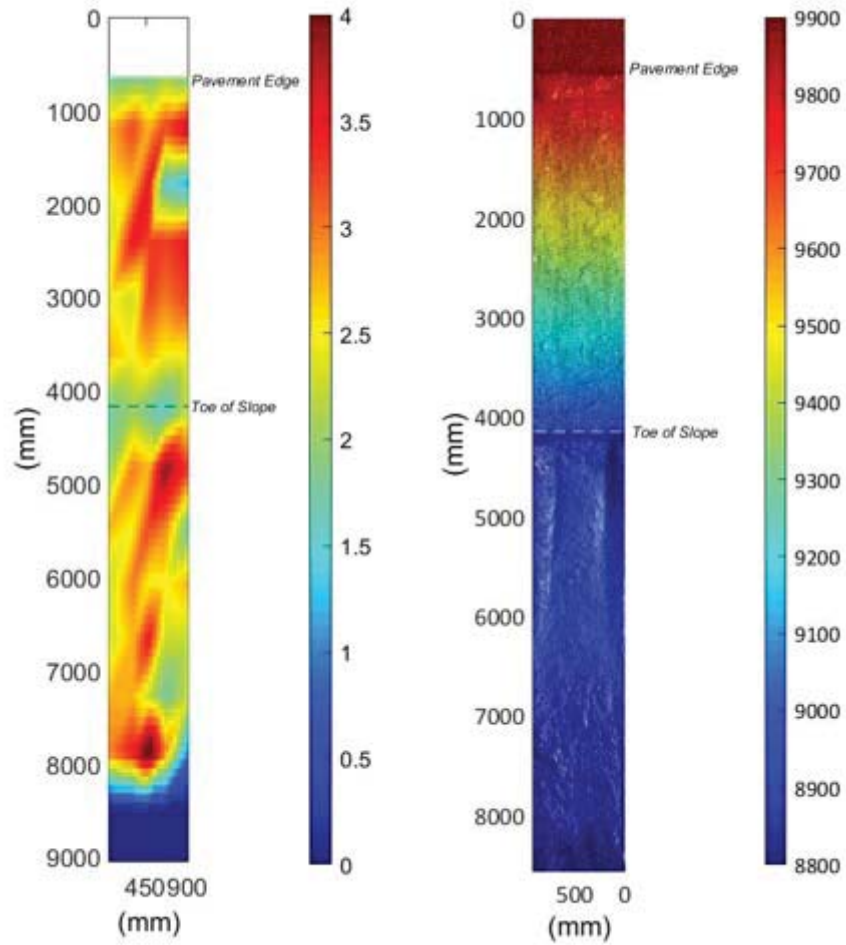
Figure 4.43. (Left). Aerial view of interpolated compaction data on slope. Compaction is presented in units of tons per square foot. (Right). Final bare soil scan showing areas of minor erosion.

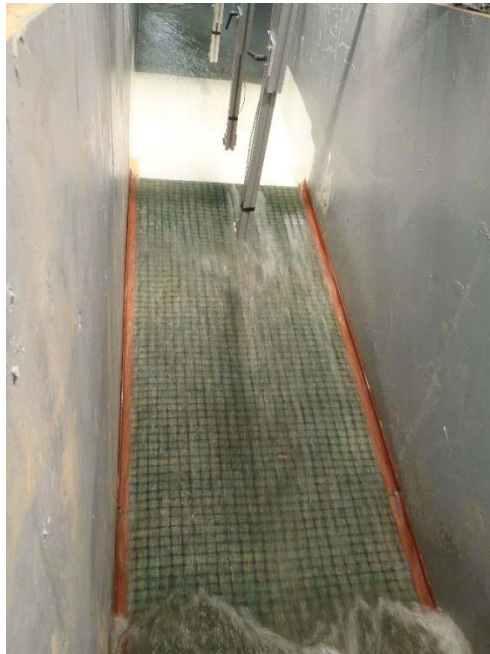
Figure 4.45. Looking upstream after 1.5 hours of run time. Erosion is observed 1.5ft downstream from the shoulder in the river-left half of flume.

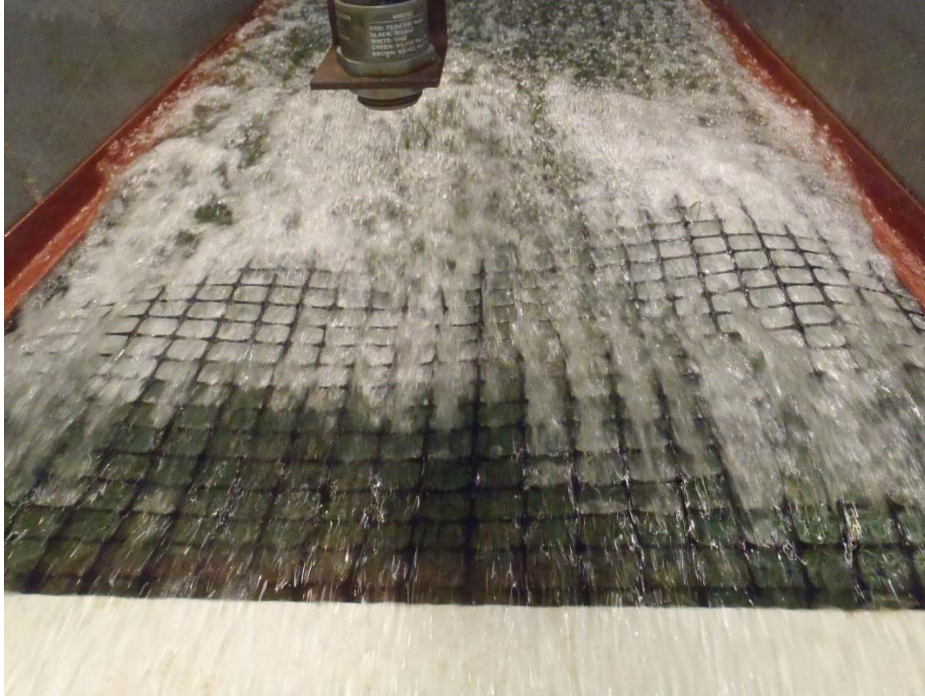
Figure 4.46. Looking downstream from the shoulder during 2-4 hour testing period. Note the large area of erosion occurring near the shoulder specifically near the left wall.

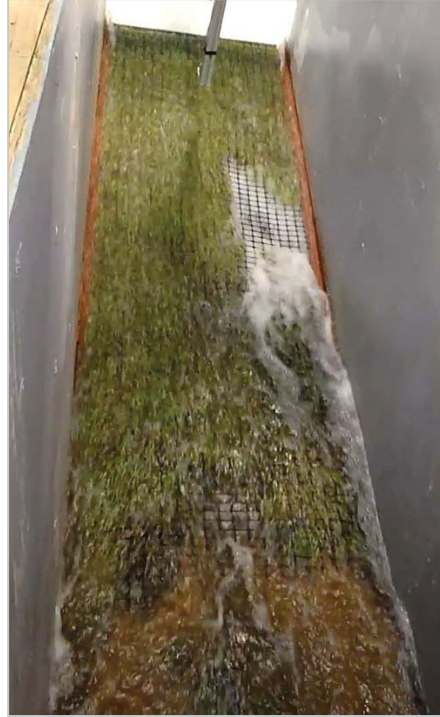
Figure 4.65. During final 4-5.5 hour run, catastrophic erosion took place. Most of the lower slope began eroding under the sod, which had come loose but was held from being washed away by the geogrid and staples.

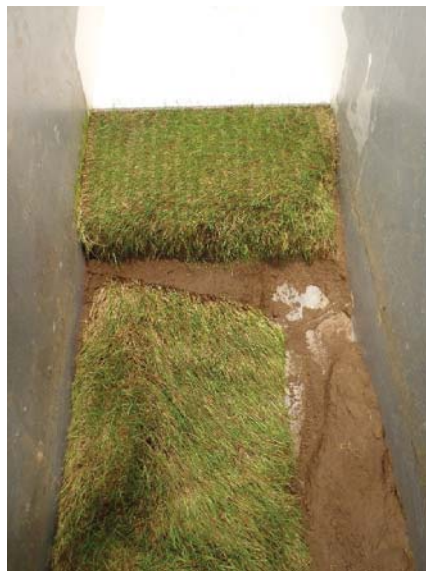
Figure 4.66. Looking upstream at shoulder to slope transition after the geogrid has been removed. Most of the transition is still intact while the areas where there was a seam between the rolled out pieces of sod allowed water to penetrate and erode the slope surface under the sod which was being partly held in place by the geogrid and landscaping staples.

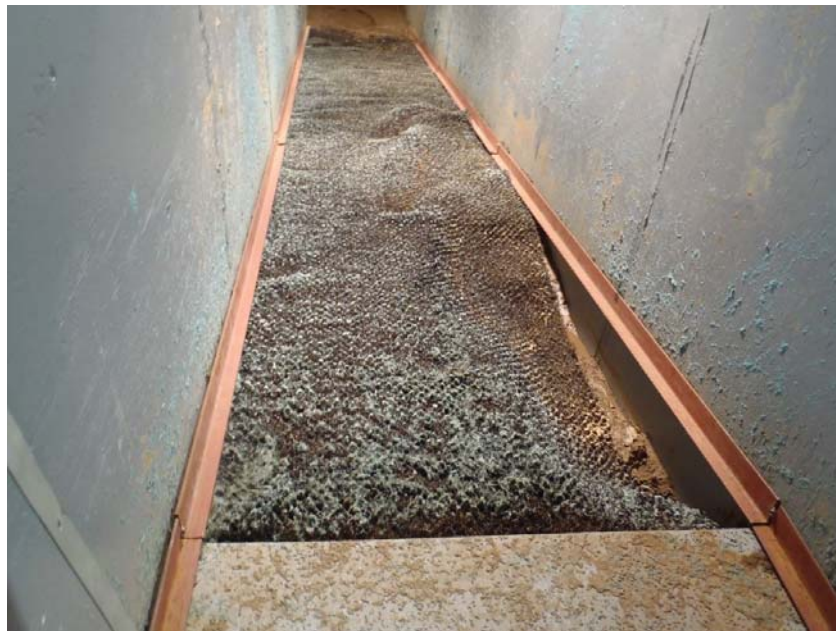
Figure 4.85. View looking downstream after 8.25 hours of run time. The large amount of erosion along right wall represents failure.

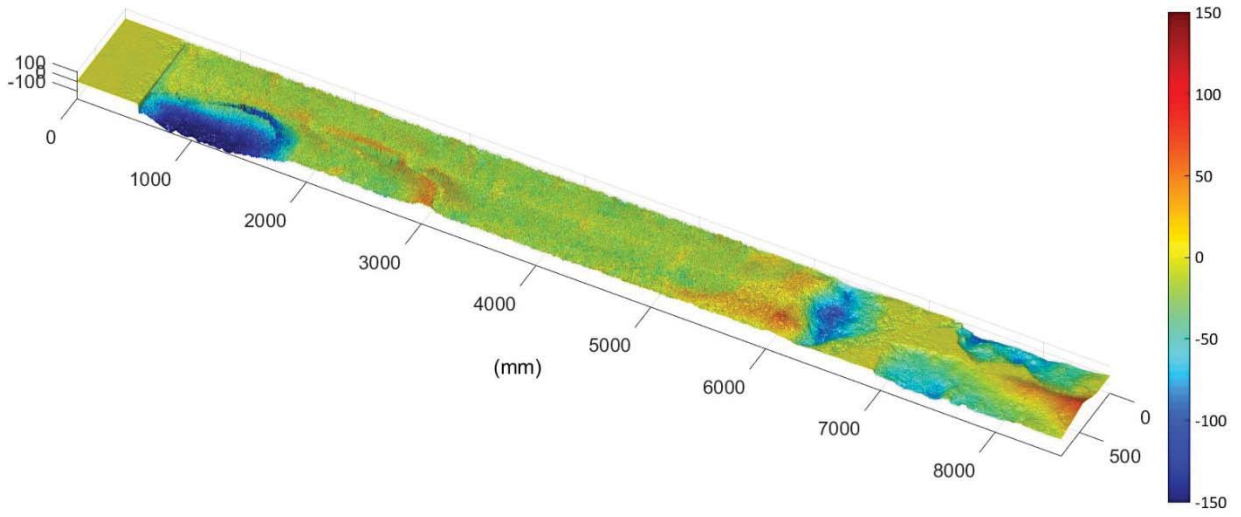
Figure 4.89. Topographic difference plot from zero to 8.25 hours. Erosion quickly expanded near the top of the slope leading to failure.

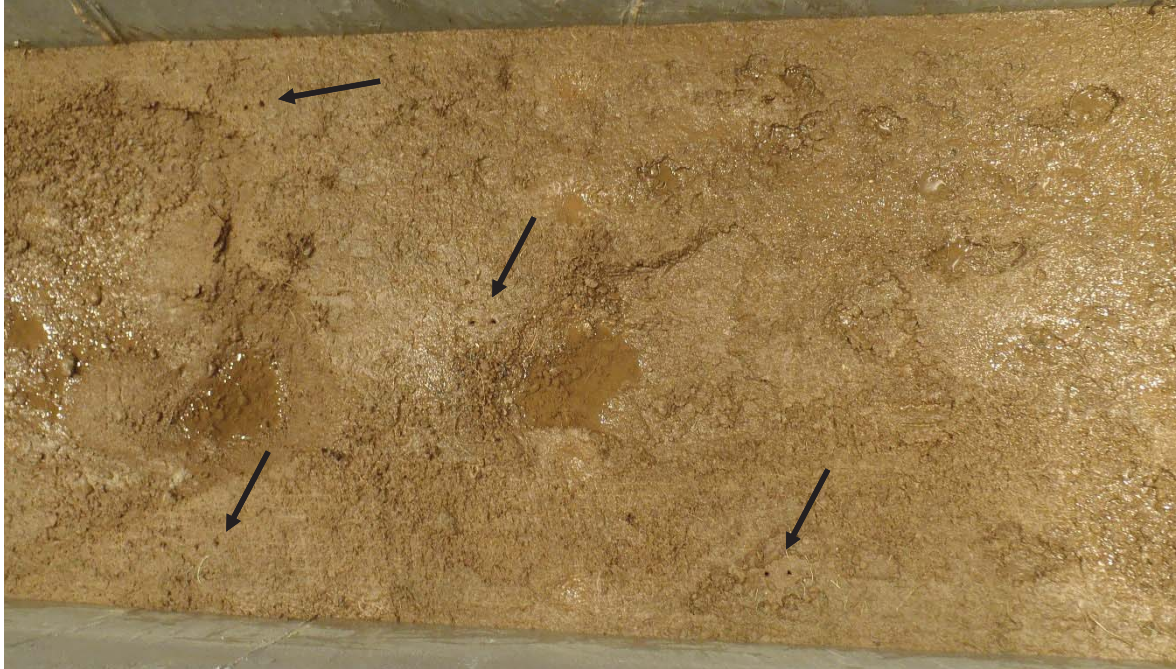
Figure 6.1. View from above of the bare soil after the ECB was removed post-testing, 6H:1V slope. Note the indicated holes where the staples were holding down the stabilization material. Flow was from right to left.

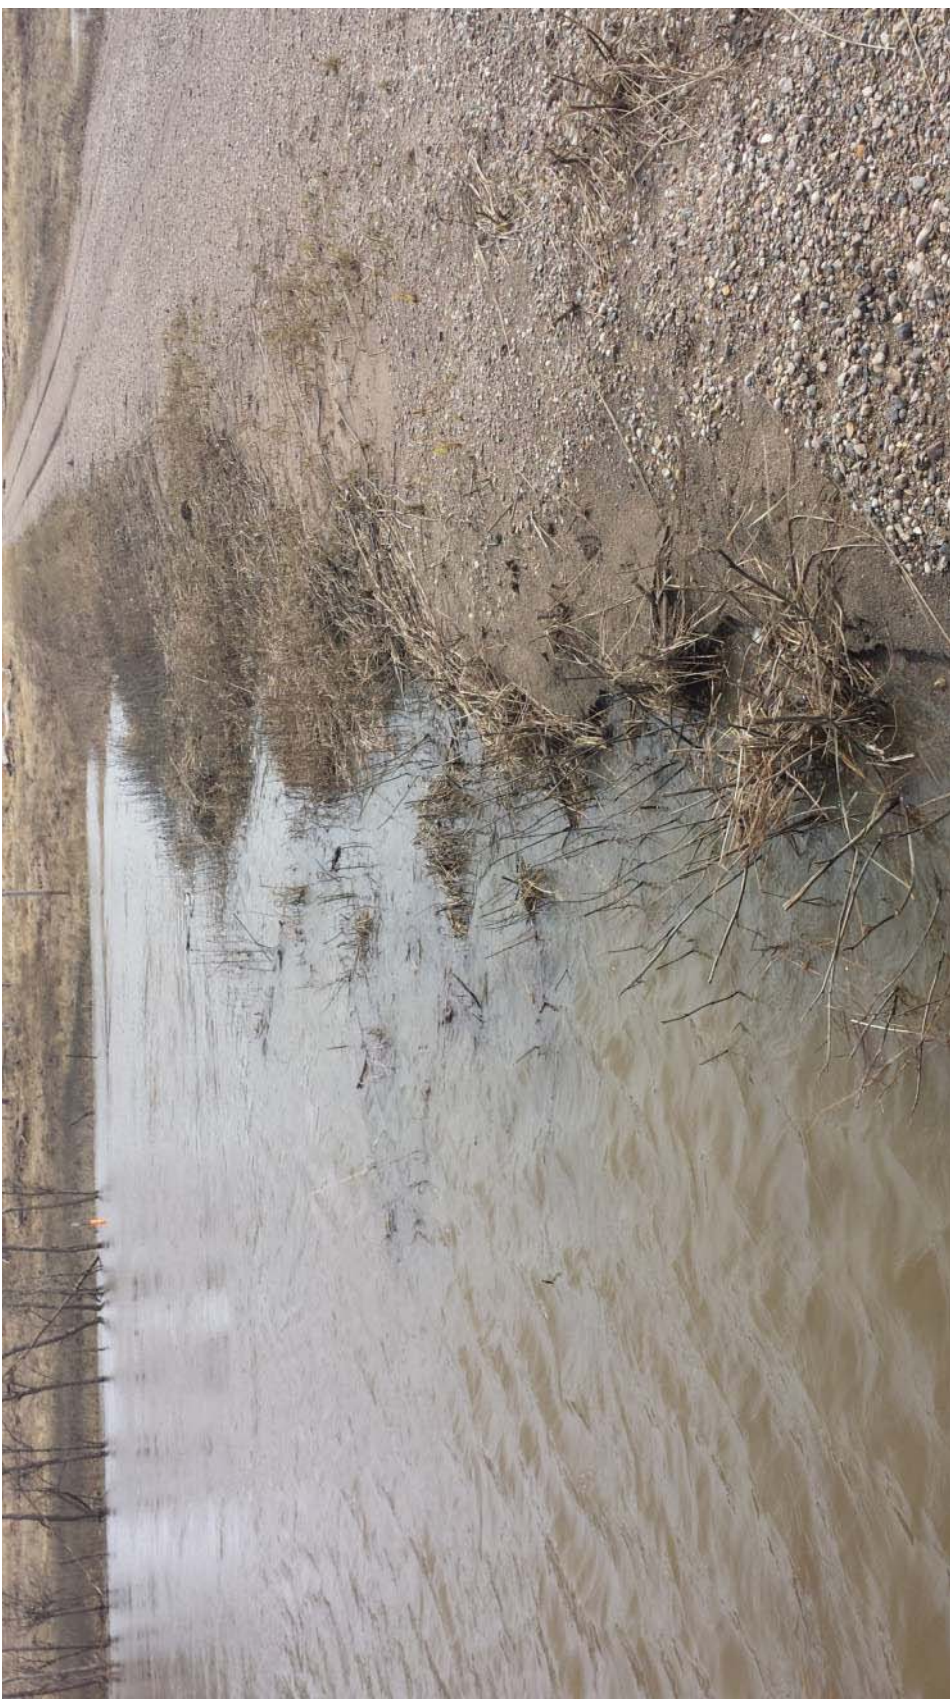
Location 4 looking east at minor erosion and deposition on the downstream shoulder, post-flooding condition
