Comprehensive Field Evaluation of Asphalt Patching Methods and Development of Simple Decision Trees and a Best Practices Manual

Department of Civil Engineering
University of Minnesota Duluth

June 2017

Research Project
Final Report 2017-25

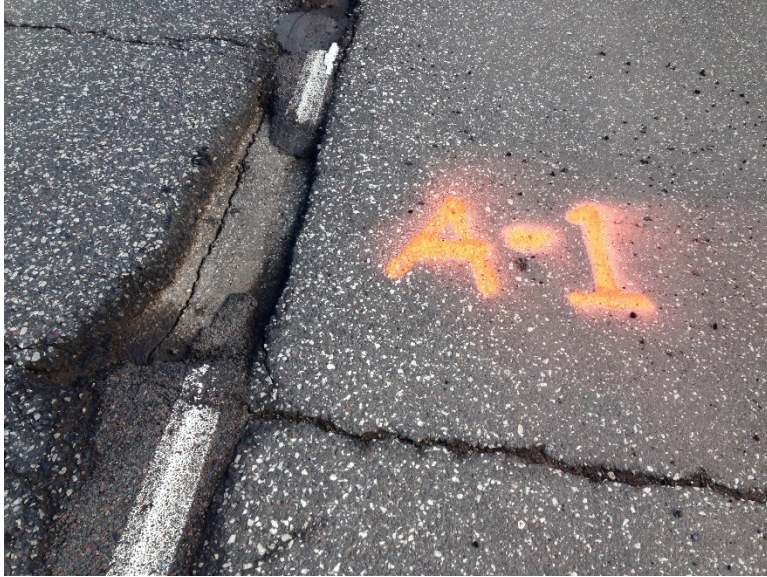
Figure 3.1 Pothole A-1 prior to Patching (After Cleaning).

Pothole A-1: This pothole was located along the shoulder joint of the roadway. The pothole lies in between two reflective transverse cracks and has a longitudinal crack running along the bottom of the pothole as shown in Figure 3.1. The pothole was prepped by sweeping the area. The size of the pothole was 40 inches x 14 inches x 2 inches.

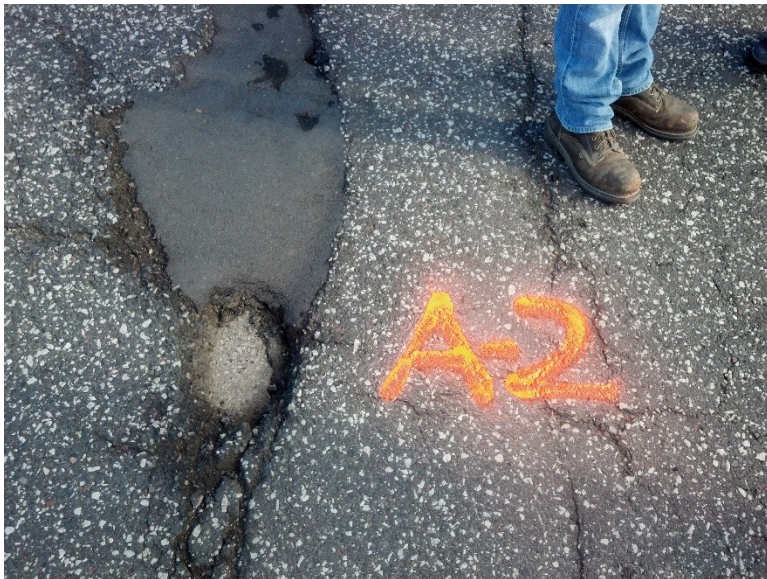
Figure 3.2 Pothole A-2 prior to Patching (After Cleaning).

Pothole A-2: This pothole was located in the non-wheel path of the driving lane. The pothole lies along a large transverse crack with the north face of the pothole being a previously placed patch material as shown in Figure 3.2. The pothole was prepped by sweeping. The size of the pothole was 13 inches x 9 inches x 2 inches.

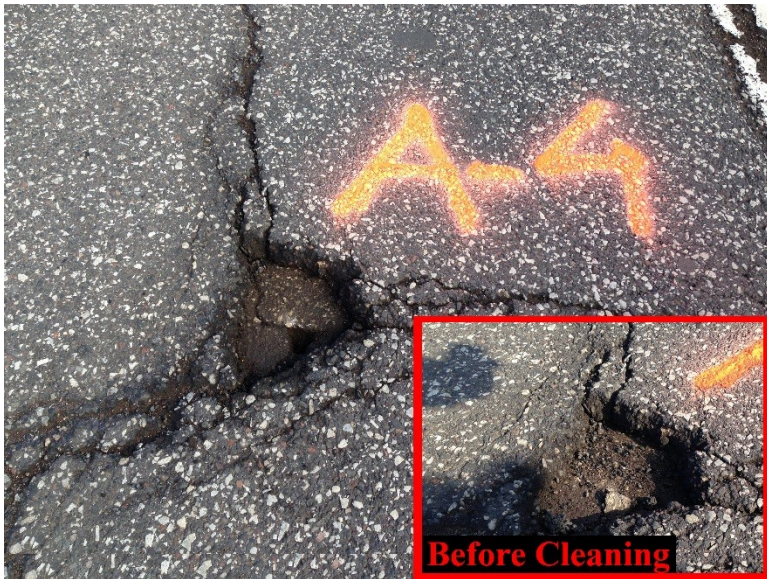
Figure 3.4 Pothole A-4 prior to Patching (Before and After Cleaning).

Pothole A-4: This pothole was located in the non-wheel path of the driving lane. The pothole exists at the intersection of a reflective longitudinal and transverse crack as shown in Figure 3.4. The pothole was prepped using compressed air. The size of the pothole was 10 inches x 10.5 inches x 1.5 inches.

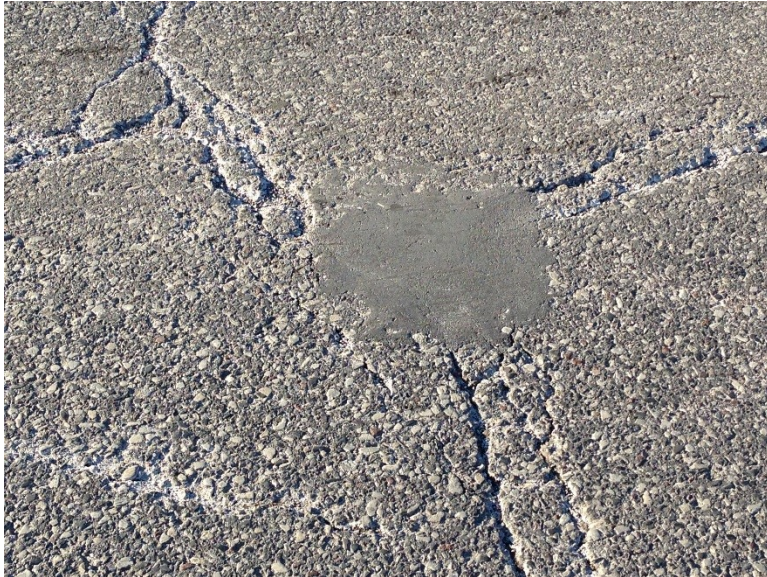
Figure 3.19 Pothole A-4 (240 days after installation) with Snow Plow Abrasion.

Although the cold mix patches had a hard compacted layer on the top of the patch, underneath that layer was pliable material that still had an oily shine consistent with the day the pothole was patched. Based on the last visit conducted on December 4, 2014, the conditions of the patches were found to be somewhat similar to the previous visits. The only noticeable difference was some abrasion on the patch material from snow plow blades. This abrasion was most noticeable in patch A-4 (Figure 3.19). Also on

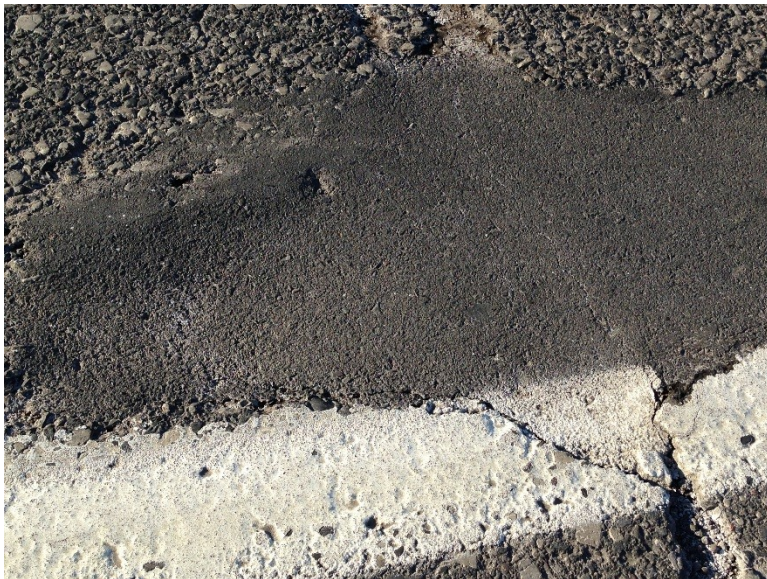
Figure 3.20 Pothole A-5 (240 Days after Installation).

December 4, 2014, it was observed that the pothole A-5 experienced a significant depression in the material since the last visit, as well as some material loss near the bottom of the patch (Figure 3.20).

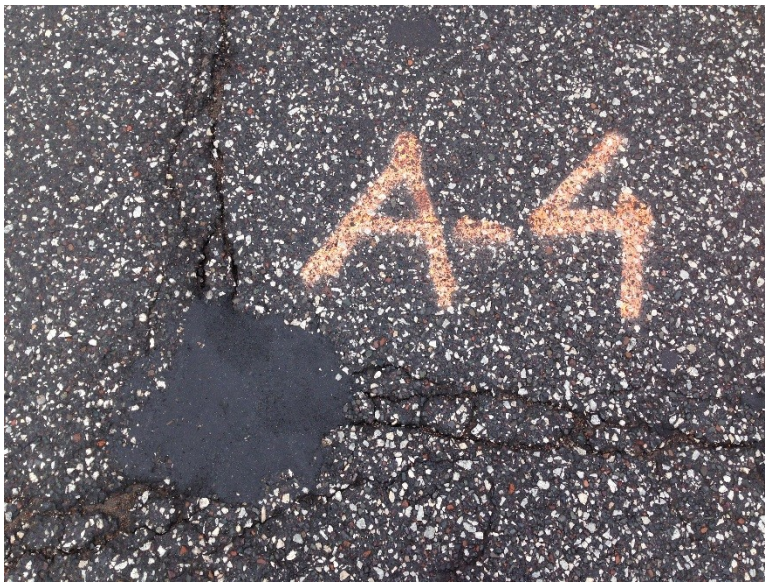
Figure 3.21 Image used for A-4 Retention Calculation (4/29/14).

Pothole A-4: Two different site visit dates were used to calculate the retention of material. The dates of comparison are April 29, 2014 (Figure 3.21) and July 9, 2014 (Figure 3.22). During that 71 day time span, the patch lost was approximately 13% of its surface area. The material lost was mostly extra patch material overlaying the existing road. The entire pothole was still patched and protected from moisture.

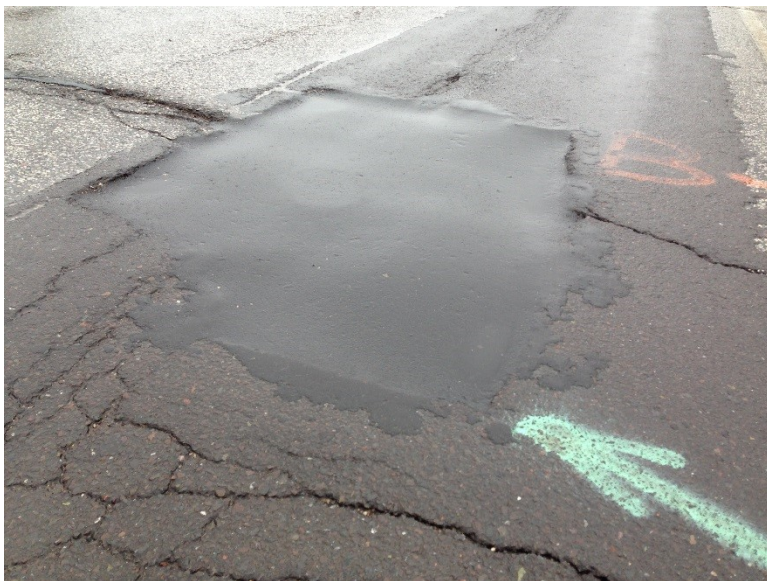
Figure 3.41 Water Accumulation in Dished Areas of Patch B-3 (18 Days after Patching).

One of the main concerns regarding dishing distresses is the accumulation of water. Pooled water on a roadway provides areas that facilitate hydroplaning during wet conditions as well as icy surfaces in cold conditions (Figure 3.41). Dished areas along patch edges may provide areas for water to infiltrate increasing the deterioration rate of both the roadway and patch material. Dished areas also provide a lower ride quality and potential hazard areas for snow plows.

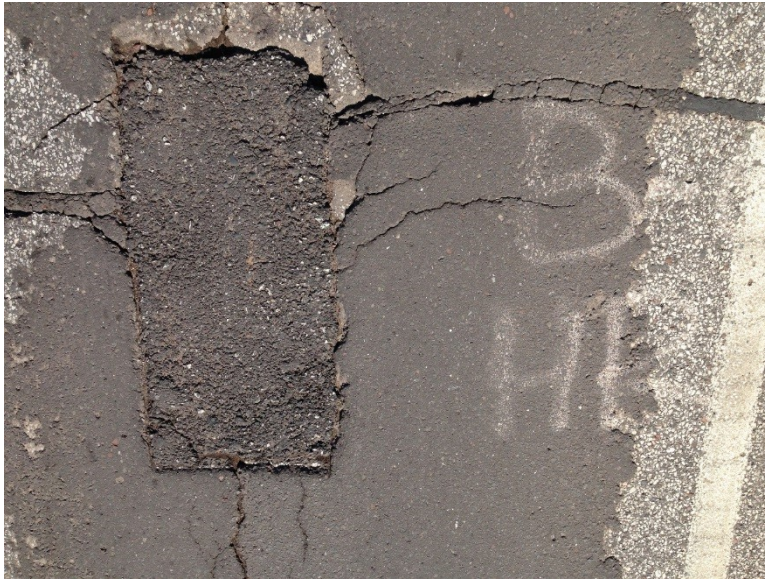
Figure 3.47 Pothole B-6 (146 Days after Patching).

The placement of patch material actually facilitated further damage to the roadway. The damage occurring appears similar to pumping action that is common with concrete panels. As traffic loads travel across the patch area there is not an efficient load transfer causing vertical movement of the patch material. This movement ejects water and fine material from underneath the patch and abrades the adjacent roadway. Comparing Figure 3.43 and Figure 3.44 illustrates that damage to the roadway in Patch B-5. Figure 3.47 provides a close view of this deterioration in Patch B-6.

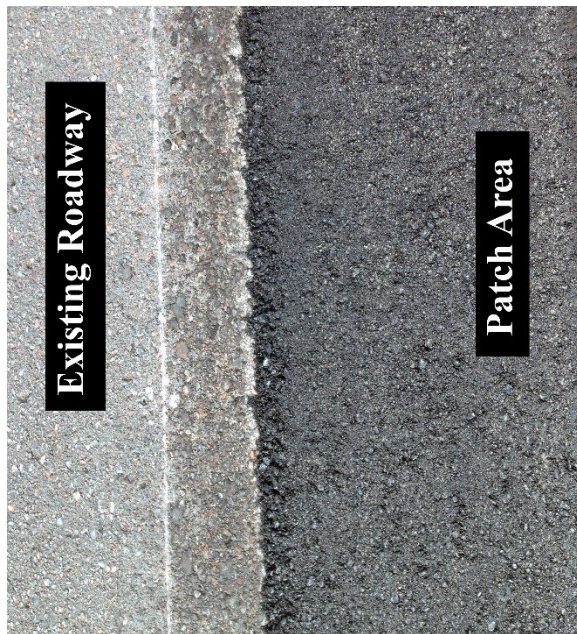
Figure 3.62 Interface between Patch Area and the Existing Roadway.

One issue with a mill and fill operation is the compaction along the edge of a patch. A closer look along the edge (Figure 3.62) shows that steel drum rollers, used to compact the fill material, are unable to completely compact the fill material. Since rollers are wider than the patch, the steel drum sits on the existing roadway preventing the compaction of material near the edge. This area of lesser compacted material may lead to a higher rate of water infiltration or patch material raveling.

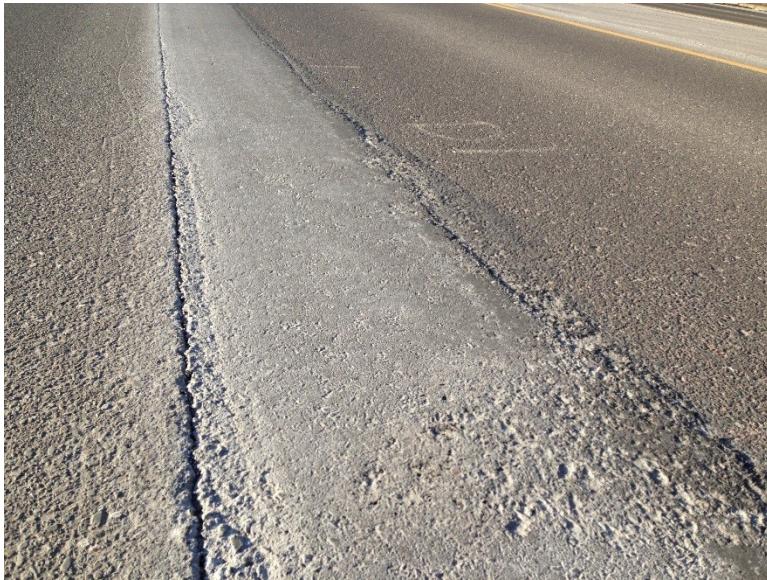
Figure 3.67 Pothole D-1 (126 Days after Installation) with Deterioration along the Patch Interface.

The site visit on December 4, 2014 indicated that Both D-1 and D-2 had significant raveling of material along the interface of the patch and existing roadway (Figure 3.67). It is also shown in Figure 3.67 that some distresses have occurred along parts of the patch surface. The crack running underneath Patch D-3 has propagated through the patch and has a width varying between $\frac{1}{4}$ and $\frac{1}{2}$ inch.

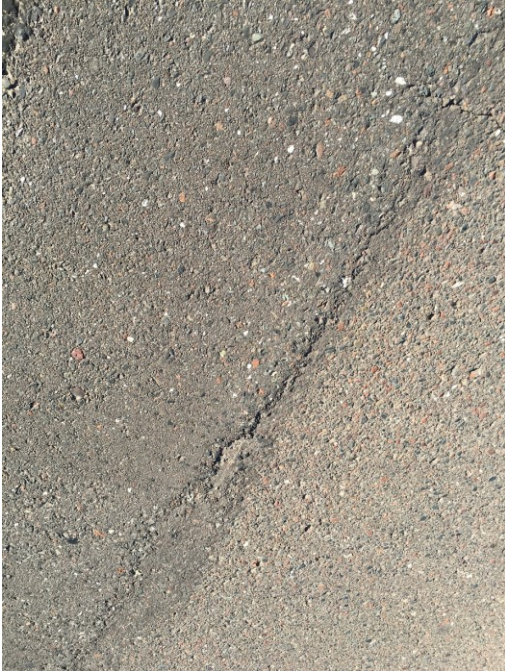
Figure 3.69 Pothole D-1 (446 Days after Installation).

Site visits conducted on July 29, 2015 and October 20, 2015 revealed that severity of the raveling did not increase in second year of service. See Figure 3.69 and Figure 3.70. It was also discovered that the cracks that had propagated through and along the edges of the patches had been sealed sometime during the summer of 2015 (Figure 3.70 and Figure 3.71). This probably helped in arresting the raveling in the year two.

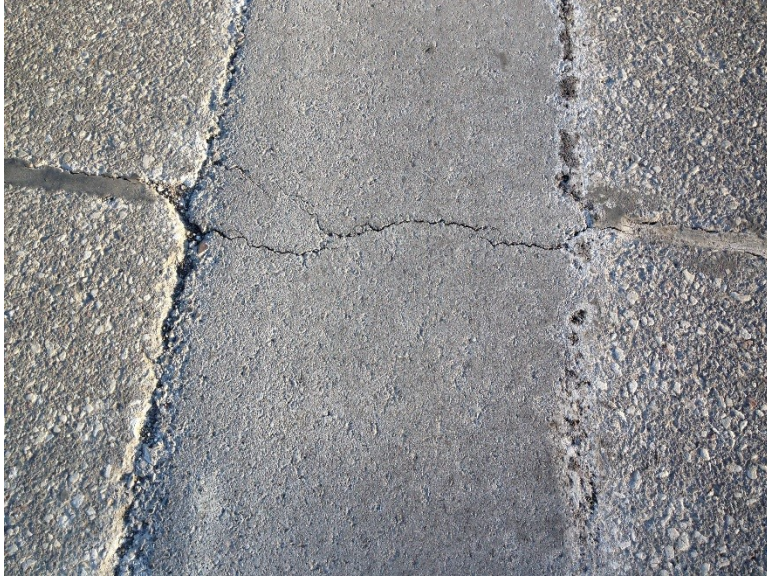
Figure 3.82 Cracking of Pothole E-3 (119 Days after Installation).

the year was made on December 4, 2014. Figure 3.82 to Figure 3.85 show that a significant amount of damage had occurred to the patch material including cracks and raveling along the patch interface.
