# **Phased Array Ultrasonic Steel Corrosion Mapping for Bridges and Ancillary Structures**

**Barritt Lovelace, Principal Investigator**  
Collins Engineers, Inc.

**August 2017**

Research Project  
Final Report 2017-33

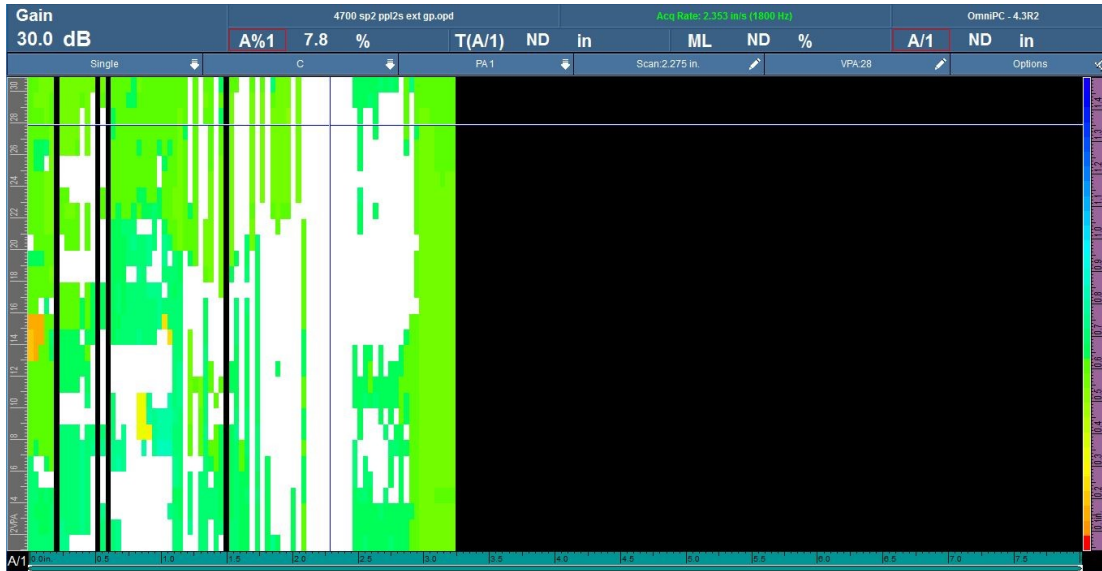
As part of this research study and the fracture critical bridge inspection corrosion measurements were taken at the bottom flange of a floor beam at a horizontal gusset plate. Three C-Scans were performed and are shown below. The C-Scans show the thickness of the member at various locations. The colors

on the scan represent different thicknesses as depicted on the scale to the right. The white areas depict missing data from the scan.

Figure 4.2 Sorlie Bridge Gusset Plate C-Scan.

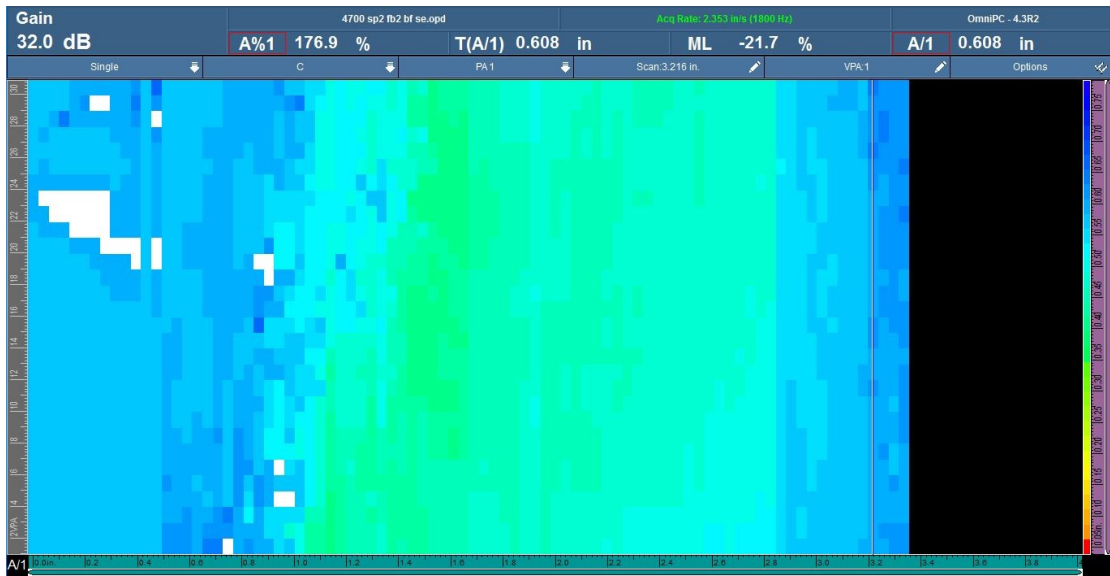
Figure 4.3 Sorlie Bridge Floor Beam 2 Bottom Flange Southeast C-Scan.

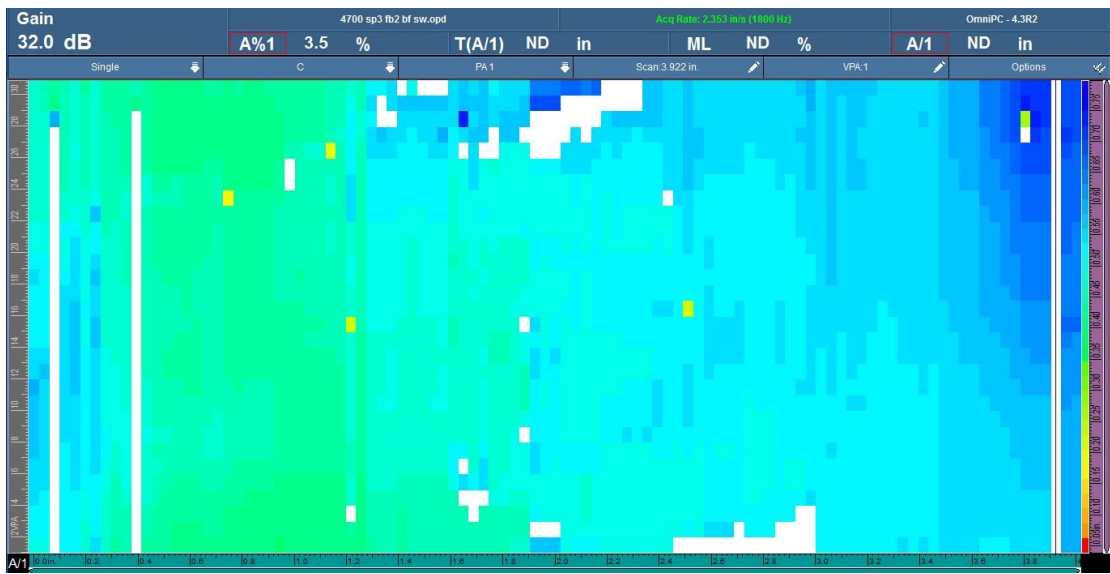
Figure 4.4 Sorlie Bridge Floor Beam 2 Bottom Flange Southwest C-Scan.

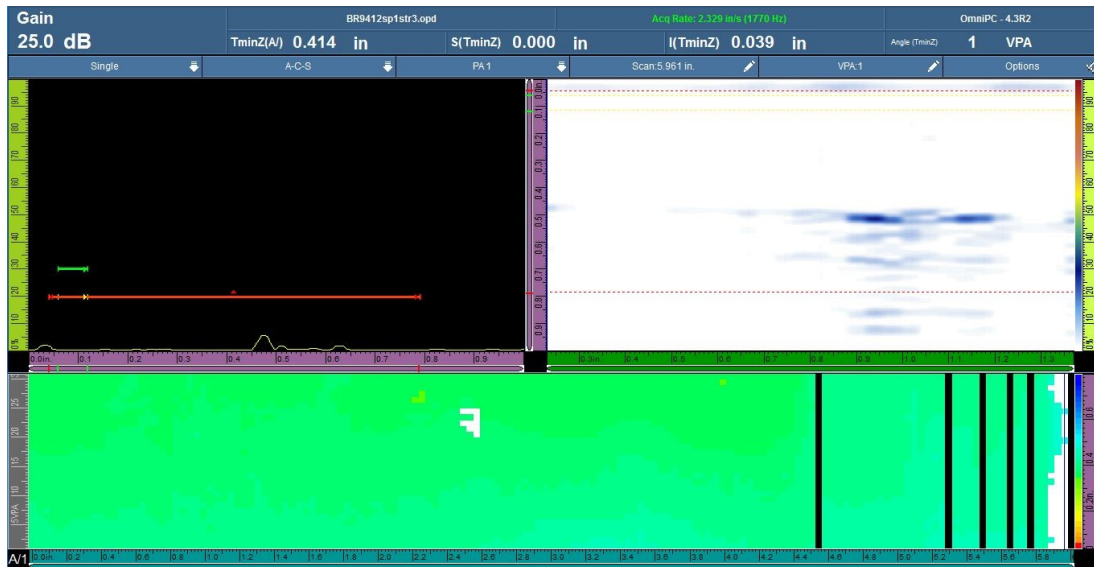
As part of this research study a stringer splice plate was scanned with the Phased Array Ultrasonic System to map the corrosion of the steel member. Two scans were performed and are shown below.

Figure 4.6 Baudette Bridge Stringer Splice Plate Scan 1.

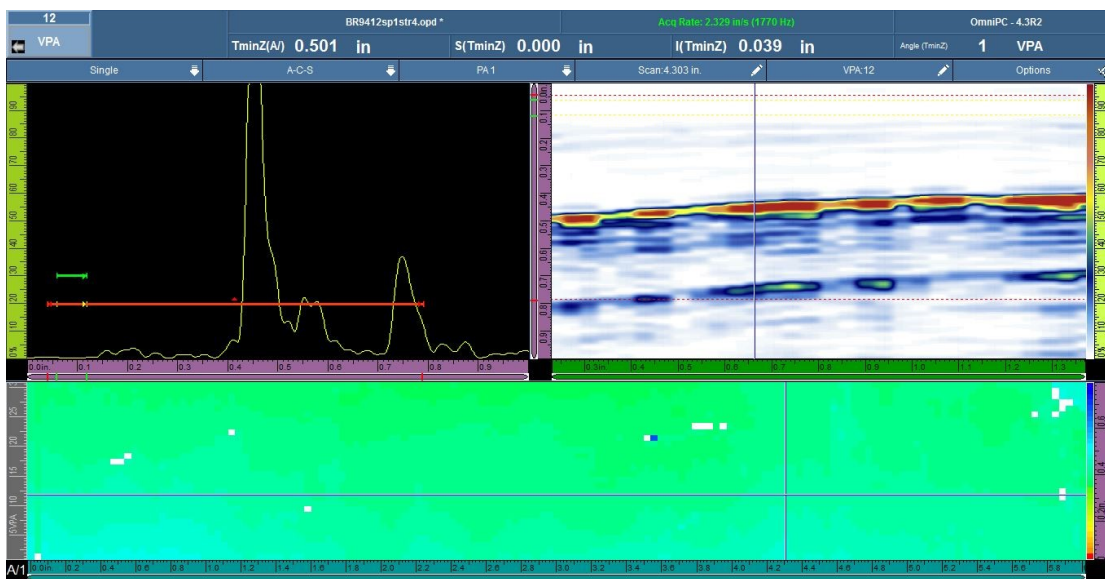
Figure 4.7 Baudette Bridge Stringer Splice Plate Scan 2.

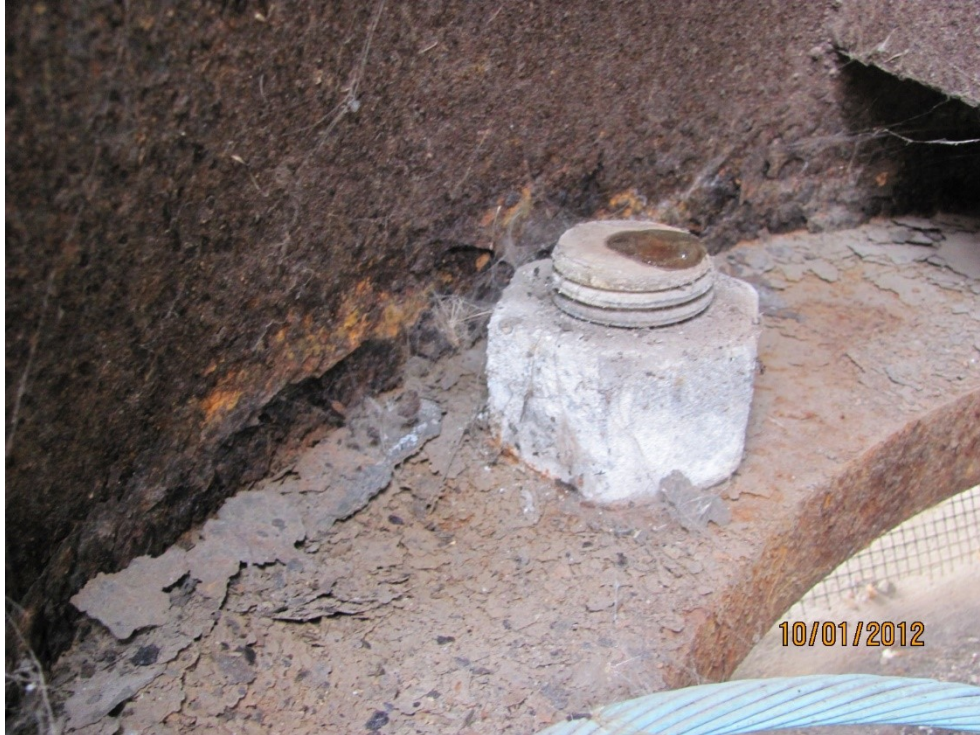
Figure 4.9 Duluth High Mast Light Interior Corrosion Photo.

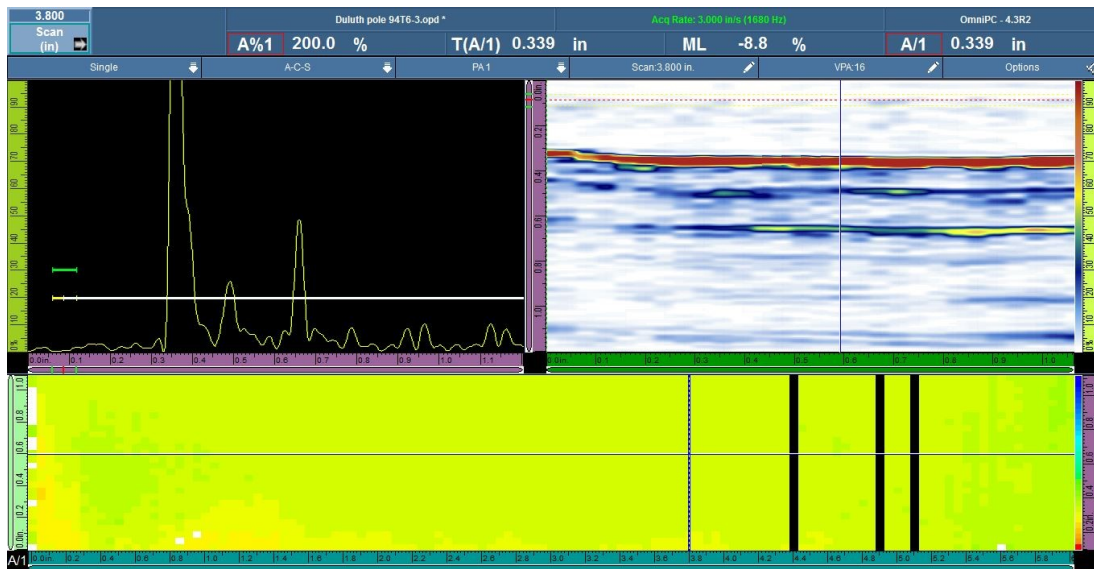
As part of this research study the base of the high mast light was scanned with the Phased Array Ultrasonic Testing System to map the corrosion. The resulting scan is shown below.

Figure 4.10 Duluth High Mast Light Scan.

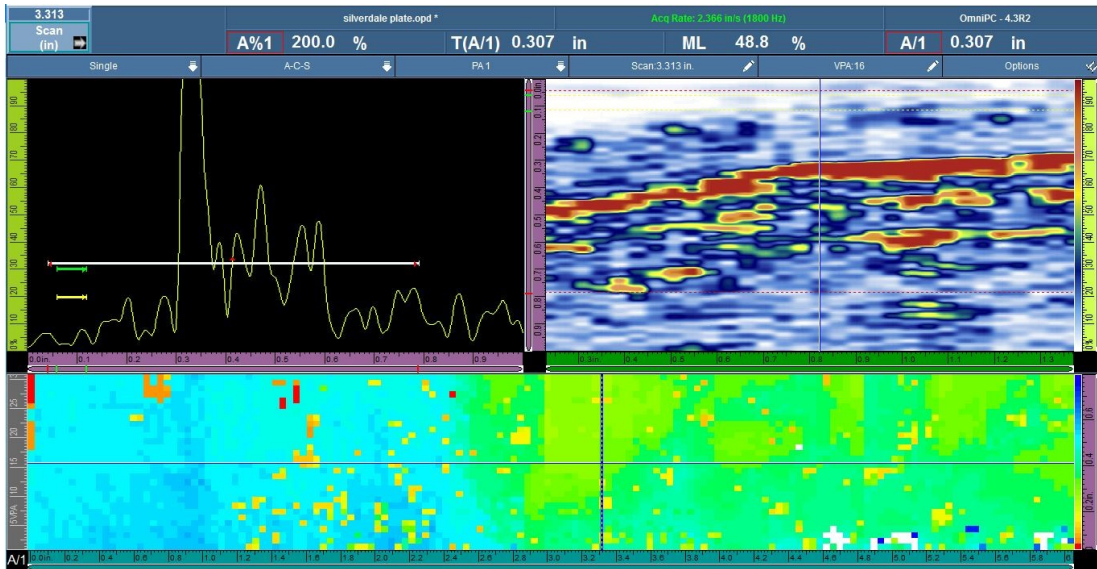
As part of this research study corrosion scanning was performed on the Silverdale Bridge Test Specimen. The results of the scan are shown below.

Figure 4.12 Silverdale Bridge Test Specimen.
