In-Service Evaluation of High Tension Cable Barrier Systems

Kentucky Transportation Center Research Report – KTC-17-17/SPR16-526-1F

April 2017

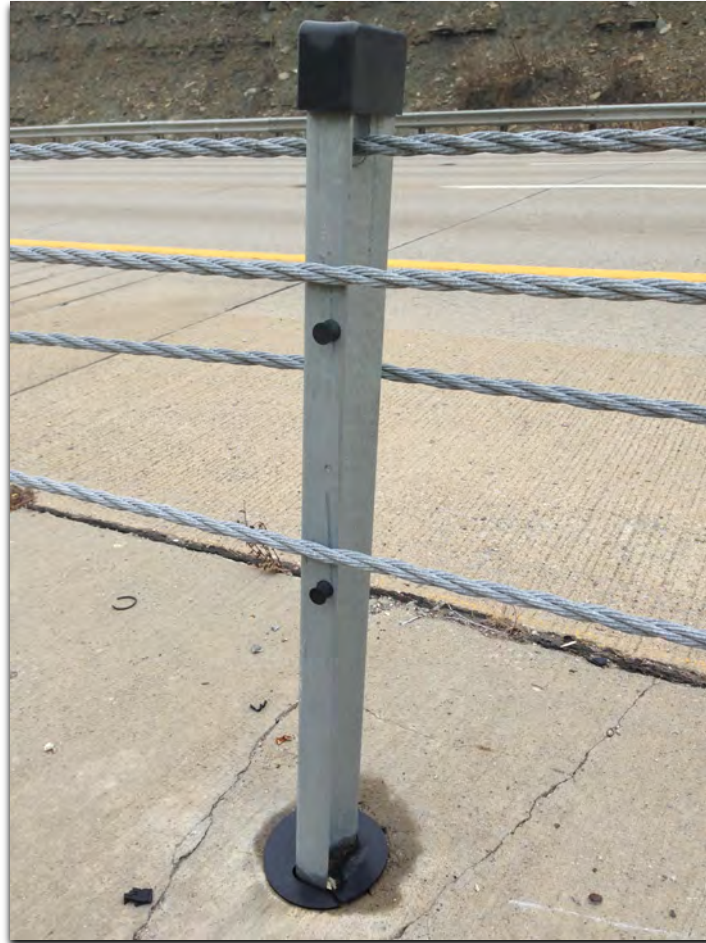
Figure I: Excessive Rope Heights (due to lack of vertical restraint, Brifen)

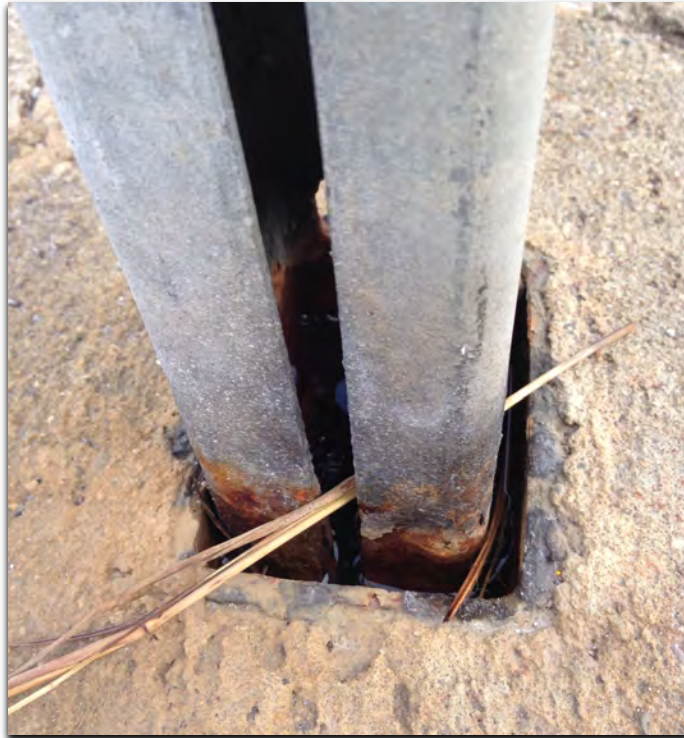
KTC researchers conducted numerous field investigations during the course of this study. Several inspections revealed instances where posts had begun rusting underneath the ground line. This was the result of water runoff accumulating in the post base, resulting in a prolonged exposure between the steel and water. The research team speculated that many of these same posts had not been replaced since their initial installation, leaving them more susceptible to rusting. It was also noted that these posts sometimes split—rather than bend—during the crash event. However, the site surveys did not provide any evidence of physical post separation (e.g., projectile motion) at these locations. If separation should occur, there could be a potential for the post to impact another secondary vehicle. Two different post configurations with sub-surface rusting conditions are displayed in the figures below.

Figure Q: Gibraltar post with rust due to water intrusion

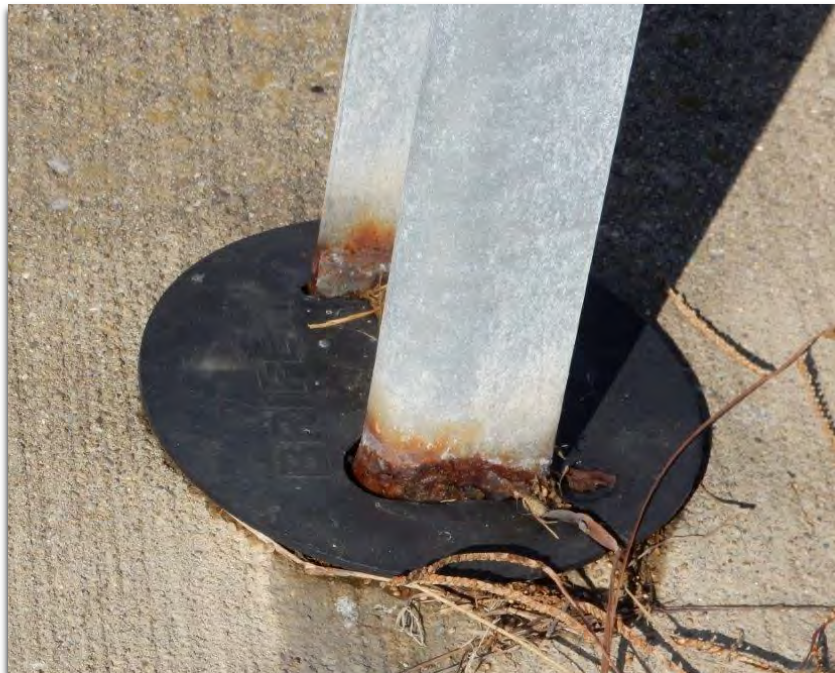
Figure R: Brifen post with rust due to water intrusion

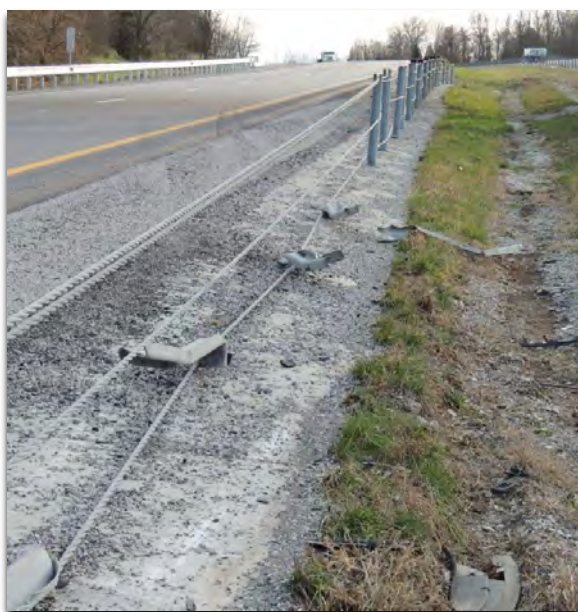
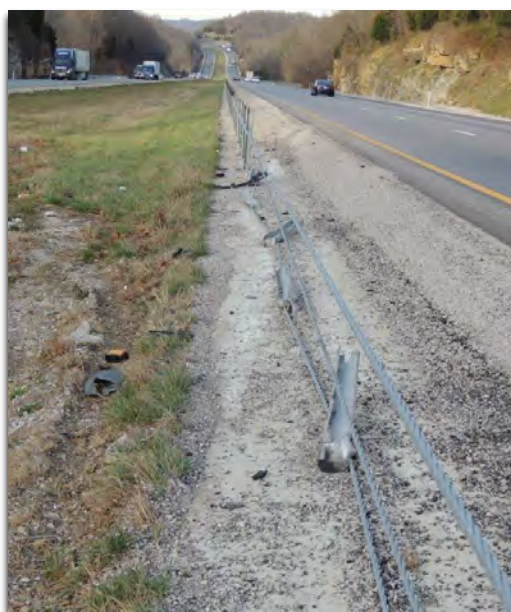
Description: Tire marks show that the BMW 325i impacted the cable barrier adjacent lane of travel at a shallow angle with eight posts down and the cable deflection up to about five feet. Two of the four cables were on the ground. The tire marks show that the vehicle was redirected back into the road. There was no reported injury for the unrestrained driver.

Damaged Brifen CMB section

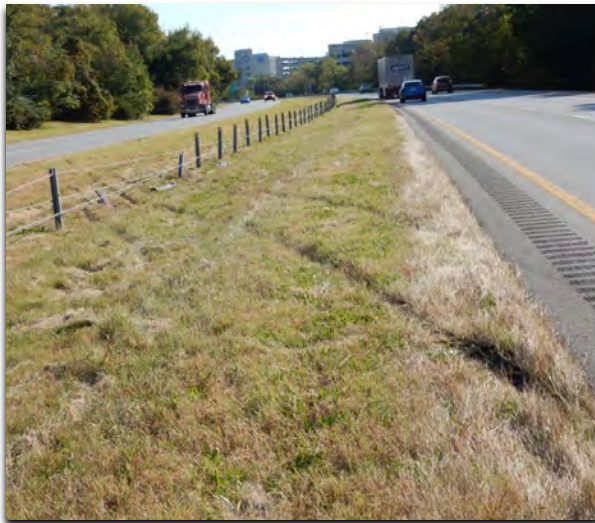
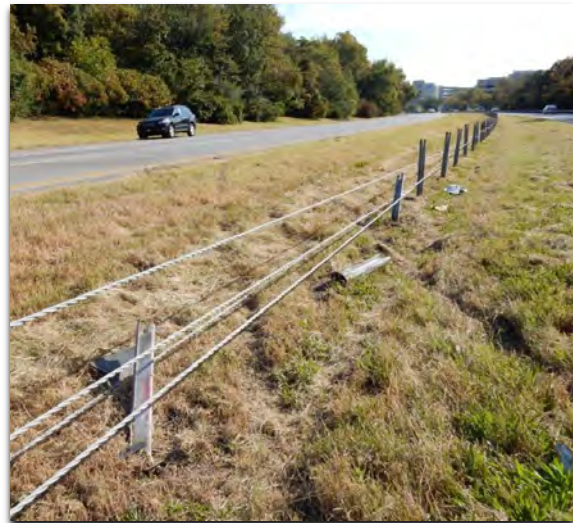
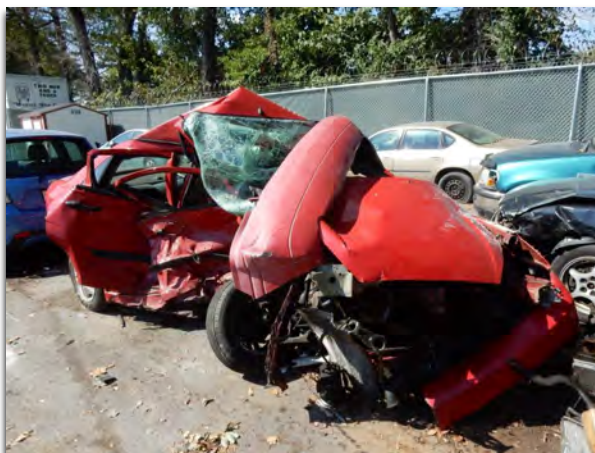
Description: Tire marks show that a Ford Focus exited the road a shallow angle and crossed the depressed grass median (at an angle of about 50 degrees). After crossing the median the vehicle went through the cable barrier entering the opposing lane. This resulted in an angle impact with an opposing vehicle (Mercedes Benz E420). The impact to the passenger side of the Ford Focus resulted in major intrusion into the vehicle and injuries to both drivers. There was paint transfer to the three posts damaged as the car traveled through the cable. It was noted that the cable was installed at a lower elevation than the location where the vehicle entered the median and just past the lowest point in the median.

Damaged Brifen CMB section

Vehicle that made impact with Brifen CMB section

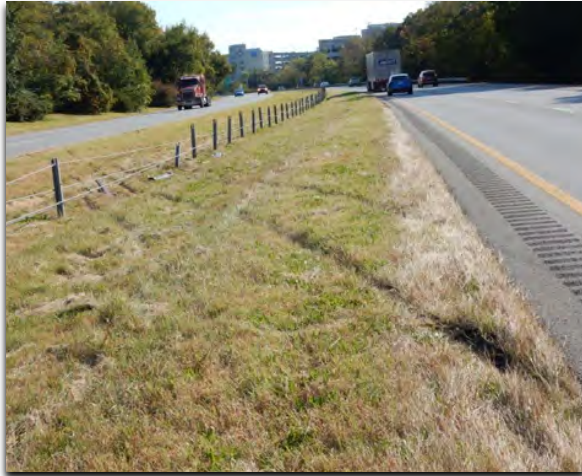
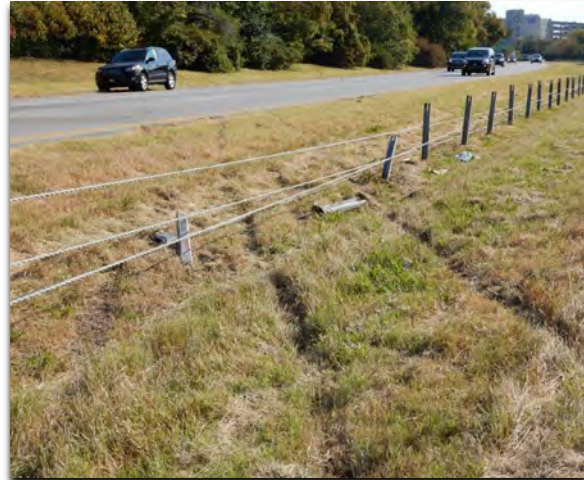
Description: Tire marks show the driver of a Jeep Grand Cherokee oversteered with the vehicle entering and crossing the median at a substantial angle. There was damage to four posts as the vehicle traveled over the cable and overturned into the opposing lanes. There was no impact with another vehicle. The cable was installed at a lower elevation than the point where the vehicle entered the median. No injuries were reported.

Damaged Brifen CMB section

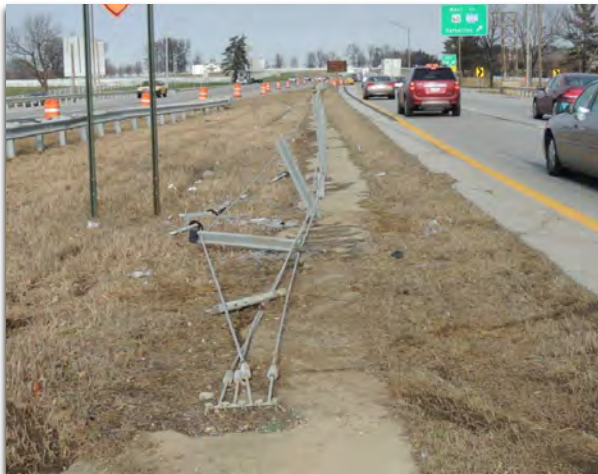
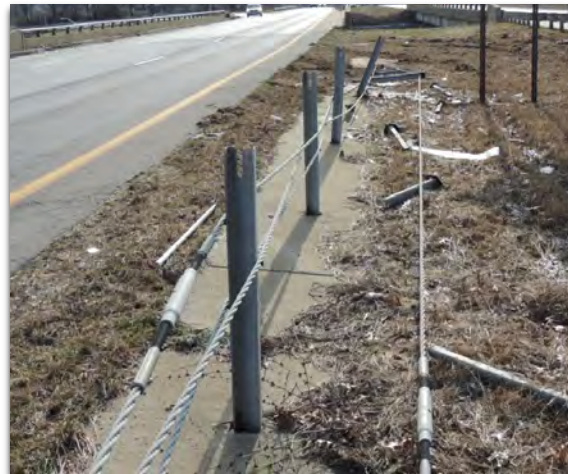
Description: There were two impacts (Jaguar XJ6 and Chevrolet CK2500) within a few minutes where a vehicle lost control on an icy bridge and contacted the end portion of the cable barrier. There was no injury from either contact. The anchor remained intact with damage to the first four posts. Tension was maintained past the area of contact.

Damaged Brifen CMB section

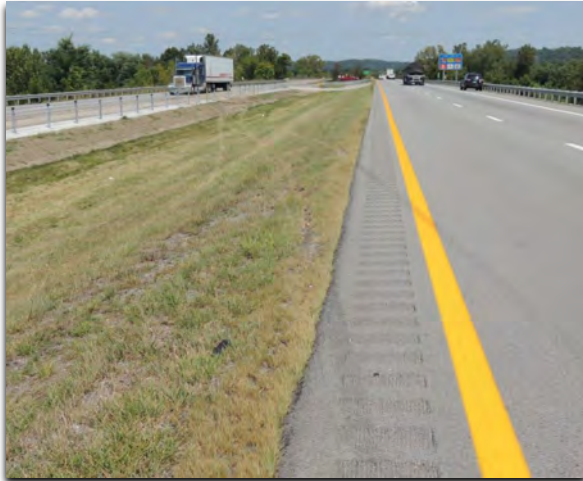
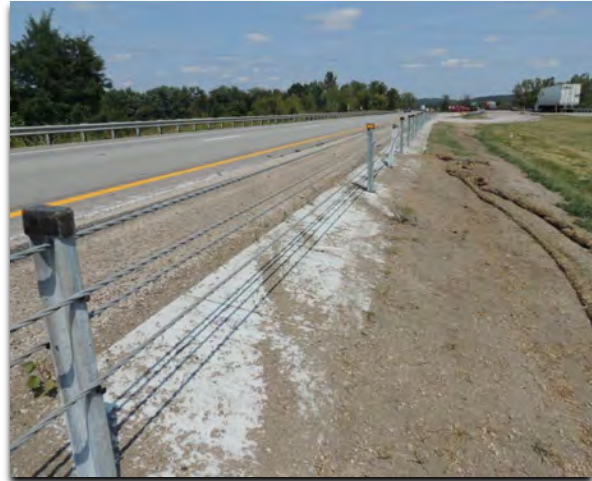
Description: A Lexus ES300 traveled through the median and contacted the cable barrier with the vehicle overturning in the median. The unrestrained passenger sustained fatal injuries when ejected. There was damage to only two posts with tension maintained.

Damaged Brifen posts

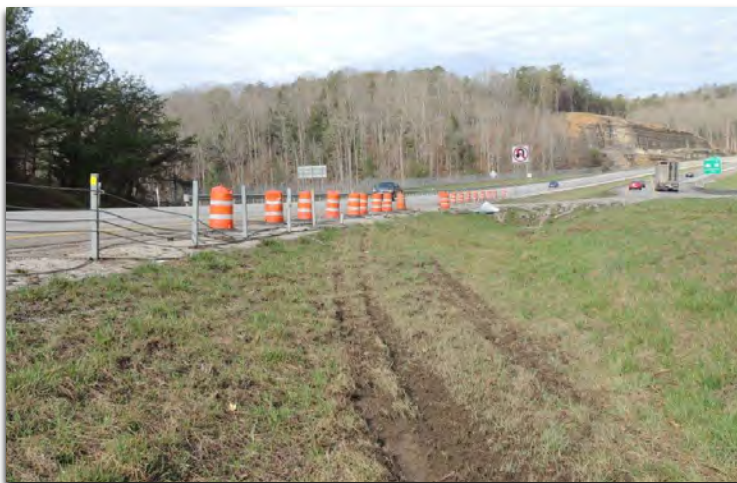
Description: A Ford F150 crossed the grass median and struck the end of the cable barrier at a crossover. The truck continued past the crossover and struck the end of the cable barrier on other side of the crossover. The first impact damaged seven posts with the second damaging 16 posts. The cables became detached from both end anchors. There was a loss of tension for a substantial distance (up to about one mile). The truck overturned in the median with minor contact to the passenger side of an opposing vehicle. There were minor injuries reported.

Damaged Gibraltar CMB section

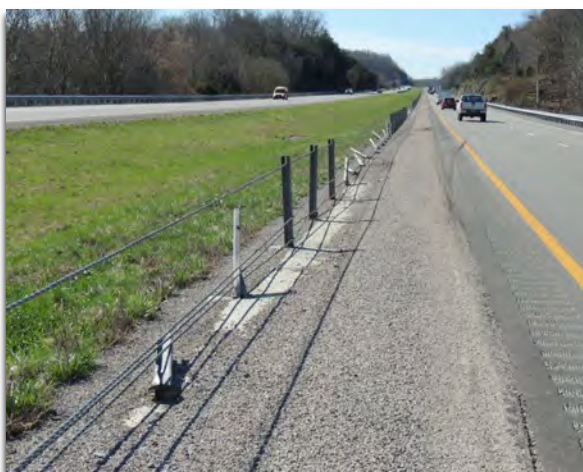
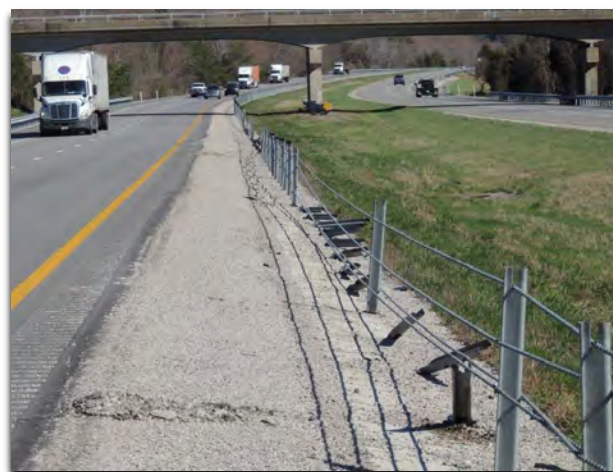
Description: A GMC Yukon struck the cable barrier adjacent to its lane of travel and rotated back into the road. It was struck with a Honda Accord with both vehicles hitting the cable. There was a total of 30 posts damaged divided in five sections (with undamaged posts between the damaged sections). The rotation of the vehicle in the initial impact and the second impacts explain the gaps in the post damage. Two injuries were reported.

Damaged Brifen posts

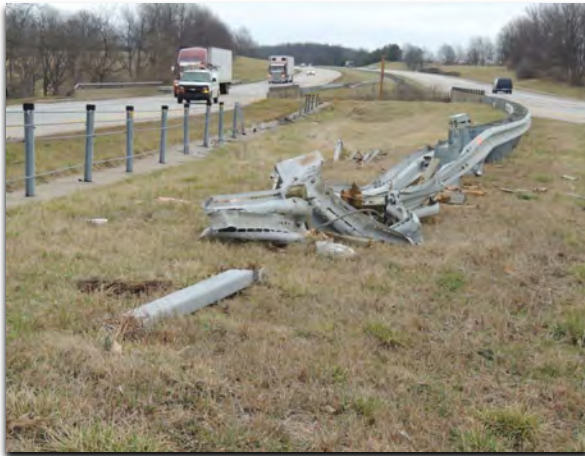
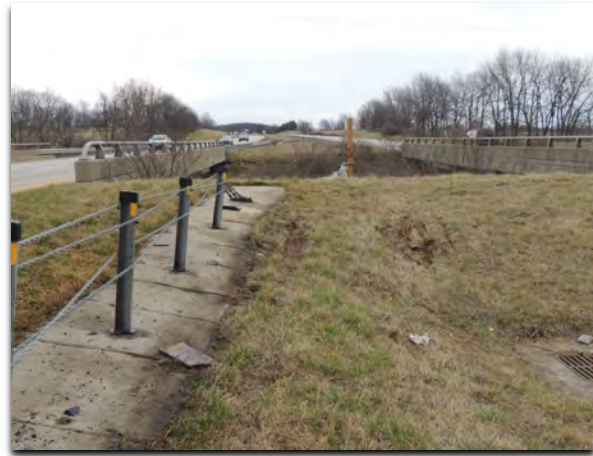
Description: A Peterbilt tractor traveled into the median after a sideswipe collision. The truck crossed the median and impacted the cable barrier resulting in damage to 10 posts. The truck was directed down the median where it traveled into the gap between two bridges and vaulted to the roadway below the interstate. One injury was reported.

Damaged Brifen posts

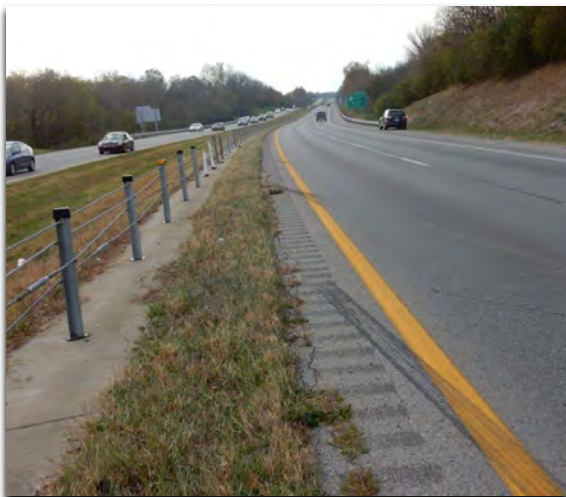
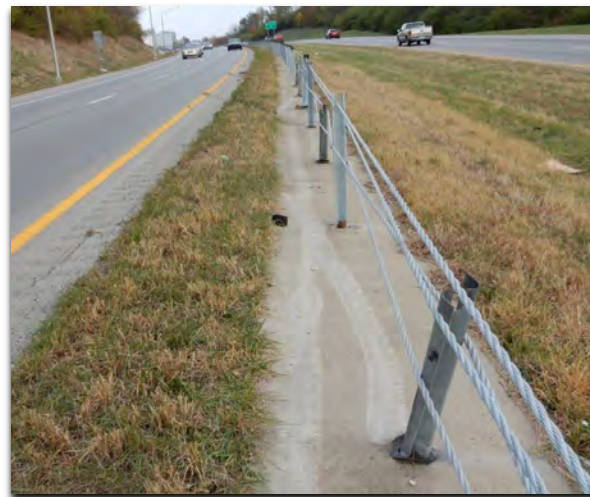
Description: A Ford Focus rotated into the cable barrier adjacent to the travel lane. There was damage to four posts with the vehicle rotating to final rest in its travel lane. There was no reported injury.

Damaged Brifen posts

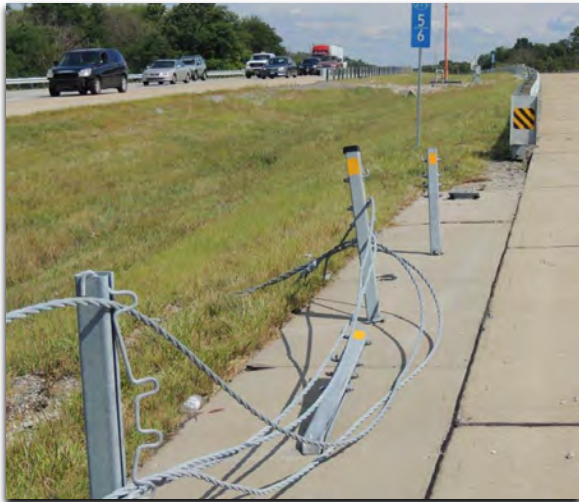
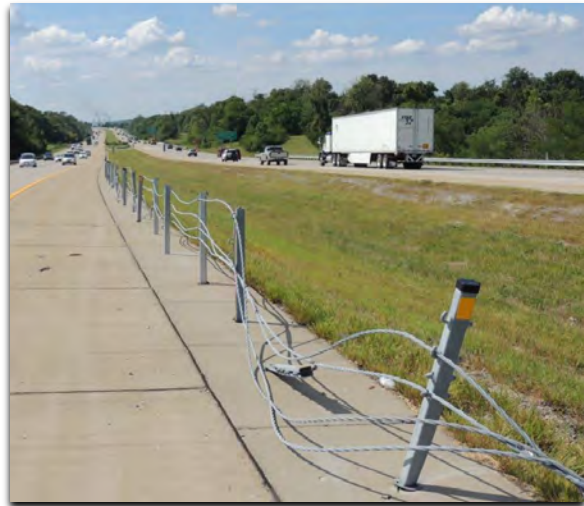
Description: A Ford Focus contacted the cable barrier within four posts of the trailing end anchor. The anchor became unattached with loss of tension in the complete 0.2-mile cable barrier section. The repair was conducted on September 11, 2015 with a cost of \$1,785. There was no reported injury.

Damaged Gibraltar CMB section

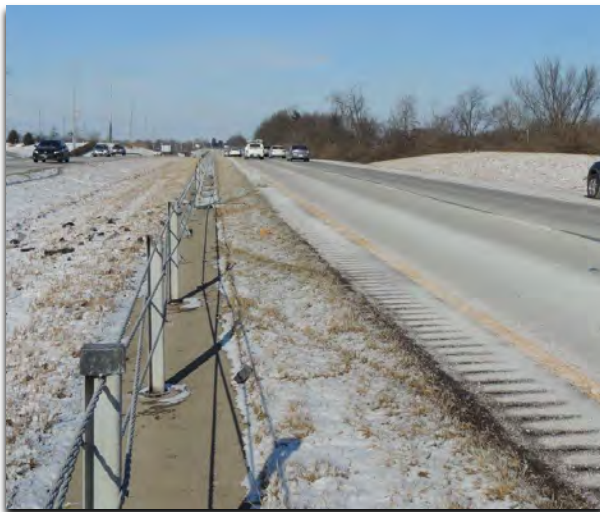
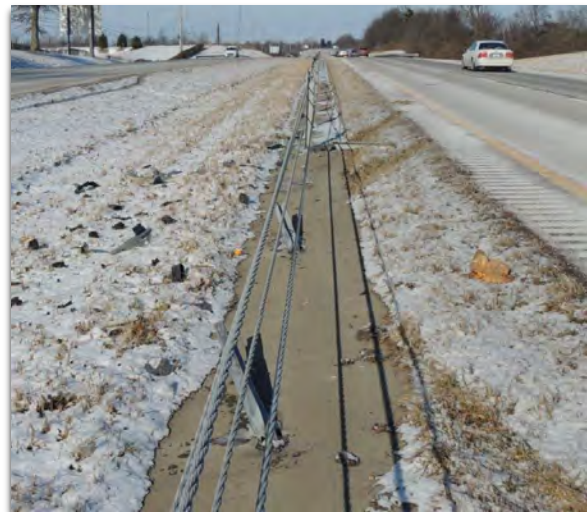
Description: A Lincoln LS passenger car slid on snow at a substance angle into the cable barrier adjacent to the direction of travel. There was damage to three posts with the car redirected back into the travel lanes. There was no reported injury.

Damaged Brifen CMB section

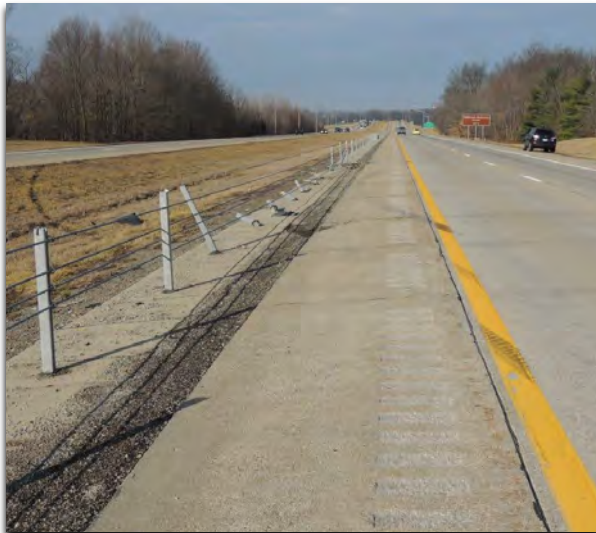
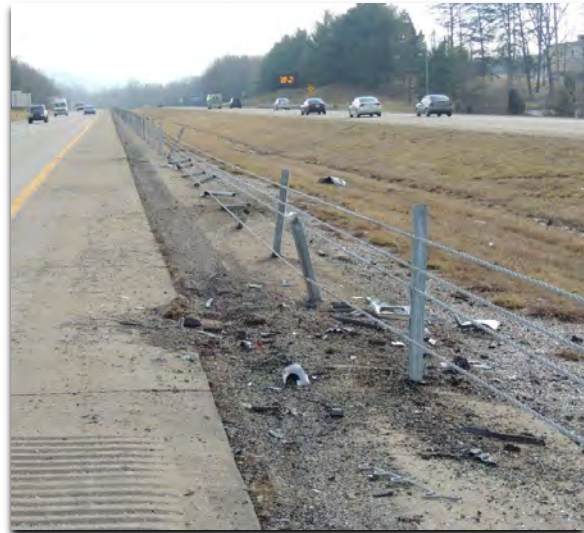
Description: A Mercury Mountaineer struck the cable barrier adjacent to the direction of travel at a moderate angle. There was damage to 10 posts with tension maintained. The vehicle was redirected in its travel lanes and overturned on its side. There was one reported injury.

Damaged Gibraltar CMB section

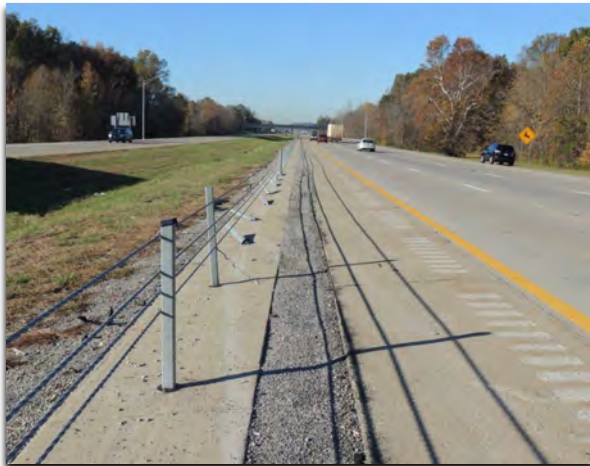
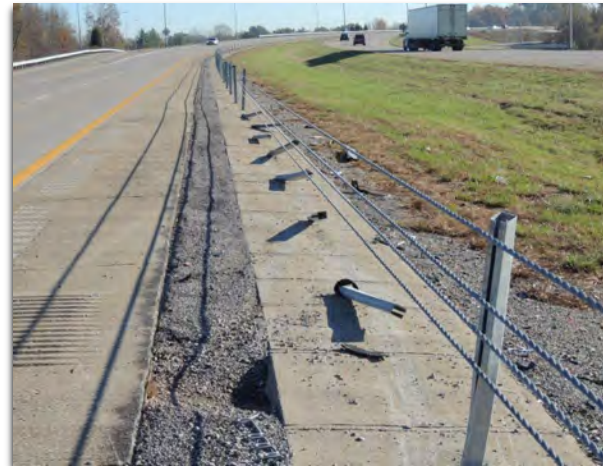
Description: A Nissan Sentra struck the cable barrier adjacent to its lane of travel and was redirected back across the road. There was damage to eight posts with the cable tension maintained. The repair was conducted on November 4, 2015 with a cost of \$1,200. There was no reported injury.

Damaged Gibraltar posts

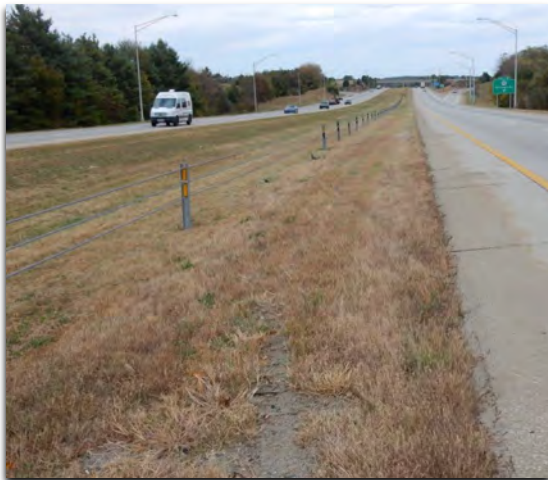
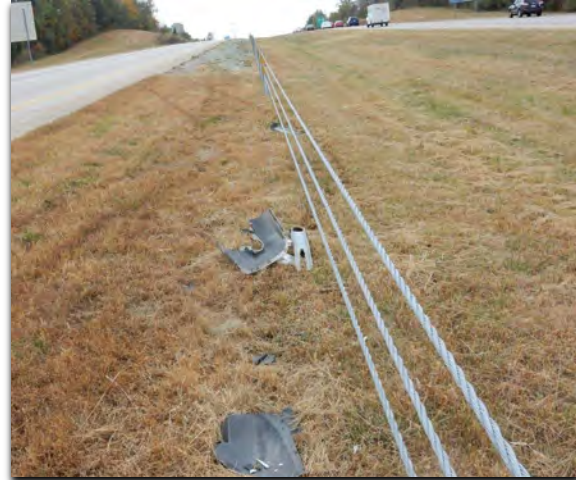
Description: A Chrysler PT Cruiser left its lane of travel at a moderate angle (about 15 degrees) and contacted the cable barrier located in the median closer to its side. The vehicle damaged two posts and was redirected to its final rest position in the median. Tension was maintained. There was no reported injury.

Damaged Trinity posts

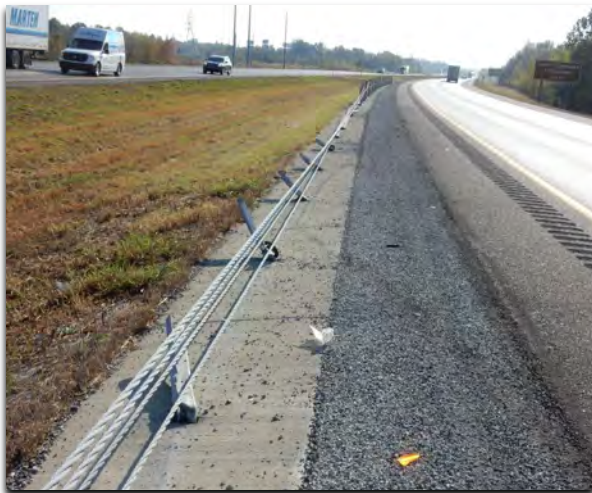
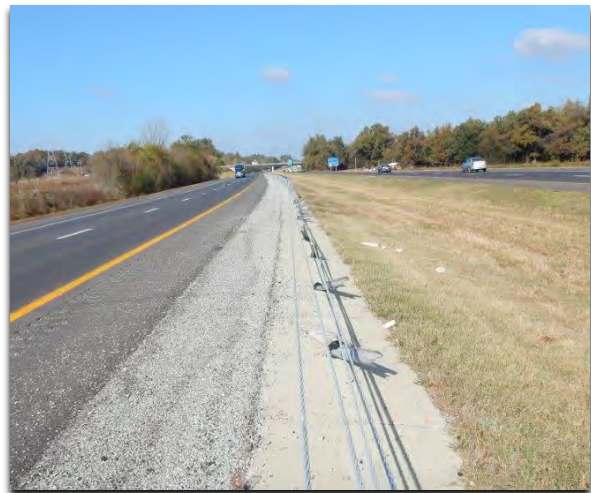
Description: A Toyota Camry contacted a cable barrier adjacent to its lane of travel after a minor contact with a truck. The impact angle was about 20 degrees with 11 posts down. There was a loss in tension with two cables on the ground. There was no reported injury.

Damaged Brifen CMB section

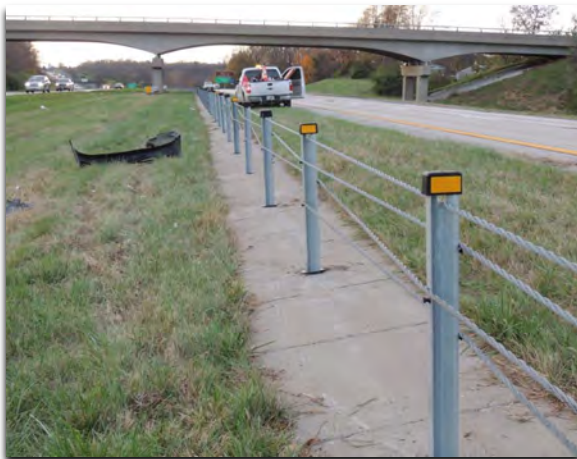
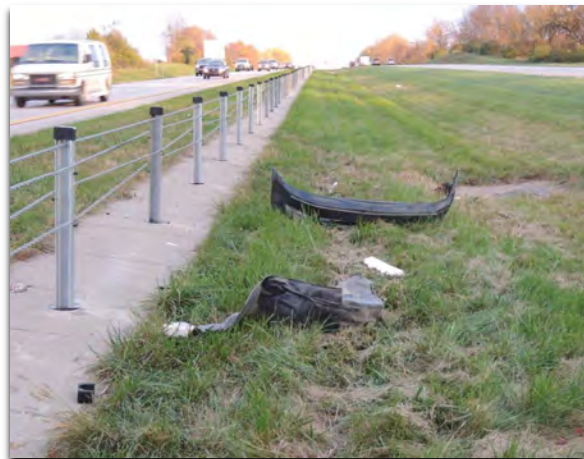
Description: A Toyota Avalon contacted the cable barrier adjacent to its travel lane at a shallow angle. There was damage to 11 posts and a deflection of seven feet. The repair was conducted on November 4, 2015 with a cost of \$2,760. There was no reported injury.

Damaged Brifen posts

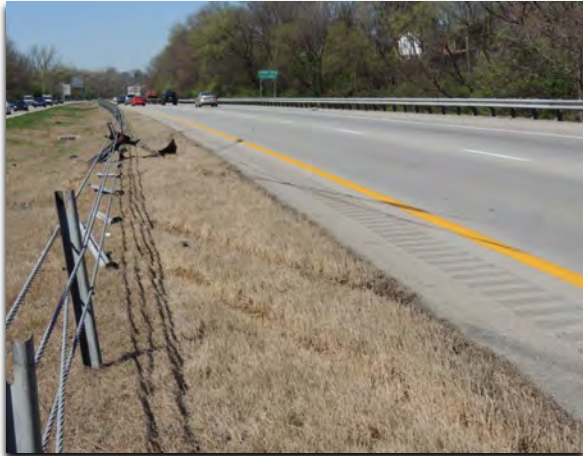
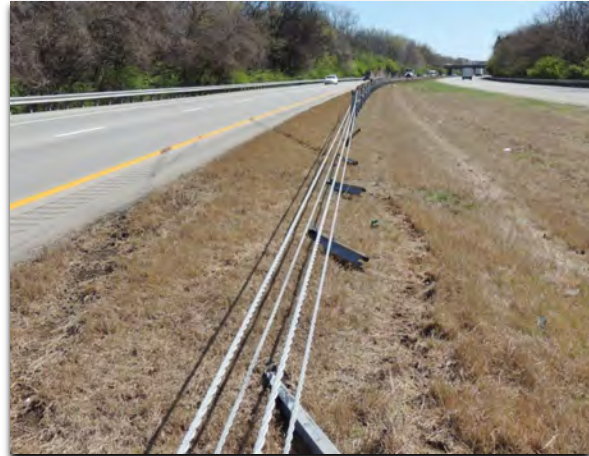
Description: A Toyota Camry traveled at a moderate angle and contacted the cable barrier located closest to its direction of travel. The cable was deflected several feet and maintained tension. The tire tracks shows the vehicle rotated back into its lanes of travel. There was no reported injury.

Damaged Brifen CMB section

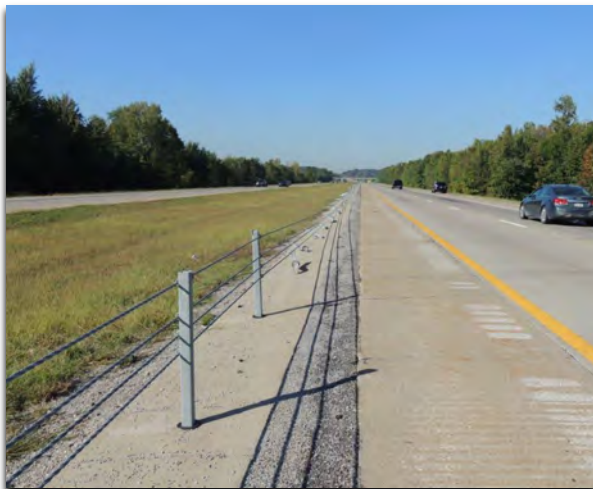
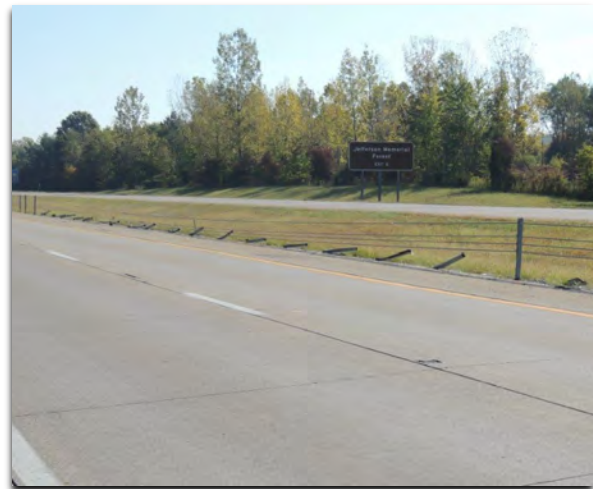
Description: An Isuzu Rodeo contacted the adjacent cable barrier after a tire failure. There was damage to 25 posts. Tension was not maintained in the impact area. The repair was conducted on October 21, 2015 with a cost of \$4,050. There was no reported injury.

Damaged Gibraltar posts

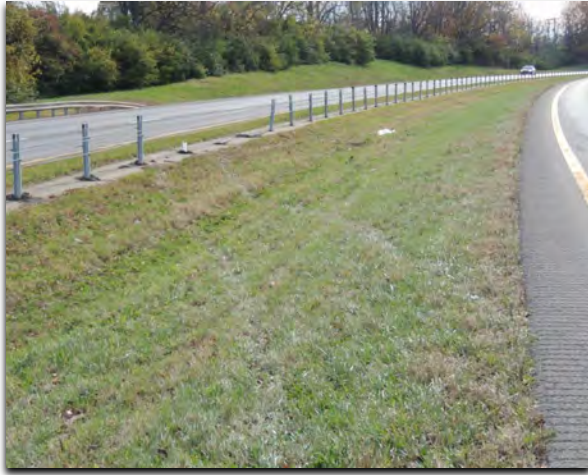
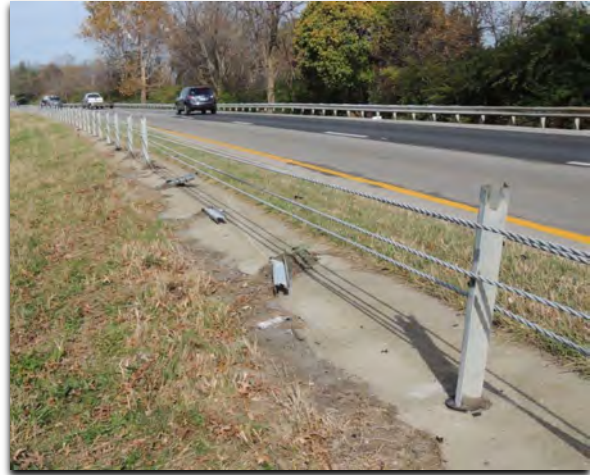
Description: A Toyota Camry rotated across the median impacted the cable barrier with resulting damage to three posts. The final rest position of the vehicle was in the median. There was no reported injury.

Damaged Brifen posts

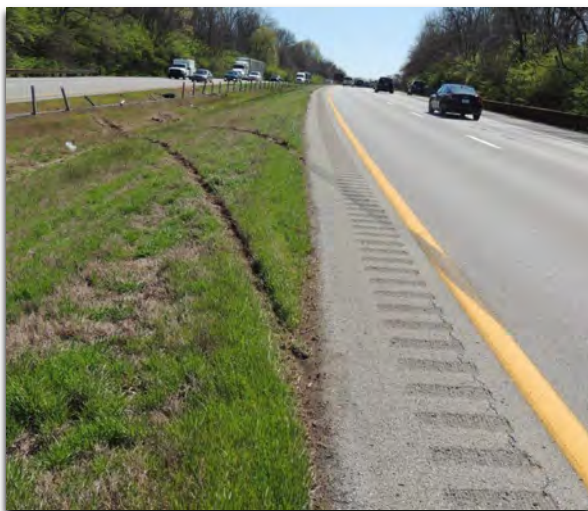
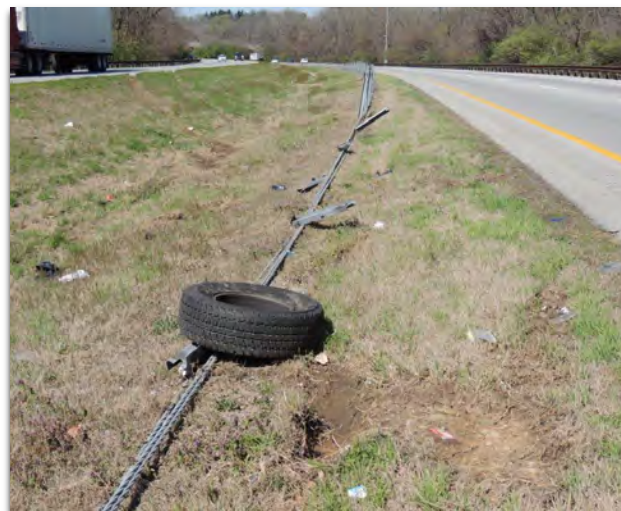
Description: A Chevrolet Tahoe crossed the median and overturned over the cable into the opposing lane. The vehicle rotated into the median. There was damage to four posts. The vehicle traveled about 75 feet to the bottom of a slope where it started to roll and traveled over the cable. The cable was at a lower location than the lanes the vehicle exited. The unrestrained driver was ejected and injured.

Damaged Brifen CMB section

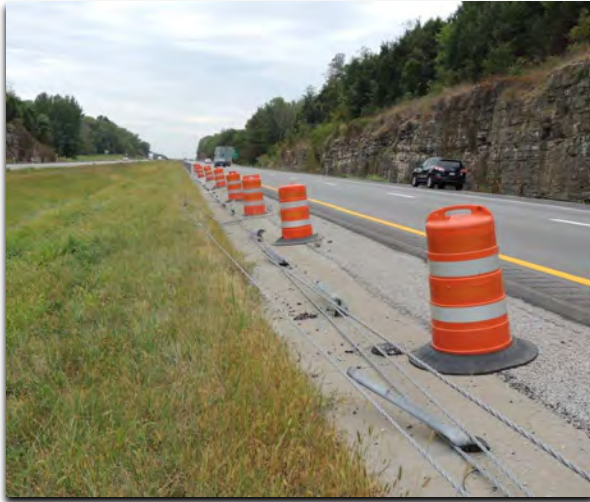
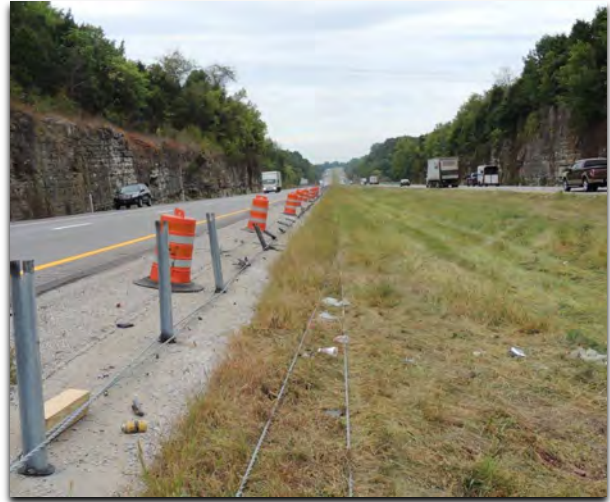
Description: A Toyota 4Runner collided with the cable barrier adjacent to its lane of travel. There was damage to 29 posts with the vehicle overturning into the median. The cable was pushed down to the turf with the vehicle traveling over the cable. The driver sustained fatal injuries. The repair was conducted on September 11 with a cost of \$7,300.

Damaged Brifen CMB section

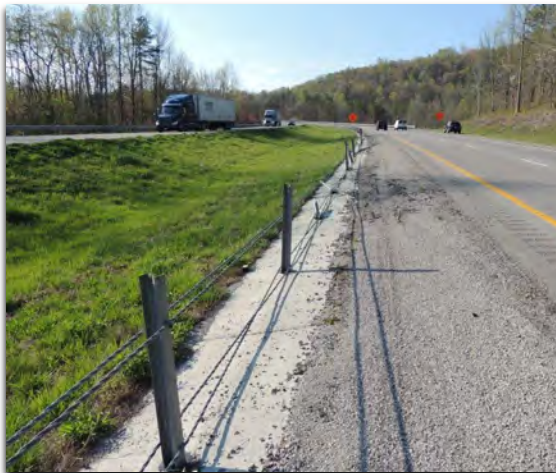
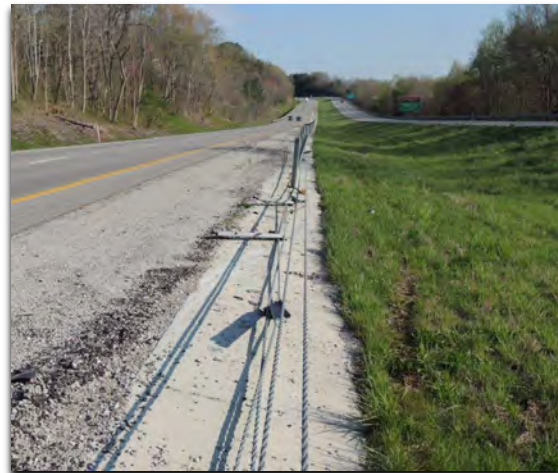
Description: A Chevrolet Blazer collided twice with the cable barrier adjacent to its lane of travel first after steering to avoid a truck and then after sideswiping the truck. There were three posts down and then, after no contact with three posts, the next six posts were down. The vehicle stopped adjacent to the cable barrier. There was no reported injury.

Damaged Brifen posts
