Proposal for Monitoring Concrete Painting as a Preventive Maintenance Tool (Abutments and Pier Caps)

KTC-TA-17-03/IPN16-57-8

Technical Assistance Report
KTC-TA-17-03/IPN16-57-8

July 2017

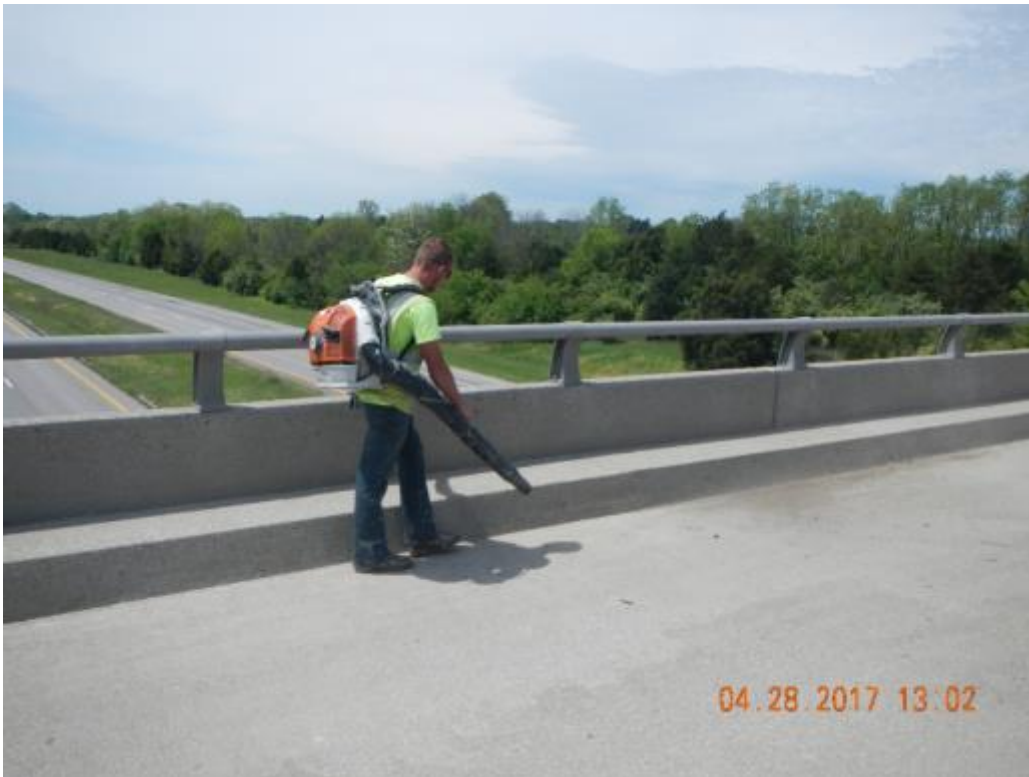
The wash crew was far ahead of the painting crew after a few days. As a result, the painting crew could not comply with the application requirement of coating within 72 hours of washing. A leaf blower was used prior to painting to remove any loose debris that had accumulated due to wind and traffic (Figure 3).

Figure 3 Removing debris with leaf blower

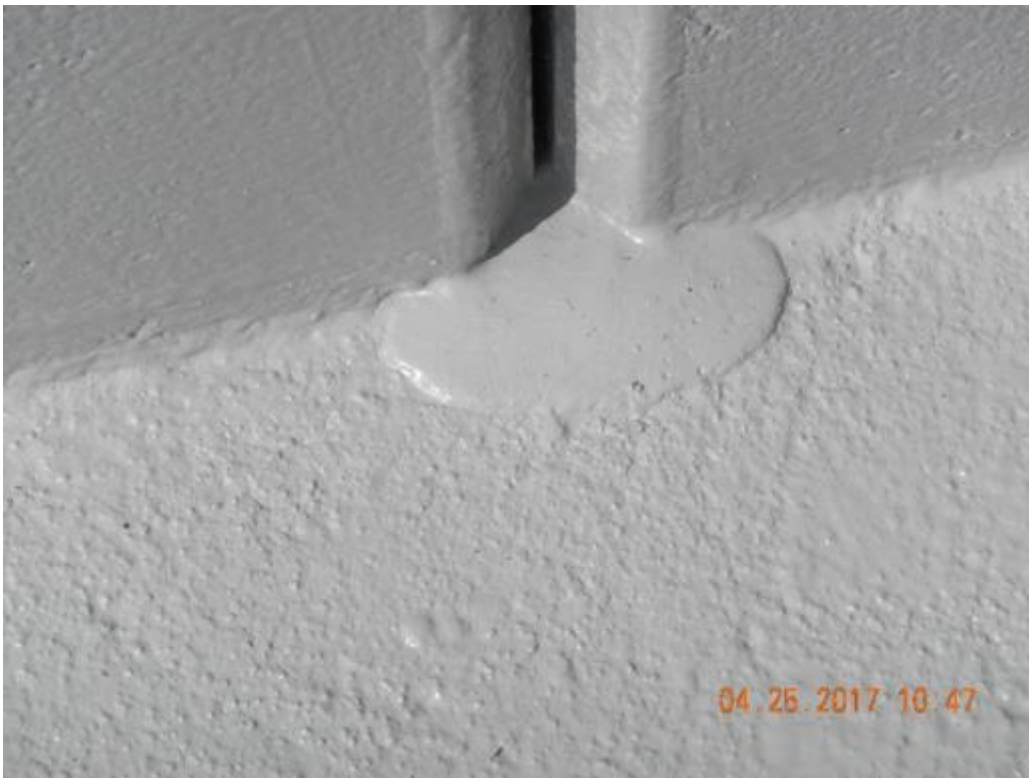
This was the first of two coats of the PPG Amerlock 400. The total recommended dry film thickness is 4 – 8 mils (4.7 – 9.4 WFT) after the application of both coats. The contractor started watching the WFT more closely on the second half of the bridge. The coating was much more consistent than initially observed, maintaining 4 – 6 mils; however, there were still numerous drips and runs, especially at the

joints in the barrier wall (Figure 4). A brush was used in an attempt to coat the bug holes that also left several runs.

Figure 4 Pooled coating due to severe run (notice pin holing)

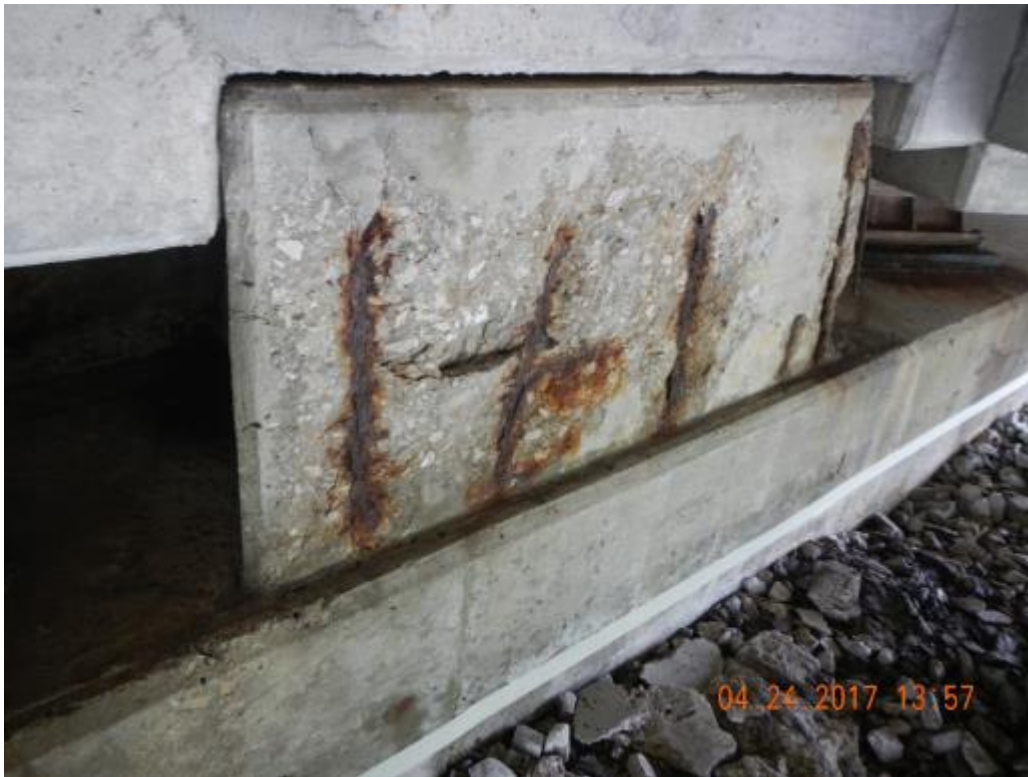
Pressure washing was complete approximately 96 hours prior to coating. The contractor continued to wash and coat in a similar fashion as the previous bridge. Although repair work was not within the scope of this project there were spalled areas with exposed reinforcement on the abutments that needed repair prior to coating (Figure 5). Washing these areas was not sufficient to remove stratified rust (Figure 6).

Figure 5 Spalled area on abutment after cleaning

9. Future KYTC concrete painting projects should incorporate repair of damaged concrete prior to the onset of coating work. That will typically entail the use of polymeric concrete repair materials as most cementitious repair materials require at least 14 days of curing prior to being painted over.

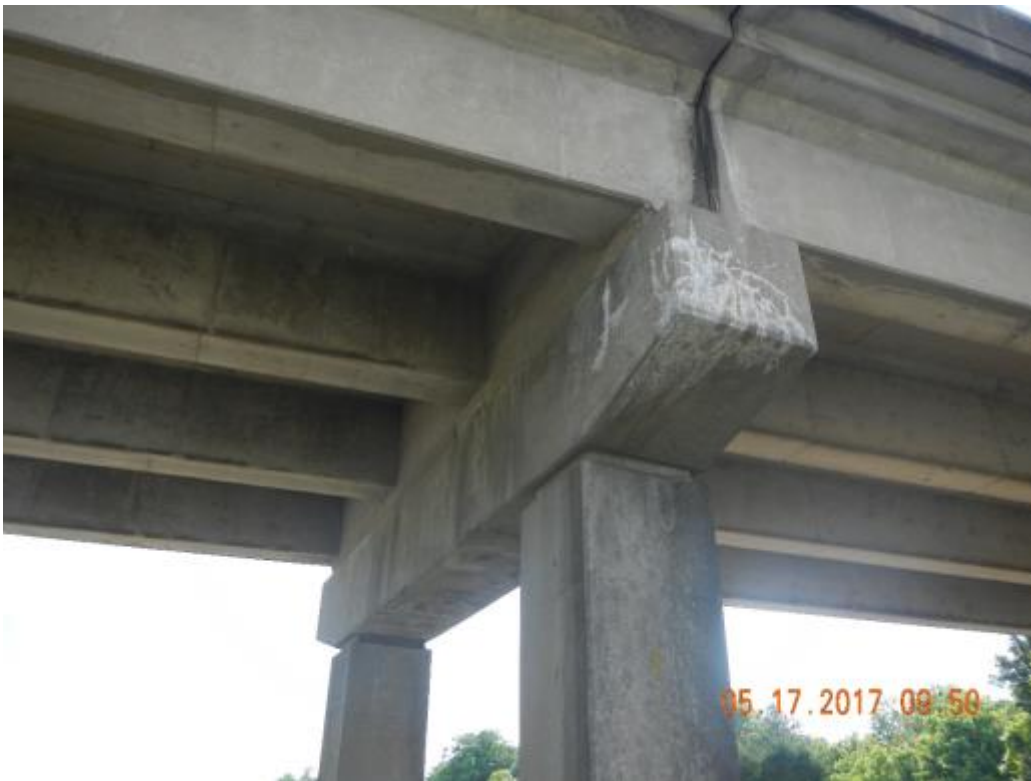
Pier 1 had a considerable amount of efflorescence remaining after pressure washing was complete (Figure 10). The crew had little success removing it with a small scraper. These areas were coated. Coating proceeded in a similar manner as the barrier walls and abutments. Each pier took approximately one hour per coat, including moving traffic control.

Figure 10 Efflorescence on pier cap after cleaning

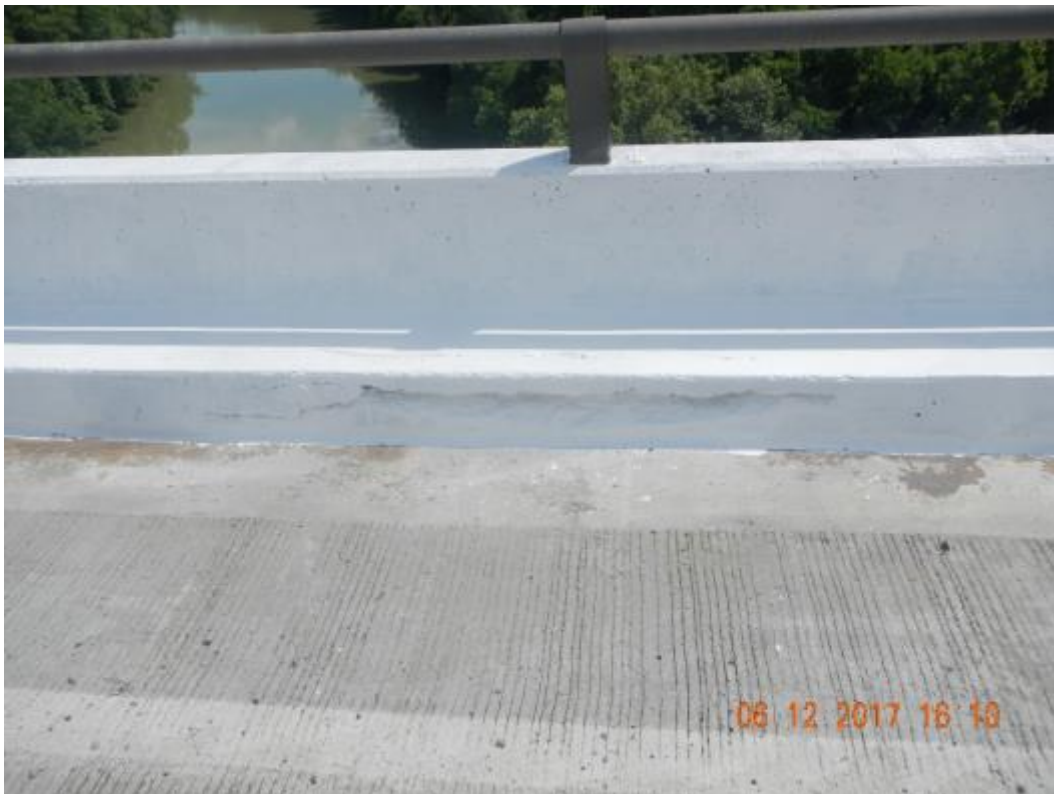
Figure 12 Spalled concrete

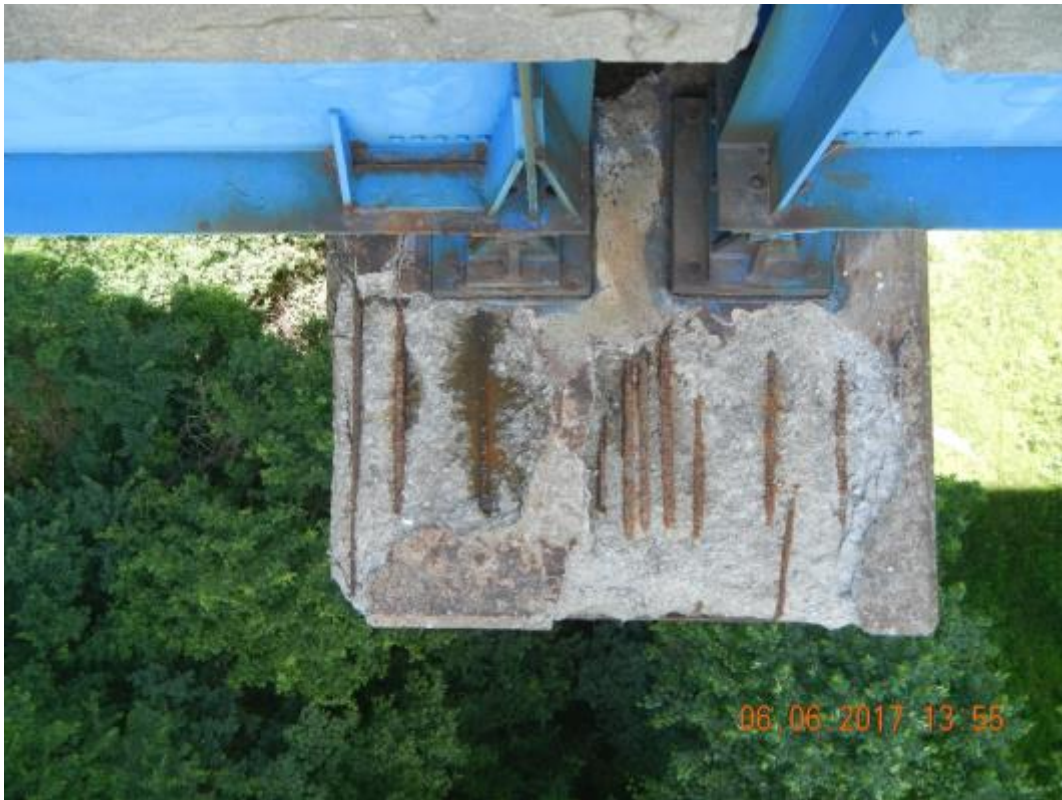
Figure 13 Pier cap with severe spalling (post washing)
