Continued Field Evaluation of Precutting for Maintaining Asphalt Concrete Pavements with Thermal Cracking

August 2017

INE/AUTC 17.17

FHWA-AK-RD-4000(155)

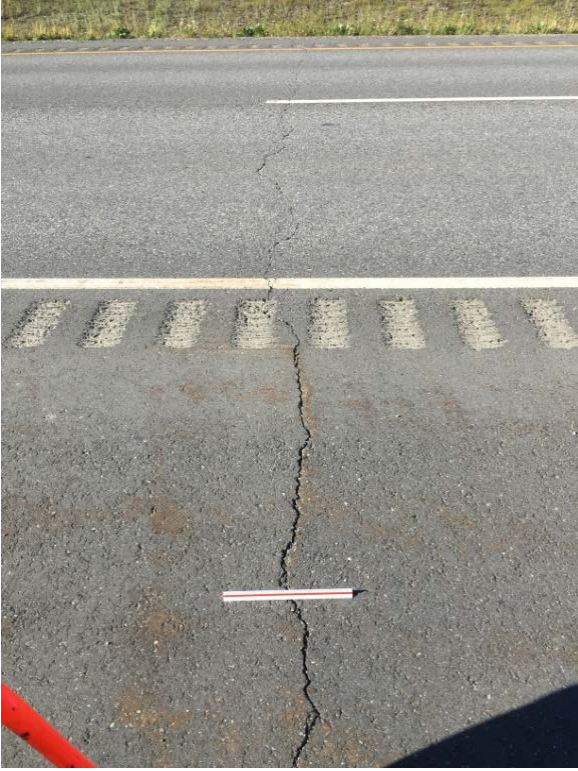
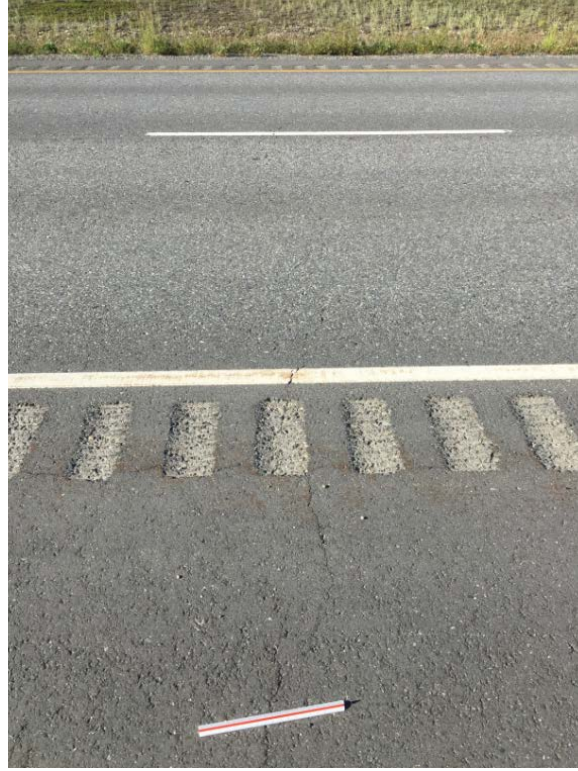
Figures 4.5 and 4.6 show observations on the control section (section No. 1 in Table 3.1). As expected, the most noticeable distress was the natural transverse cracks during the 3 years after construction. Figure 4.5 presents natural transverse cracks at different severity levels perpendicular to the road centerline. Natural transverse cracks skewed to the road centerline were also observed, as shown in Figure 4.6.

Figure 4.5 Transverse cracks perpendicular to the road centerline on the control section of the Moose Creek project: (a) high severity; (b) low severity

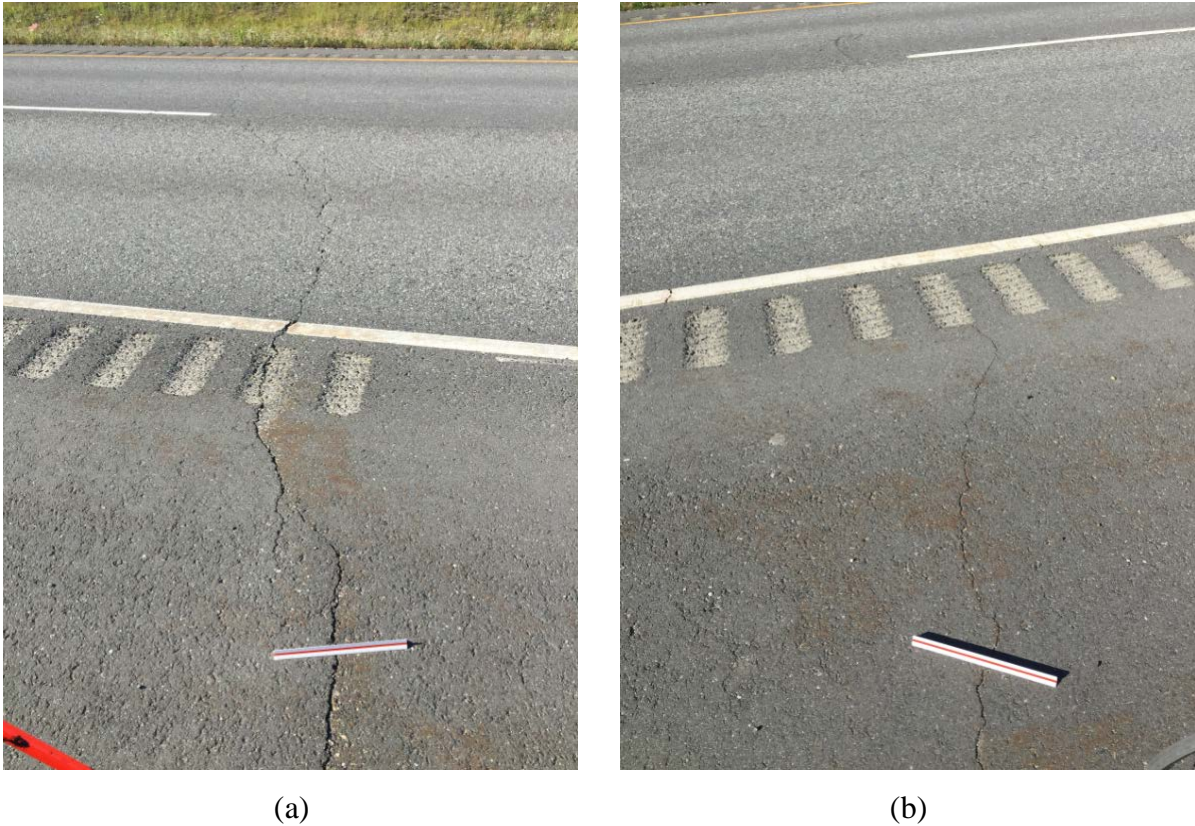
Figure 4.6 Transverse cracks skewed to the road centerline on the control section of the Moose Creek project: (a) high severity; (b) low severity

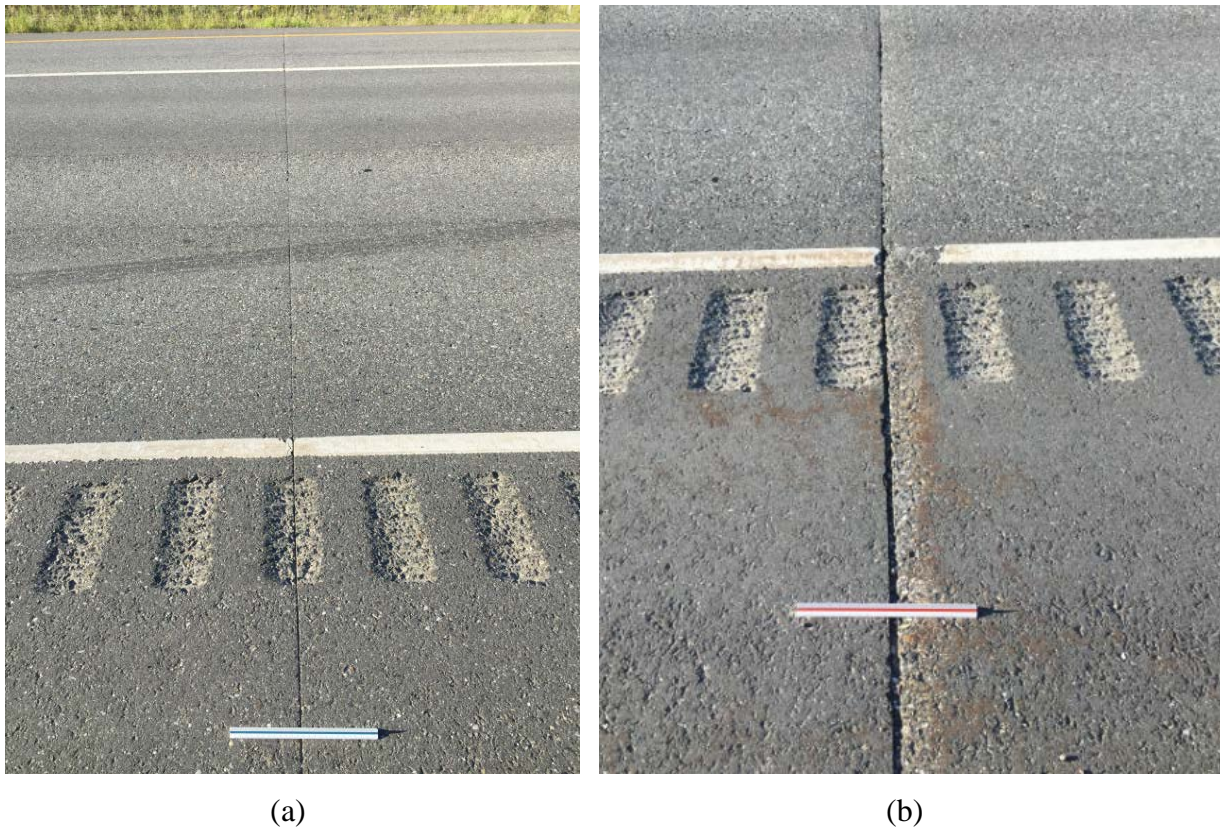
Figures 4.7 through 4.10 show observations of the precut sections with designed spacings (Moose Creek sections No. 2 to No. 7). Figure 4.7 presents the current conditions of precuts. Many precuts were non-active or closed, similar to the form of the one shown in Figure 4.7a. This means that stress concentrations sufficient to rupture the small amount of remaining pavement along the bottom of the precut slots and produce an active crack had not yet occurred. In contrast, a few active or open precuts were observed, as shown in Figure 4.7b. These open precuts are considered “nicely designed cracks,” and more are expected in a future survey. The existence of them might indicate that potential natural cracks were prevented by the precutting technique. In addition, it seems that most precuts did not require any maintenance, even if they were active.

Figure 4.7 Precuts observed on the precut sections with designed spacings on the Moose Creek project: (a) non-active (closed) (section No. 7); (b) active (open) (section No. 9)

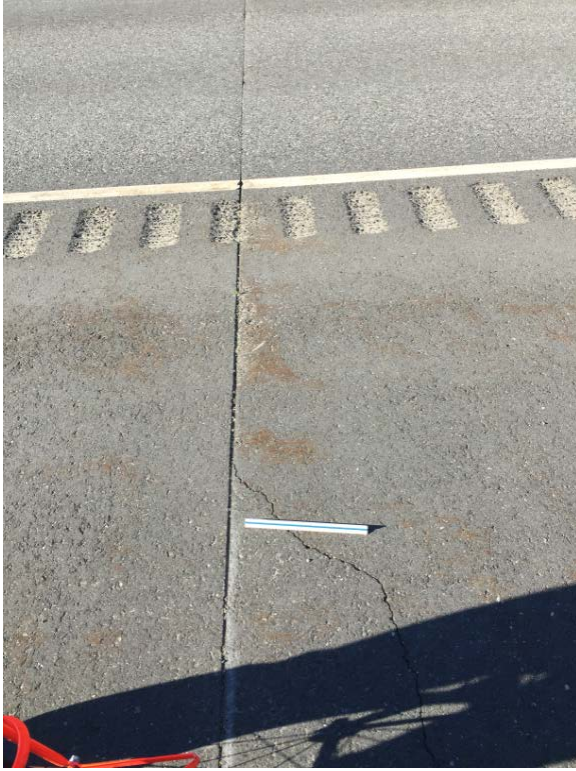
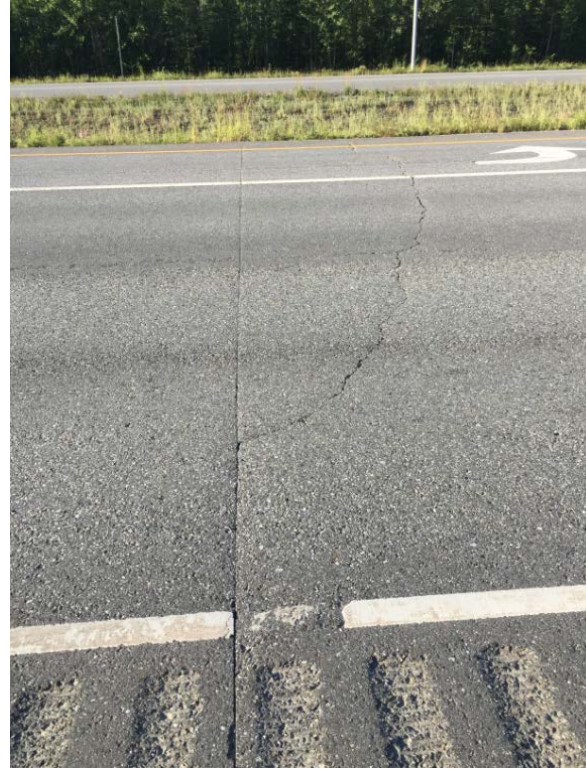
The locations of a few natural cracks were found to be at least partially controlled by precutting (Figure 4.8). Figures 4.8a and 4.8b show that the propagation of natural cracks was influenced by precutting. Both photos show natural cracks that were at least partially controlled (partially captured) by precutting. Several years of field observations during this study made it obvious that the effectiveness of precutting for controlling natural crack location can vary significantly from location to location. It is especially dependent on the thickness of the newly constructed section (the total thickness of pavement plus any other newly placed layers) that receives the precut treatment. The reader is reminded that the total thickness for new construction at the Moose Creek precut test site was only about 6 inches.

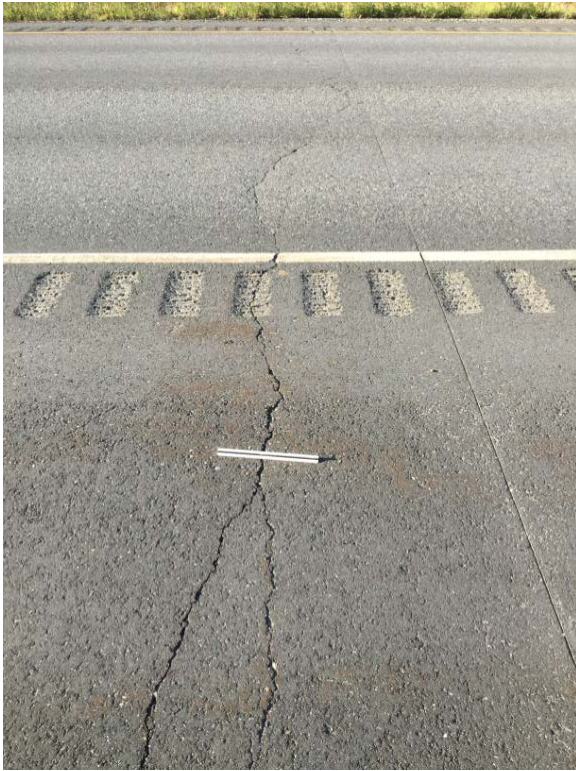
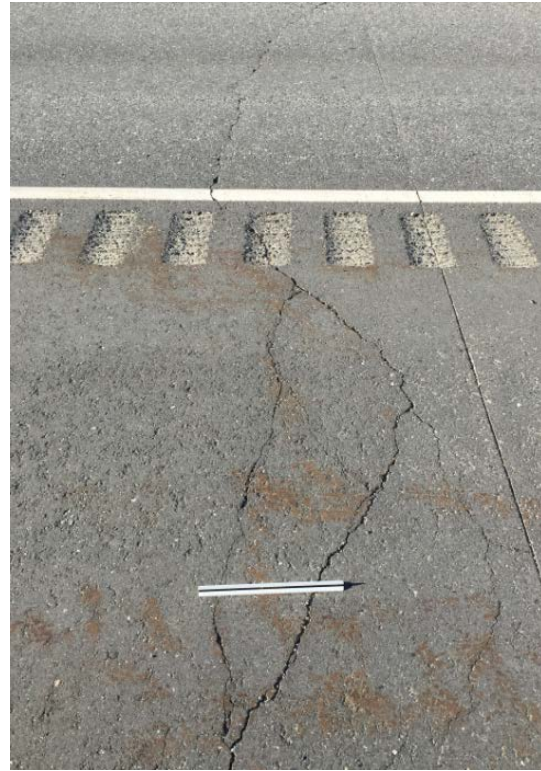
A few natural cracks were observed to develop near precuts that were not active at all (Figure 4.9). These natural cracks were generally of complicated shape, which might indicate that they were reflective thermal cracks rather than new natural thermal cracks. It seems that precuts installed with designed spacings may not necessarily even partially control the location of reflective cracks.

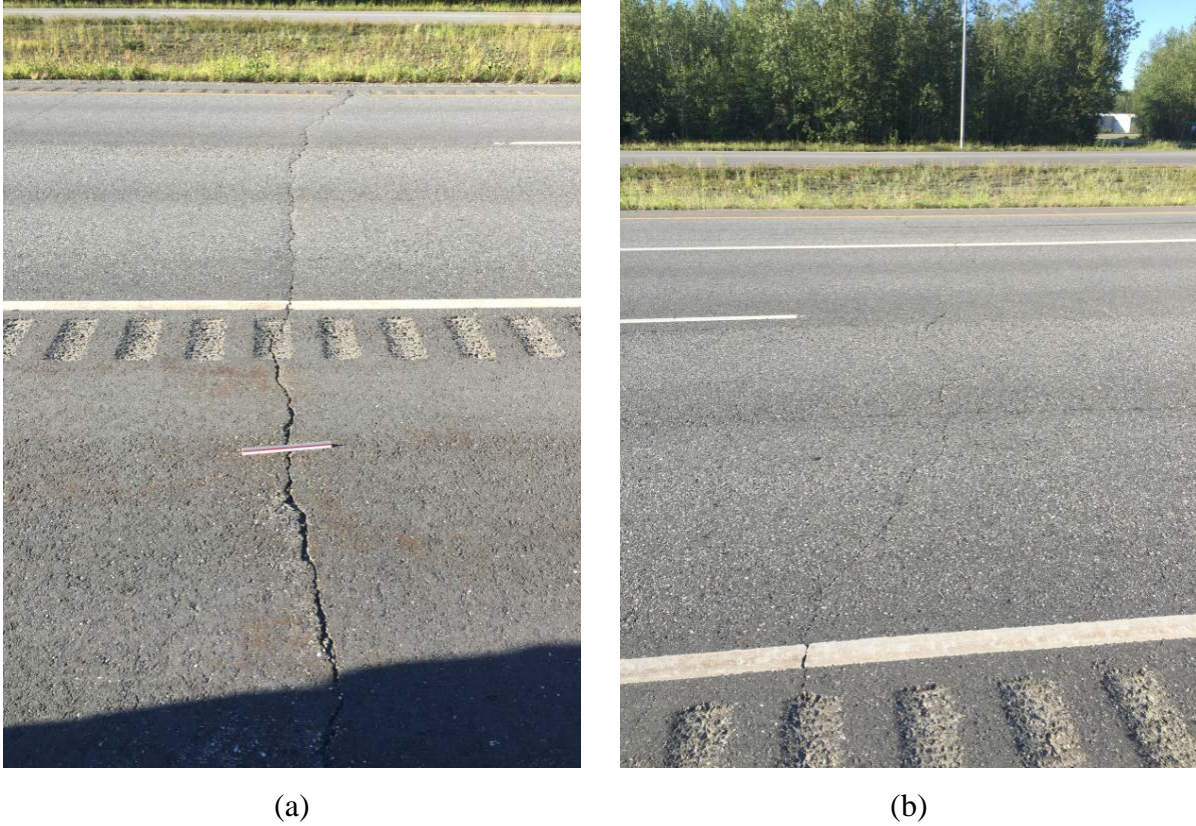
Figure 4.10 presents natural cracks of different severity level observed between the precuts. These cracks mean that a natural crack could still occur even with a short precut spacing of 40 feet.

Figure 4.10 Transverse cracks in between precuts on the precut sections with designed spacings on the Moose Creek project: (a) high severity (section No. 6); (b) low severity (section No. 7)

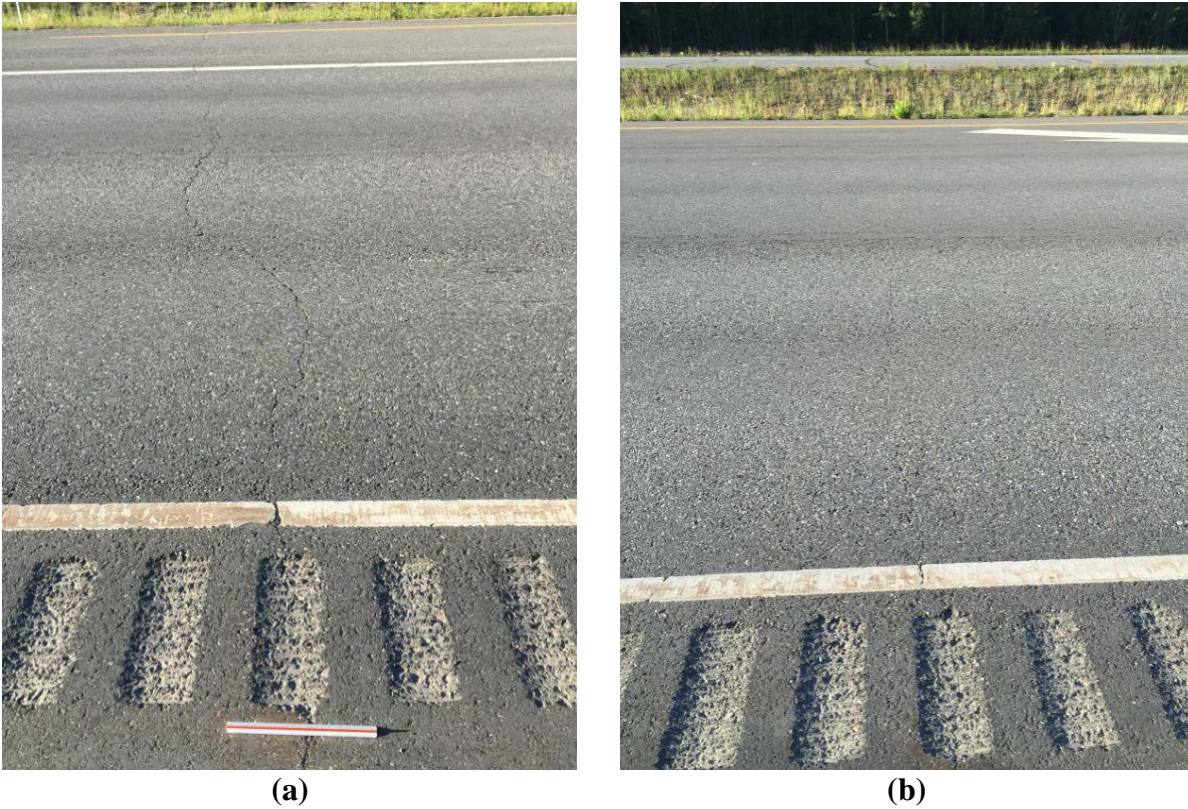
Transverse cracks that occurred between two precuts were mostly at low-severity level (Figure 4.12).

Figure 4.12 Natural transverse cracks between precuts—where precuts are at locations of old thermal cracks on the Moose Creek project: (a) high severity (section No. 8); (b) low severity (section No. 9)

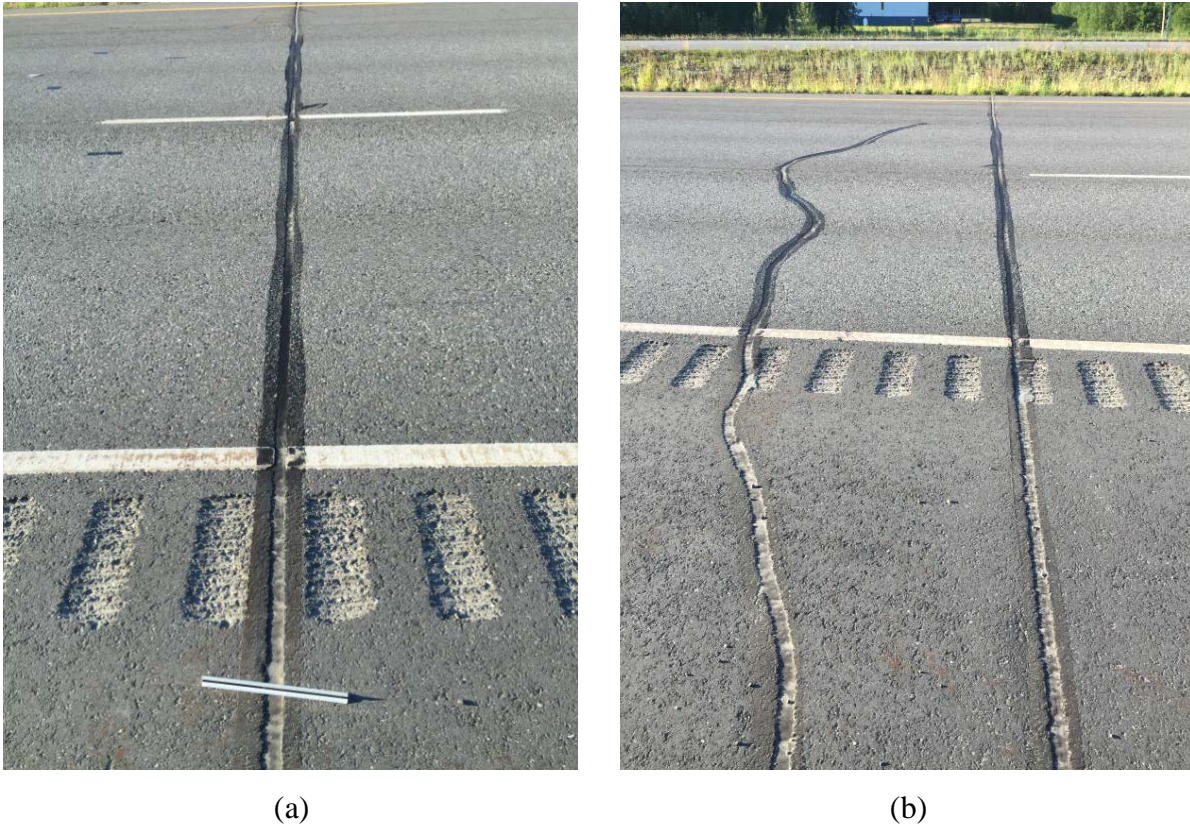
One special observation (Figure 4.13) was that the cut-on-existing-cracks section with a 1.5 inch cut depth (No. 10 in Table 3.1) was maintained with routing followed by crack sealing. It is not known why this type of expensive maintenance treatment was used at this and some nearby locations, but its effectiveness can become part of future field evaluations of the precut test sections.

Figure 4.13 Crack sealing with routing observed on: (a) precut (section No. 10); (b) precut and adjacent natural crack (section No. 10)

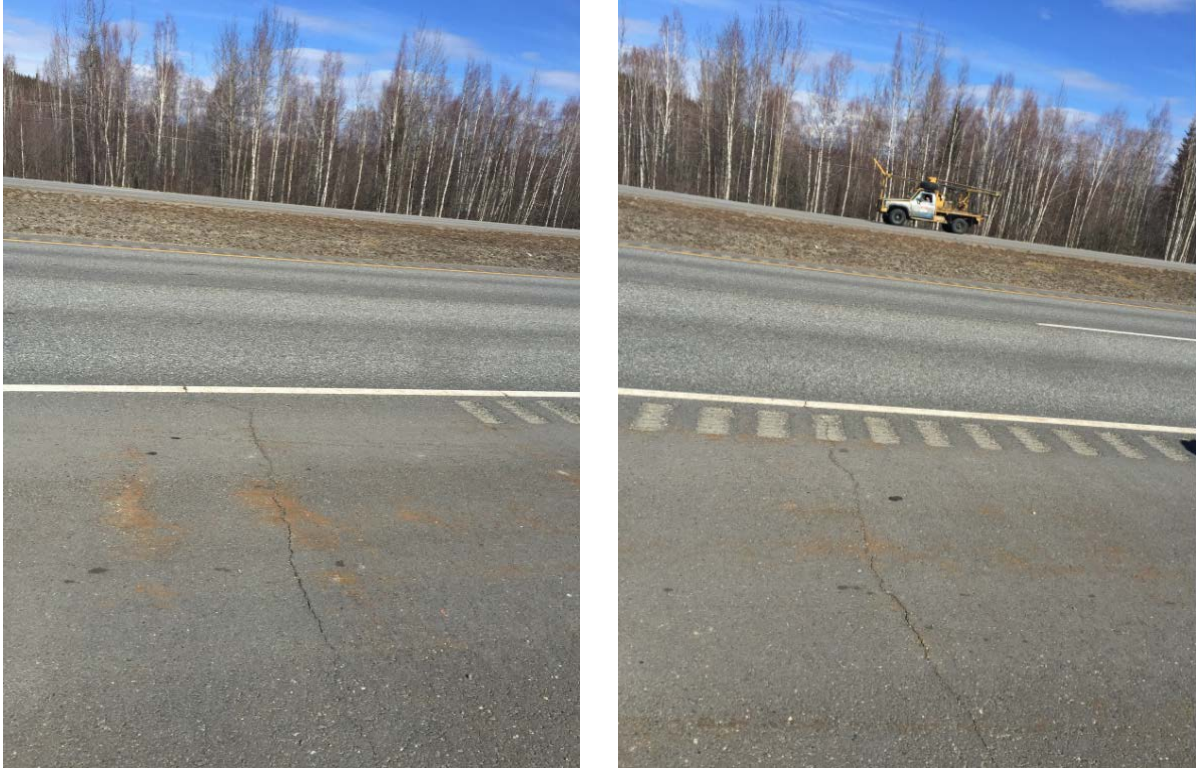
Figure 4.14 presents two new transverse cracks across the entire road on the control section. It can be seen that both cracks were at low- to medium-severity levels.

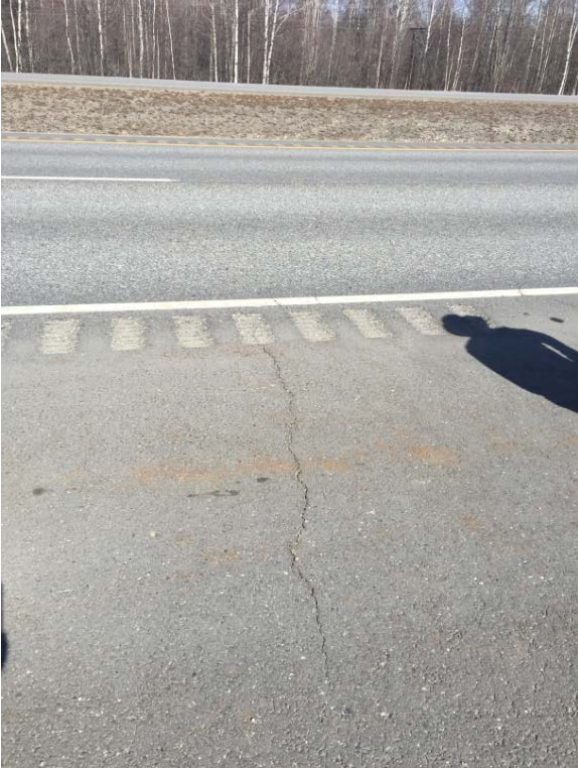
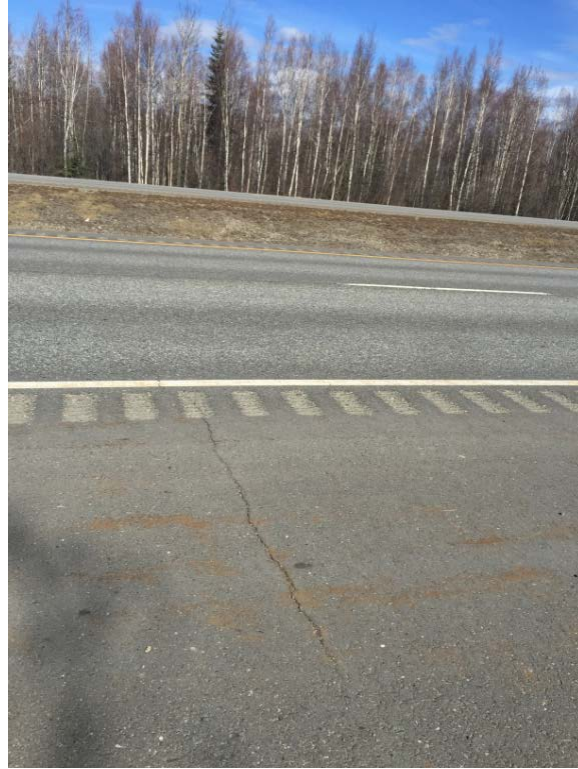
Figure 4.15 presents two new small cracks that were perpendicular to the road centerline. The cracks had not developed to cross the entire road, but may propagate to full width in future years. The types of cracks seen in 2016 and 2017 were similar, and the 2016 survey shown in Appendix B was supplemented with the 2017 survey to become Appendix D. Most cracks and interesting spots were documented with photos that can be seen in Appendix D. Several newly taken pictures are presented below.

Figure 4.15 New partial cracks observed on the control section of Moose Creek project:
(a) case 1; (b) case 2

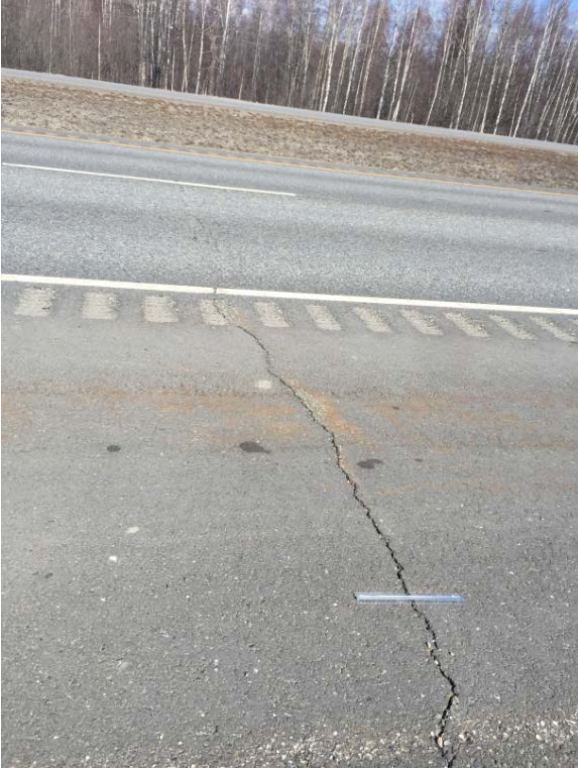
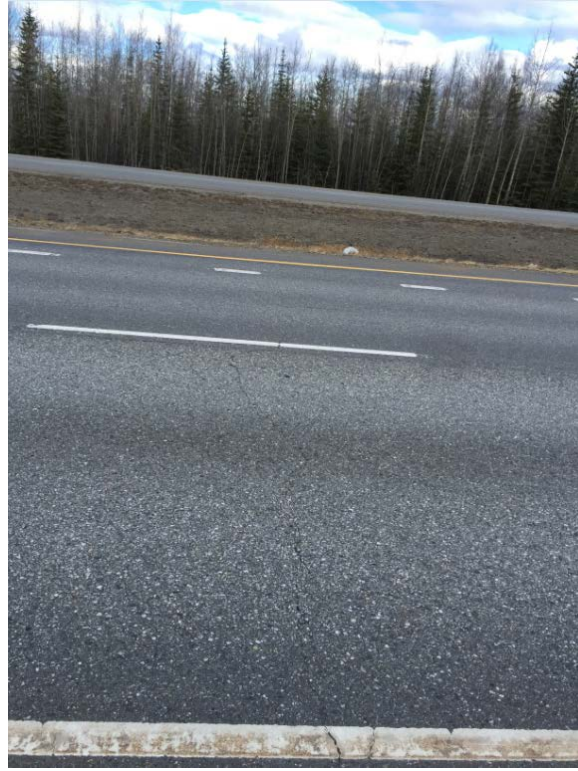
Figure 4.16 Newly documented natural cracks observed on sections of Moose Creek project in summer 2017: (a) the control section; (b) section No. 6

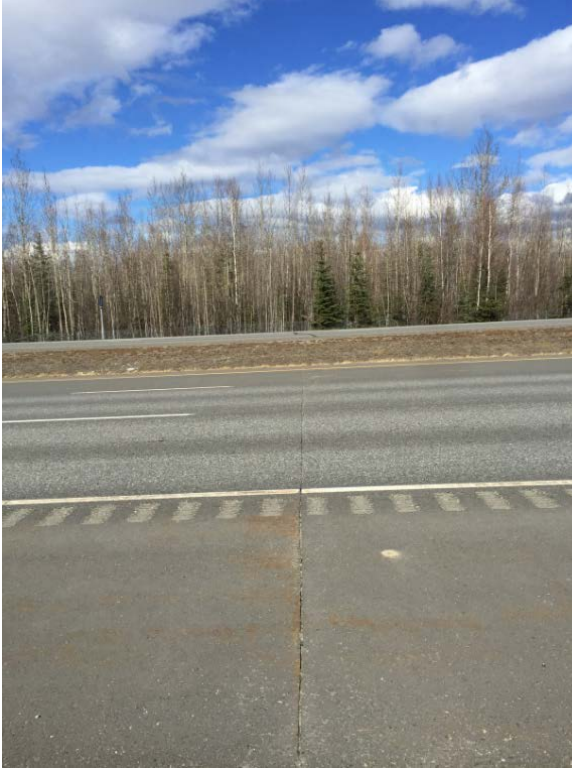
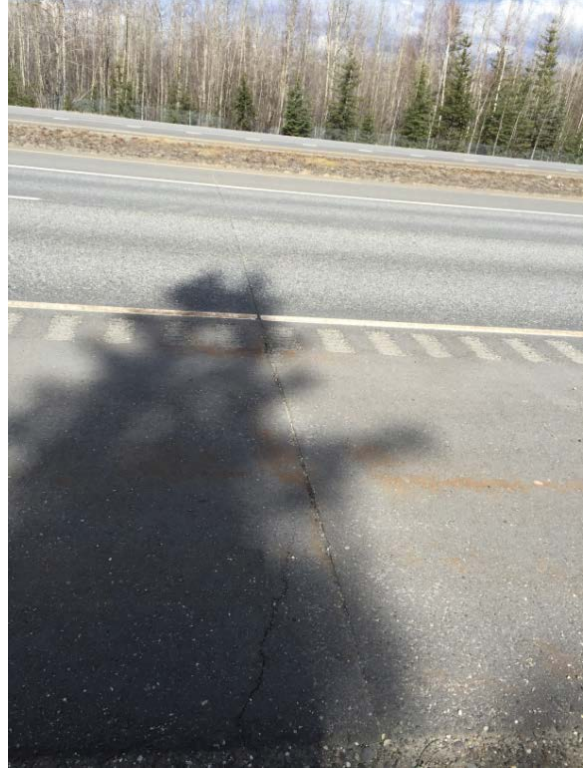
Figure 4.17 Newly documented precuts observed on sections of Moose Creek project in summer 2017: (a) section No. 9; (b) section No. 8

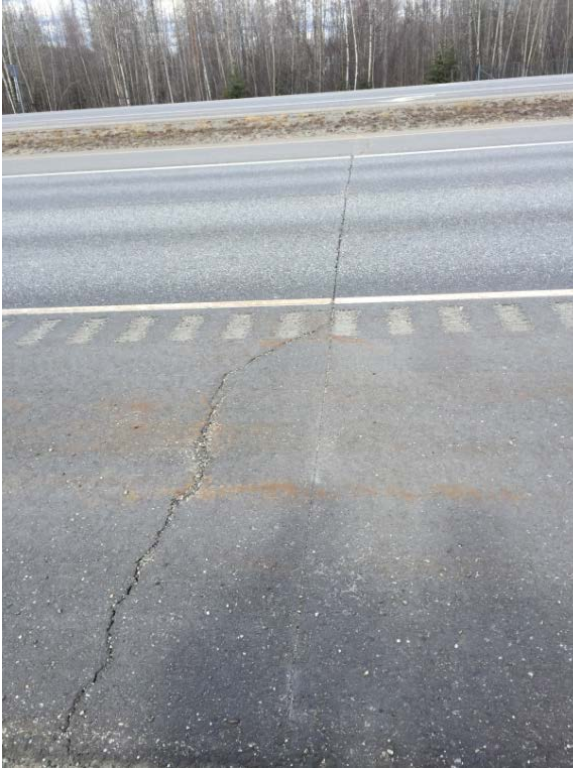
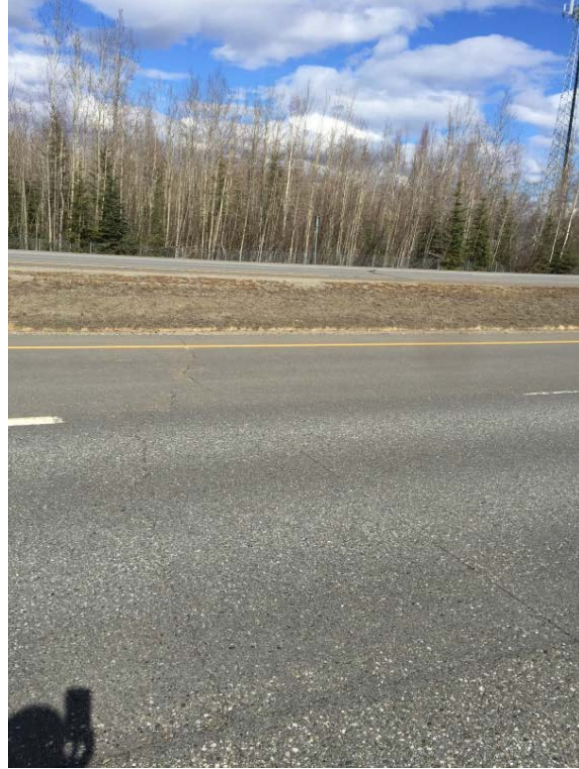
Figure 4.18 Newly documented cracks adjacent to precuts in sections of Moose Creek project in summer 2017: (a) section No. 8; (b) section No. 9

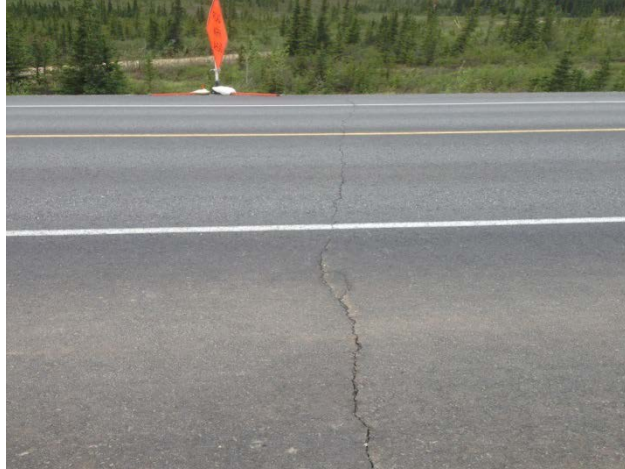
Figure 4.20 Natural transverse crack observed

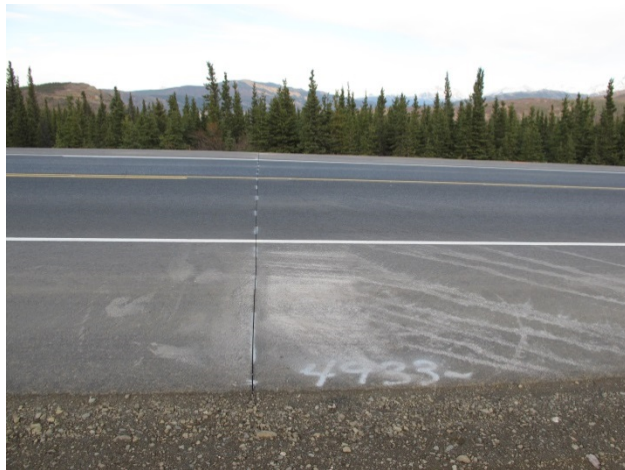
Figure 4.21 Precut observed

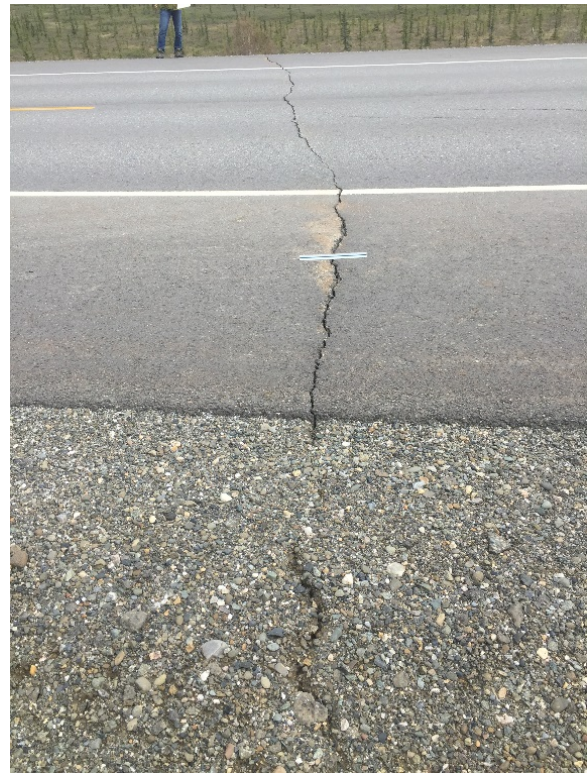
Figure 4.23 Transverse cracks observed: (a) low-severity crack (on precast section) (section No. 6); (b) high-severity crack (on control section) (section No. 2)

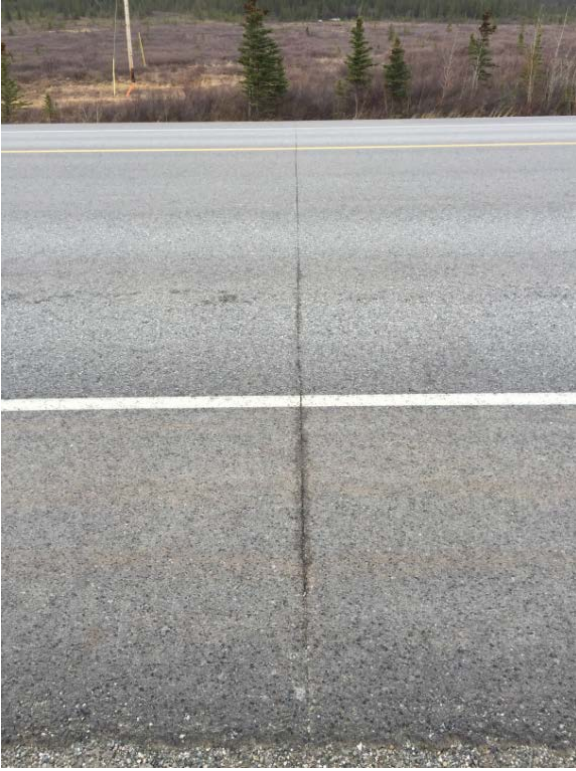
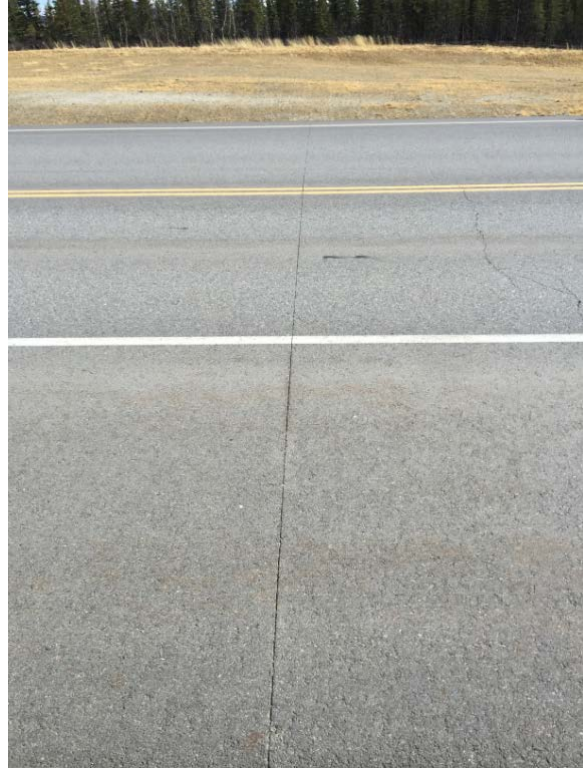
Figure 4.25 Completely closed precuts observed: (a) section No. 13; (b) section No. 7

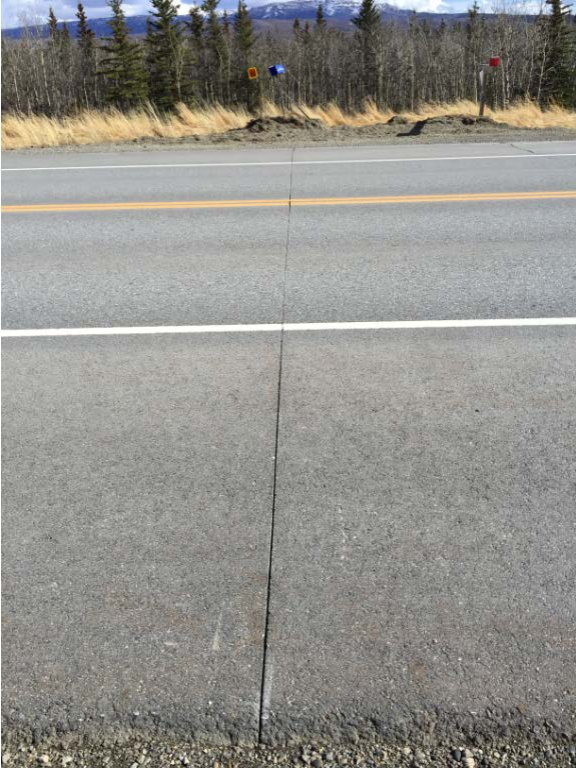
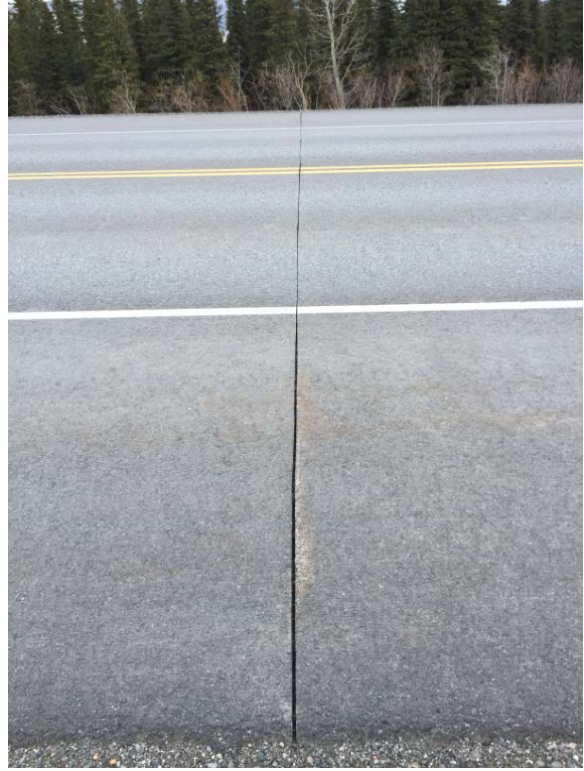
Figure 4.26 Partially open precuts observed: (a) section No. 6; (b) section No. 16

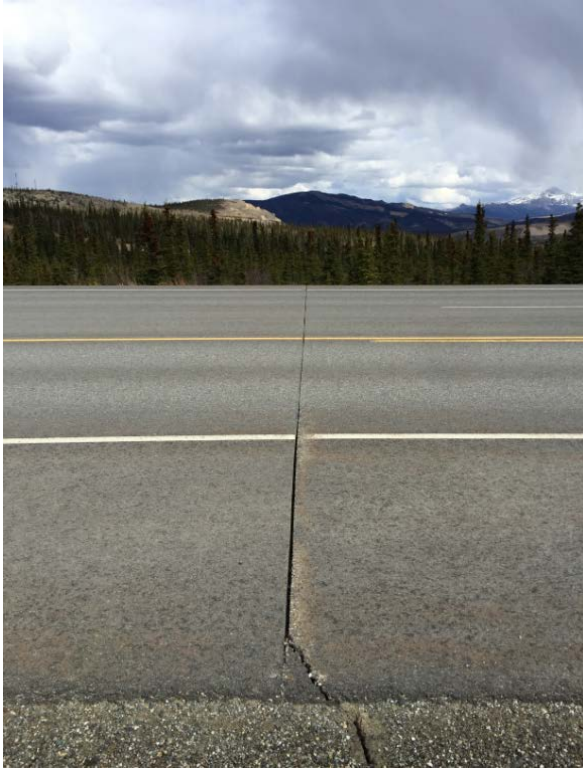
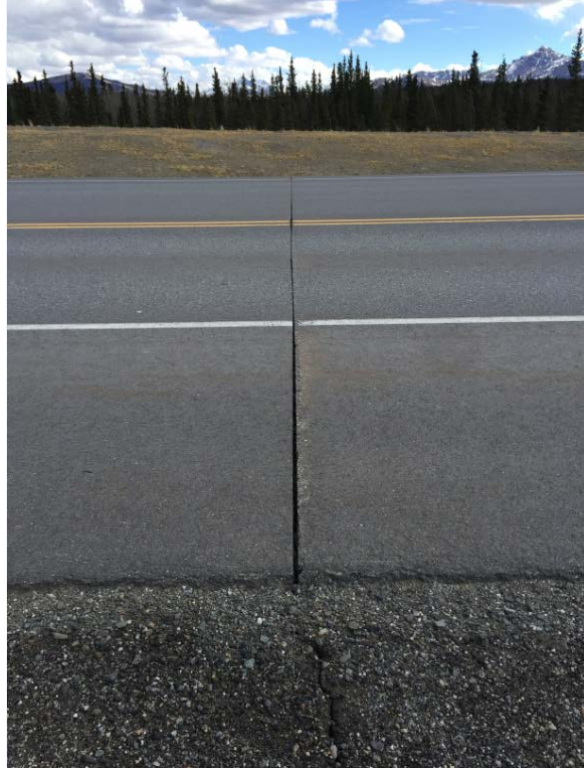
Figure 4.27 Very active (open) precuts observed: (a) section No. 14; (b) section No. 8

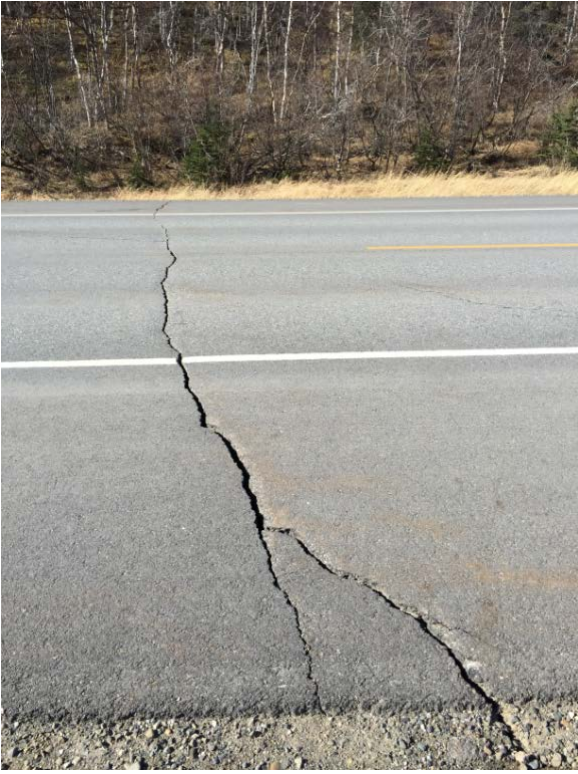
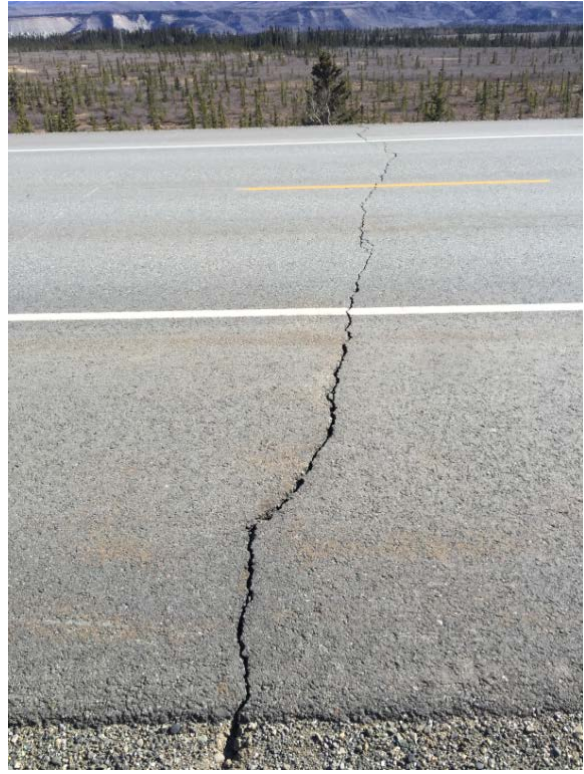
Figure 4.28 Natural transverse crack examples: (a) section No. 2; (b) section No. 1

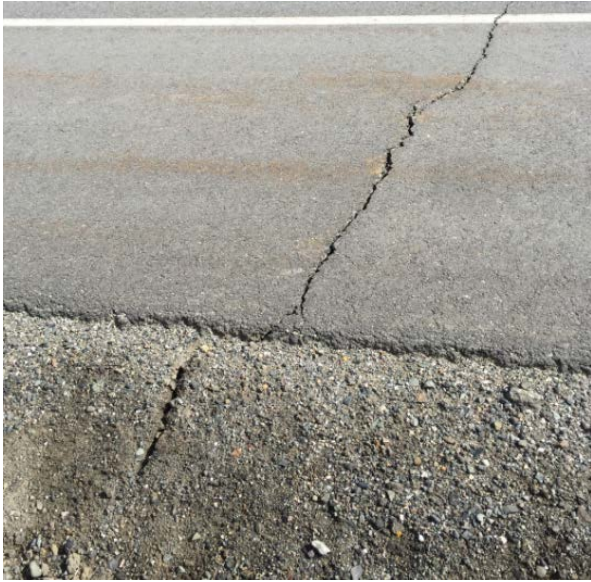
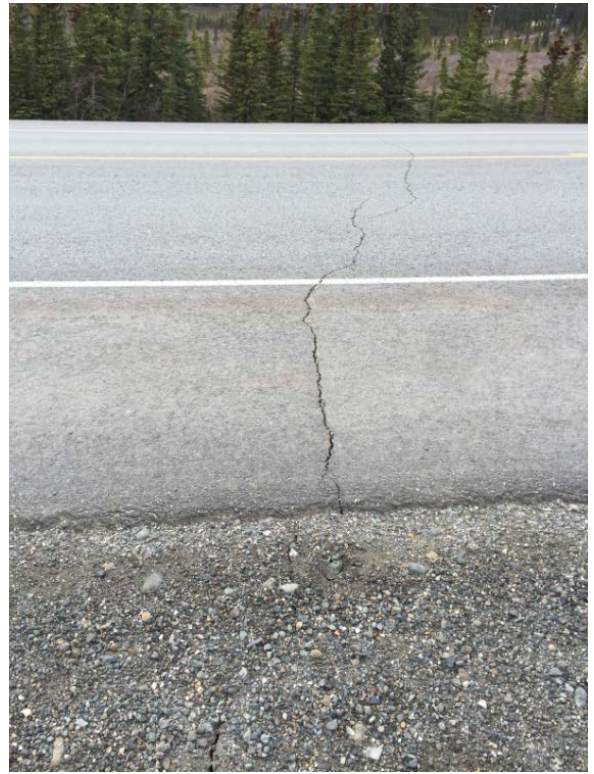
Figure 4.29 Cracks extending past the paved surface: (a) section No. 9; (b) section No. 15

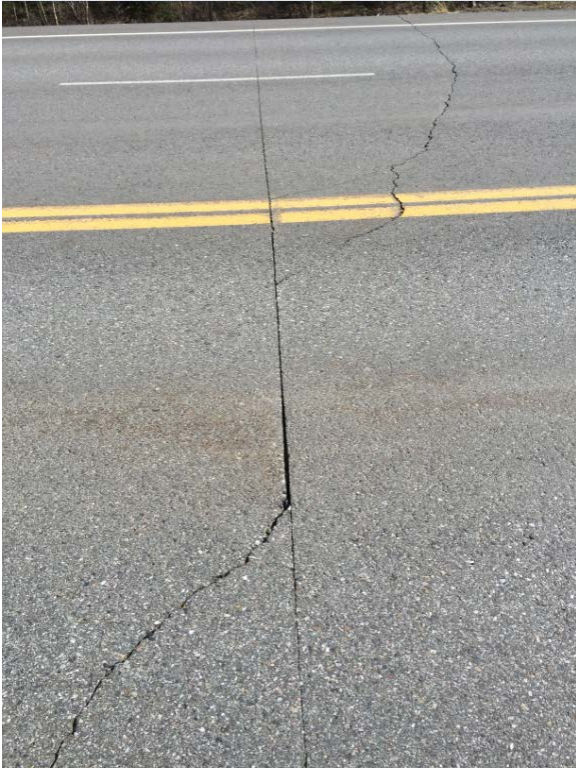
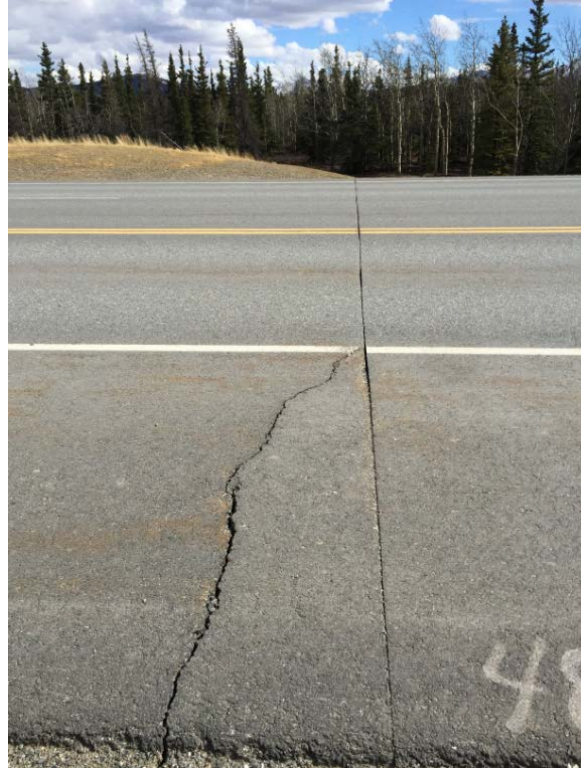
Figure 4.30 Cracks partially captured by the precuts: (a) section No. 9; (b) section No. 8

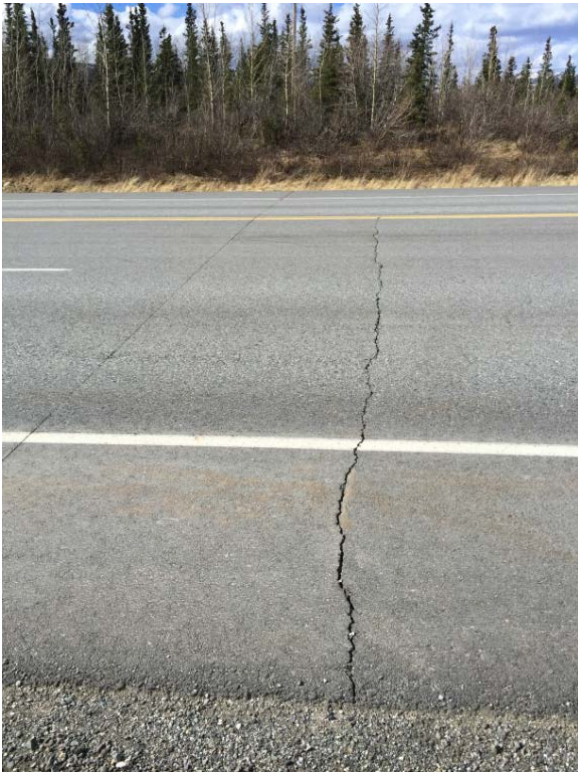
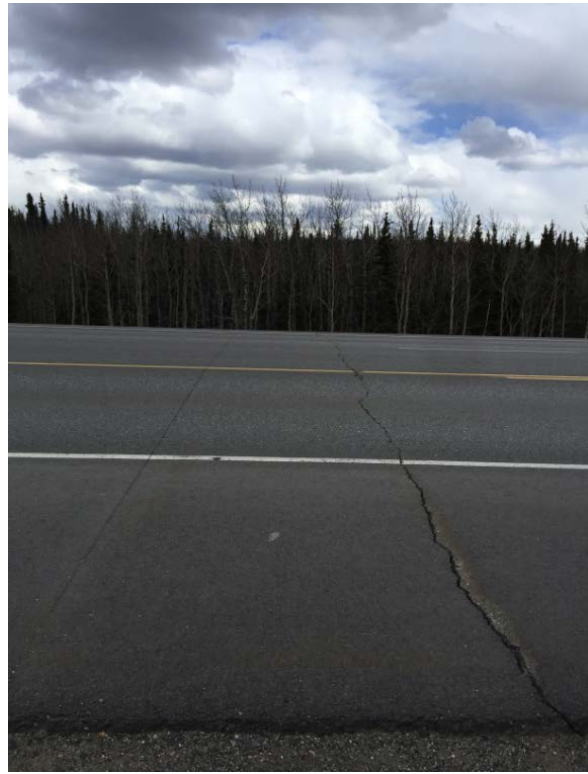
Figure 4.31 Cracks adjacent to precuts, without capture: (a) section No.9; (b) section No.12

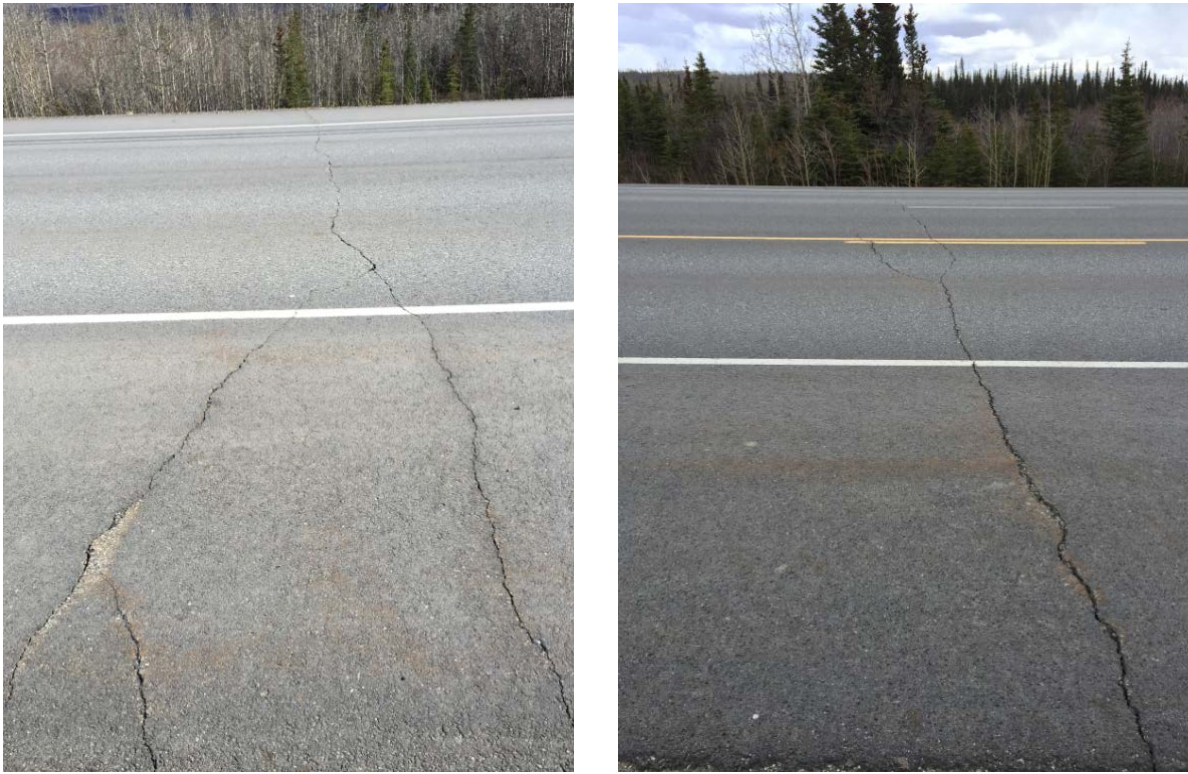
Healy sections were revisited in summer 2017. Detailed survey maps and photos can be found in Appendix E. Figures 4.25–4.32 show some newly observed features worth discussion. Three forms of precuts were observed: completely closed (non-active) (Figure 4.25), partially active (Figure 4.26), and very active (Figure 4.27). Figure 4.28 presents natural transverse cracks with irregular shapes but low levels of severity. Some of the natural cracks obviously extended past the edge of the pavement and into the unpaved shoulder, as can be clearly seen in (Figure 4.29). Some natural crack paths were found to be redirected and partially captured by precuts (Figure 4.30). On the other hand, Figure 4.31 shows examples of natural transverse cracks located quite near precuts but without the apparent tendency to be captured or even influenced by precuts. Examples of low-severity bifurcating transverse cracks are shown located in a control section (Figure 4.32a) and between precuts (Figure 4.32b).
