# CFRP Strengthening of KY 583 Over the Bluegrass Parkway Bridge in Hardin County

Kentucky Transportation Center Research Report – KTC-17-19/KHIT88-06-1F

September 2017

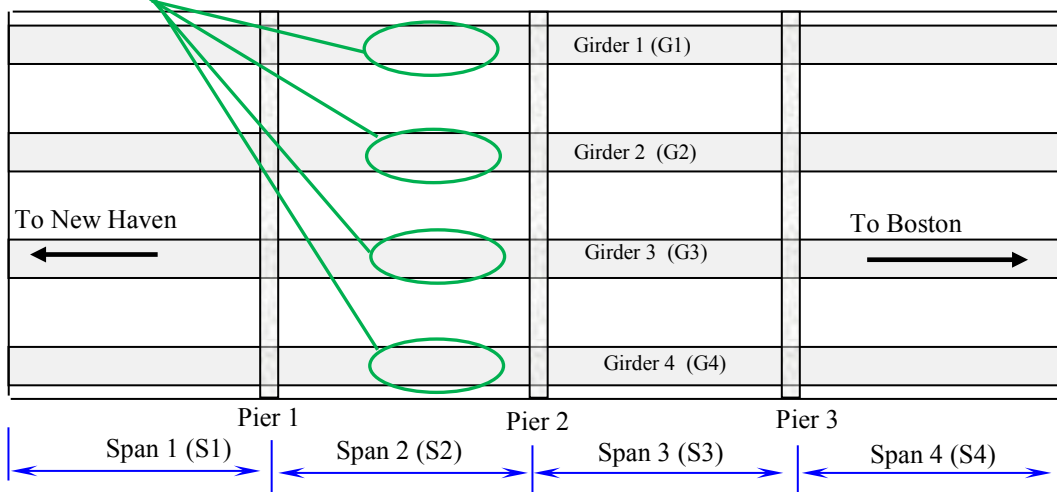
(c) Plan view showing the location of damage

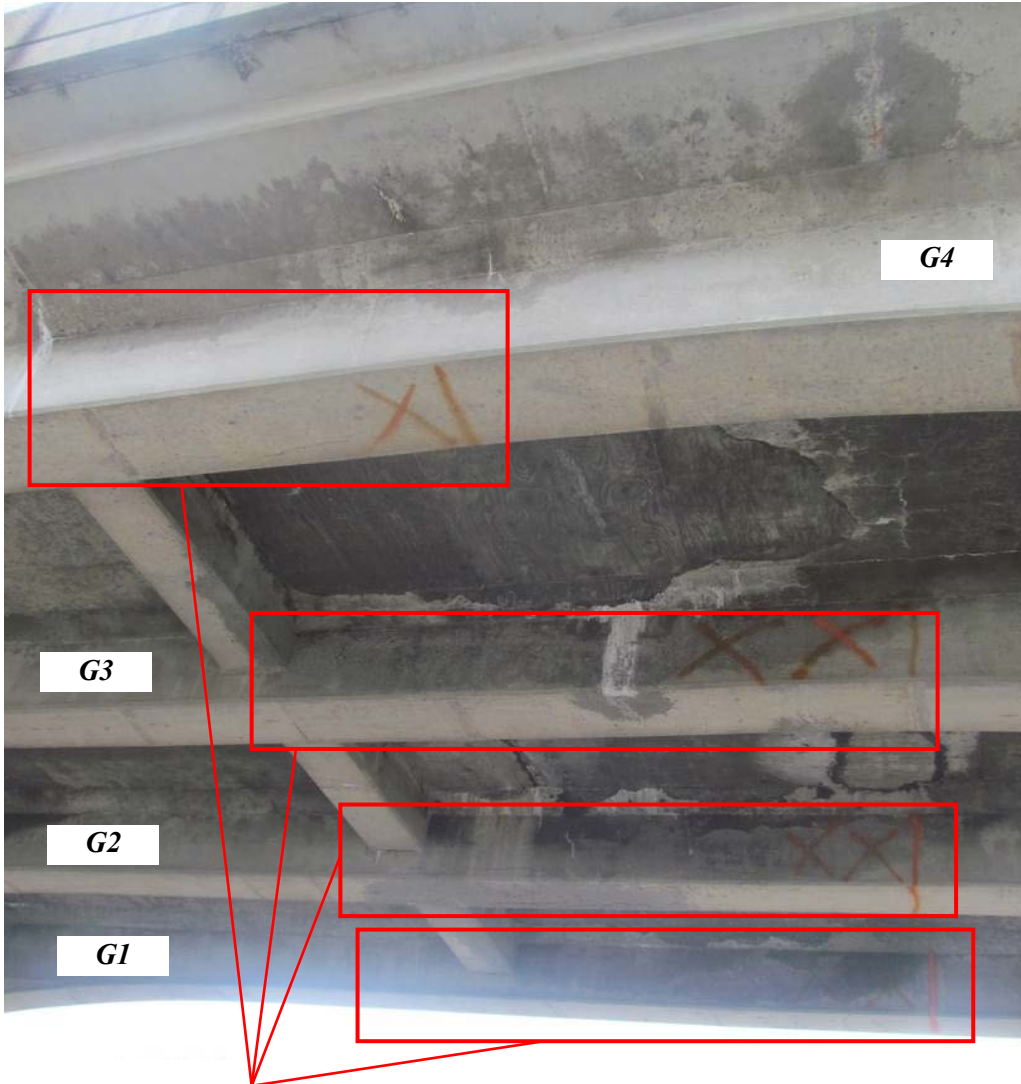
**Figure 3** Damage to RC Girders in Span 2 of the KY 583 Bridge in Hardin County, KY (damage within constant depth area of all beams)

As indicated by Figure 3, large cracks appeared on all four girders on the span over the eastbound lanes of the Bluegrass Parkway. The cracks materialized along the vertical faces of the beams as well as along the bottom faces. The cracks produced concrete delamination and spalling. The longest cracks were nearly 12 feet long and spanned the vertical face longitudinally, while shorter longitudinal and diagonal cracks were observed. All the cracks and damaged area over the left lane of eastbound Bluegrass Parkway were within the constant depth region of the beams. An additional cracked area in Girder 3 over the right lane of eastbound Bluegrass Parkway was within the varying depth section of the beam. This was identified later and retrofitted by the KYTC D04 bridge crew.

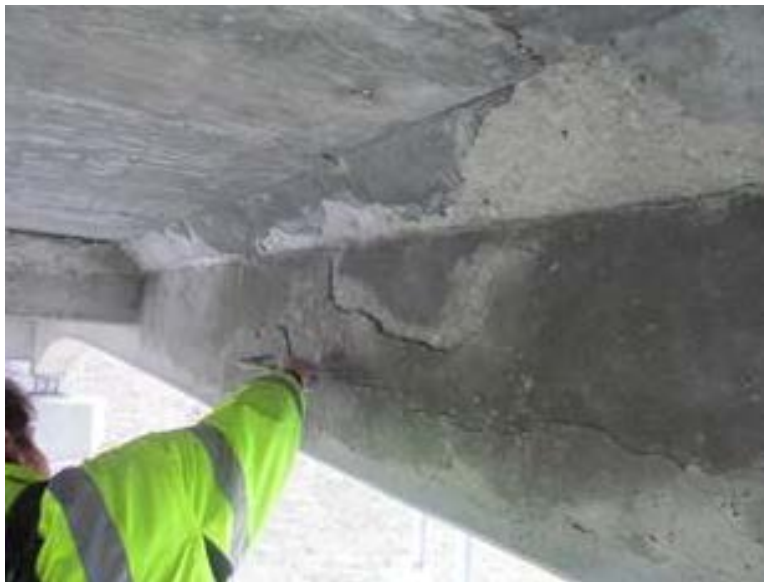
**Figure 4** Typical Cracking Observed on All Four Beams

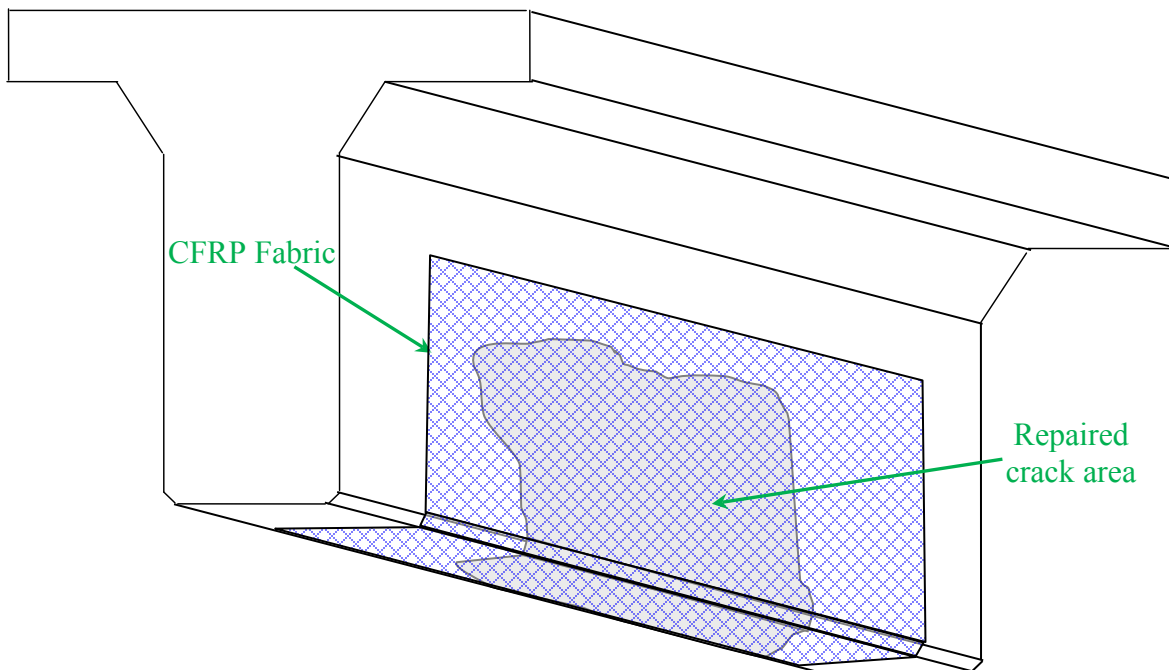
**Figure 5** General Retrofit Plan

The general layout of the retrofit is shown in Figure 5. The fabric was applied in U-wraps around the bottom of each beam perpendicular to the longitudinal direction of the beams. Each U-wrap is 52" wide with a 4" overlap between adjacent pieces. The CFRP fabric must extend a minimum of 6" beyond the end of the repaired region. Appendix A provides more details on the CFRP fabric strengthening and placement.

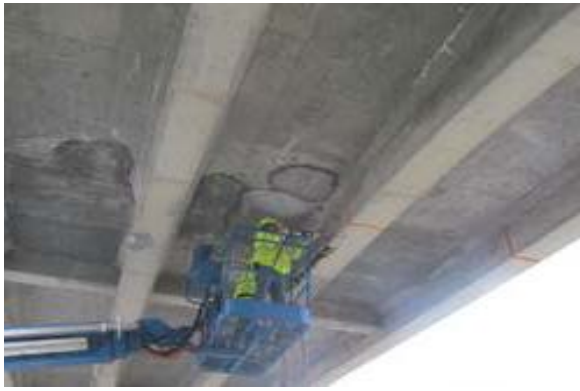
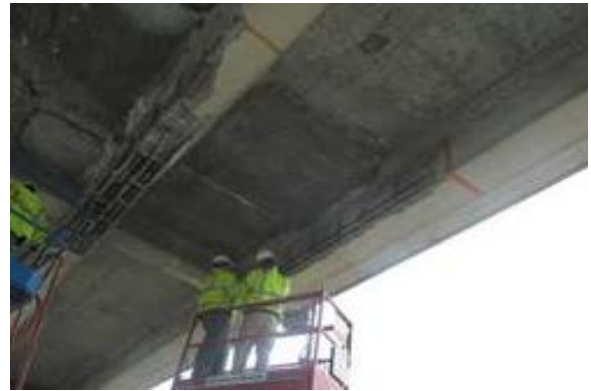
**Figure 7** Removing Loose Concrete

Before repairs commenced, all loose concrete was removed from the cracked regions of the beams. Crew members used pneumatic chipping hammers to remove the material and expose at least one inch of non-corroded reinforcing steel. The steel was then sandblasted to remove rust, and a zinc primer was applied with a brush after wiping it with a solvent. Wooden forms were erected to ensure the repair mortar cured appropriately to provide the original shape of the beam. A bonding agent was applied to facilitate bonding between the old concrete and repair mortar. The repair mortar was then placed and vibrated to prevent voids.

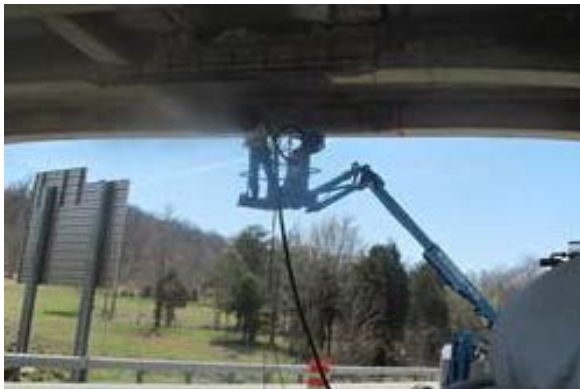
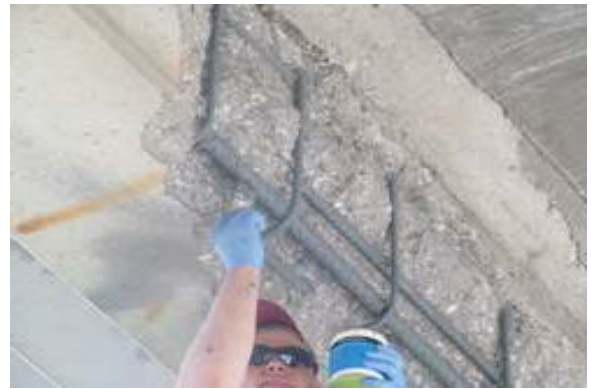
**Figure 8** Blast Cleaning and Coating Exposed Steel

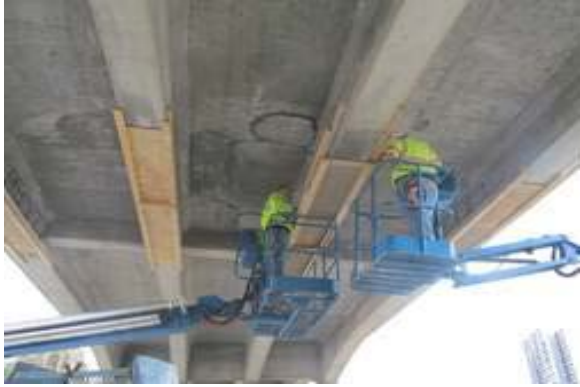
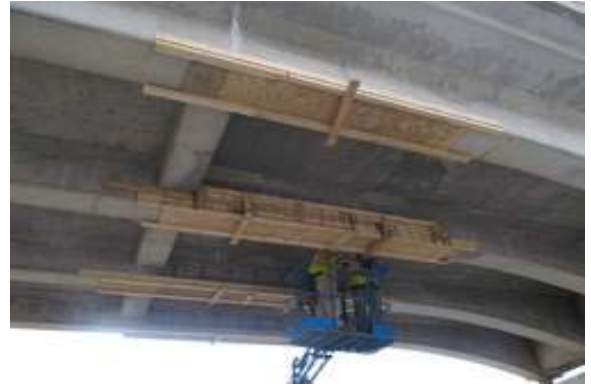
**Figure 9** Attaching Forms and Placing Repair Mortar

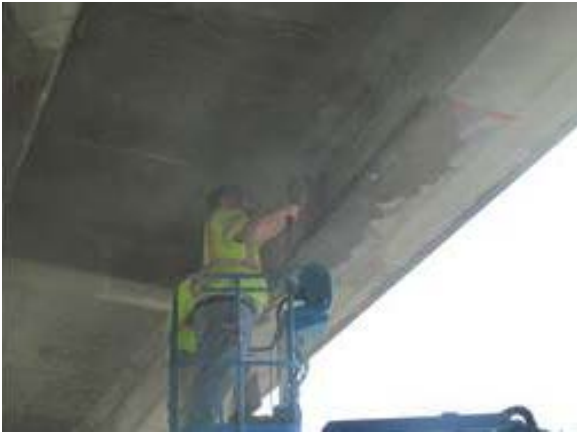
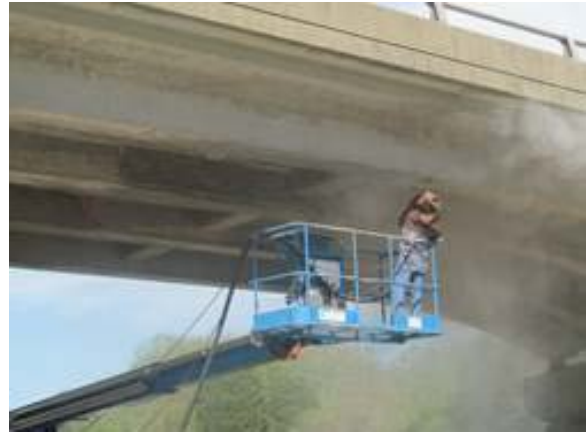
**Figure 10** Preparing the CFRP Application Surface

Once the repair mortar cured the forms were removed. The mortar was ground to remove any in-plane variations between the repair mortar and pre-existing concrete. The entire region was then sandblasted to create a clean surface for the CFRP fabric to bond to. The two-part saturating epoxy was applied to the clean concrete; fabric was placed over the epoxy by hand. All air pockets and irregularities were smoothed out of the fabric with laminating rollers. An outer layer of the same epoxy was placed over the fabric with paint rollers to ensure adequate coverage. After the epoxy cured, a UV protective coating was applied to the outside and bottom faces of the outer beams on either side of the span.

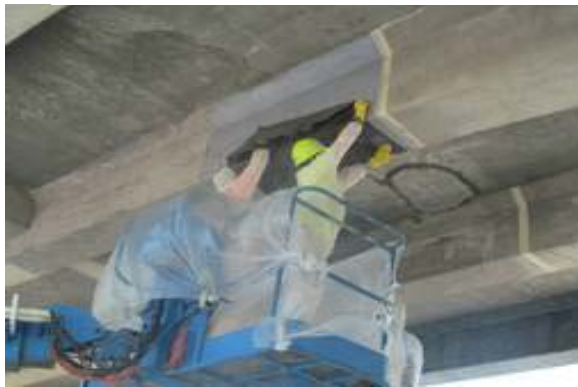
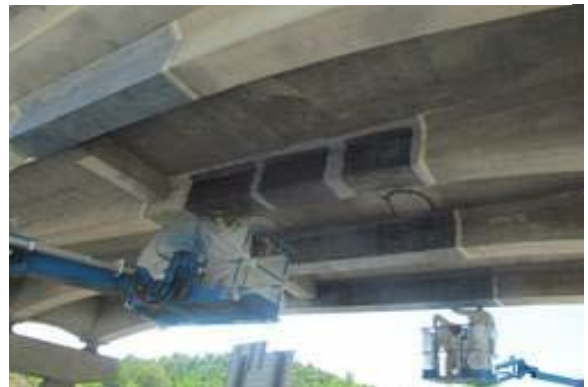
**Figure 11** Applying CFRP Fabric

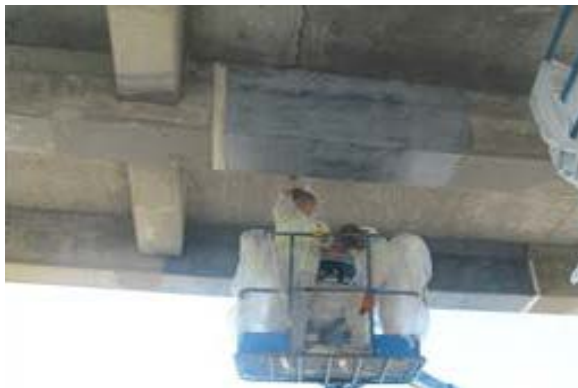
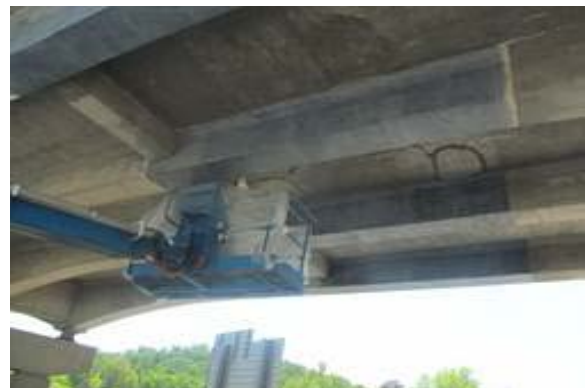
**Figure 12** Applying Outer Layer of Epoxy

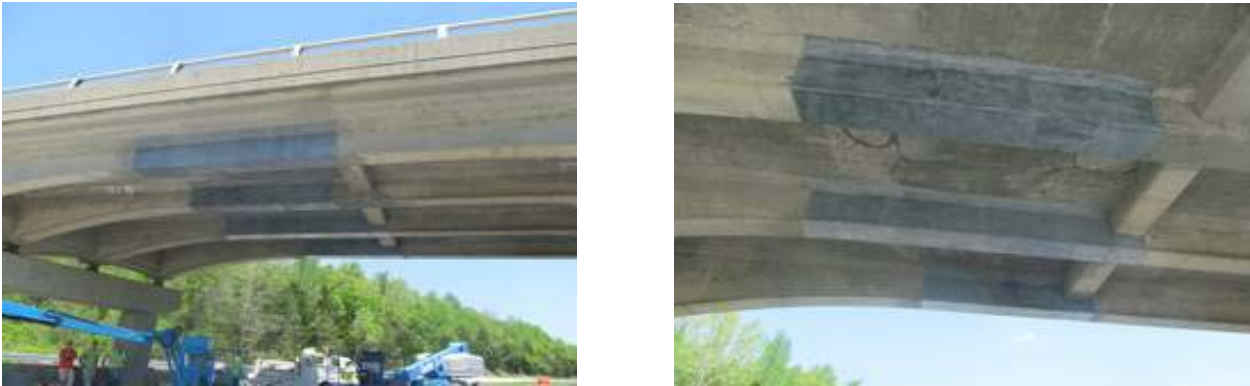
**Figure 13** Retrofit Complete

The retrofitted beams, prior to the application of the protective coating on the outside beams, are shown in Figure 13. After the epoxy cured, the UV protective coating was applied to the outside and bottom faces of the two edge beams. As previously stated, an additional beam (Girder 3) over the right lane of the Bluegrass Parkway had concrete damage due to cracks. This was also retrofitted by the KYTC District 04 bridge crew. The retrofit of the all the bridge beams was completed in May 2014.

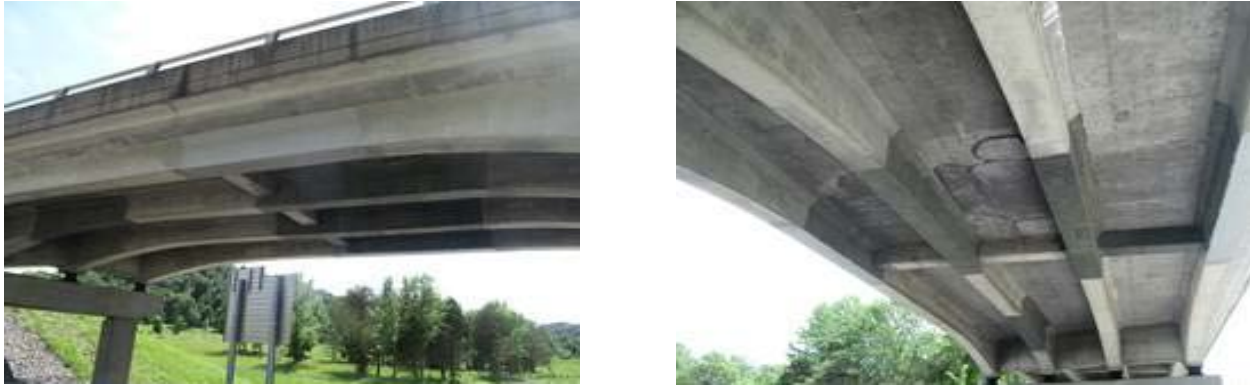
Following the completion of the retrofit construction, KTC monitored the retrofit for three years. A May 2017 inspection revealed no defects (e.g., delamination or separation of the CFRP fabric) in the retrofitted beams. Figure 14 shows the retrofitted areas, including the additional retrofit area over the eastbound right lane of the Bluegrass Parkway. Some epoxy discoloration occurred on the interior girders that lacked a UV protective coating.

**Figure 14** Retrofit Inspection - May 2017

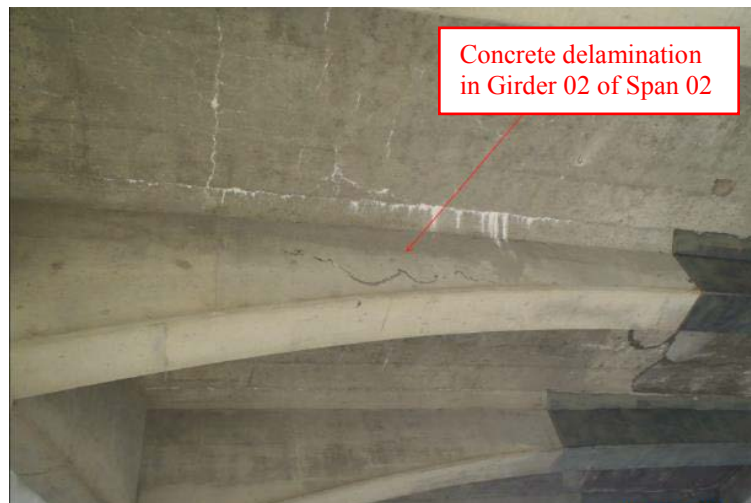
A routine inspection in November 2015 uncovered a new crack in Girder 2 causing concrete delamination. The damaged area was within the varying depth region of the beam over the left lane of eastbound Bluegrass Parkway and away from the previously retrofitted area (Figure 15). No additional cracks or concrete delamination was observed for the remainder of the monitoring period.

**Figure 15** New Crack in Girder 02 Observed in November 2015
