Preventive Maintenance Study – Interim Report

WA-RD 871.1

**Washington State
Department of Transportation**

Preventive Maintenance Study

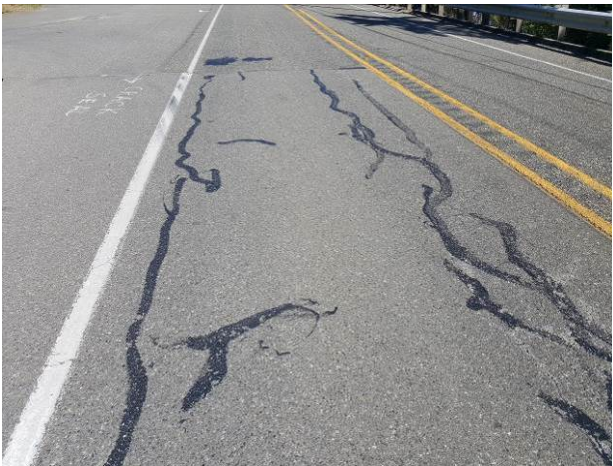
Figure 3. OR1, SR101, Reactive, age 50 months.

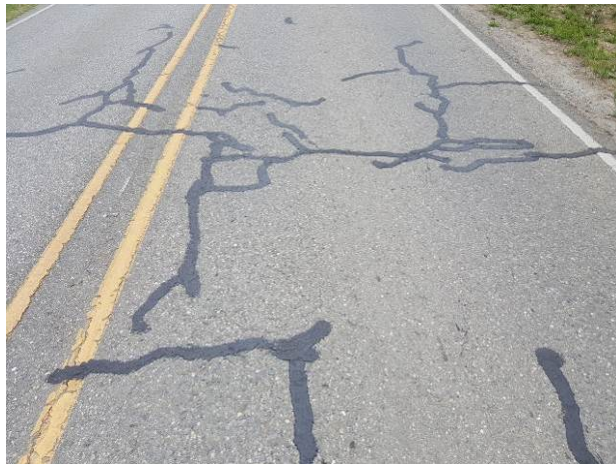
Figure 14. OR34, SR302, Strategic, age 3 months.

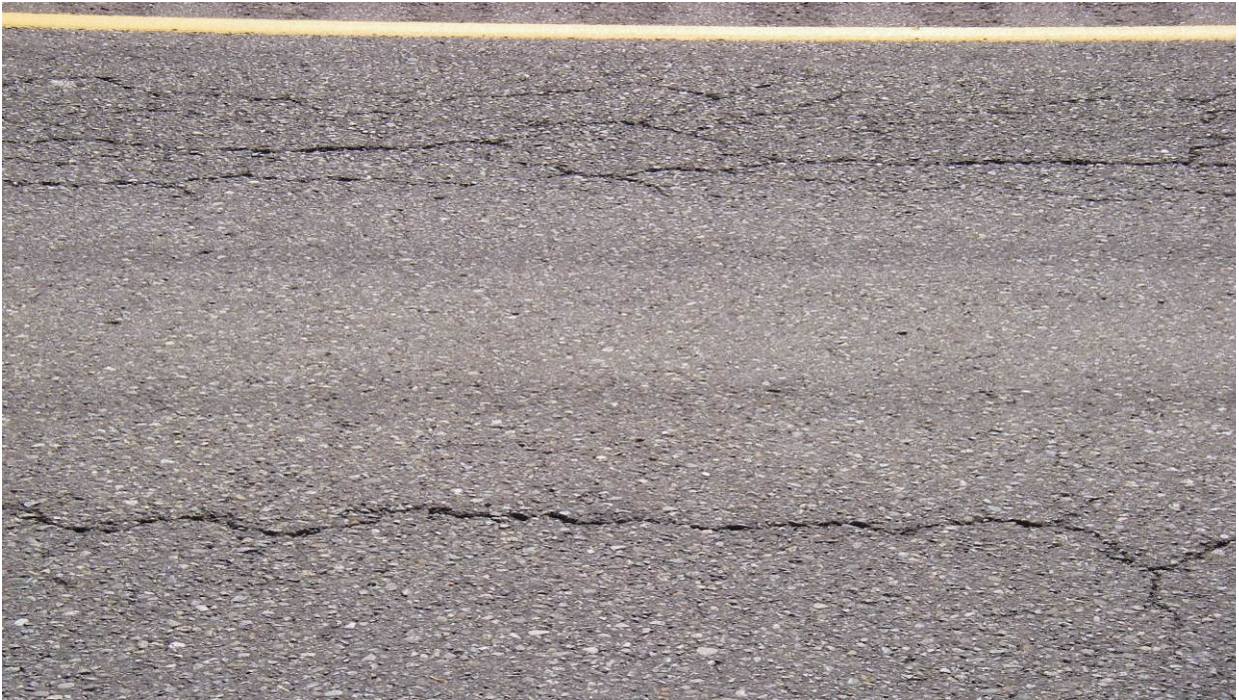
Figure 15. OR1, SR101, prior to treatment. Cracks exceed 1/4 inch in width in places.

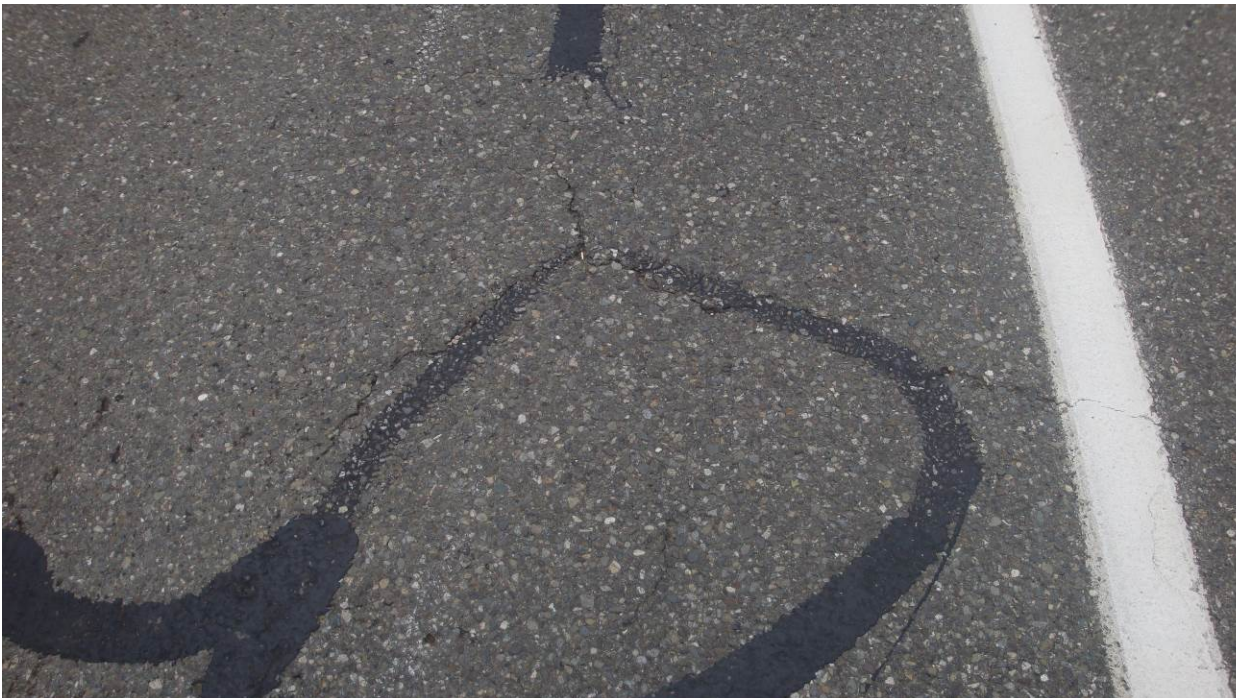
Figure 16. OR1, SR101, one year after installation. Slight wear of sealant over banding.

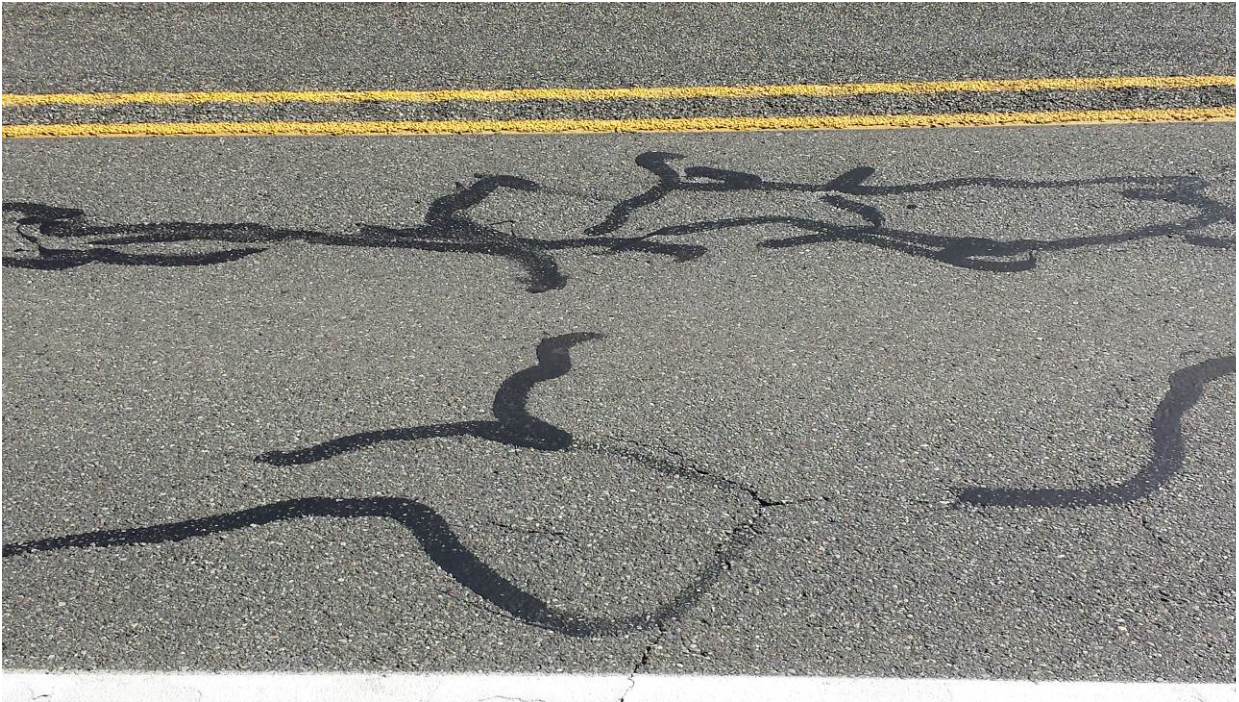
Figure 17. OR1, SR101, two years after installation. There is not much change from year one.

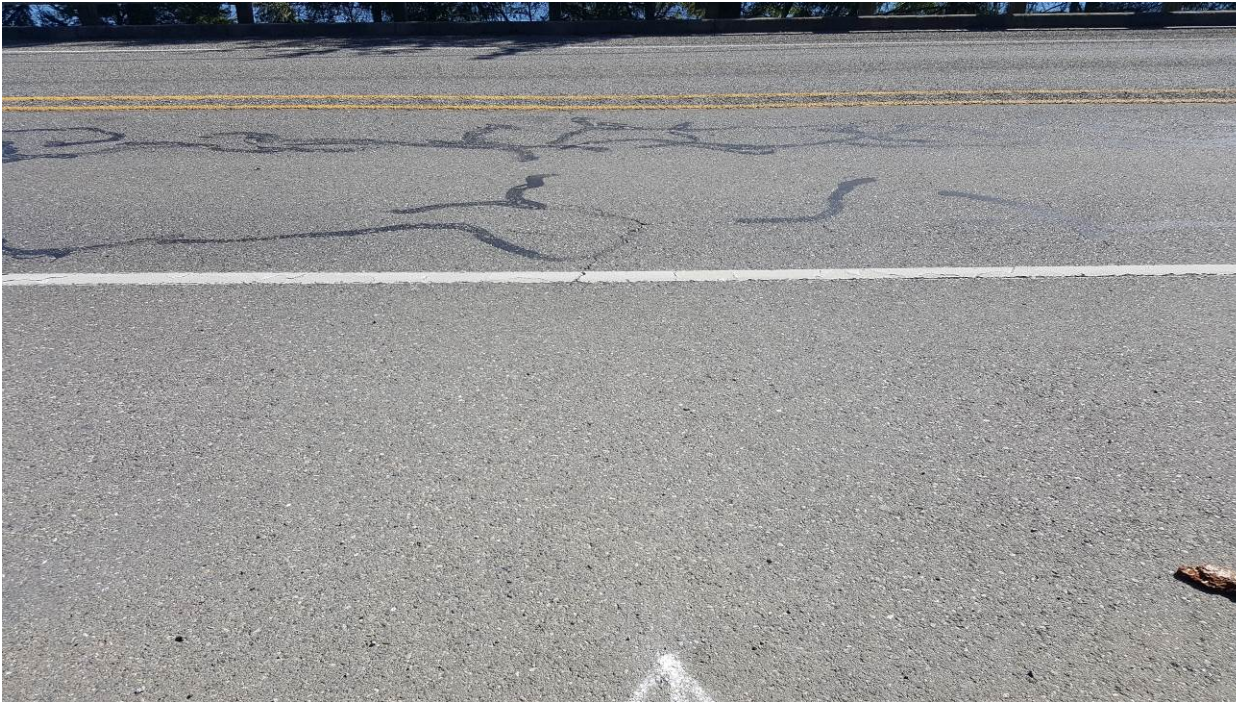
Figure 19. OR1, SR101, four years after installation. There has not been much change in the condition of the crack sealant since year one.

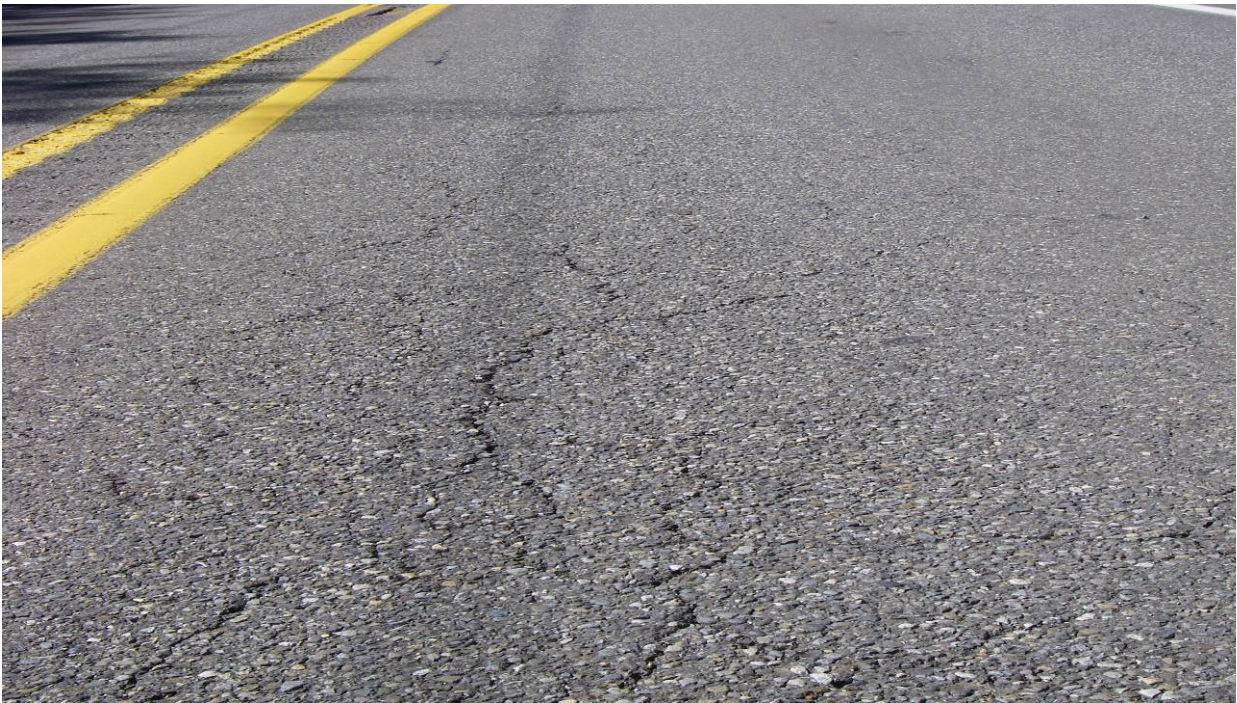
Figure 24. OR1b, SR101, prior to treatment. Alligator cracking was noted over the entire lane, but especially severe in the wheel paths.

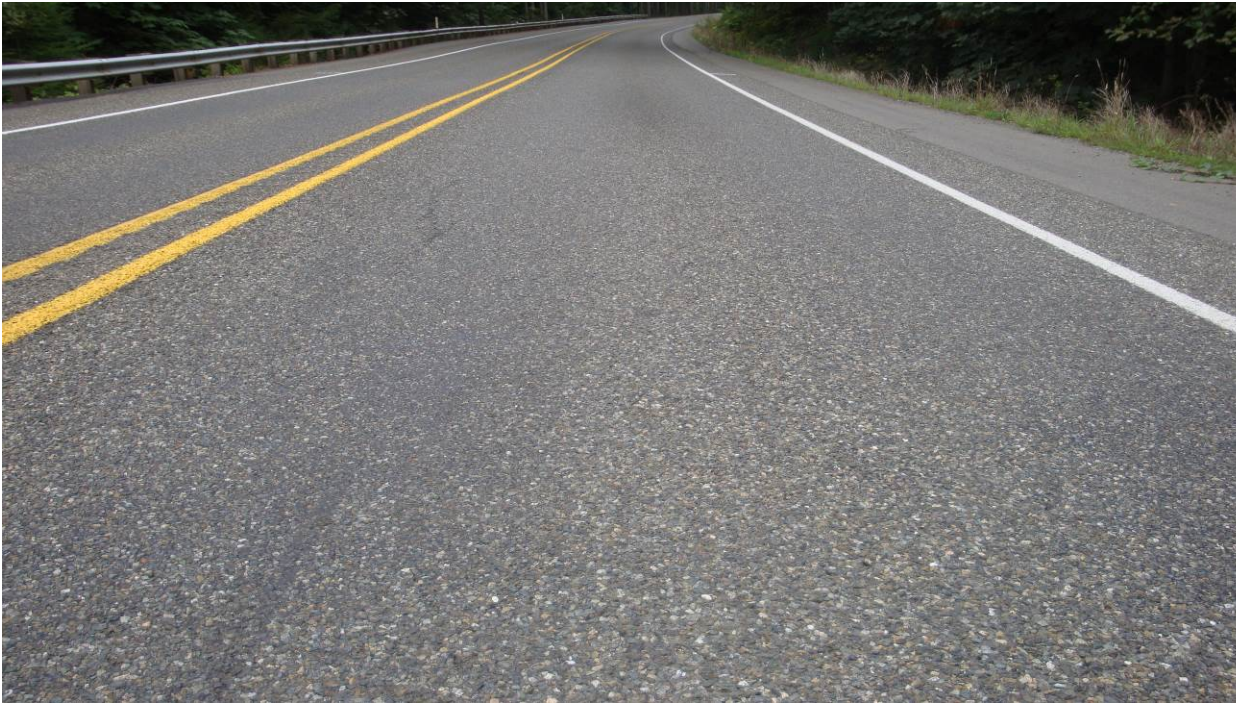
Figure 25. OR1b, SR101, one year after installation. Slight flushing in the wheel paths, one longitudinal crack in the left wheel path.

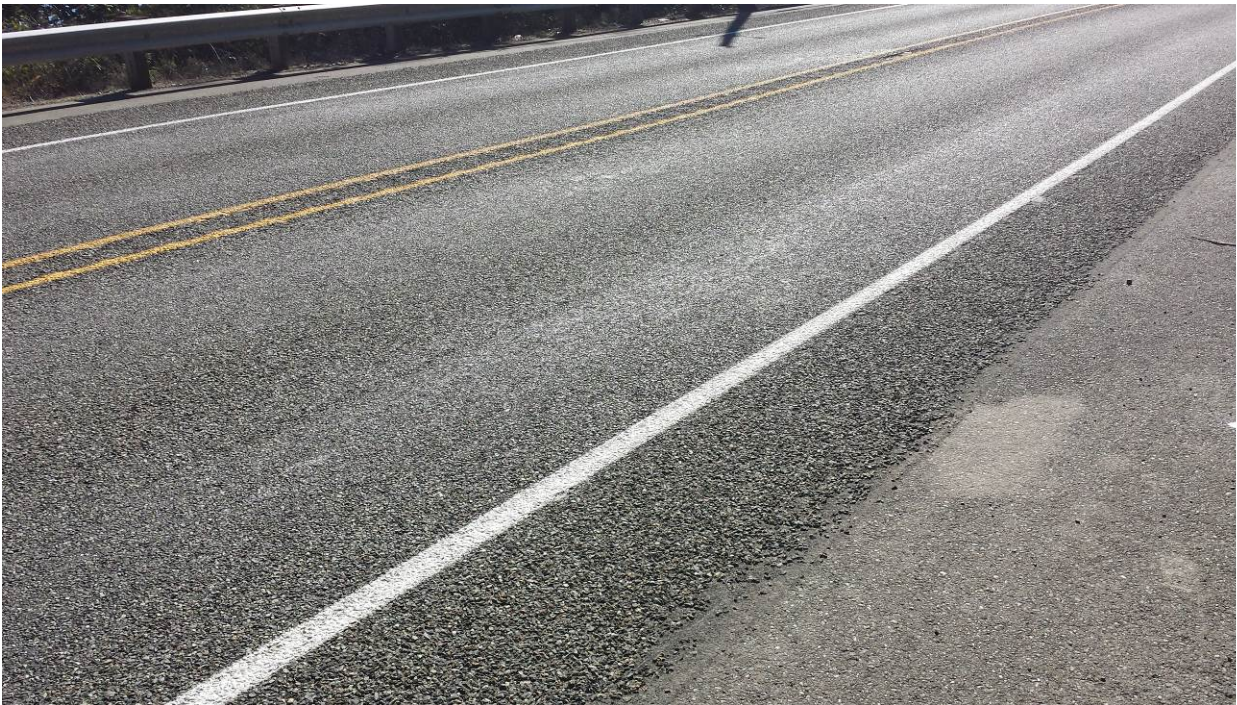
Figure 26. OR1b, SR101, two years after installation. Longitudinal crack appears to have “healed”. There is slight flushing in the wheel paths.

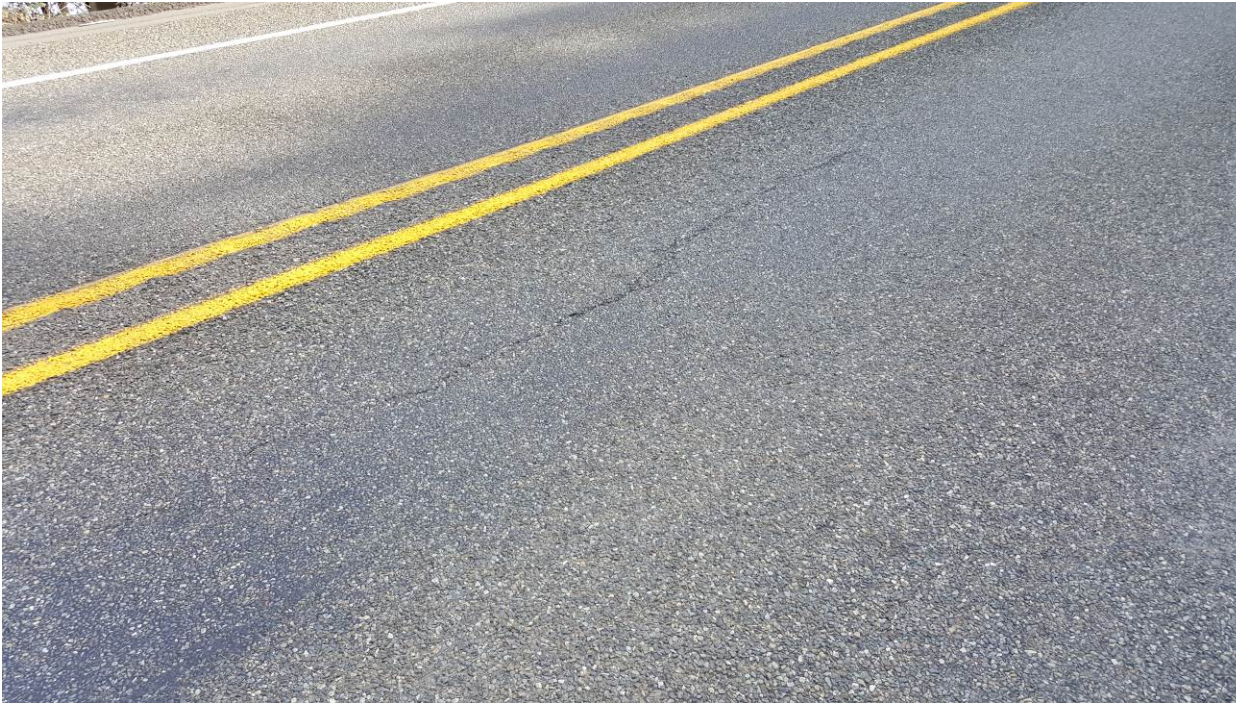
Figure 27. OR1b, SR101, three years after installation. Longitudinal crack is getting longer and wider. The flushing in the wheel paths is about the same.

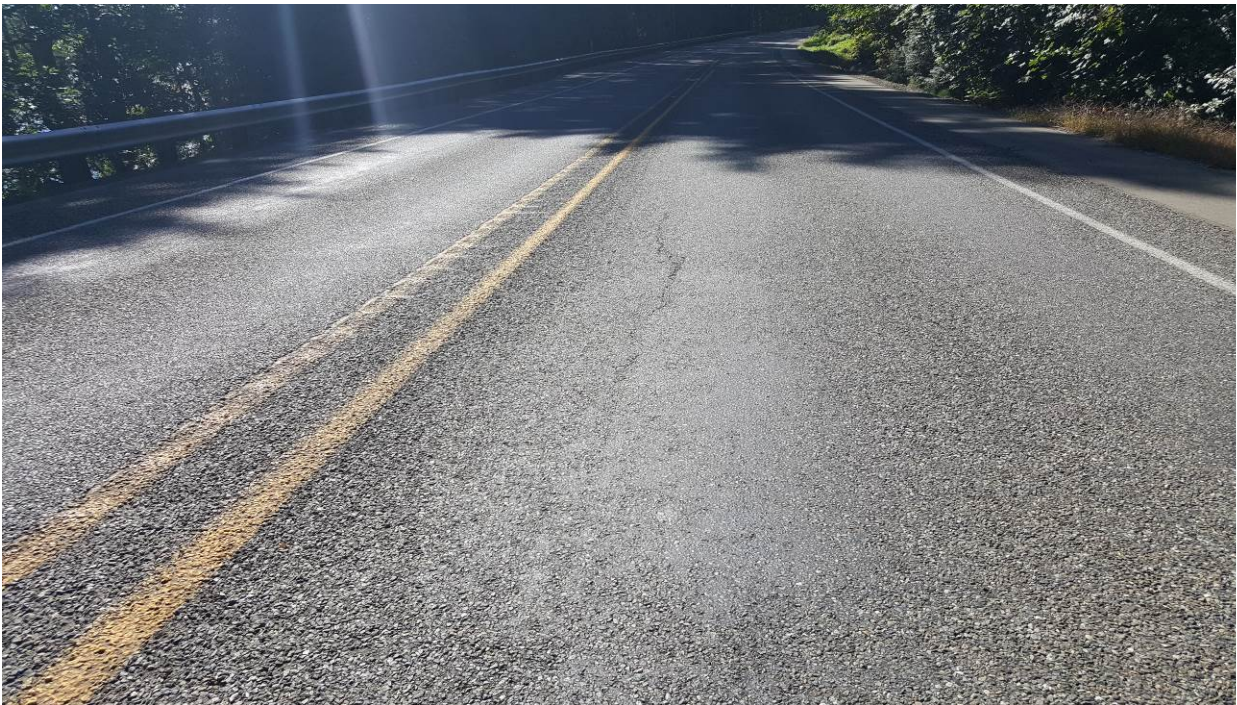
Figure 28. OR1b, SR101, four years after installation. Longitudinal crack condition is about the same, slight rutting and flushing in the wheel paths.

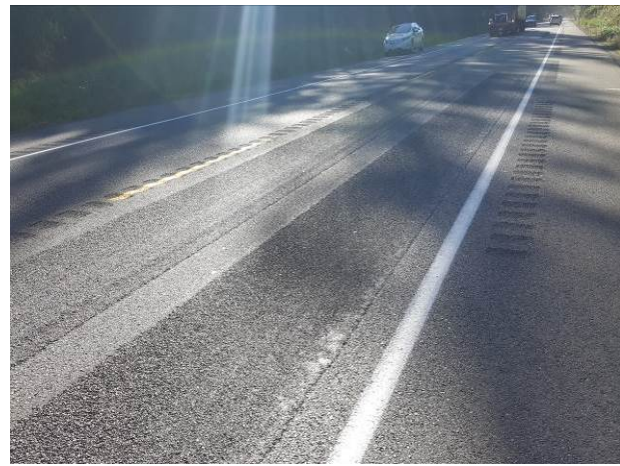
Figure 30. OR23, SR104, Strategic, age 13 months.

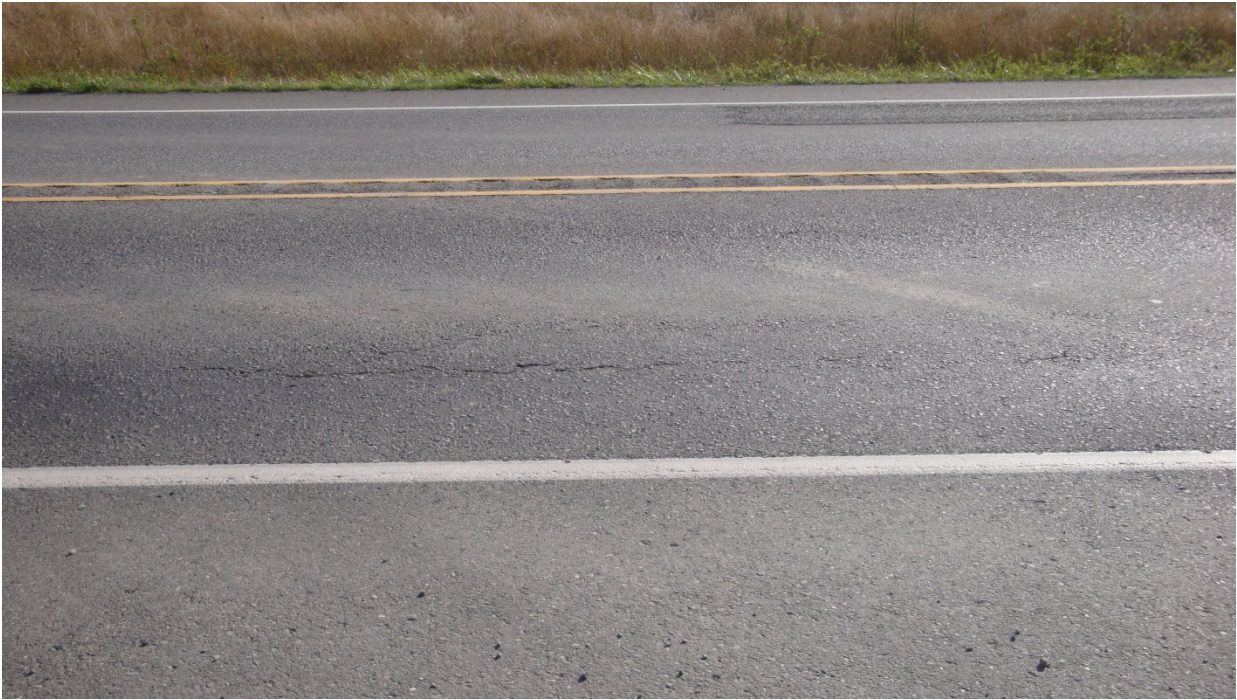
Figure 31. OR12, SR20, prior to treatment. Longitudinal and alligator cracking is present in the wheel paths.

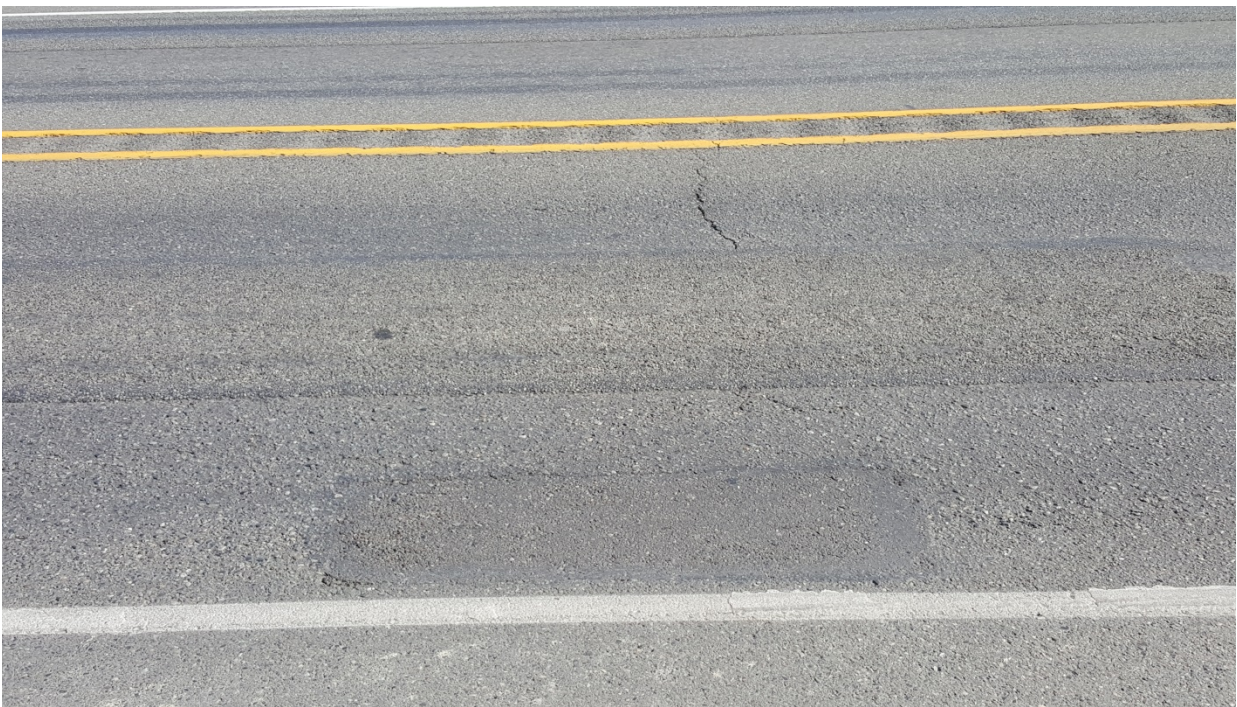
Figure 34. OR12, SR20, two years after installation. Some loss of aggregate but no reflection cracking.

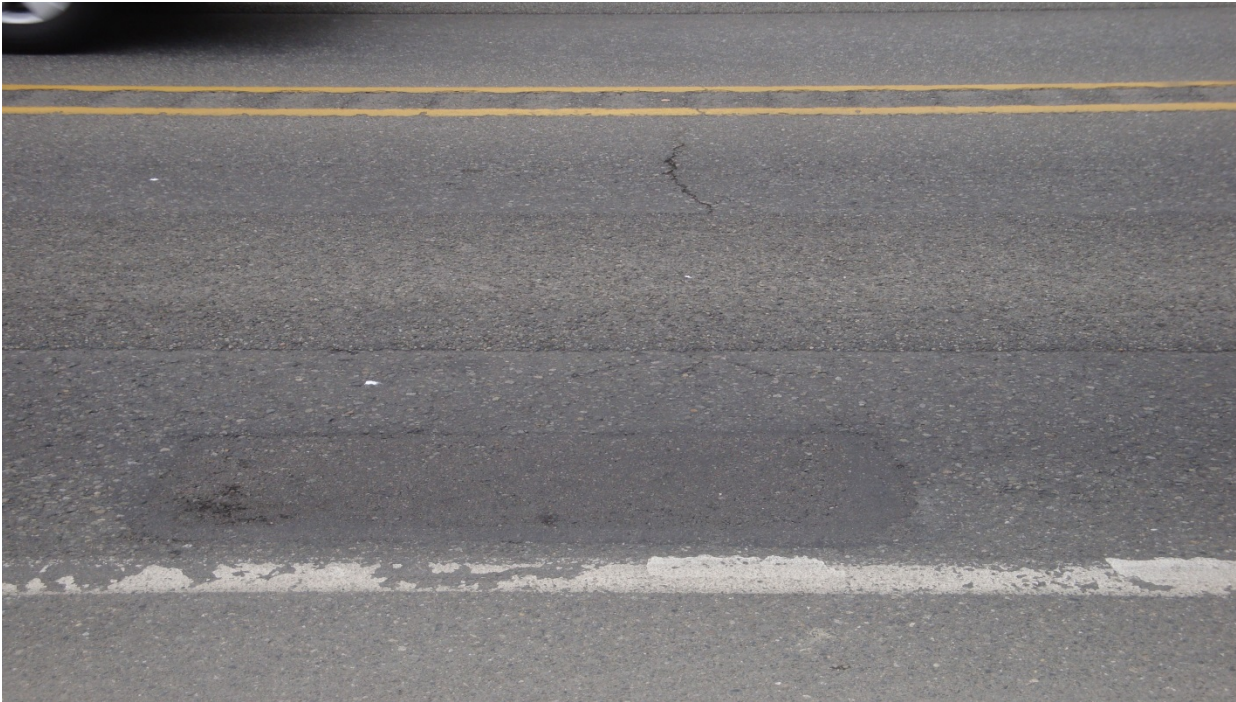
Figure 35. OR12, SR20, three years after installation. Some loss of aggregate but no reflection cracking.

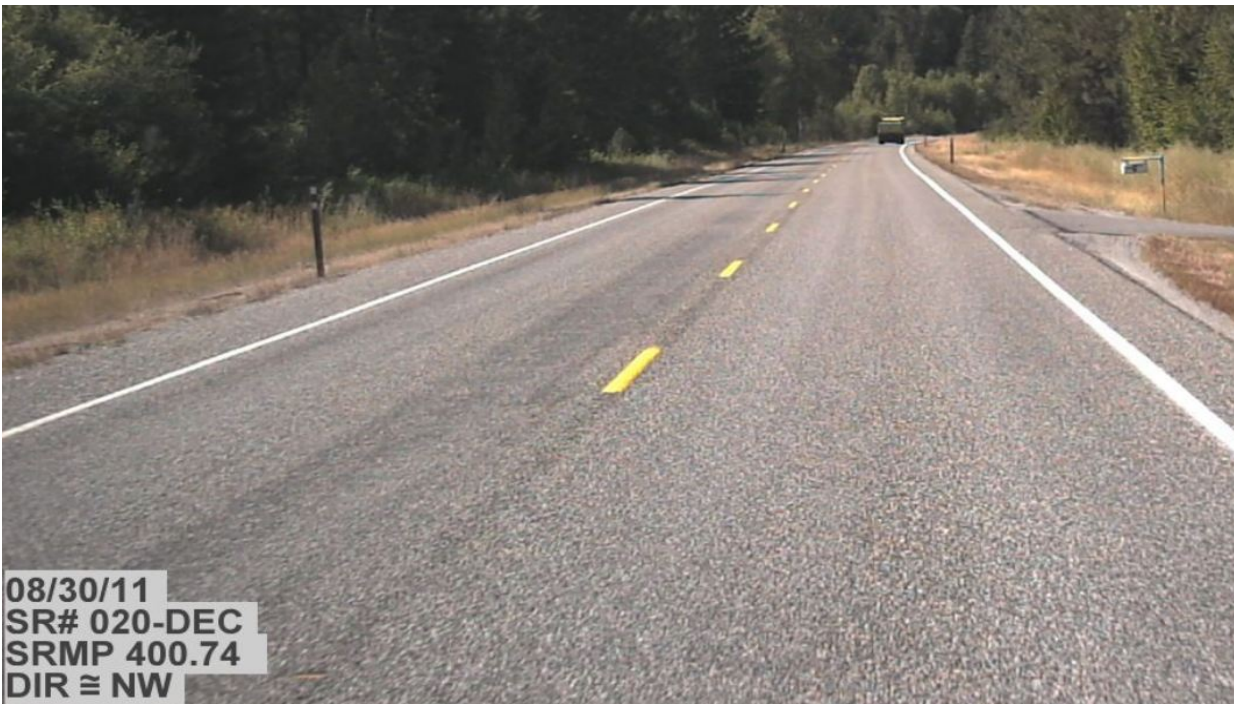
Figure 41. ER7, SR20, prior to installation. Rutting is visible in the wheel paths.

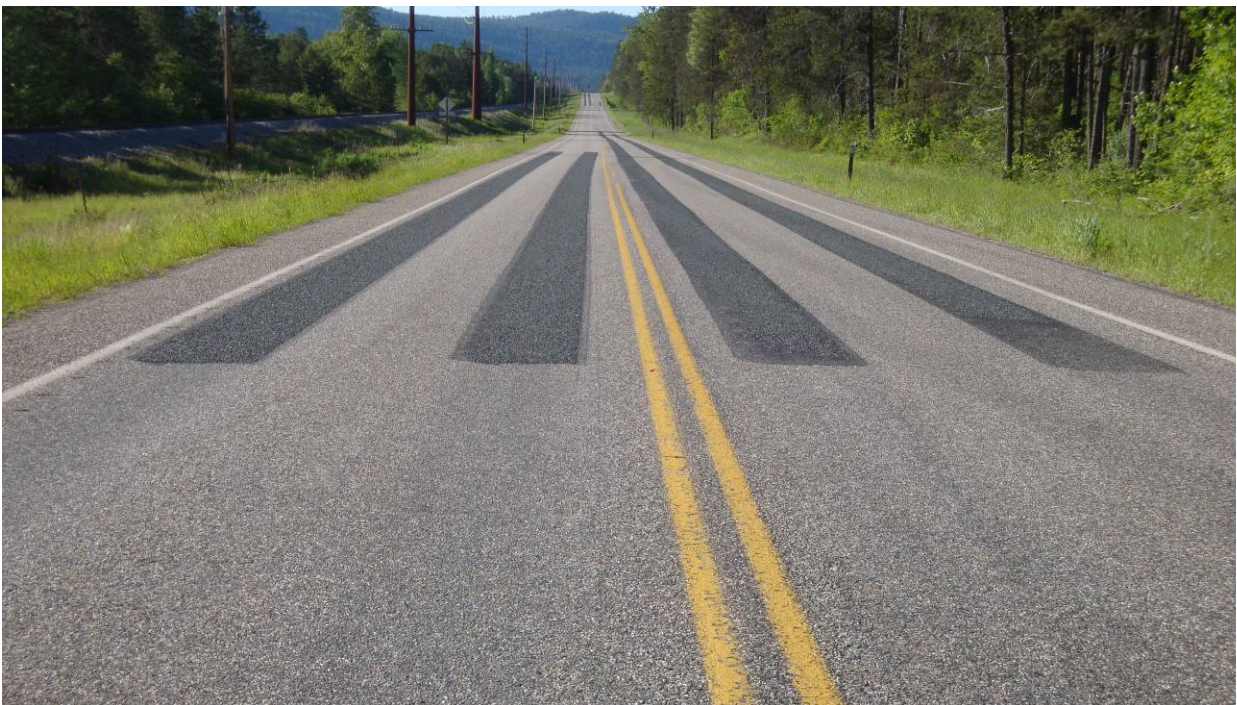
Figure 43. ER7, SR20, one year after installation. Wheel path chip seal rut fills are in excellent condition.

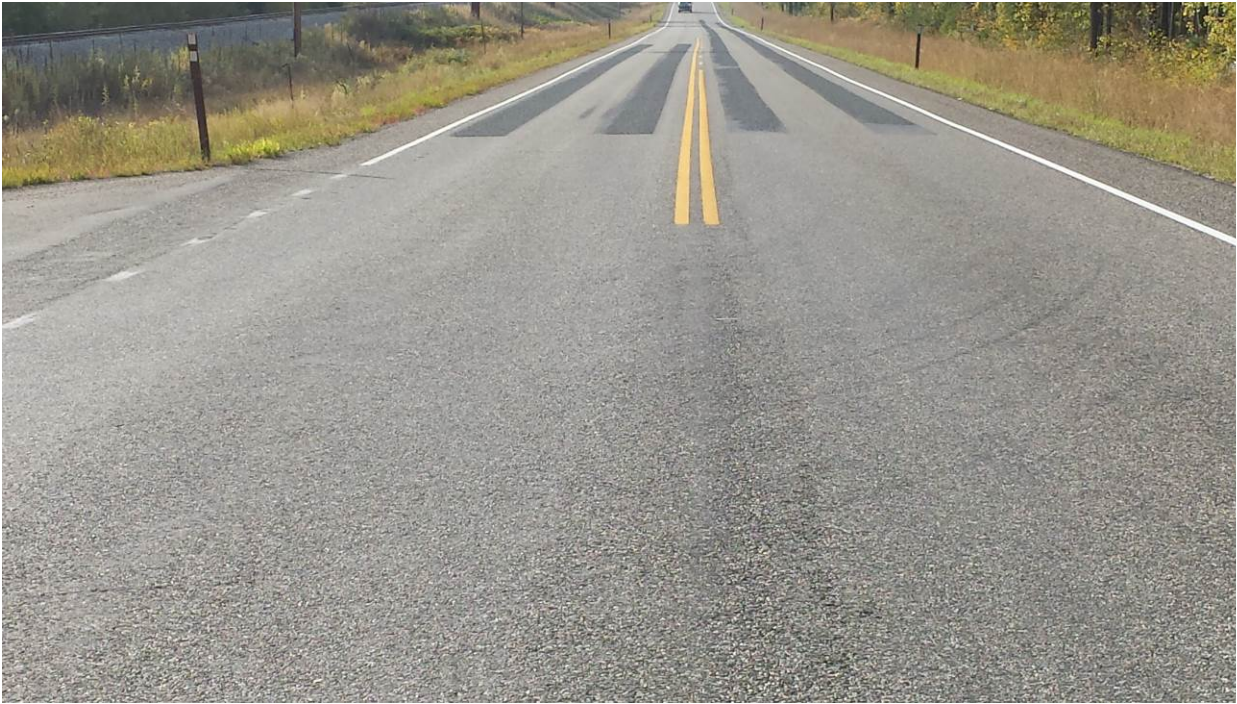
Figure 44. ER7, SR20, two years after installation. No change in chip seals.

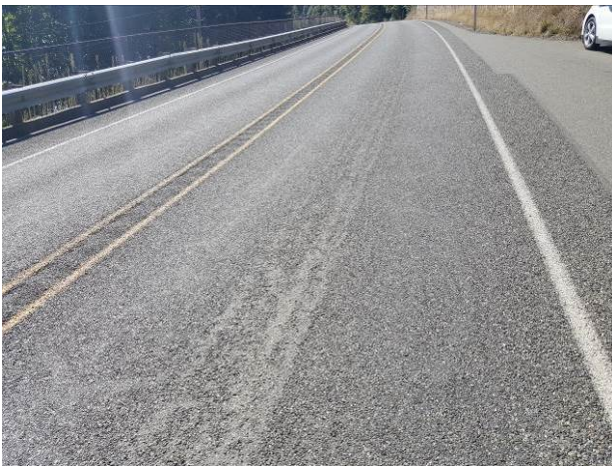
Figure 46. OR1a, SR101, Reactive, age 50 months. Underlying crack sealant can be seen as shadowing.

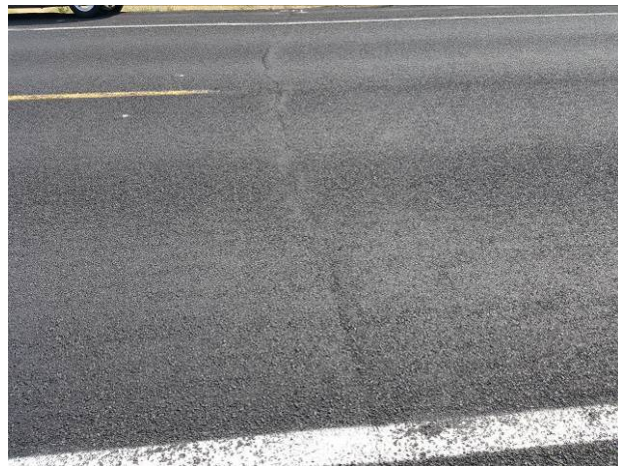
Figure 47. NC1, SR155, Strategic, age 26 months. Transverse crack locations are visible.

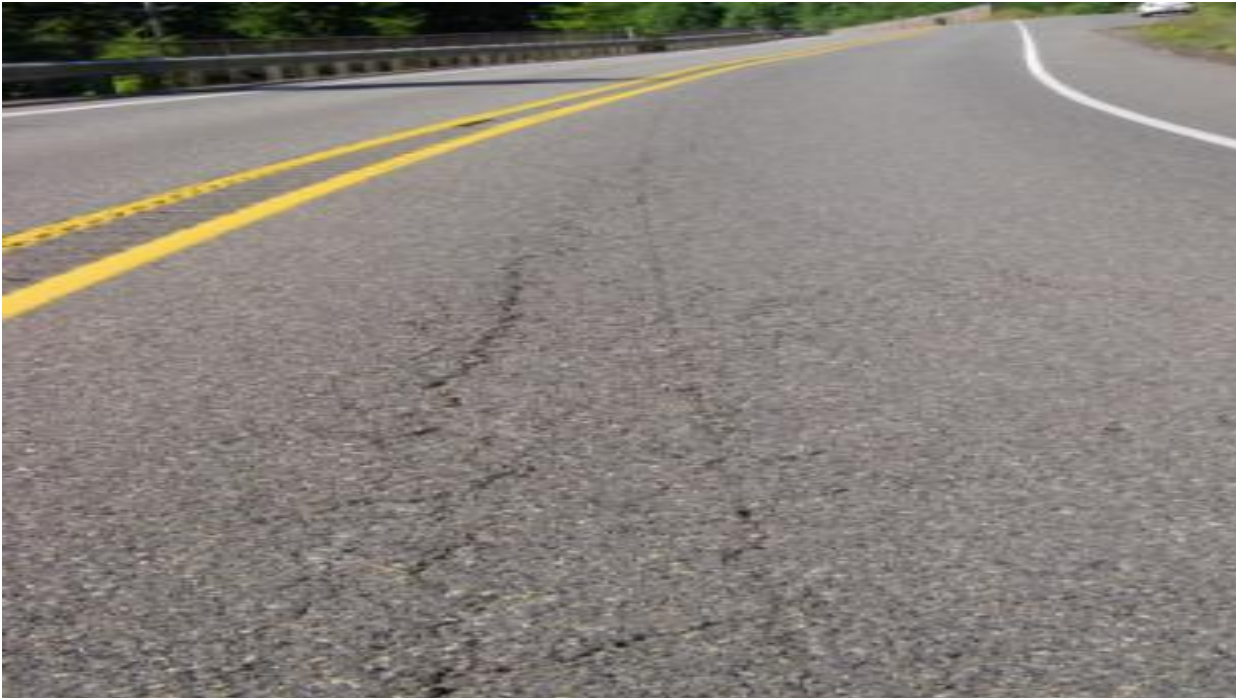
Figure 48. OR1a, SR101, prior to treatment. Alligator and longitudinal cracking noted.

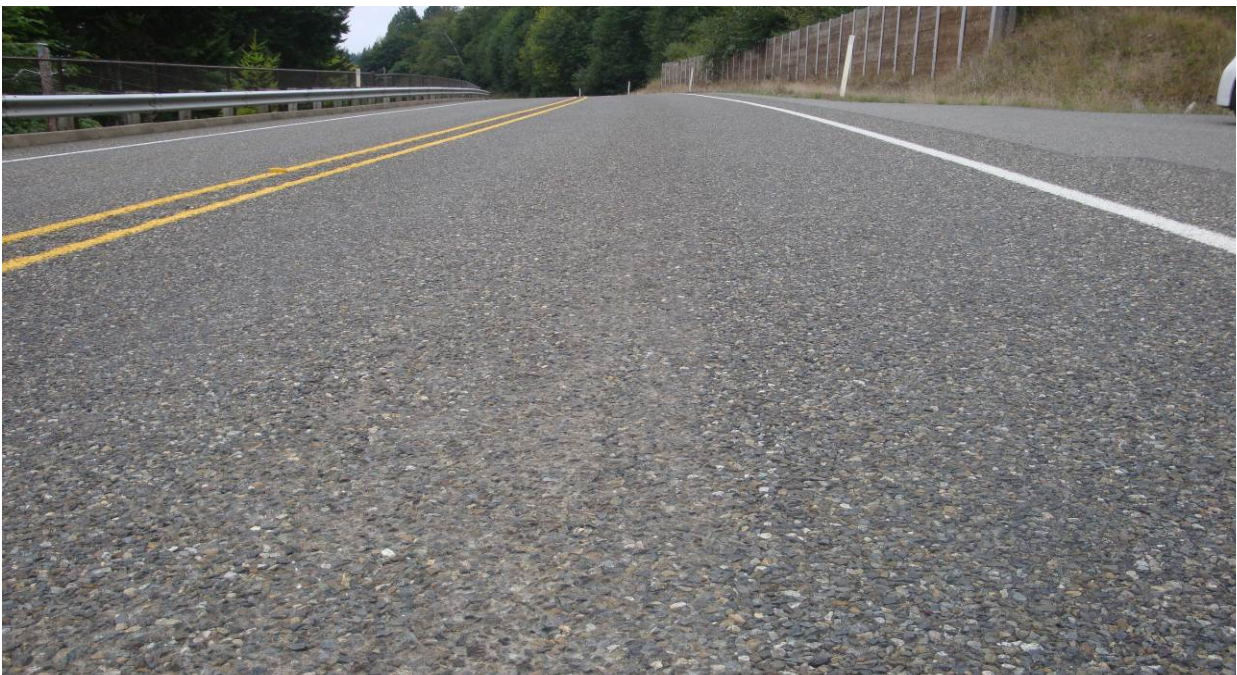
Figure 49. OR1a, SR101, one year after installation. Chip seal looks excellent.

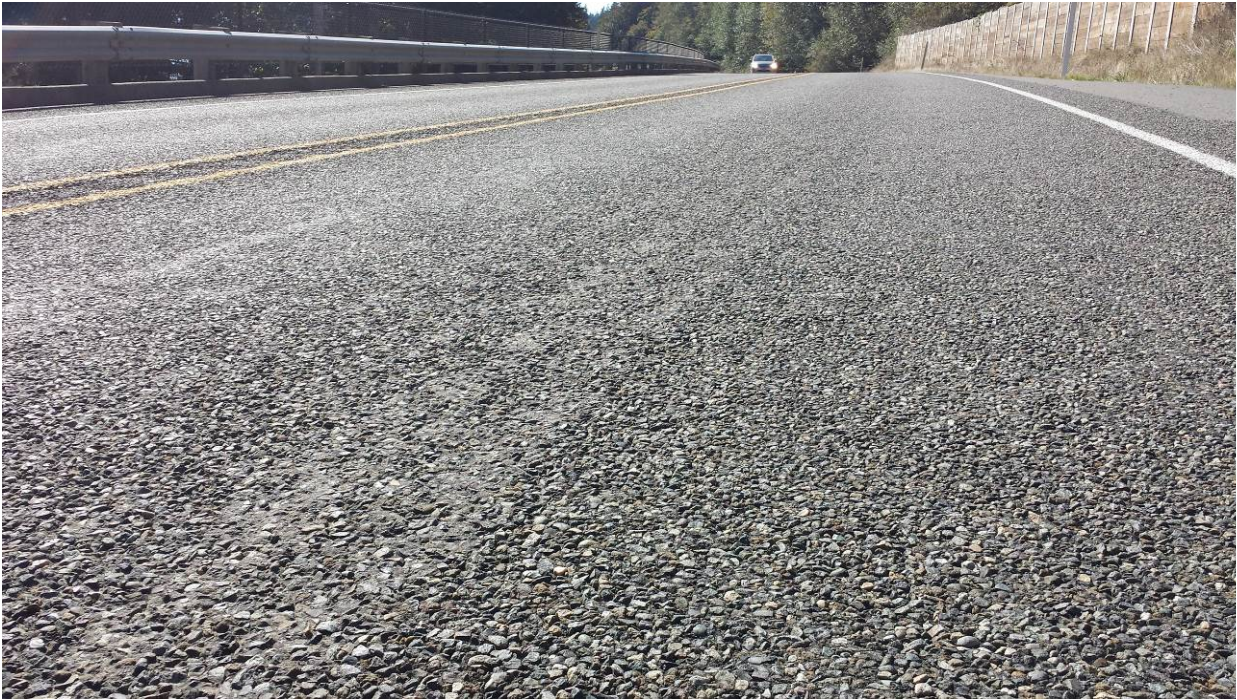
Figure 50. OR1a, SR101, two years after installation. Shadowing of the sealed cracks visible.

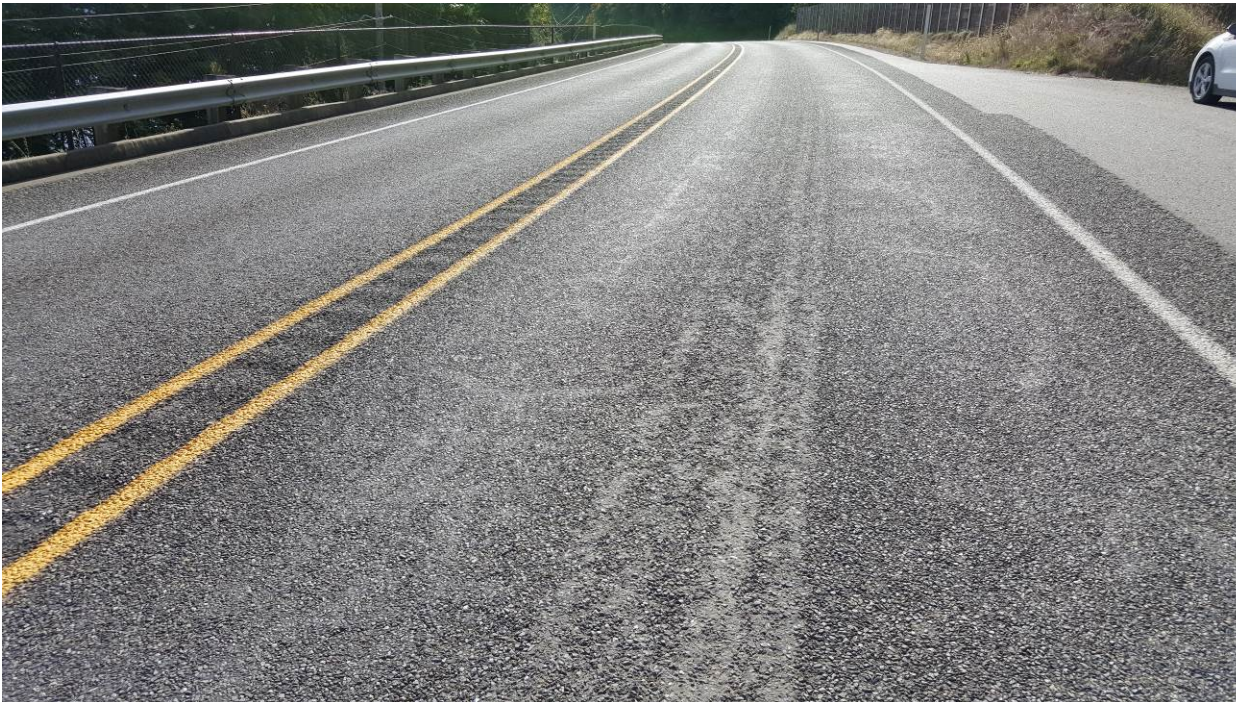
Figure 51. OR1a, SR101, three years after installation. Very slight flushing and shadowing of the sealed cracks.

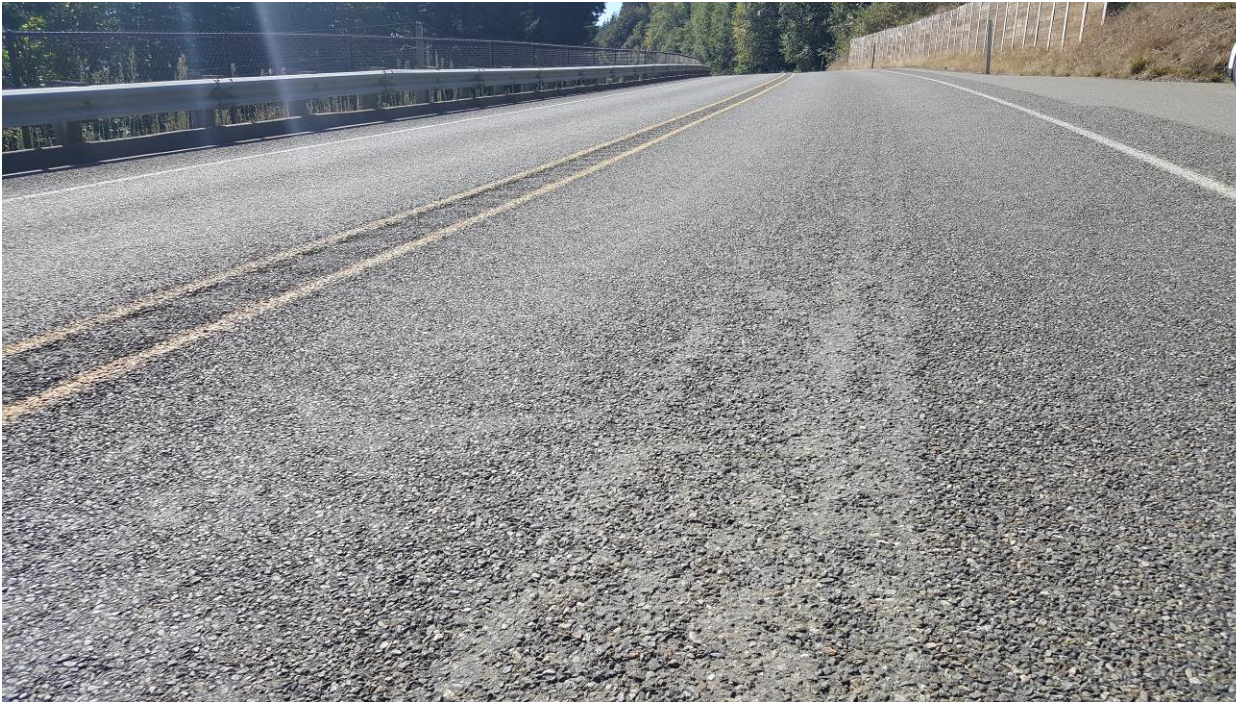
Figure 52. OR1a, SR101, four years after installation. Slight amount of rutting beginning to appear. Flushing does not seem to be a big issue.

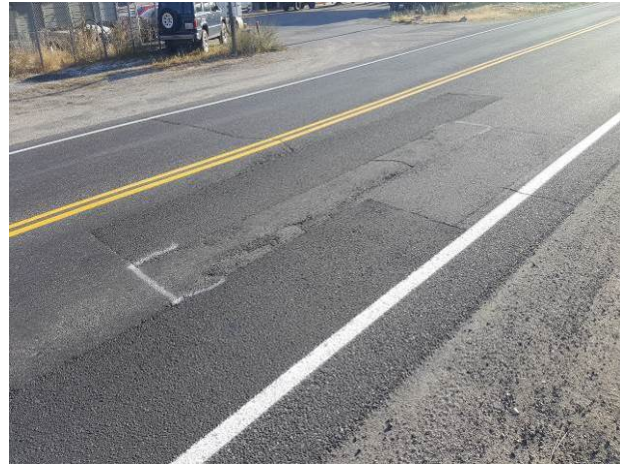
Figure 54. ER3, SR291, Emerging, age 50 months. Additional dig outs added in 2015. Transverse reflection crack noted at 10 months after treatment. More dig outs are scheduled for installation in 2017.

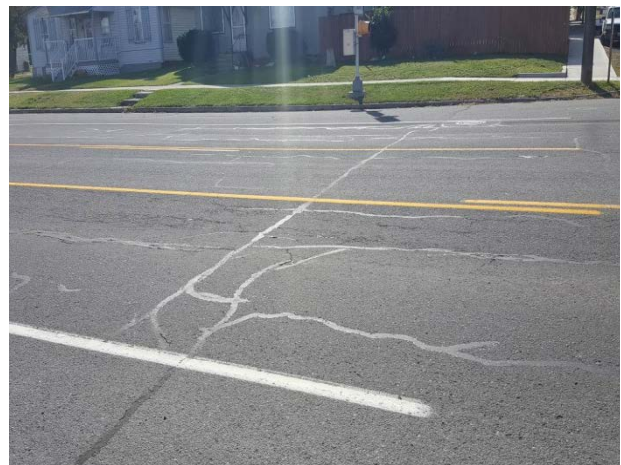
Figure 56. ER5, SR2, Reactive, age 38 months. Transverse reflection crack noted at the age of 10 months after treatment.

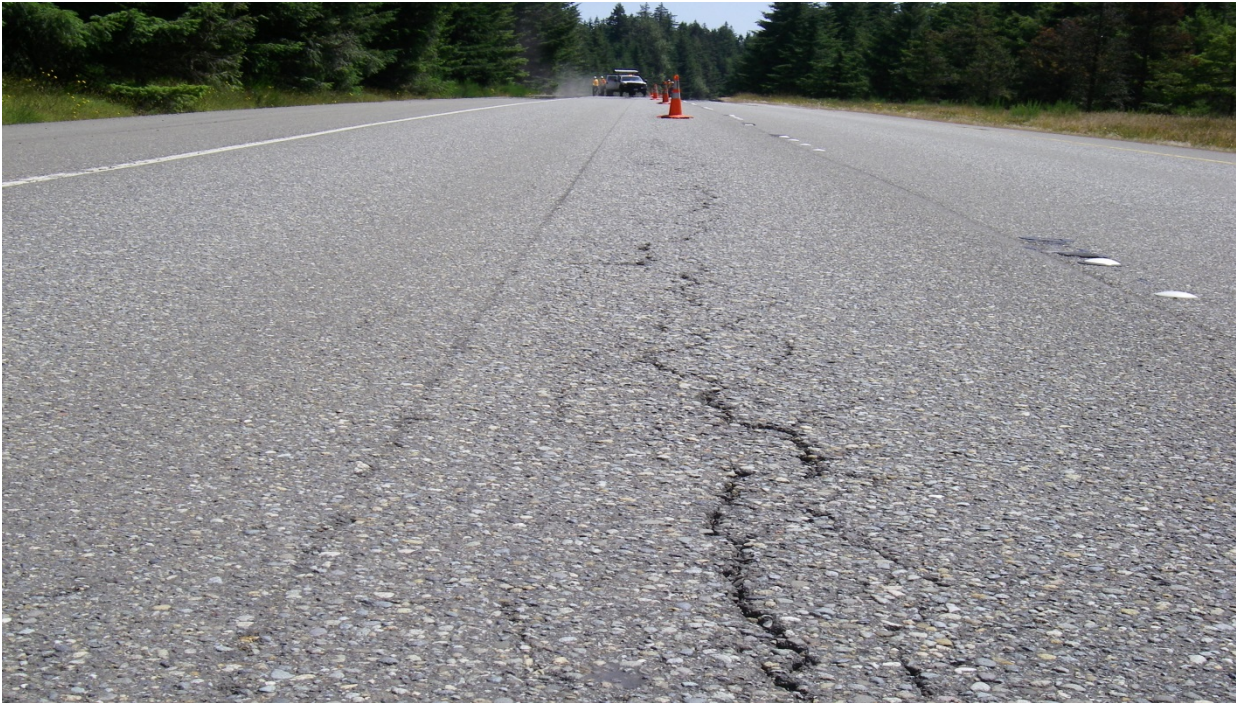
Figure 74. OR2, SR8, prior to treatment. Alligator cracking in the left wheel path. This is not the same location as the following photos which had alligator cracking in both wheel paths.

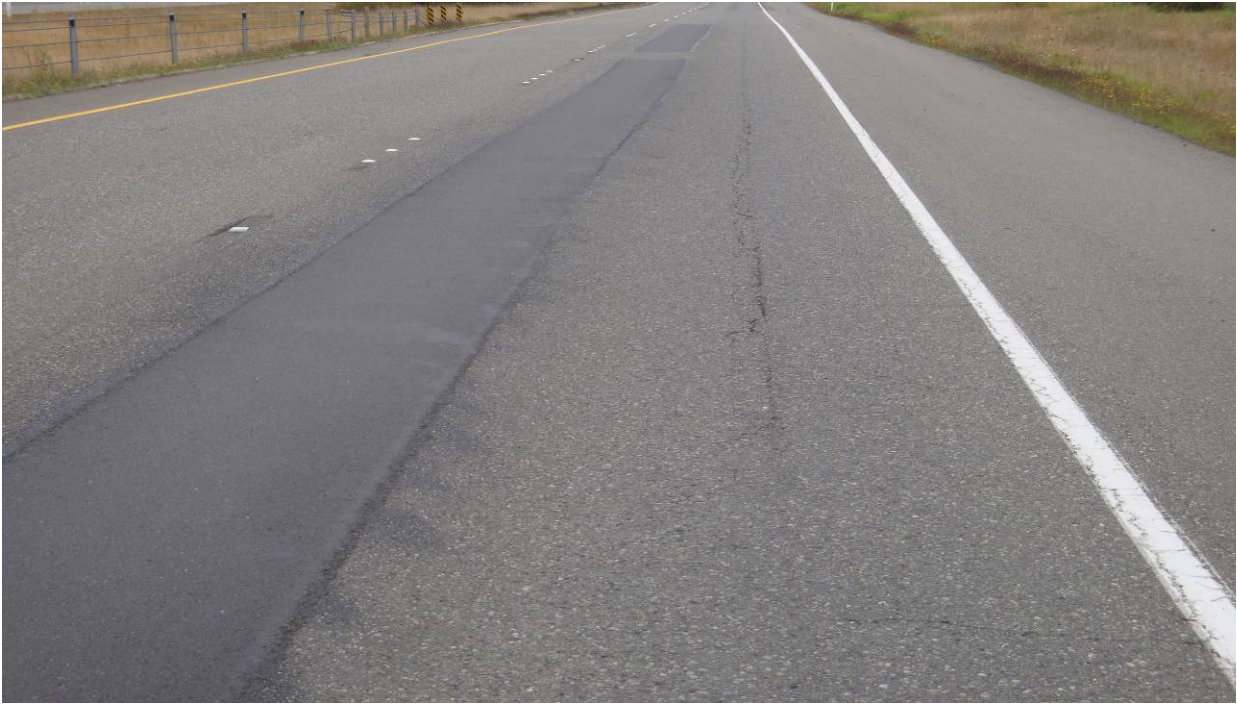
Figure 75. OR2, SR8, one year after installation. Dig out patch looks excellent.

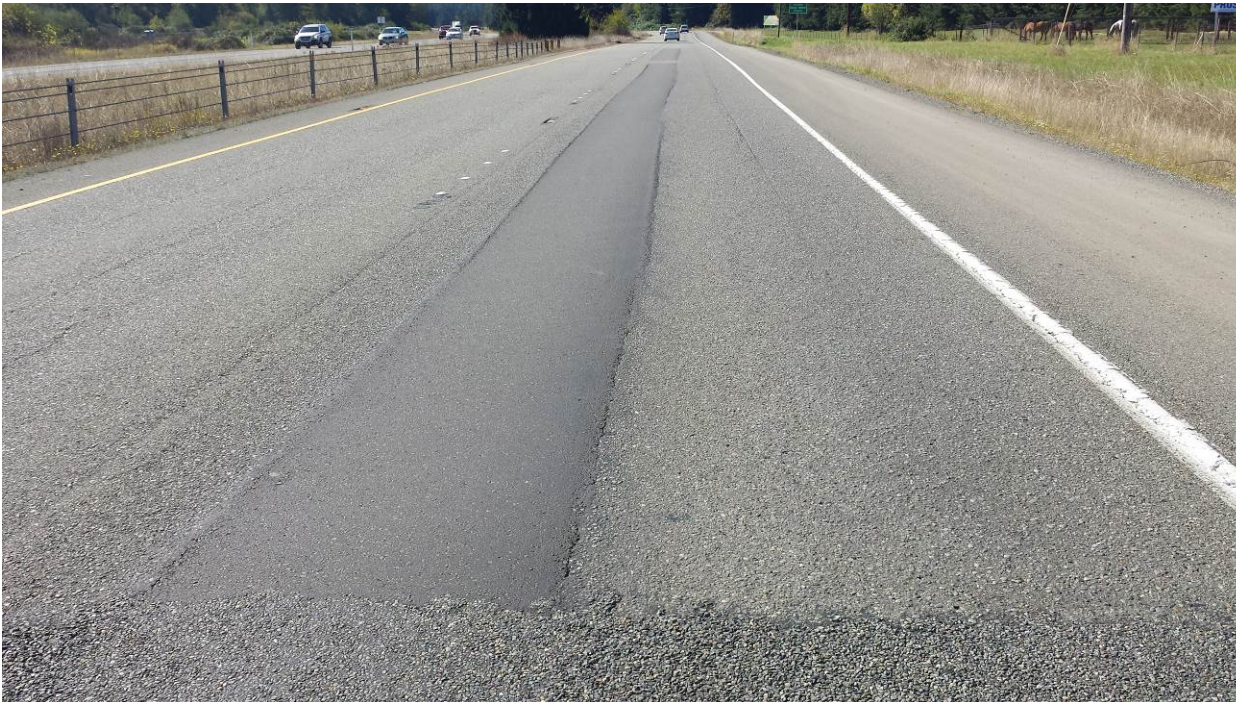
Figure 76. OR2, SR8, two years after installation. No change in condition of patch.
