Preventive Maintenance Study – Interim Report

WA-RD 871.1

**Washington State
Department of Transportation**

Preventive Maintenance Study

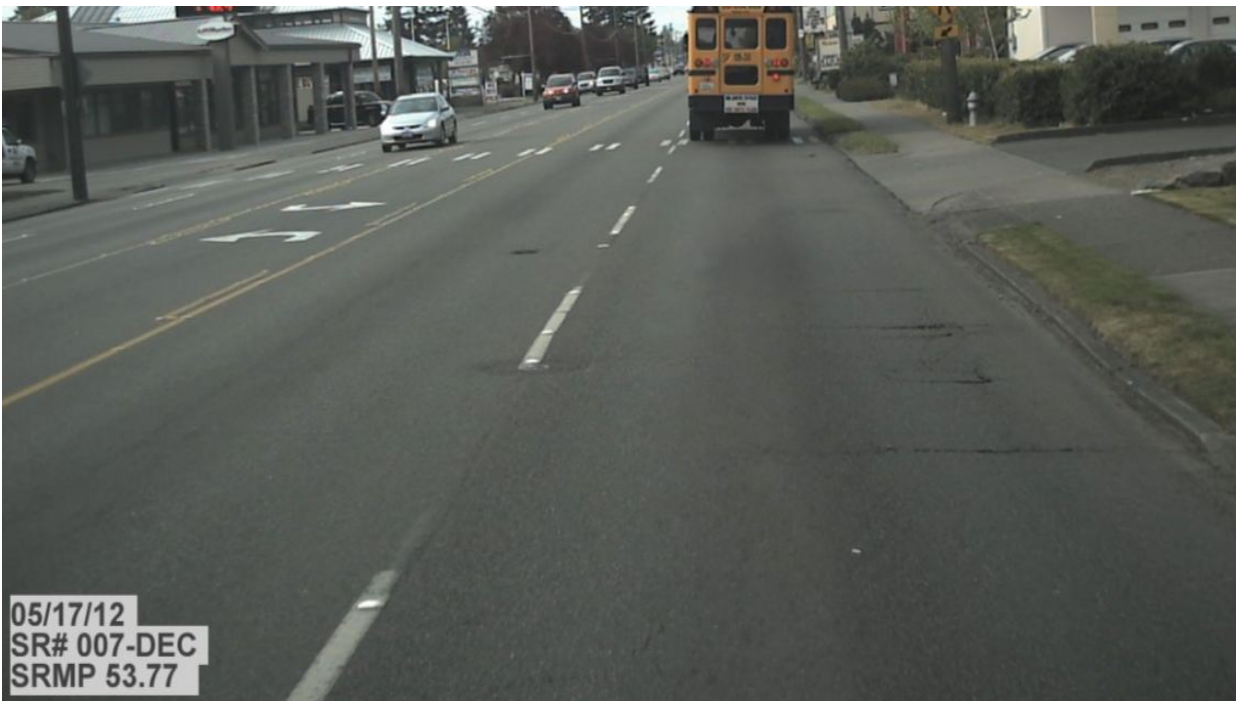
Figure 79. OR5, SR7, prior to treatment. Not at same location as following photos.

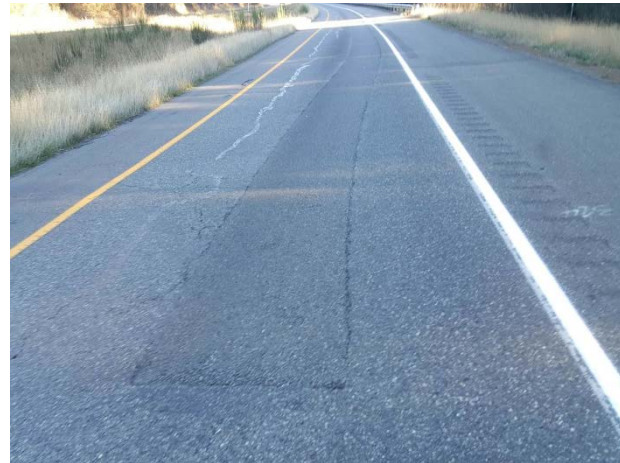
Figure 85. OR4, SR3, Strategic, age 39 months.

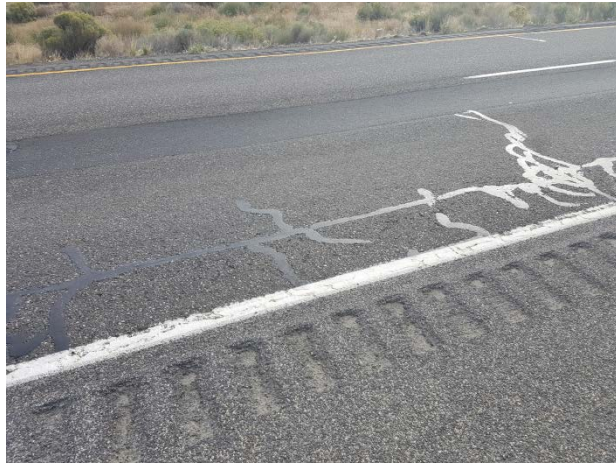
Figure 87. SC4, SR395, Strategic, age 13 months. Portions of the test site are in the Reactive category.

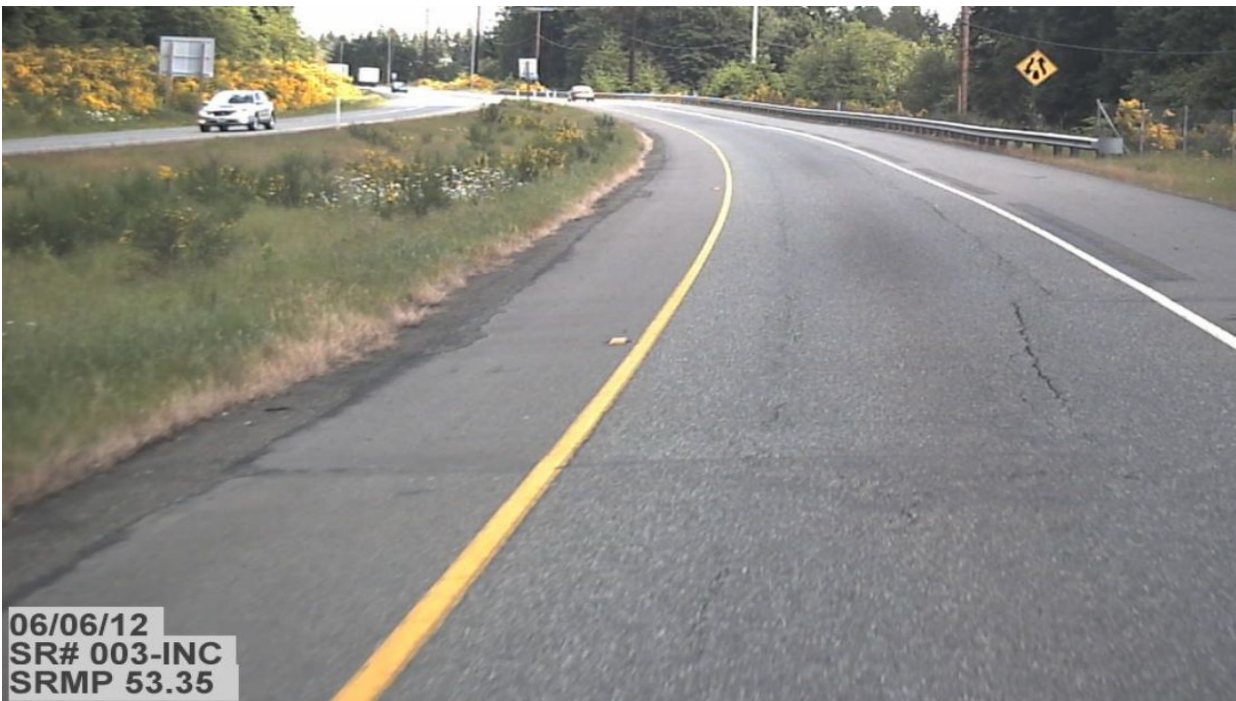
Figure 88. OR4, SR3, prior to treatment. Longitudinal, transverse and alligator cracking.

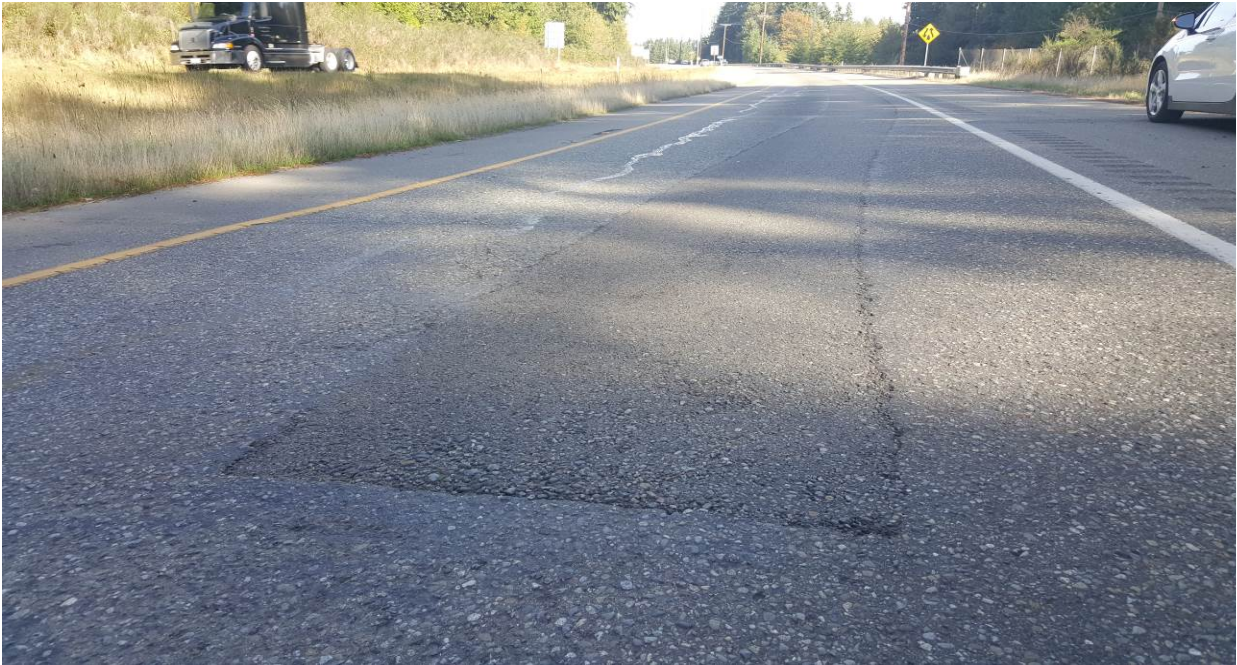
Figure 91. OR4, SR3, two years after installation. No change in dig out patch or crack sealing.

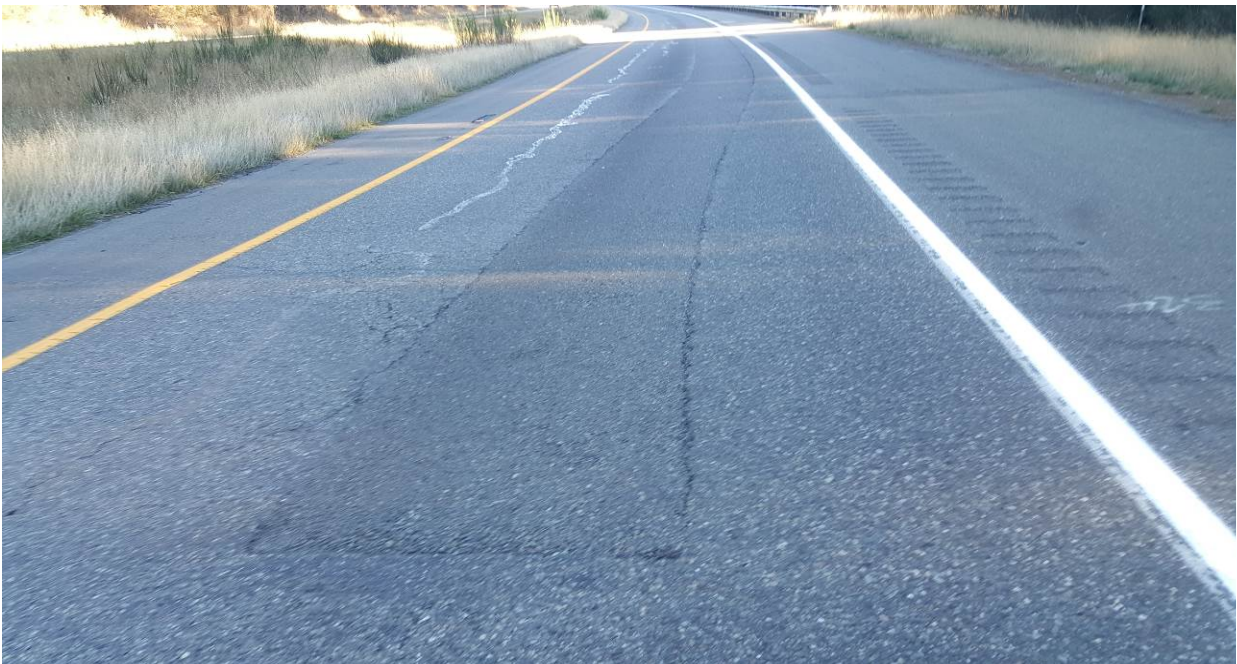
Figure 92. OR4, SR3, three years after installation. No change in dig out patch or crack sealing.

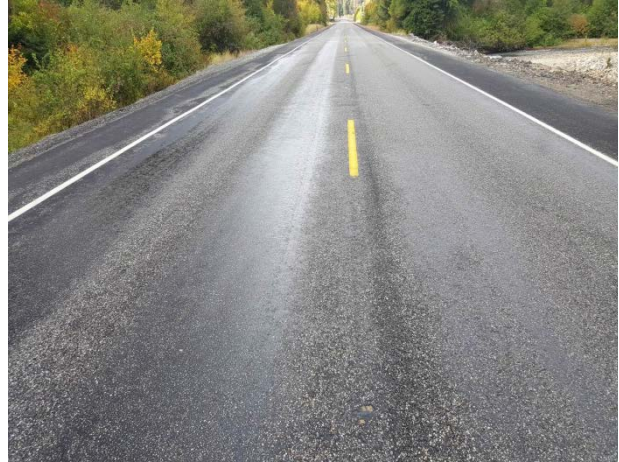
Figure 97. OR14, SR7, Strategic, age 39 months. Dig out patches flushing through the chip seal at 27 months.

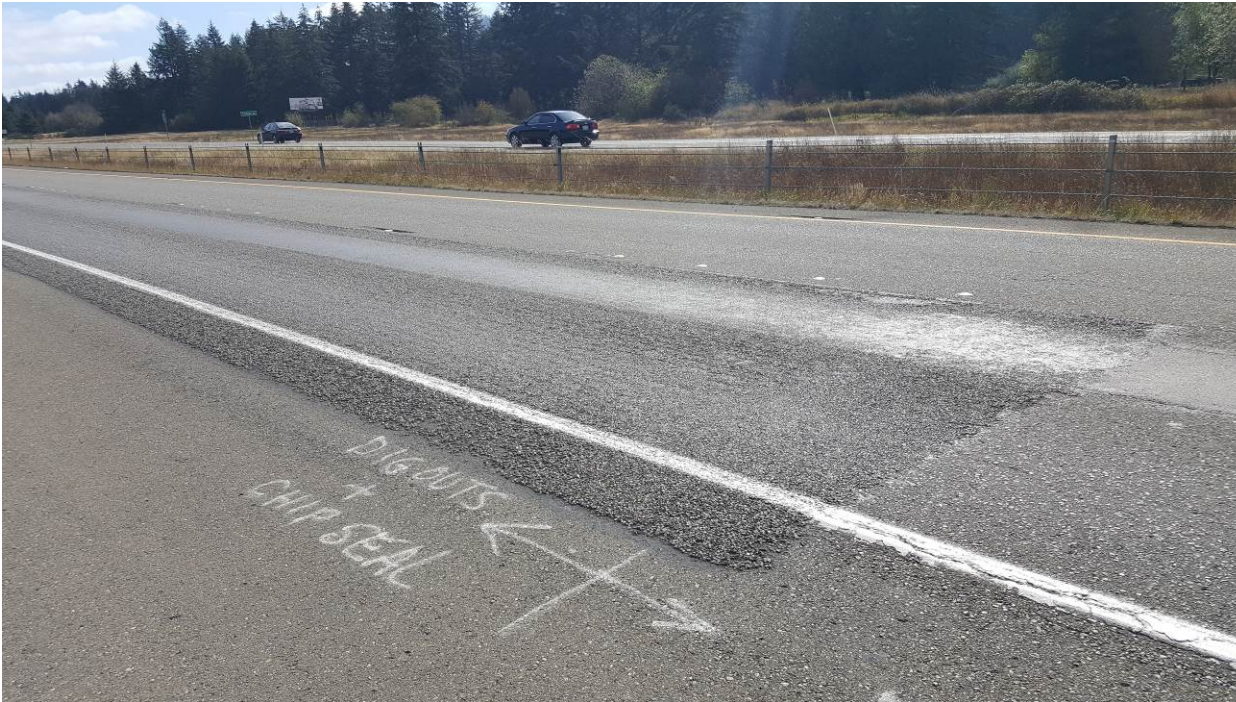
Figure 103. OR2a, SR8, four years after installation. Flushing has remained about the same as in 2015.

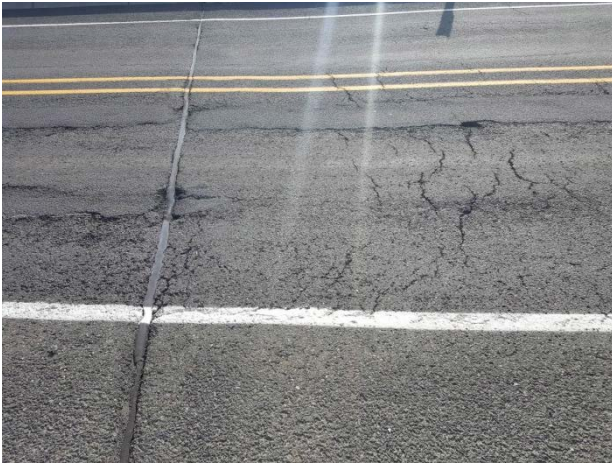
Figure 104. ER8, SR195, Strategic, are 27 months. Blade patch used to fill wheel path ruts.

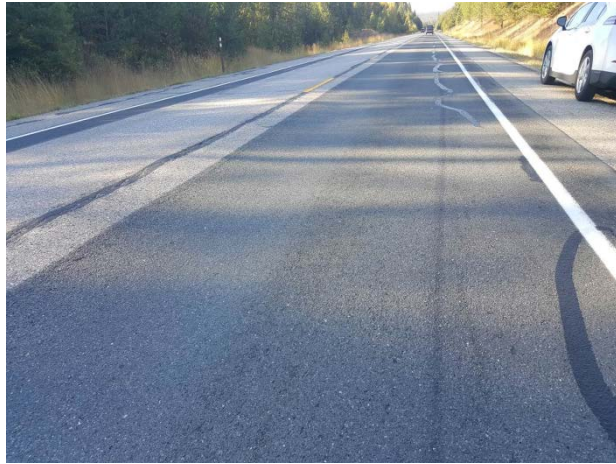
Figure 105. ER9a, SR395, Strategic, age 25 months. Transverse and longitudinal cracking reflecting through the patch at 13 months. It is possible that this could have been a paver and not a blade patch.

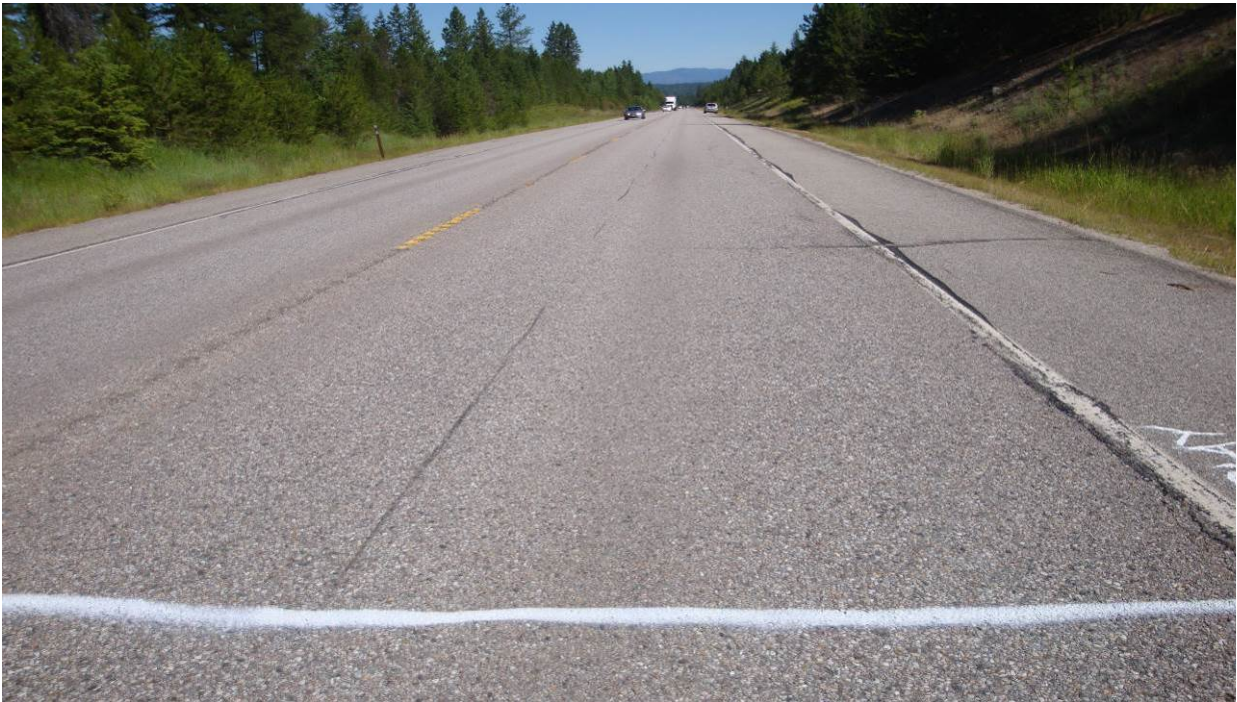
Figure 113. ER9a, SR395, prior to treatment. Longitudinal, transverse and alligator cracking.

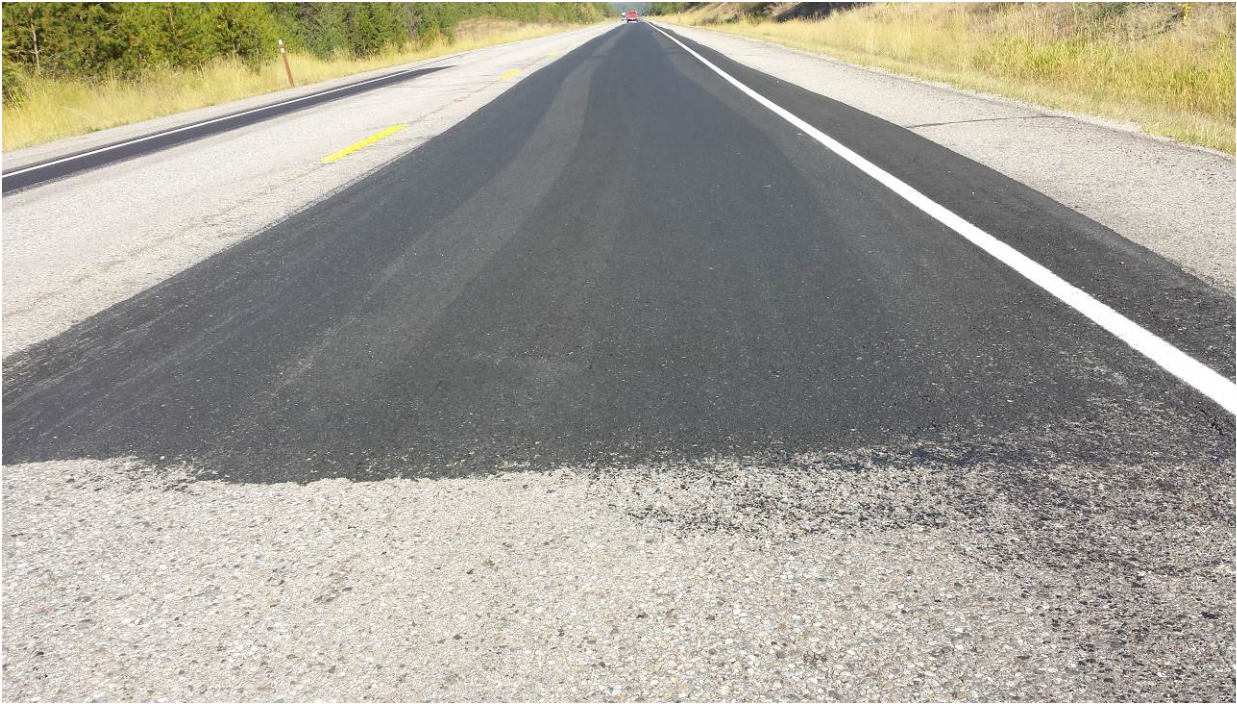
Figure 114. ER9a, SR395, a few months after installation. Blade patch looks excellent.

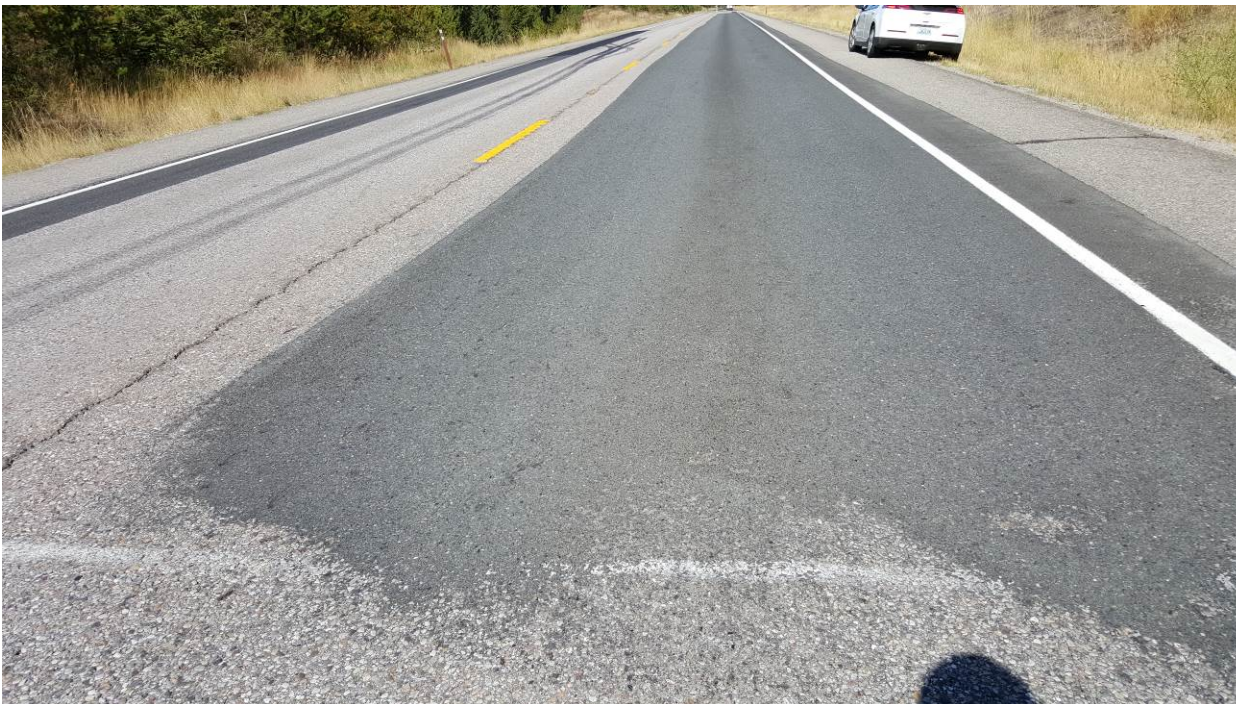
Figure 115. ER9a, SR395, one year after installation. Some wear of the blade patch at each end. Transverse cracks reflected through the blade patch after only one year.

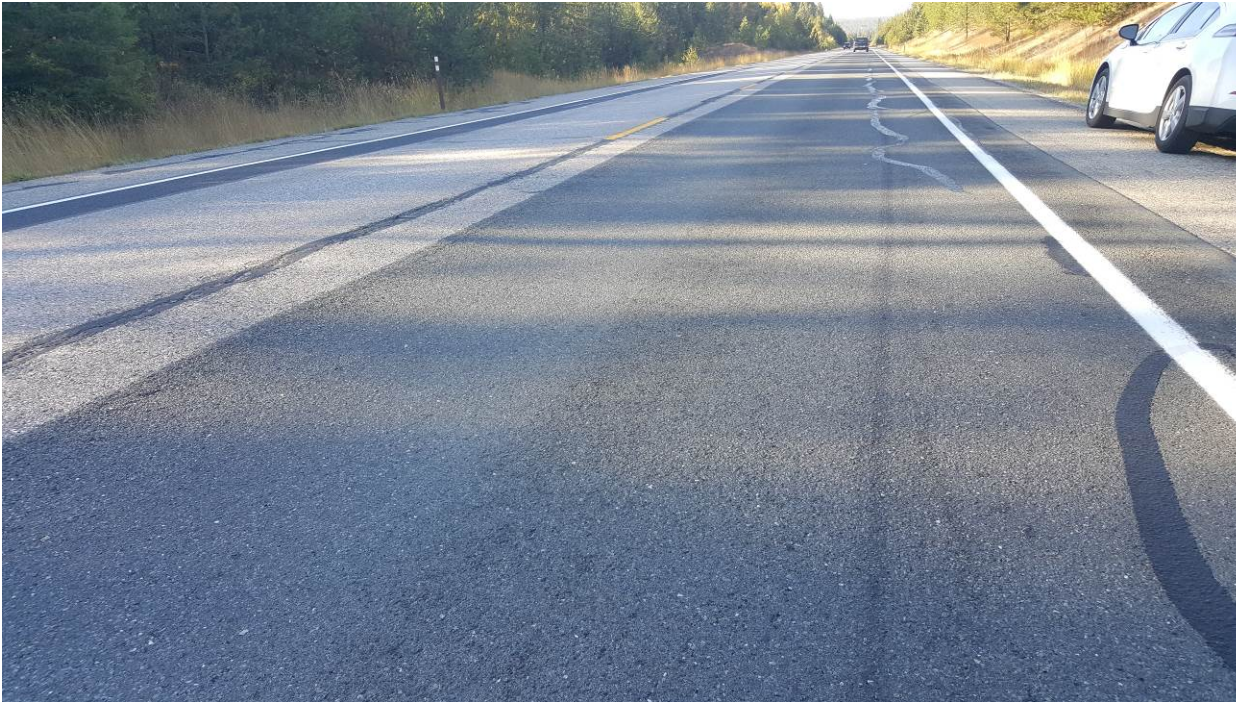
Figure 116. ER9a, SR395, two years after installation. Longitudinal reflection cracking has been sealed. Note slight flushing in the left wheel path.

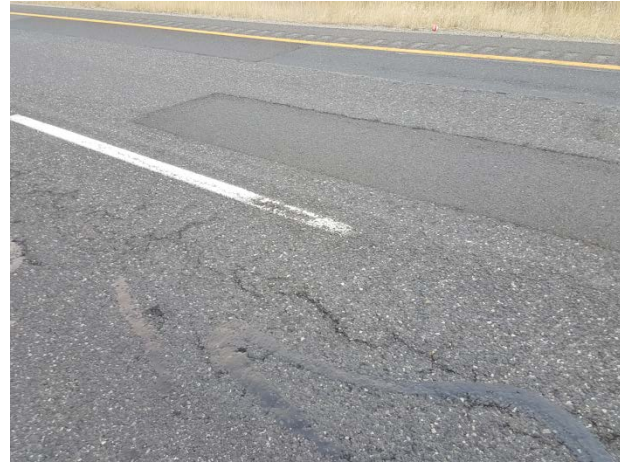
Figure 118. ER1a, SR2, Reactive, at 2016 inspection. Dig outs, crack sealing and patching were necessary to preserve the roadway.

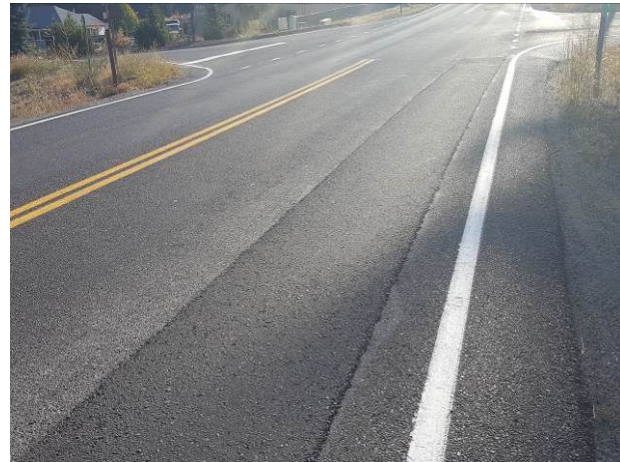
Figure 120. ER3a, SR291, Emerging, at 2016 inspection. Dig outs, crack sealing and patching were necessary to preserve the roadway.

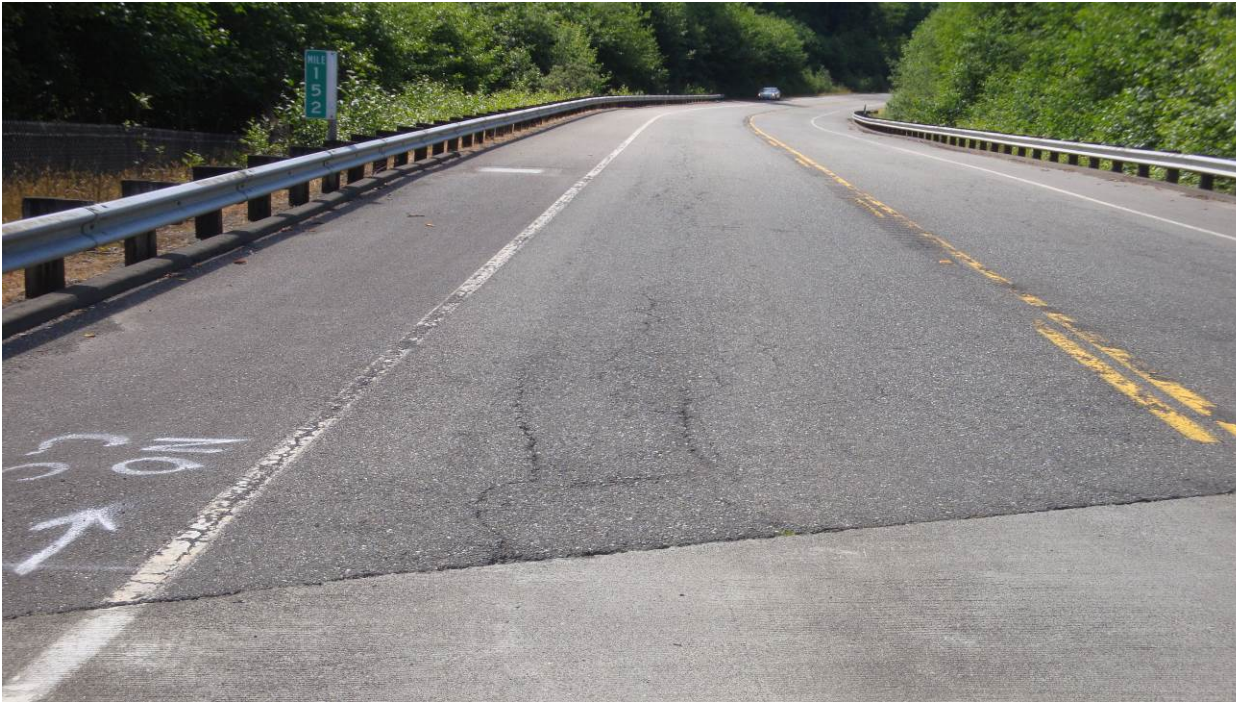
Figure 121. OR3a, SR101, condition in 2012, the year that the other sections were treated.

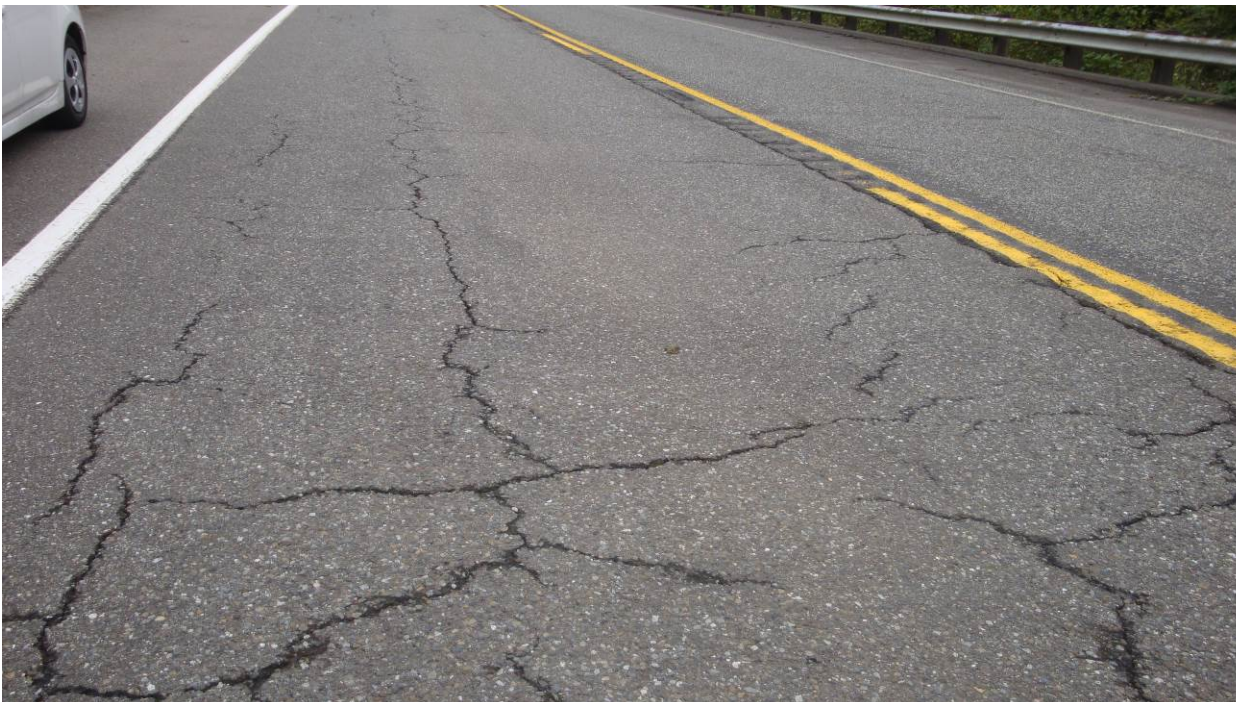
Figure 122. OR3a, SR101, one year after the other sections were treated. Cracking looks severe due to moisture in the cracks.

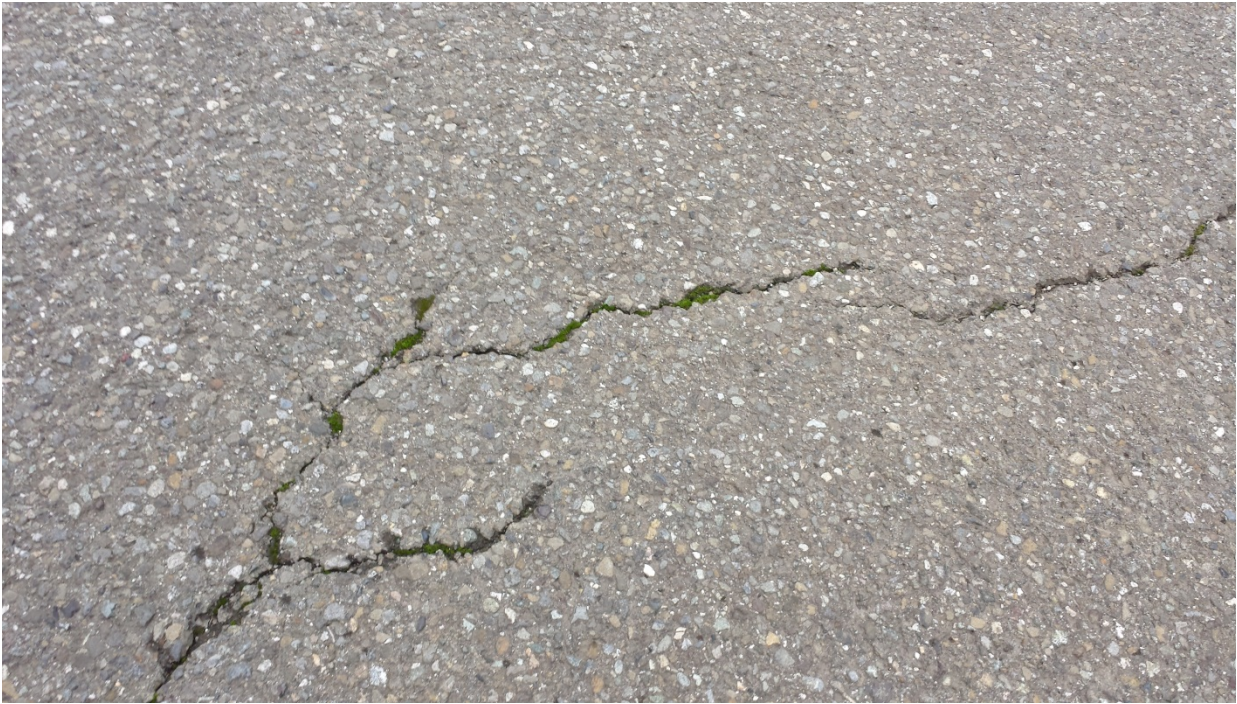
Figure 123. OR3a, SR101, two years after the other sections were treated. Vegetation growing in the wider cracks.

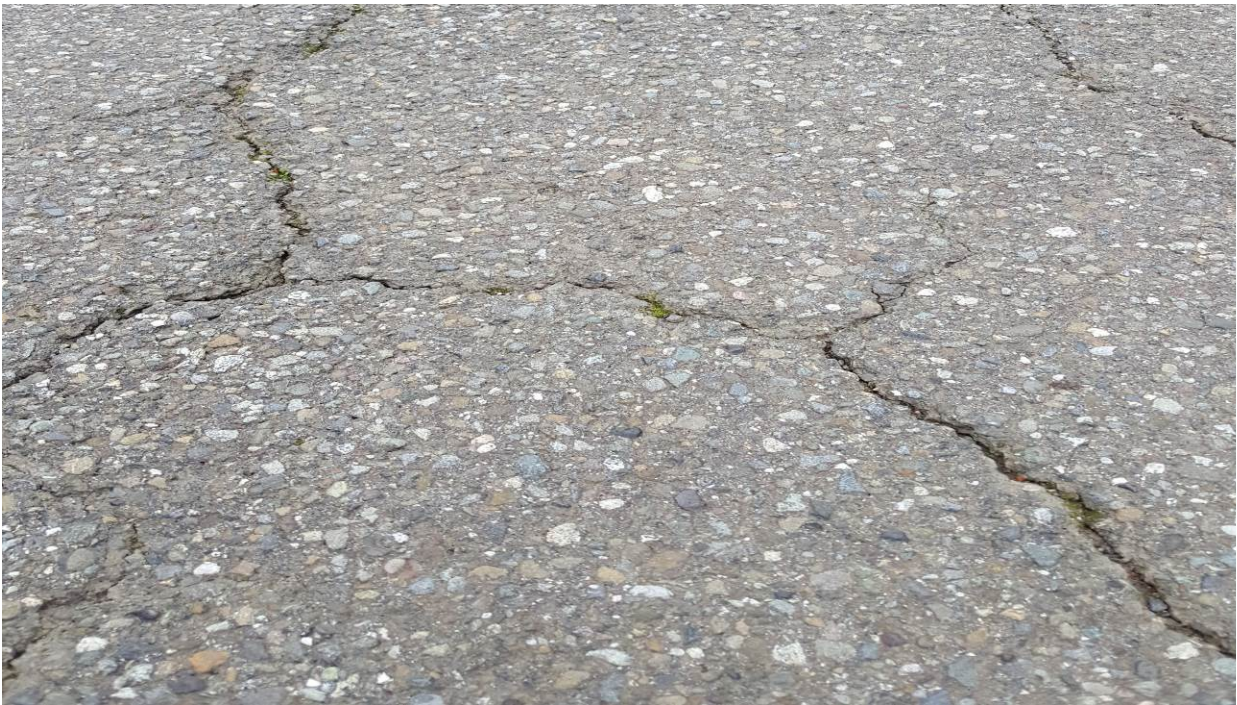
Figure 124. OR3a, SR101, three years after the other section were treated. Cracks are wide but not spalling.

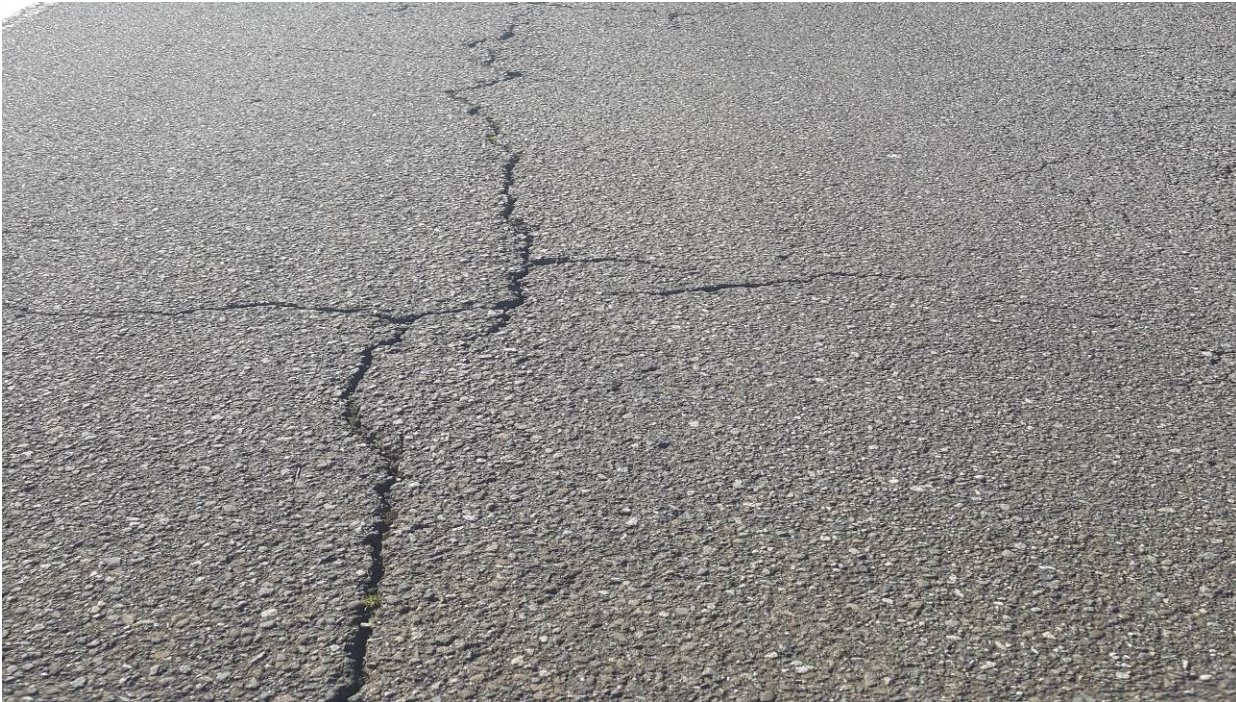
Figure 125. OR3a, SR101, four years after the other sections were treated. Cracks are wide and beginning to spall.

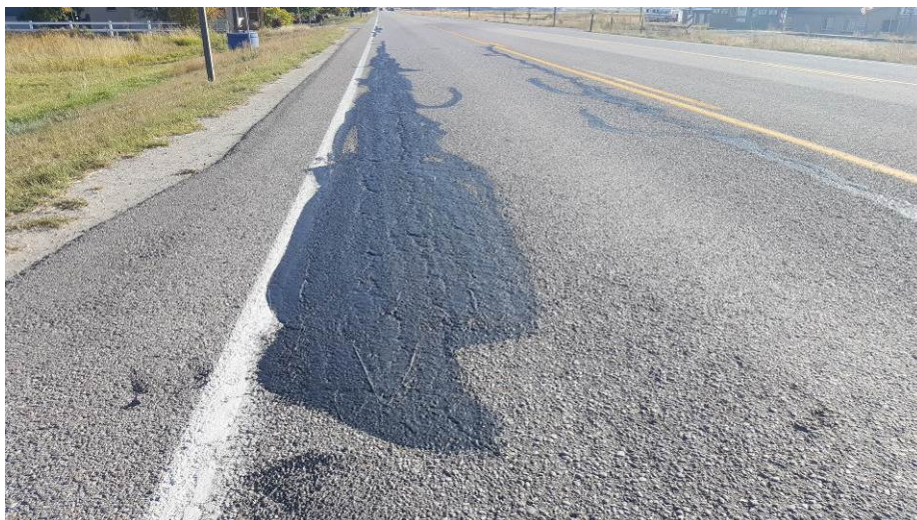
Figure 132. ER41, excessive crack sealant used on alligator cracking on SR 20, ER41. (November 2016)
