AIR SAFETY BOARD
REPORT

Accident involving aircraft NC 13727
of Braniff Airways, Inc., near Okla-
homa City, Oklahoma, March 26, 1939.

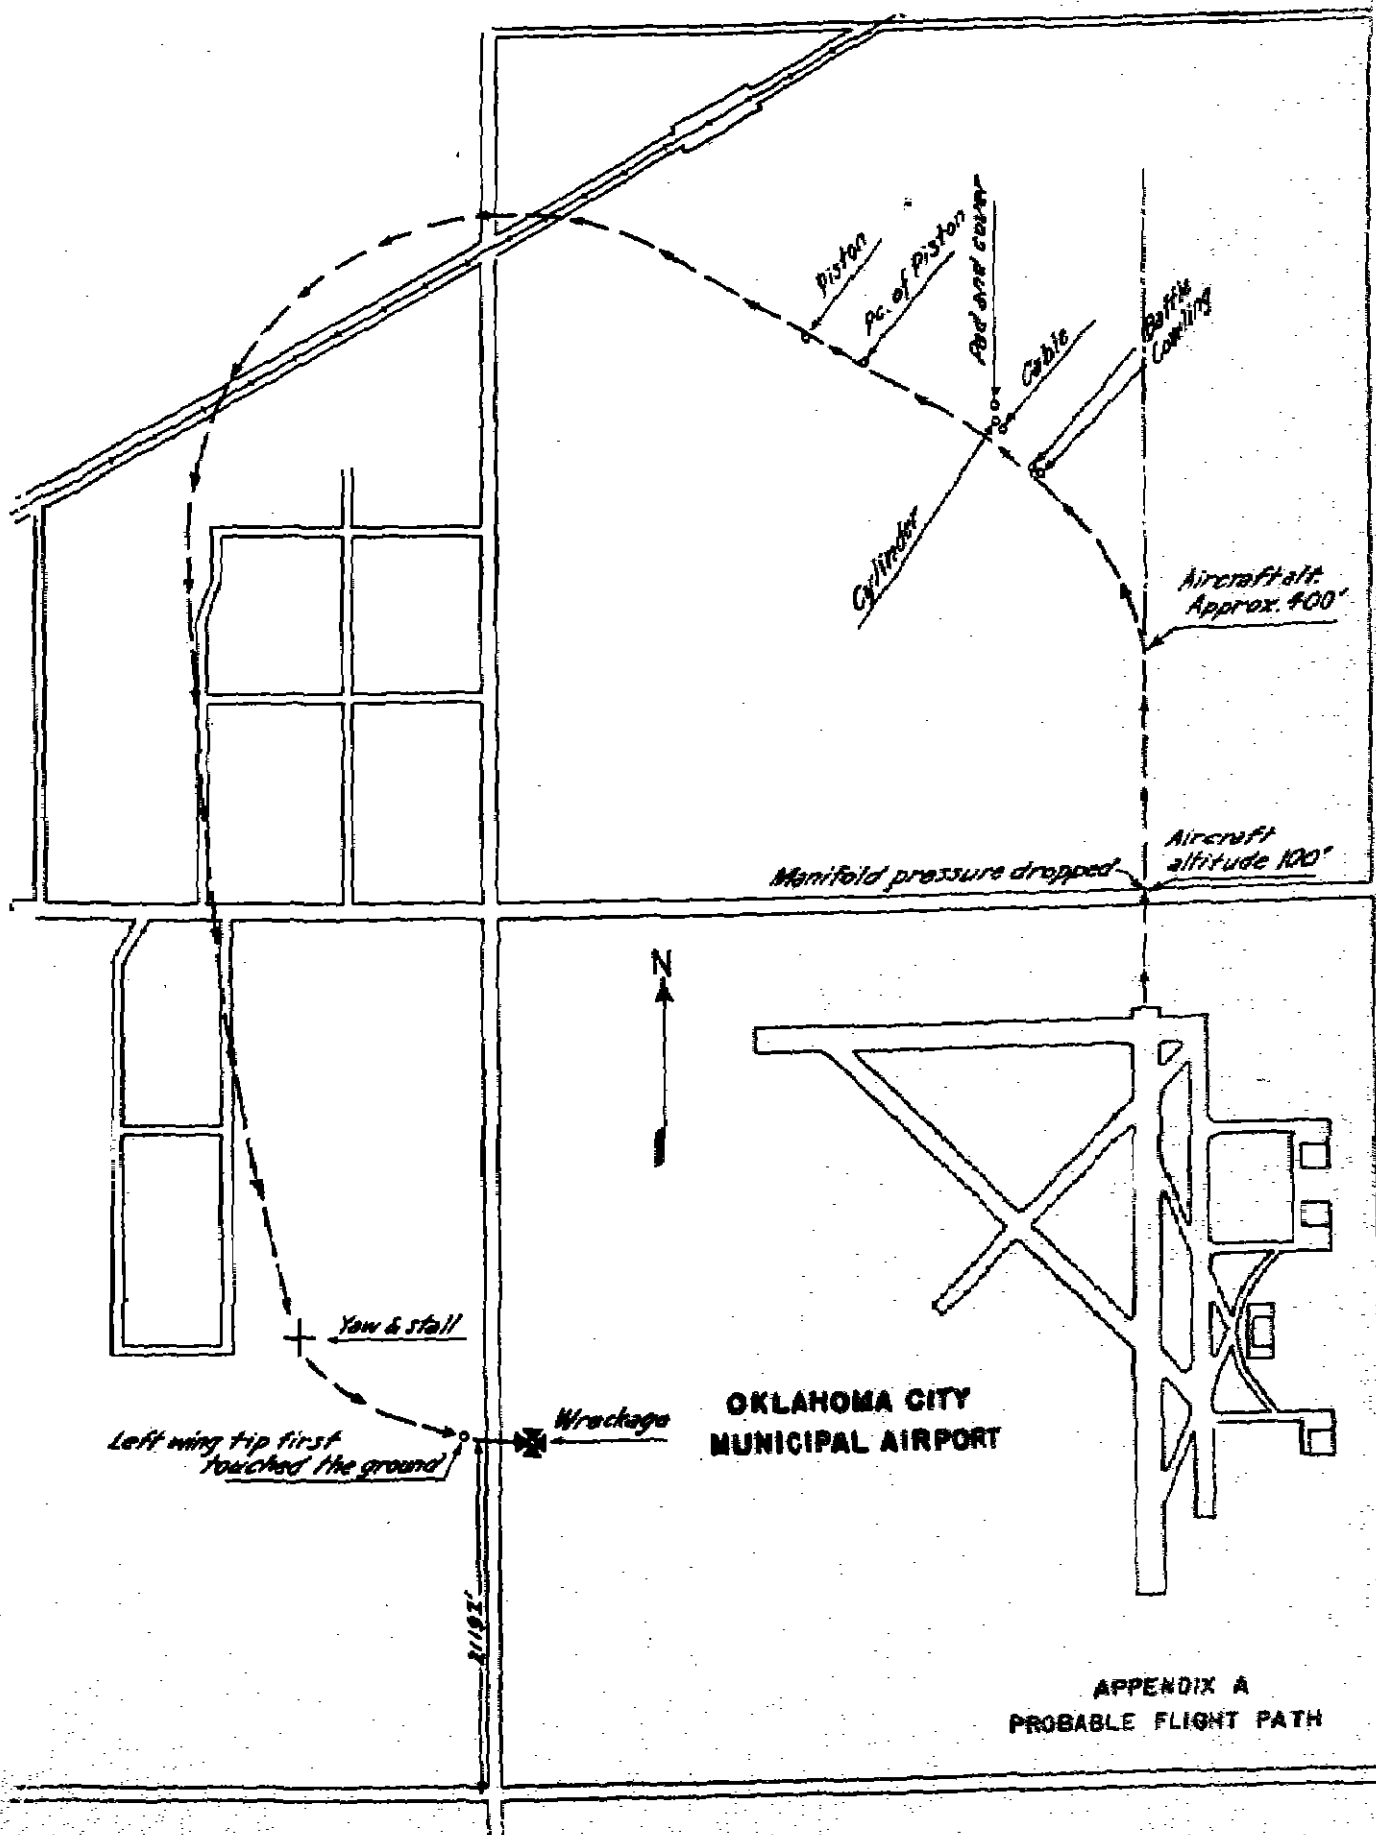
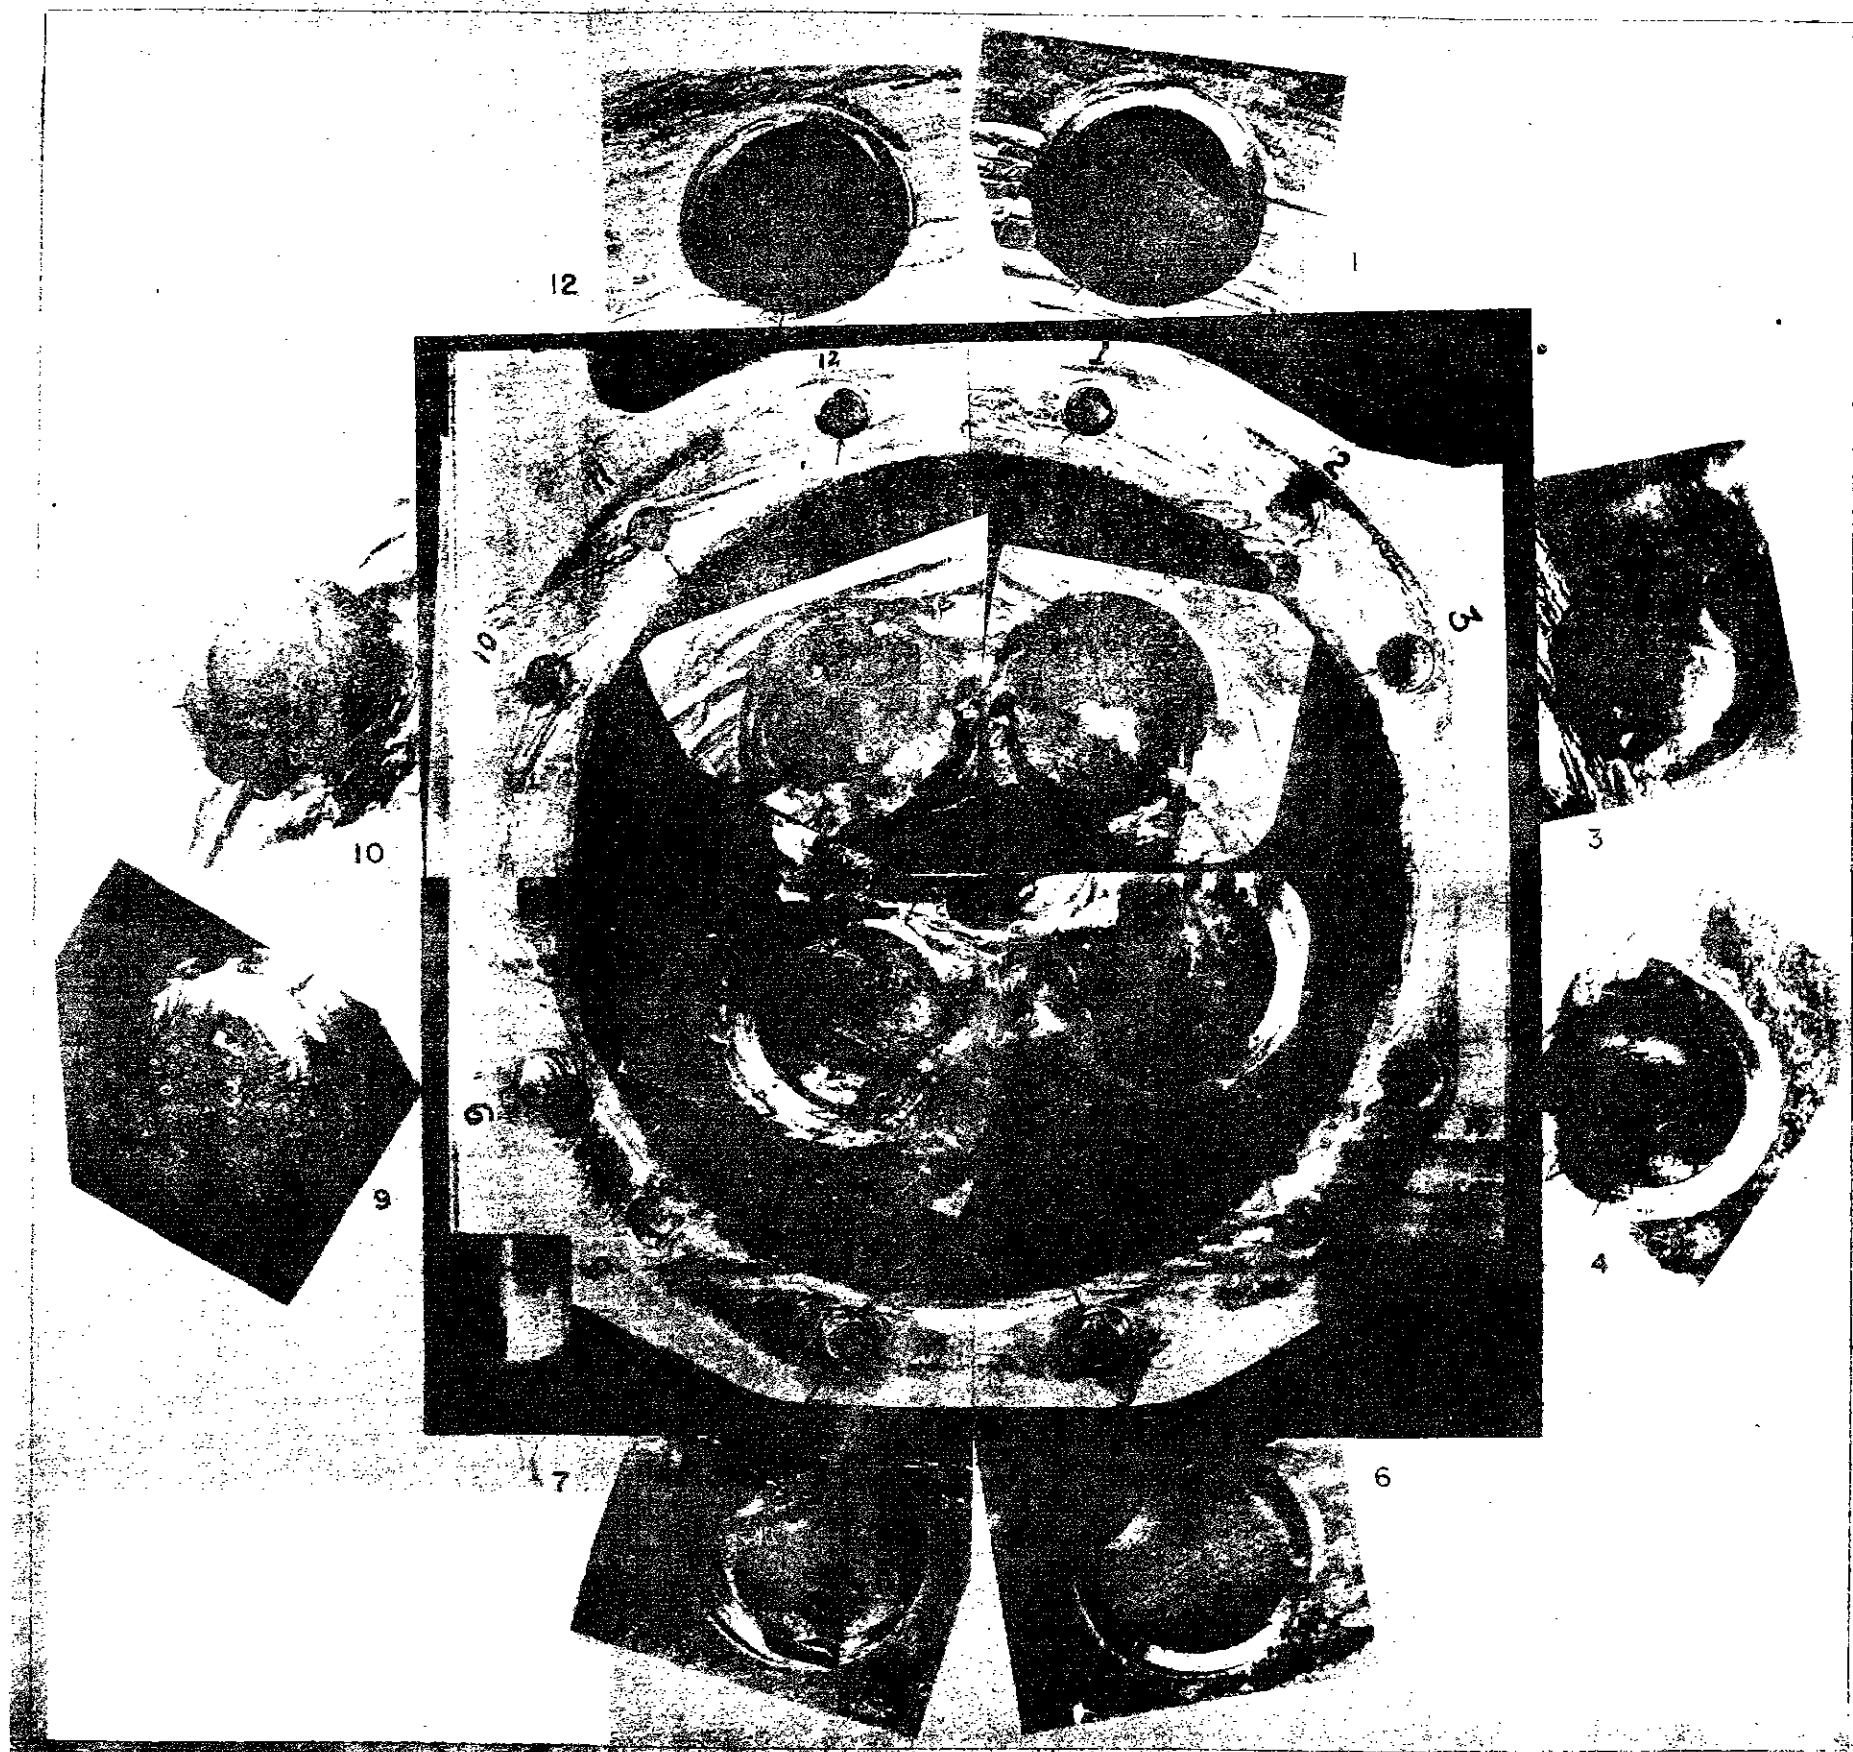
Only the crankcase and the cylinder flanges from No. 6 and No. 5 cylinders were submitted to the National Bureau of Standards. The appearance of the No. 6 cylinder-flange seat on the crankcase is shown, in the condition as received, in the photograph, Figure 1, accompanying this report. It was evident that fracture of the 12 hold-down studs had permitted the cylinder to be separated bodily from the crankcase. It was further evident, from the appearance of the fractured surfaces that on each stud a considerable portion of the section had been severed by a fatigue fracture. The characteristic markings of fatigue fractures are plainly evident on photographs of the fractured surfaces of the studs at 6 diameters magnification, placed in appropriate positions on the photograph of the flange seat, Figure 1. The location of the origin of the fatigue fracture on each stud, according to the best estimate that could be made from the appearance of the markings, is indicated by arrows on the photographs. It is noteworthy that according to these estimates the fractures on each stud, except No. 10, originated at or near that portion of the circumference of the stud closest to the cylinder sleeve.

Positive evidence indicating that the nuts on cylinder No. 6 had or had not been drawn up the same as those on the other cylinders was not available from examinations of the parts concerned after the failure. There was a definite impression of the cylinder flange on the crank case pad, Figure 1. This impression was more deeply marked in the regions of studs Nos. 7, 8, and 9, and 1, 2, and 3, than in

the regions of studs 10, 11, and 12, and 4, 5, and 6. This condition might be considered to indicate that one or more of the nuts on the studs 7, 8, 9, --1, 2, 3 had been less tight than those on the other axis, 10, 11, 12 --4, 5, 6; permitting a rocking of the cylinder that resulted in the deeper markings on the crankcase pad. This condition would also have made the stresses higher in one or more of the studs 10, 11, 12 --4, 5, 6 than in the looser studs, a condition which could be reconciled with the conjecture that studs 10, 11, and 12 might have been among the first to fail. Although it is possible that the impression of the cylinder flange on the crankcase pad was caused, in part at least, by looseness between flange and seat because some of the nuts had been insufficiently tightened, it is equally possible that the battered condition occurred only after some of the studs had been fractured, permitting the flange to batter on the seat.

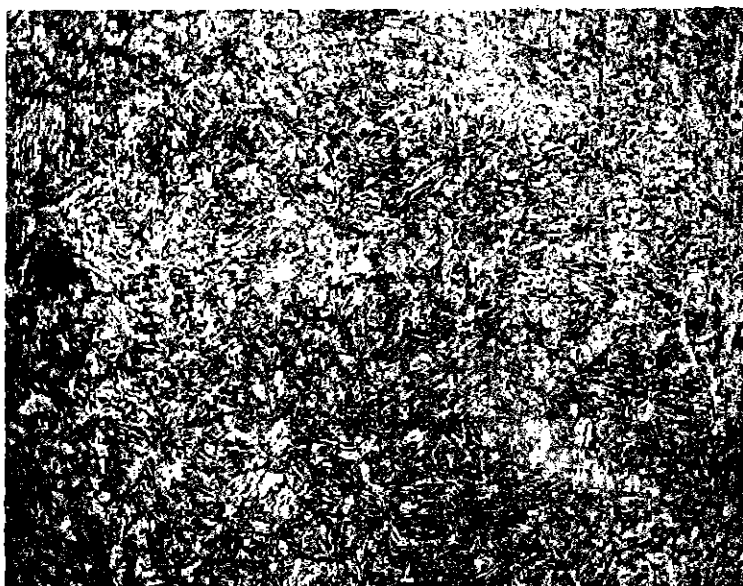
Fig. 2. - Microstructure on longitudinal section of one of failed studs, No. 6 cylinder. Structure is typical of unetched and tempered alloy steel. Etched in 1 percent nitric acid in alcohol. x 500.

The first of these possibilities was investigated. A specimen for metallographic examination and hardness tests was cut from the lower end of each of the failed studs, leaving the fractured surface intact. The representative microstructure on one of these studs is shown in Figure 2. This structure is typical of a quenched and tempered alloy steel. The appearance of the nonmetallic inclusions on the polished but not etched surface of this specimen is shown in
