A I R S A F E T Y B O A R D
Civil Aeronautics Authority
Washington, D. C.

REPORT

OF AN INVESTIGATION OF AN ACCIDENT INVOLVING AIRCRAFT

Accident involving aircraft NC 16933 of
Pan American Airways, Inc., near Rio de
Janeiro, Brazil, August 13, 1939.

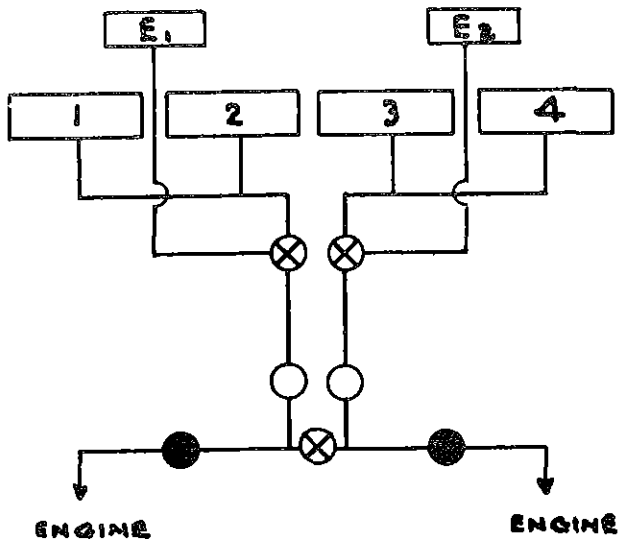
FUEL SYSTEM OF NC-16933

Four 100 gallon main tanks and two 55 gallon reserve tanks installed in NC 16933 gave the aircraft a total gasoline capacity of 510 gallons. The installation of the entire fuel system, including these 6 tanks, of NC 16933, is illustrated on a blueprint drawing of this system designated Appendix "A", attached hereto and made a part of this report. It is to be noted in connection with such installation that outlets from both main tanks supplying each engine

passed through one valve and that the pilot could switch only from main tanks to the reserve tank and could not select between main tanks to the same engine. Each main tank, as is to be further noted, had a float valve, the purpose of which was to close the outlet from the tank when the gasoline supply became exhausted and thus prevent an air lock in the fuel lines. Experience of Pan American Airways, Inc., however, with this installation had resulted in the decision to eliminate these float valves and change the selector valves so as to enable the pilot to select between the two main tanks to each engine as well as the reserve tank. Detailed drawing of such revised fuel system installation is also illustrated in Appendix "A." Although such changes had been made in several similar aircraft operated by Pan American Airways, Inc., no change had been made in the fuel system in NC 16933 as illustrated herein in Appendix "A."

According to records of the Victoria Station and other available evidence, 120 gallons of 87 octane fuel was taken aboard at this point, making a total of approximately 275 gallons of gasoline aboard at the time of departure, distributed in the following manner: 80 gallons in each of the two inside main tanks, 50 gallons in each of the two reserve tanks, and the balance in the two outside main tanks (designated in Appendix "A" attached hereto as tanks 2, 3, E1, E2, 1, and 4, respectively).
