REPORT OF THE CIVIL AERONAUTICS BOARD

Of the investigation of an accident
involving civil aircraft of the United
States NC 16086 which occurred near
Centerville, Utah, on November 4, 1940.

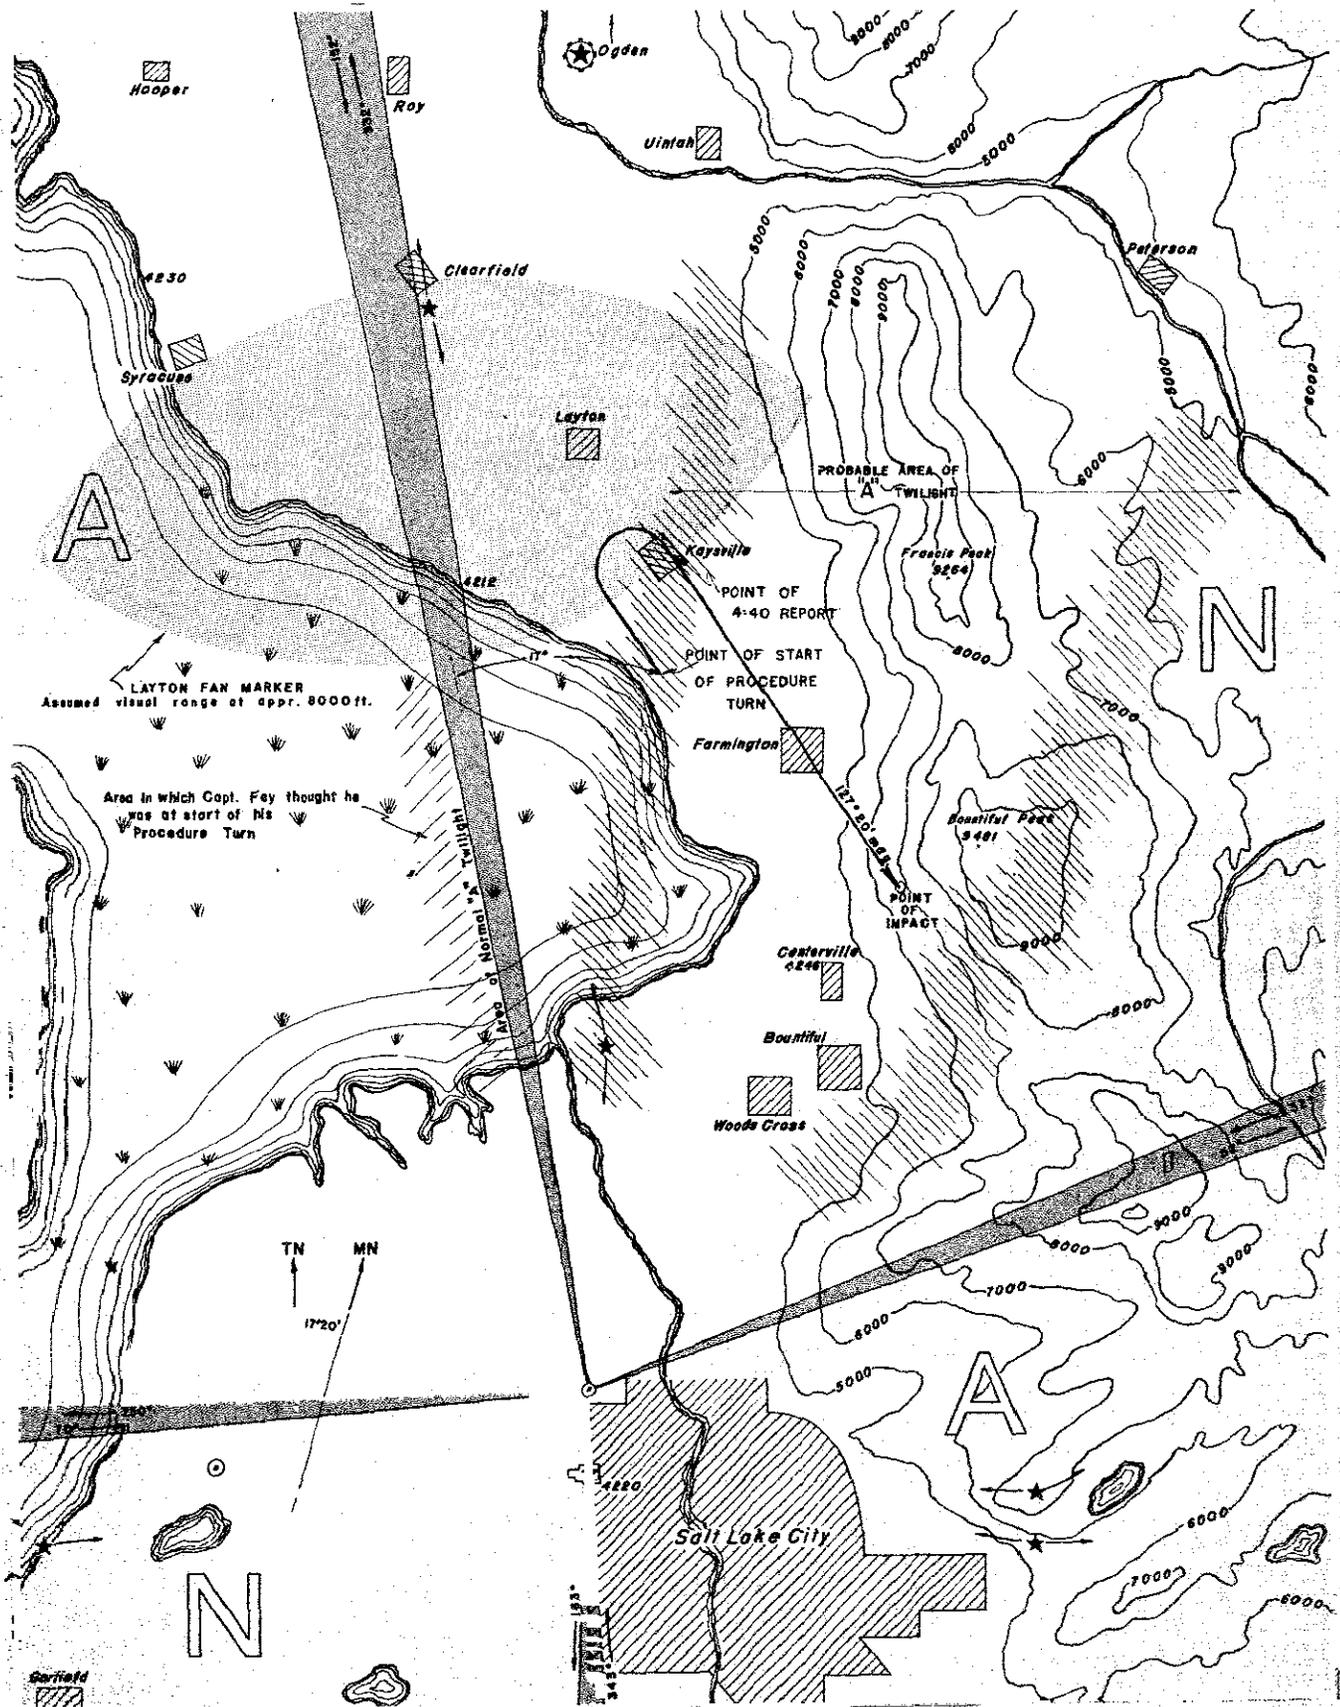
FIGURE 'A'

It also seems reasonable to assume that at the time Captain Fey reported over Layton at 8,000 feet, he had just completed the 180-degree timed turn portion of the procedure turn. That Captain Fey would make the prescribed procedure turn seems apparent since, to a pilot of Captain Fey's training and experience, in addition to being the prescribed practice, this maneuver would be the most natural and easiest way of making a 180-degree change in course during a let-down-through procedure. That he would have reported to the Salt Lake station upon the completion of the timed turn portion of the procedure turn rather than at some other time seems reasonable since, from pilots' testimony taken at the hearing, it appears to be the established practice for pilots to report at this point during a let-down procedure.

Since an examination of Figure A will show that the shortest distance between the limits of the visual signal of the Layton marker and the scene of the accident is about 8-1/4 miles, Trip 16 must have made good a ground speed of at least 165 miles per hour between the time the report "over Layton" was made and the time the airplane crashed. Moreover, the evidence would indicate that this ground speed is probably the highest ground speed that we could reasonably assume to have been made in the area in which Trip 16 was flying. According to the let-down procedure prescribed by United for Salt Lake City,

and which we have already assumed Captain Fey to have been following, the procedure is executed at an indicated air speed of 120 miles per hour. On the basis of the temperature and altitude, this, in the case of Trip 16, would result in a true air speed of 135 miles per hour in the general location, and at the altitudes in which it was flying. Thus, in order to account for a 165-mile-per-hour ground speed, it is necessary to assume a helping wind or wind of northwesterly component of approximately 30 miles per hour. This velocity is higher than is indicated by evidence bearing upon the upper air winds in the Salt Lake Valley for the morning of November 4. Therefore, we would not be justified in concluding that the trip would have encountered a northwest wind of over 30 miles per hour, or that it could have made on this portion of the flight a ground speed of more than 165 miles per hour.

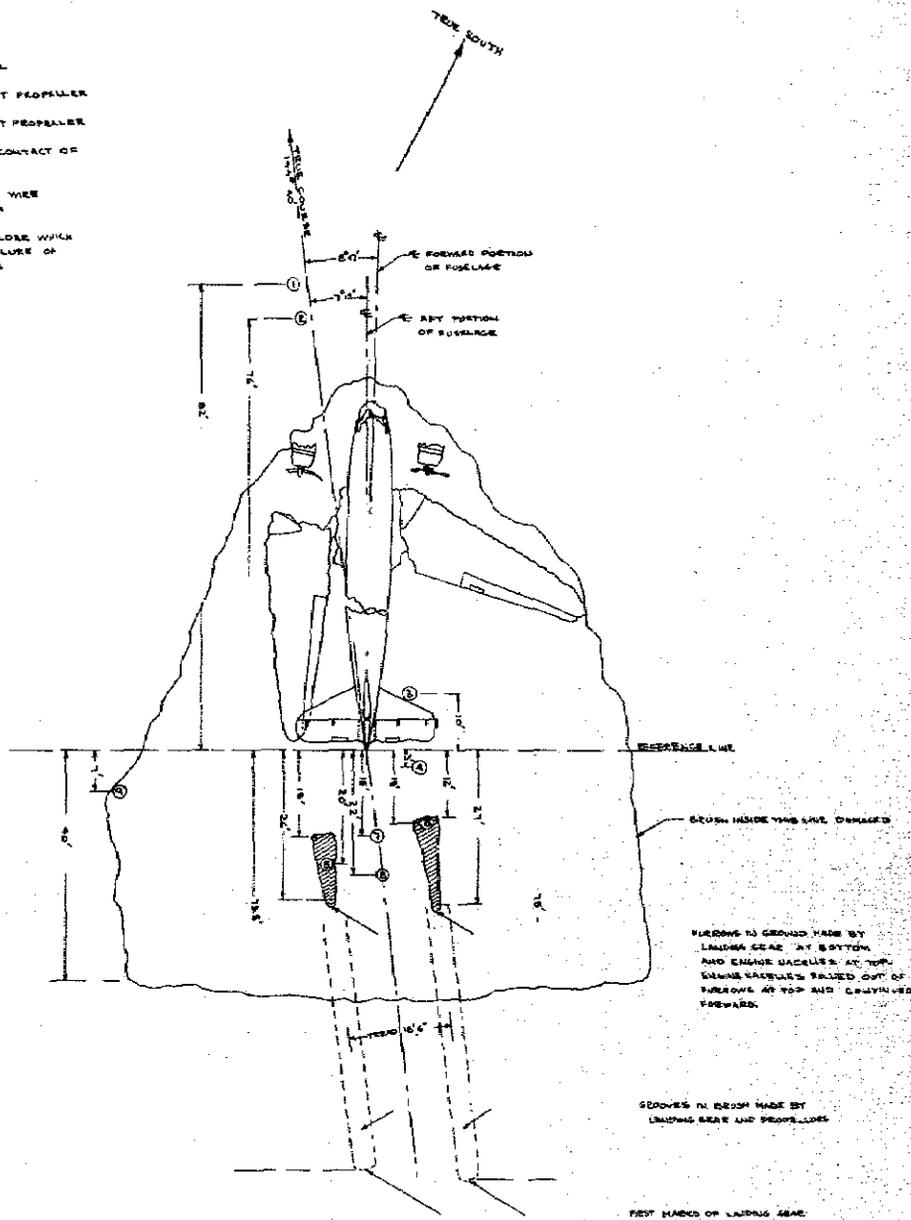
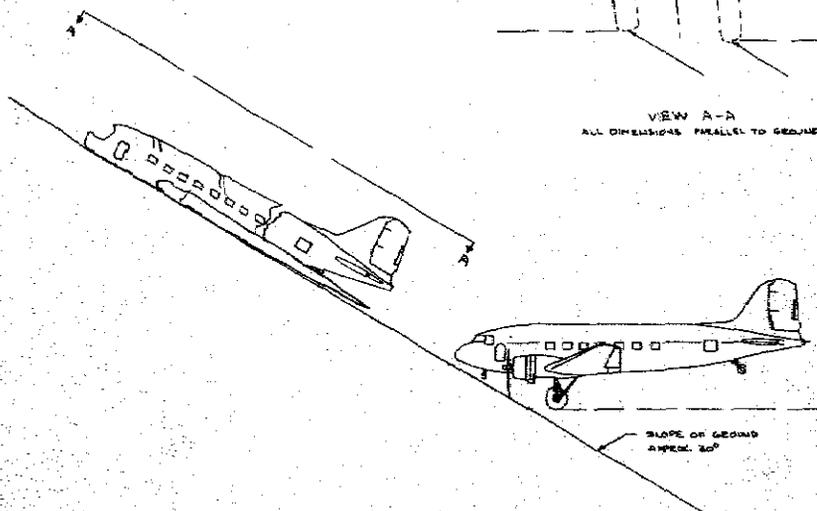
SKETCH OF ACCIDENT TO
U.S. AIRPLANE NE-16086
NEAR SALT LAKE CITY, UTAH NOVEMBER 4, 1940

- ① CAPTAIN
- ② FIRST OFFICER
- ③ RIGHT OIL COOLER
- ④ RIGHT OIL COOLER COWL
- ⑤ ONE BLADE FROM LEFT PROPELLER
- ⑥ ONE BLADE FROM RIGHT PROPELLER
- ⑦ APPROXIMATE POINT OF CONTACT OF FUSELAGE W/GR.
- ⑧ SPRING, INSULATOR AND WIRE FROM BELLY ANTENNA
- ⑨ HEAVY BUSH AND BOULDER WHICH CAUSED COMPLETE FAILURE OF WING CENTER SECTION

VIEW A-A
ALL DIMENSIONS PARALLEL TO GROUND

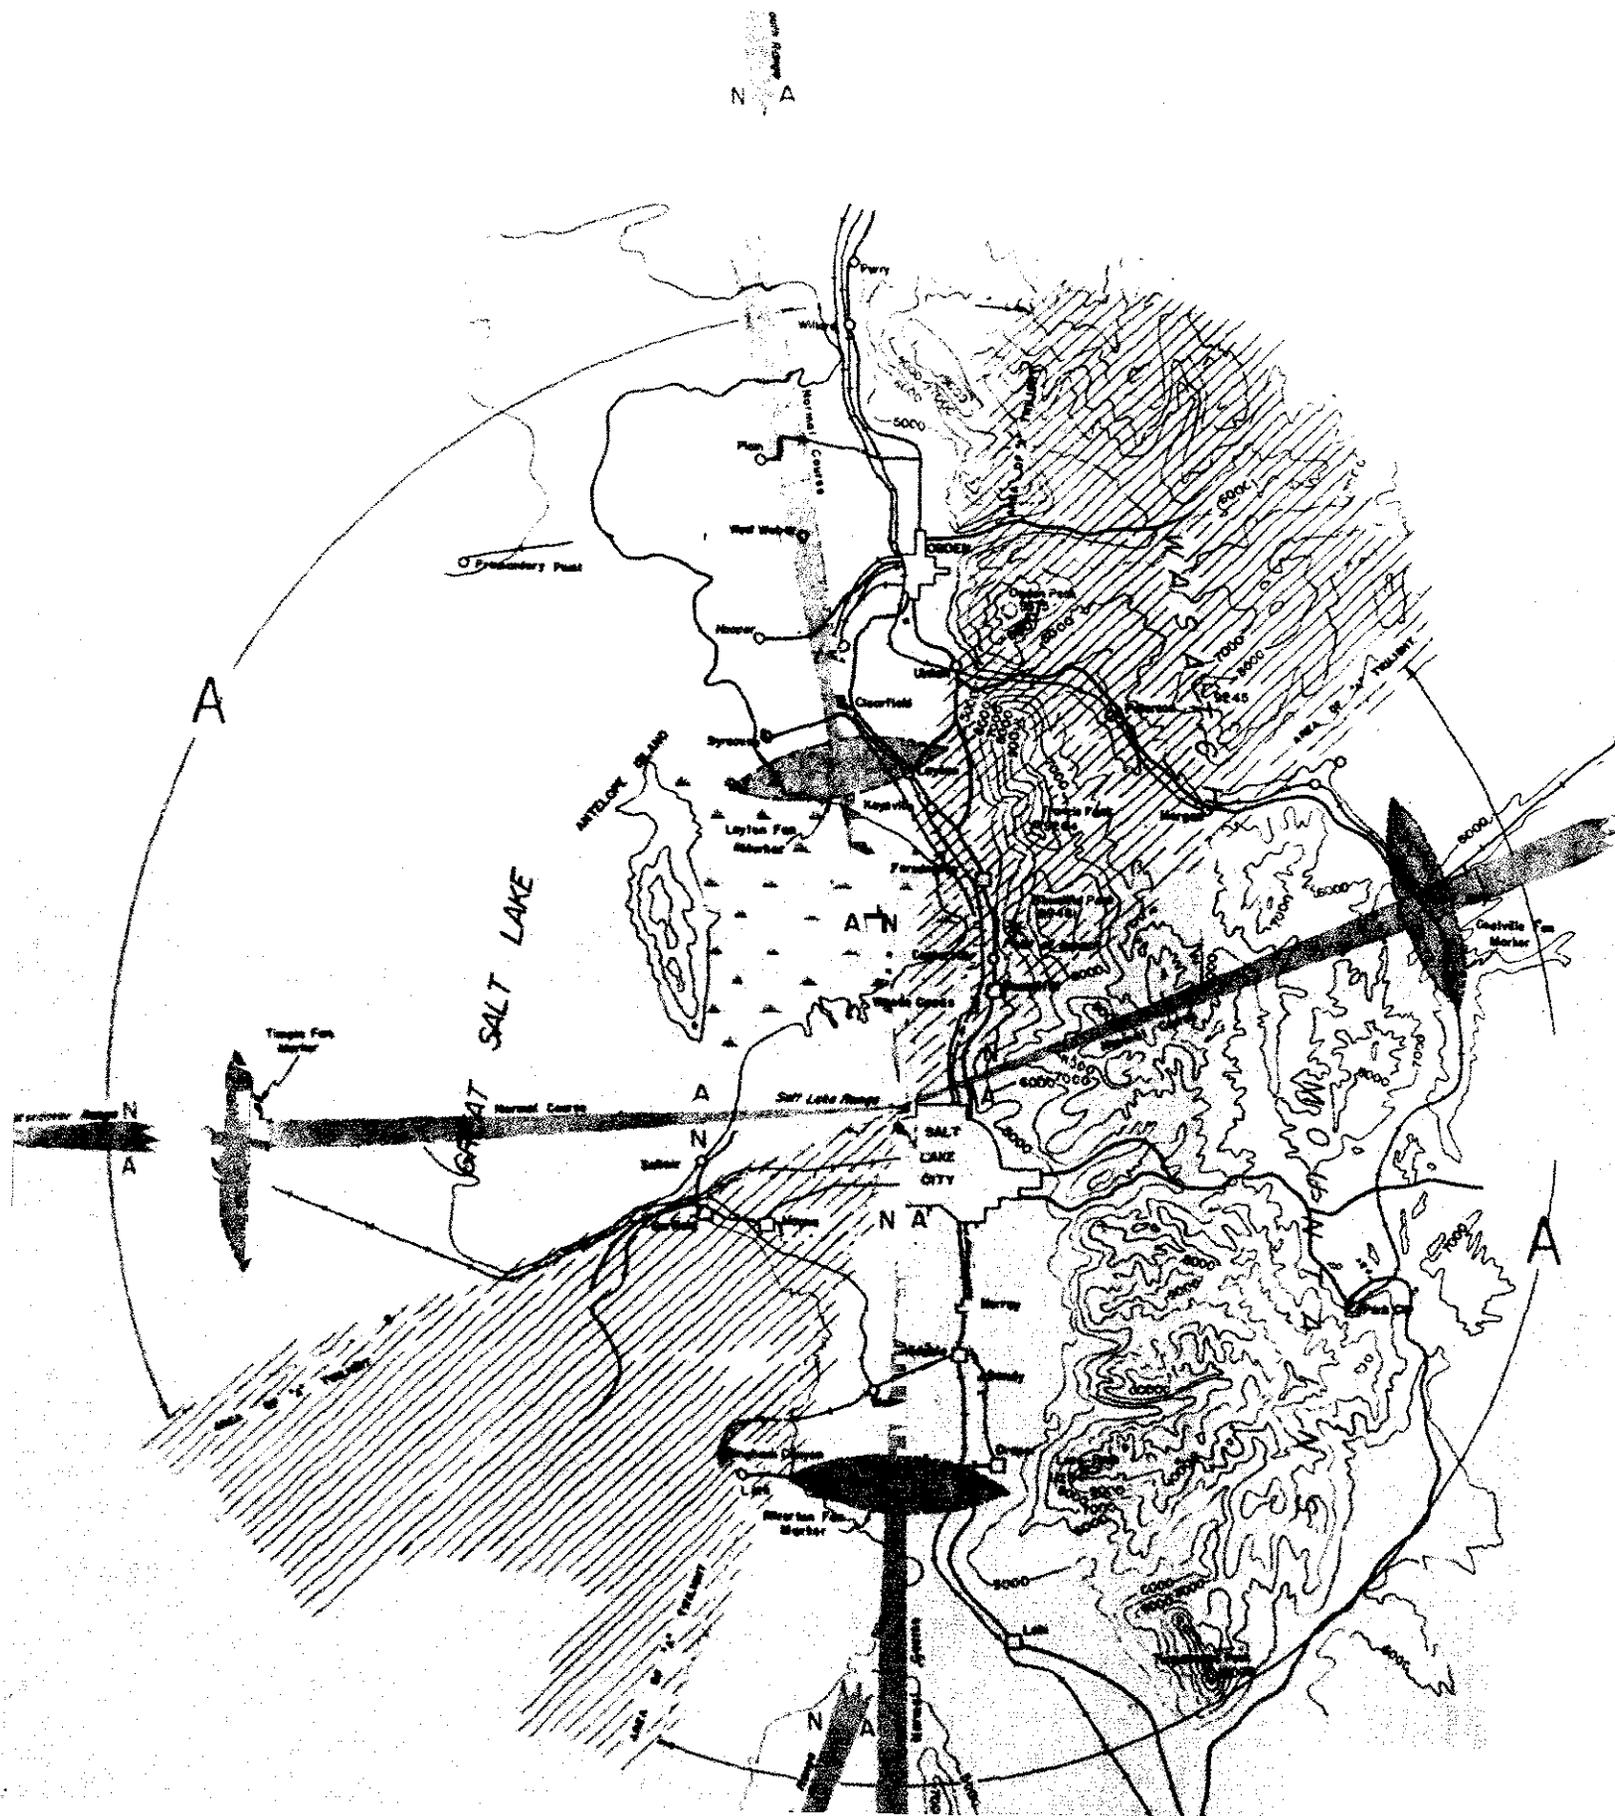
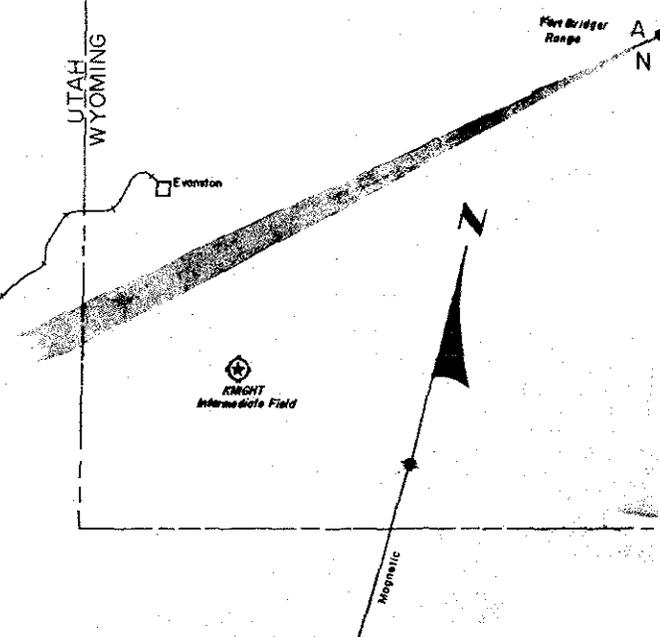
SALT LAKE AREA

SHOWING NORMAL PATTERN OF SALT LAKE
RANGE AND THE PROBABLE PATTERN AT
TIME OF ACCIDENT TO
NO. 16086
