REPORT OF THE CIVIL AERONAUTICS BOARD

Of the investigation of an accident involving civil aircraft of the United States NC 13359, which occurred near Charleston, West Virginia, on April 16, 1941.

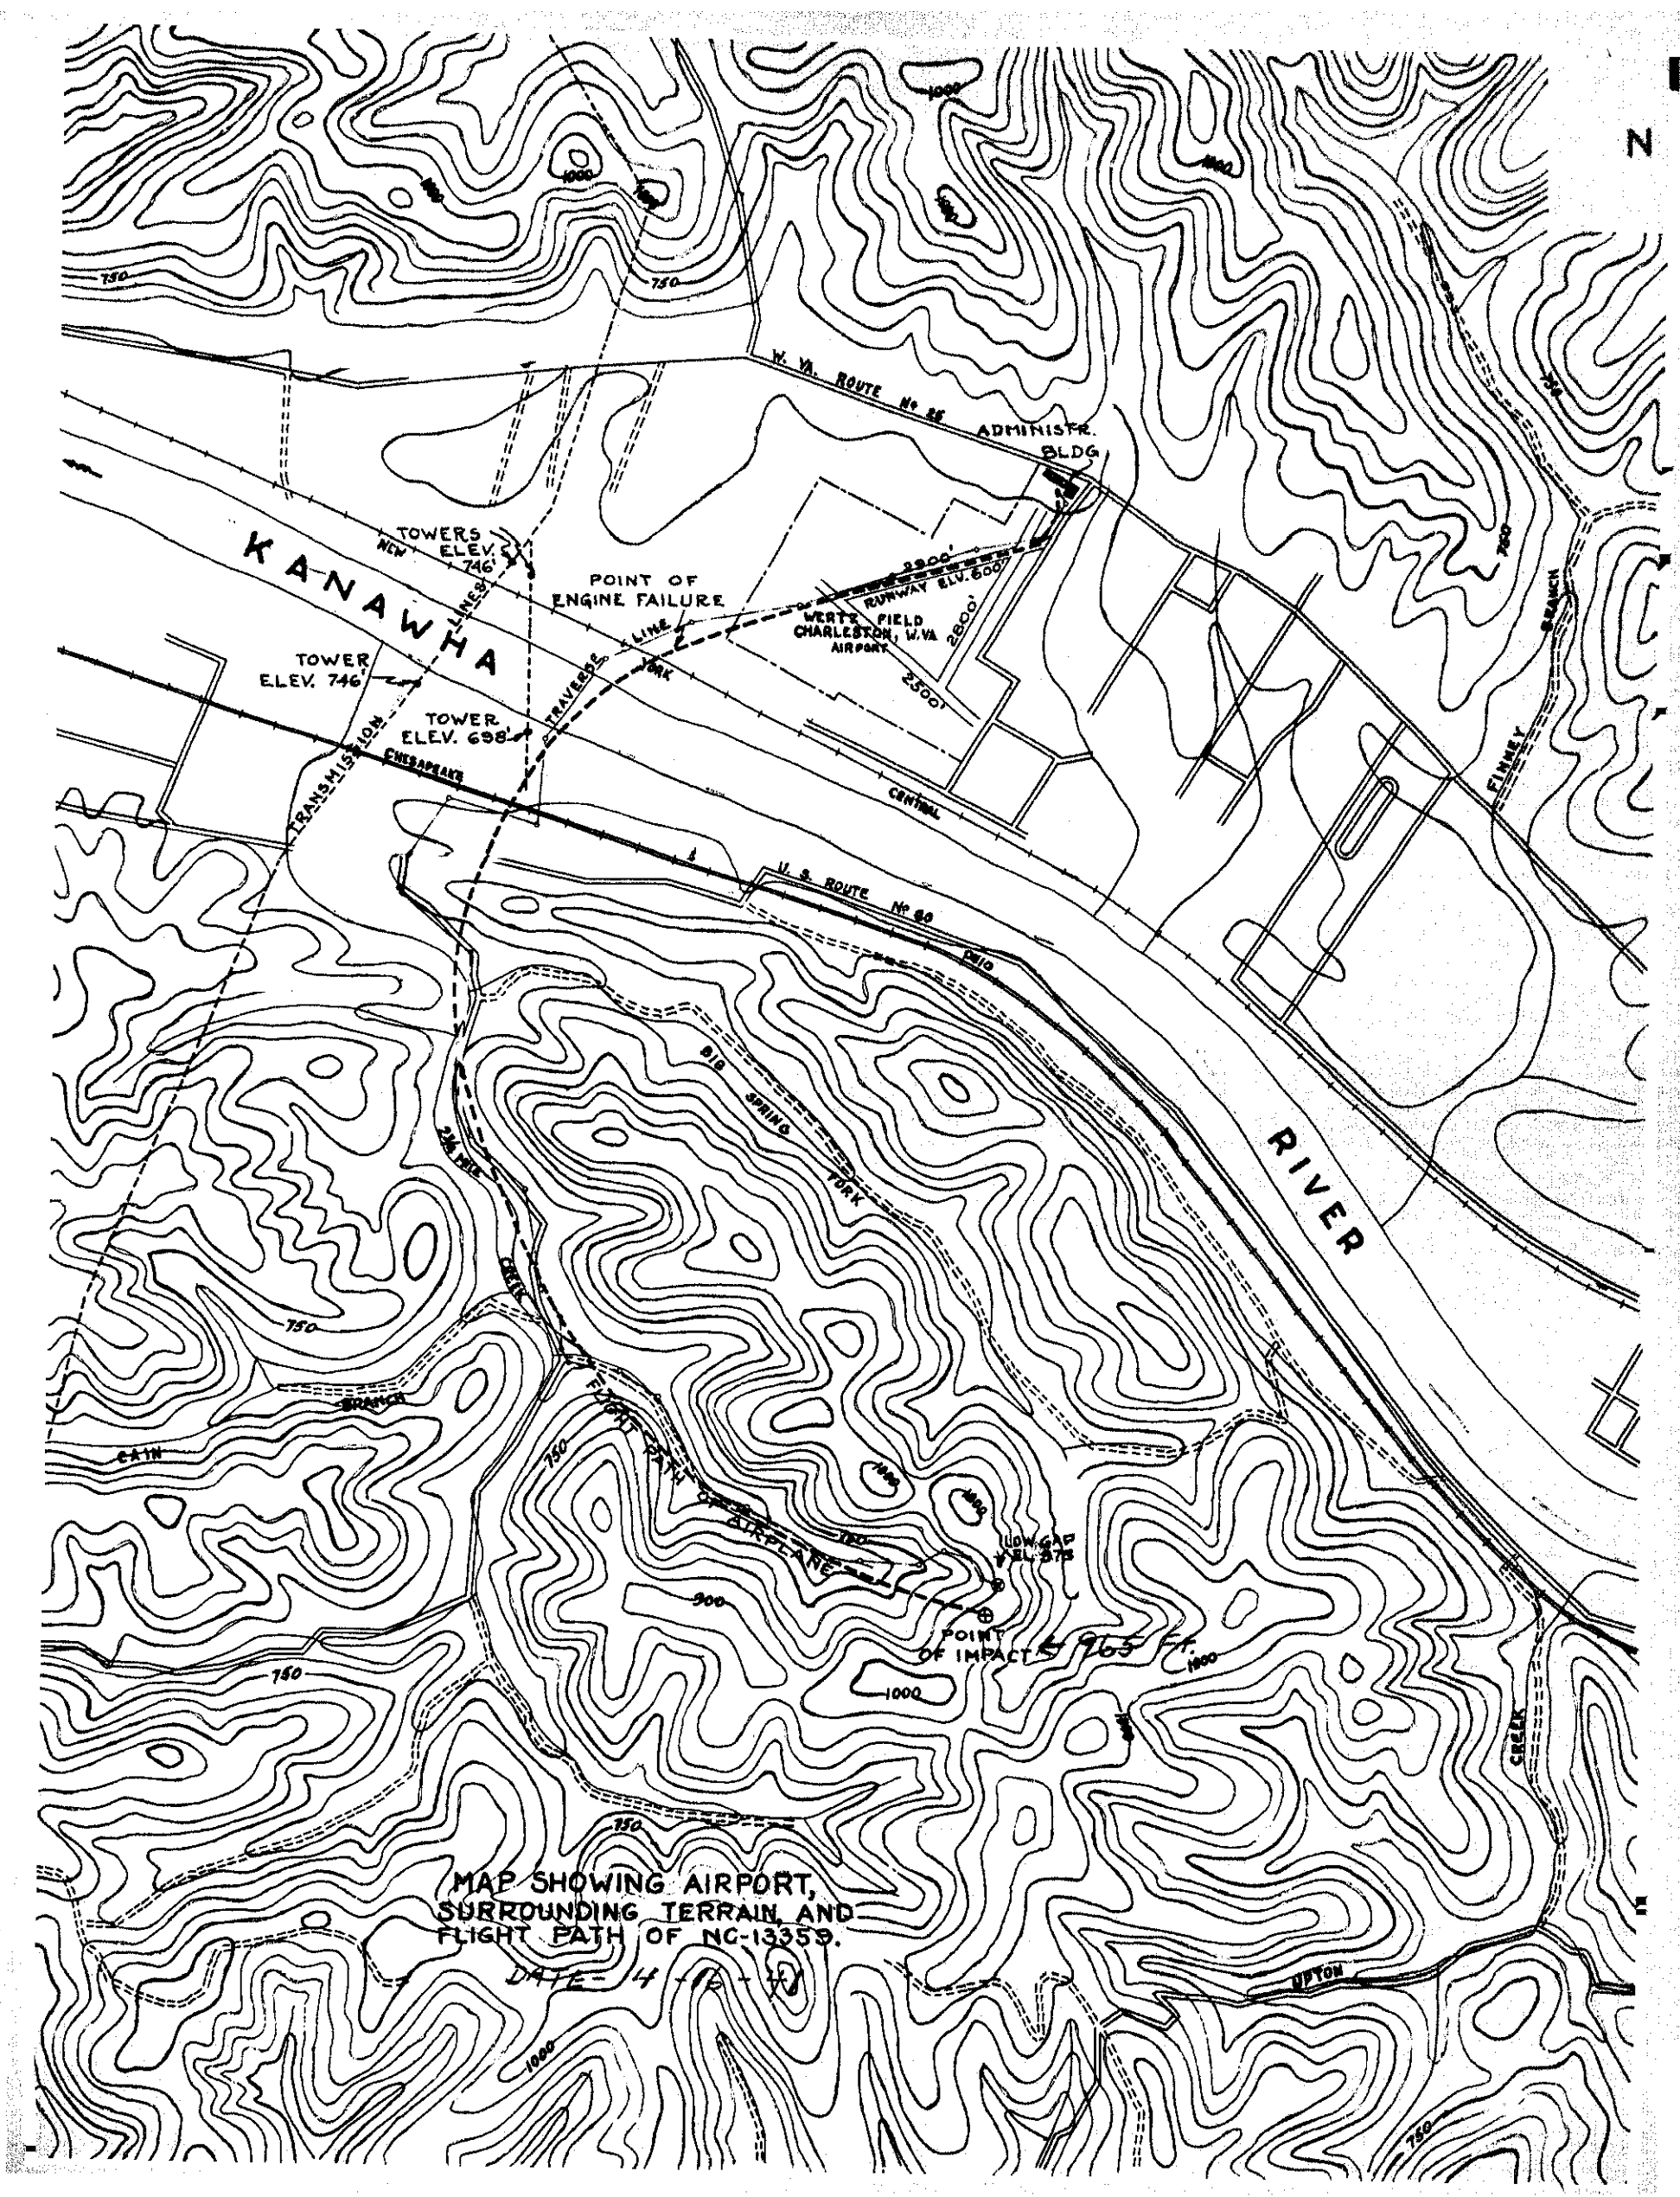
MAP SHOWING AIRPORT,
SURROUNDING TERRAIN, AND
FLIGHT PATH OF NC-13359.

The Charleston Municipal Airport is situated approximately nine miles west of the City of Charleston in the Kanawha River Valley at a mean elevation of 600 feet above sea level.^{5/} It is equipped with three runways, extending approximately north-northeast -- south-southwest, east-northeast -- west-southwest, and southeast-northwest. The Kanawha River channel lies immediately to the south of the airport and is bordered on the south by a range of hills which extend to approximately 1000 feet above sea level. On the north, the airport is bordered by another range of hills which also extend to approximately 1000 feet above sea level. To the west of the airport a primary high-tension line extends across the valley in a north-south direction on towers which are 146 feet above the mean level of the airport. This high-tension line crosses the flight path from the east-northeast -- west-southwest runway at a point 2750 feet from the west end of the runway. At a point west of the airport a secondary high-tension line branches off from the primary one and extends across the valley toward the southeast on towers 98 feet above the level of the airport. This secondary line crosses the flight path from the east-northeast -- west-southwest runway at a point 2500 feet from the west end of the runway. The secondary power line constitutes an obstruction which requires, to clear it, a minimum climb angle of about 25 to 1 from the end of this runway, while the primary power line constitutes an obstruction which requires a minimum climb angle as steep as 19 to 1 from the end of this runway.

The Charleston Municipal Airport presents conditions of great hazard to a pilot in case of an engine failure in take-off towards the west or southwest. The primary and secondary high tension lines form very prominent obstructions, and the ridges to the south and southwest are so close to the airport that any attempt during single-engine operation to make a left turn and proceed eastward up the Kanawha Valley would be attended by serious risks. Although the municipal officers of the City of Charleston have recognized the hazards incident to operation into and out of the present airport and have considered various sites for a new airport, no new site has been finally selected.

17. The high tension lines and hills which surround the Charleston Municipal Airport are definite hazards ^{16/} in case of a complete or partial power plant failure during a take-off toward the west or southwest in an air carrier airplane.
