REPORT OF THE CIVIL AERONAUTICS BOARD

Of the investigation of an accident involving civil aircraft of the United States NC 25667 and NC 1941, which occurred near Wichita, Kansas, on June 1, 1941.

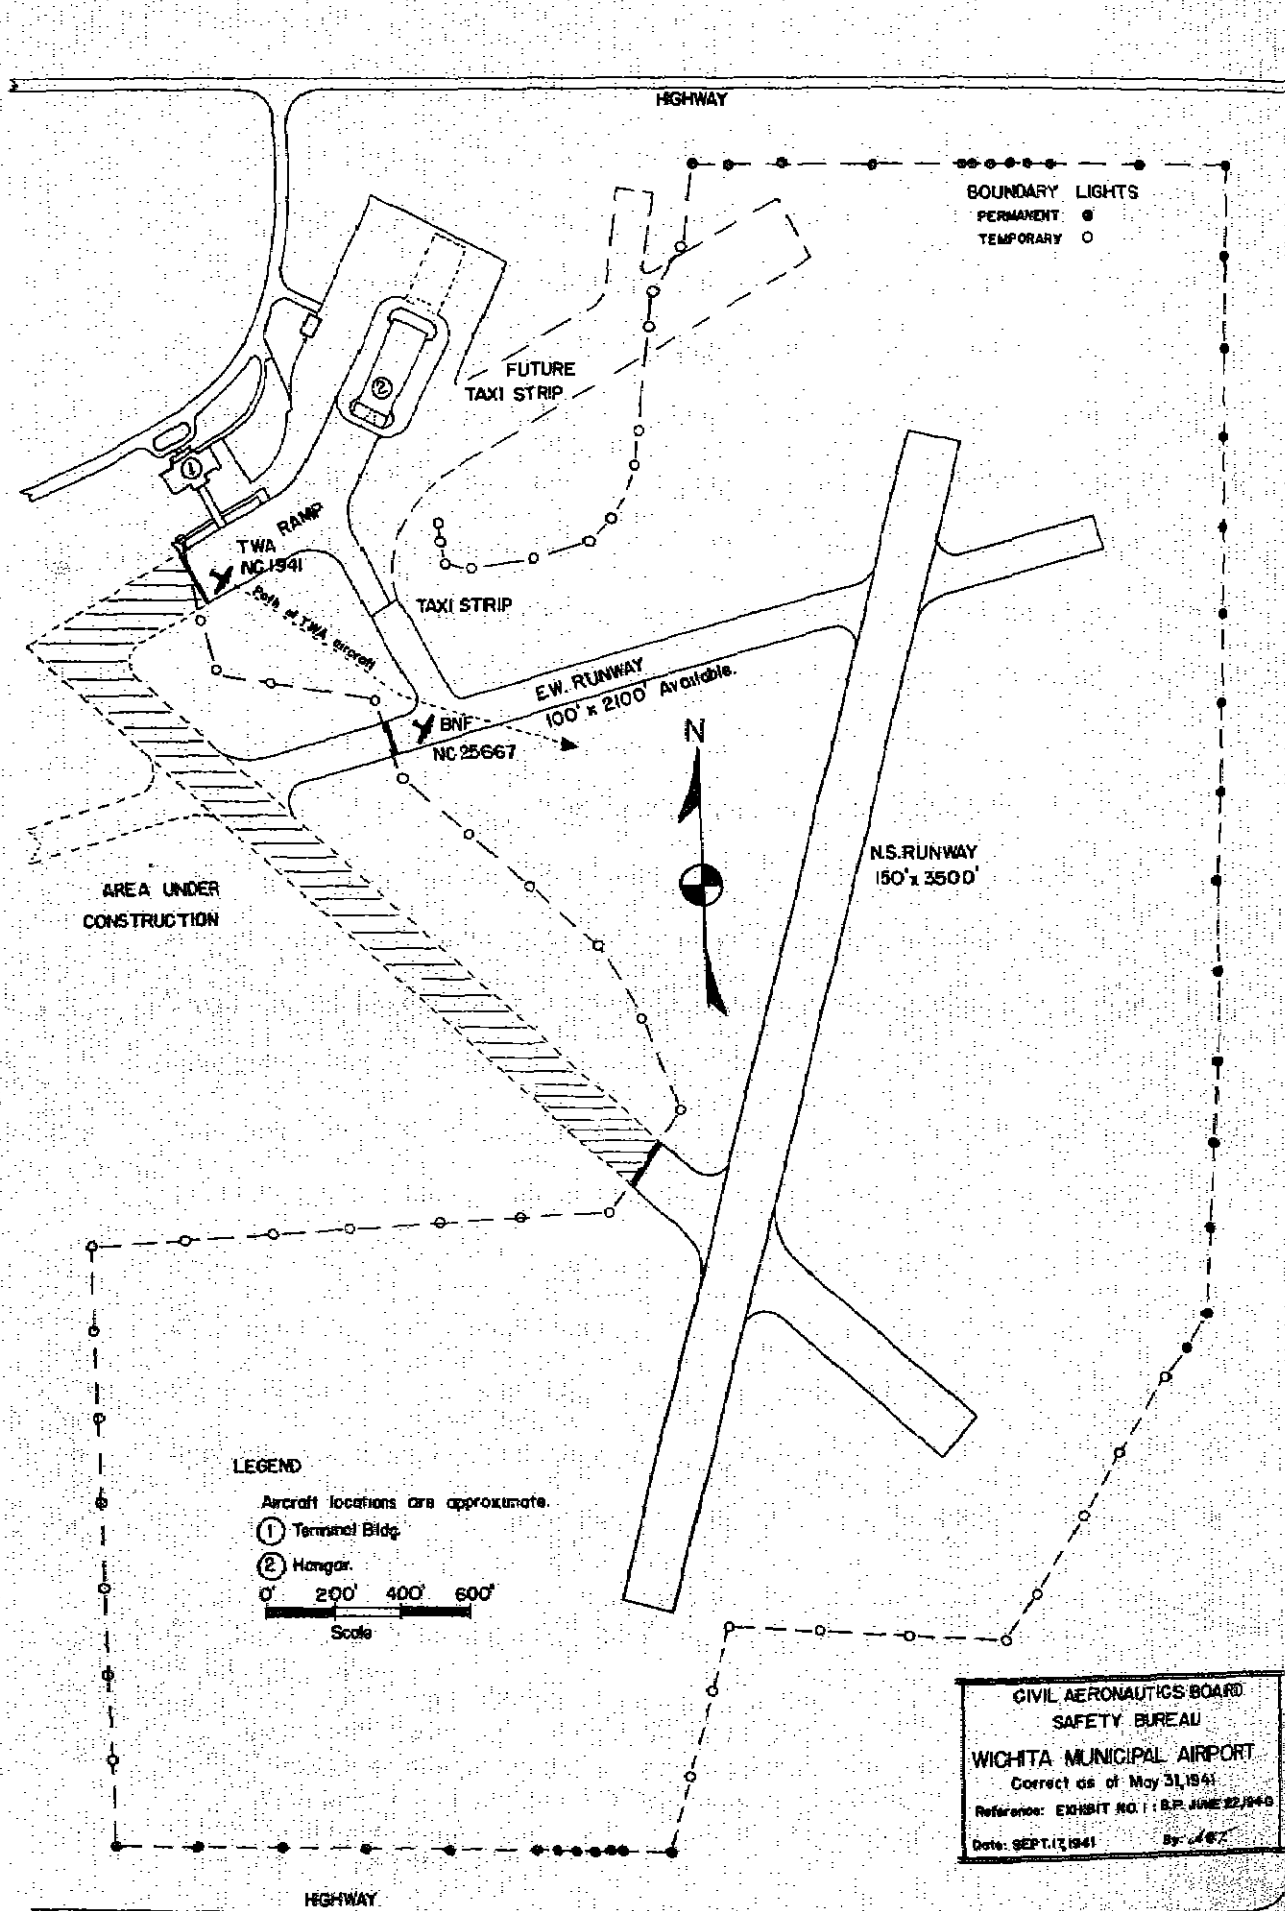
CIVIL AERONAUTICS BOARD
SAFETY BUREAU
WICHITA MUNICIPAL AIRPORT
Correct as of May 31, 1941
Reference: EXHIBIT NO. 1: B.P. JUNE 22, 1940
Date: SEPT. 17, 1941 By: [Signature]

Aircraft locations are approximate.

① Terminal Bldg.

② Hangar.
