REPORT OF THE CIVIL AERONAUTICS BOARD

Of the investigation of an accident involving aircraft of United States registry NC 1946 which occurred near Las Vegas, Nevada, on January 16, 1942.

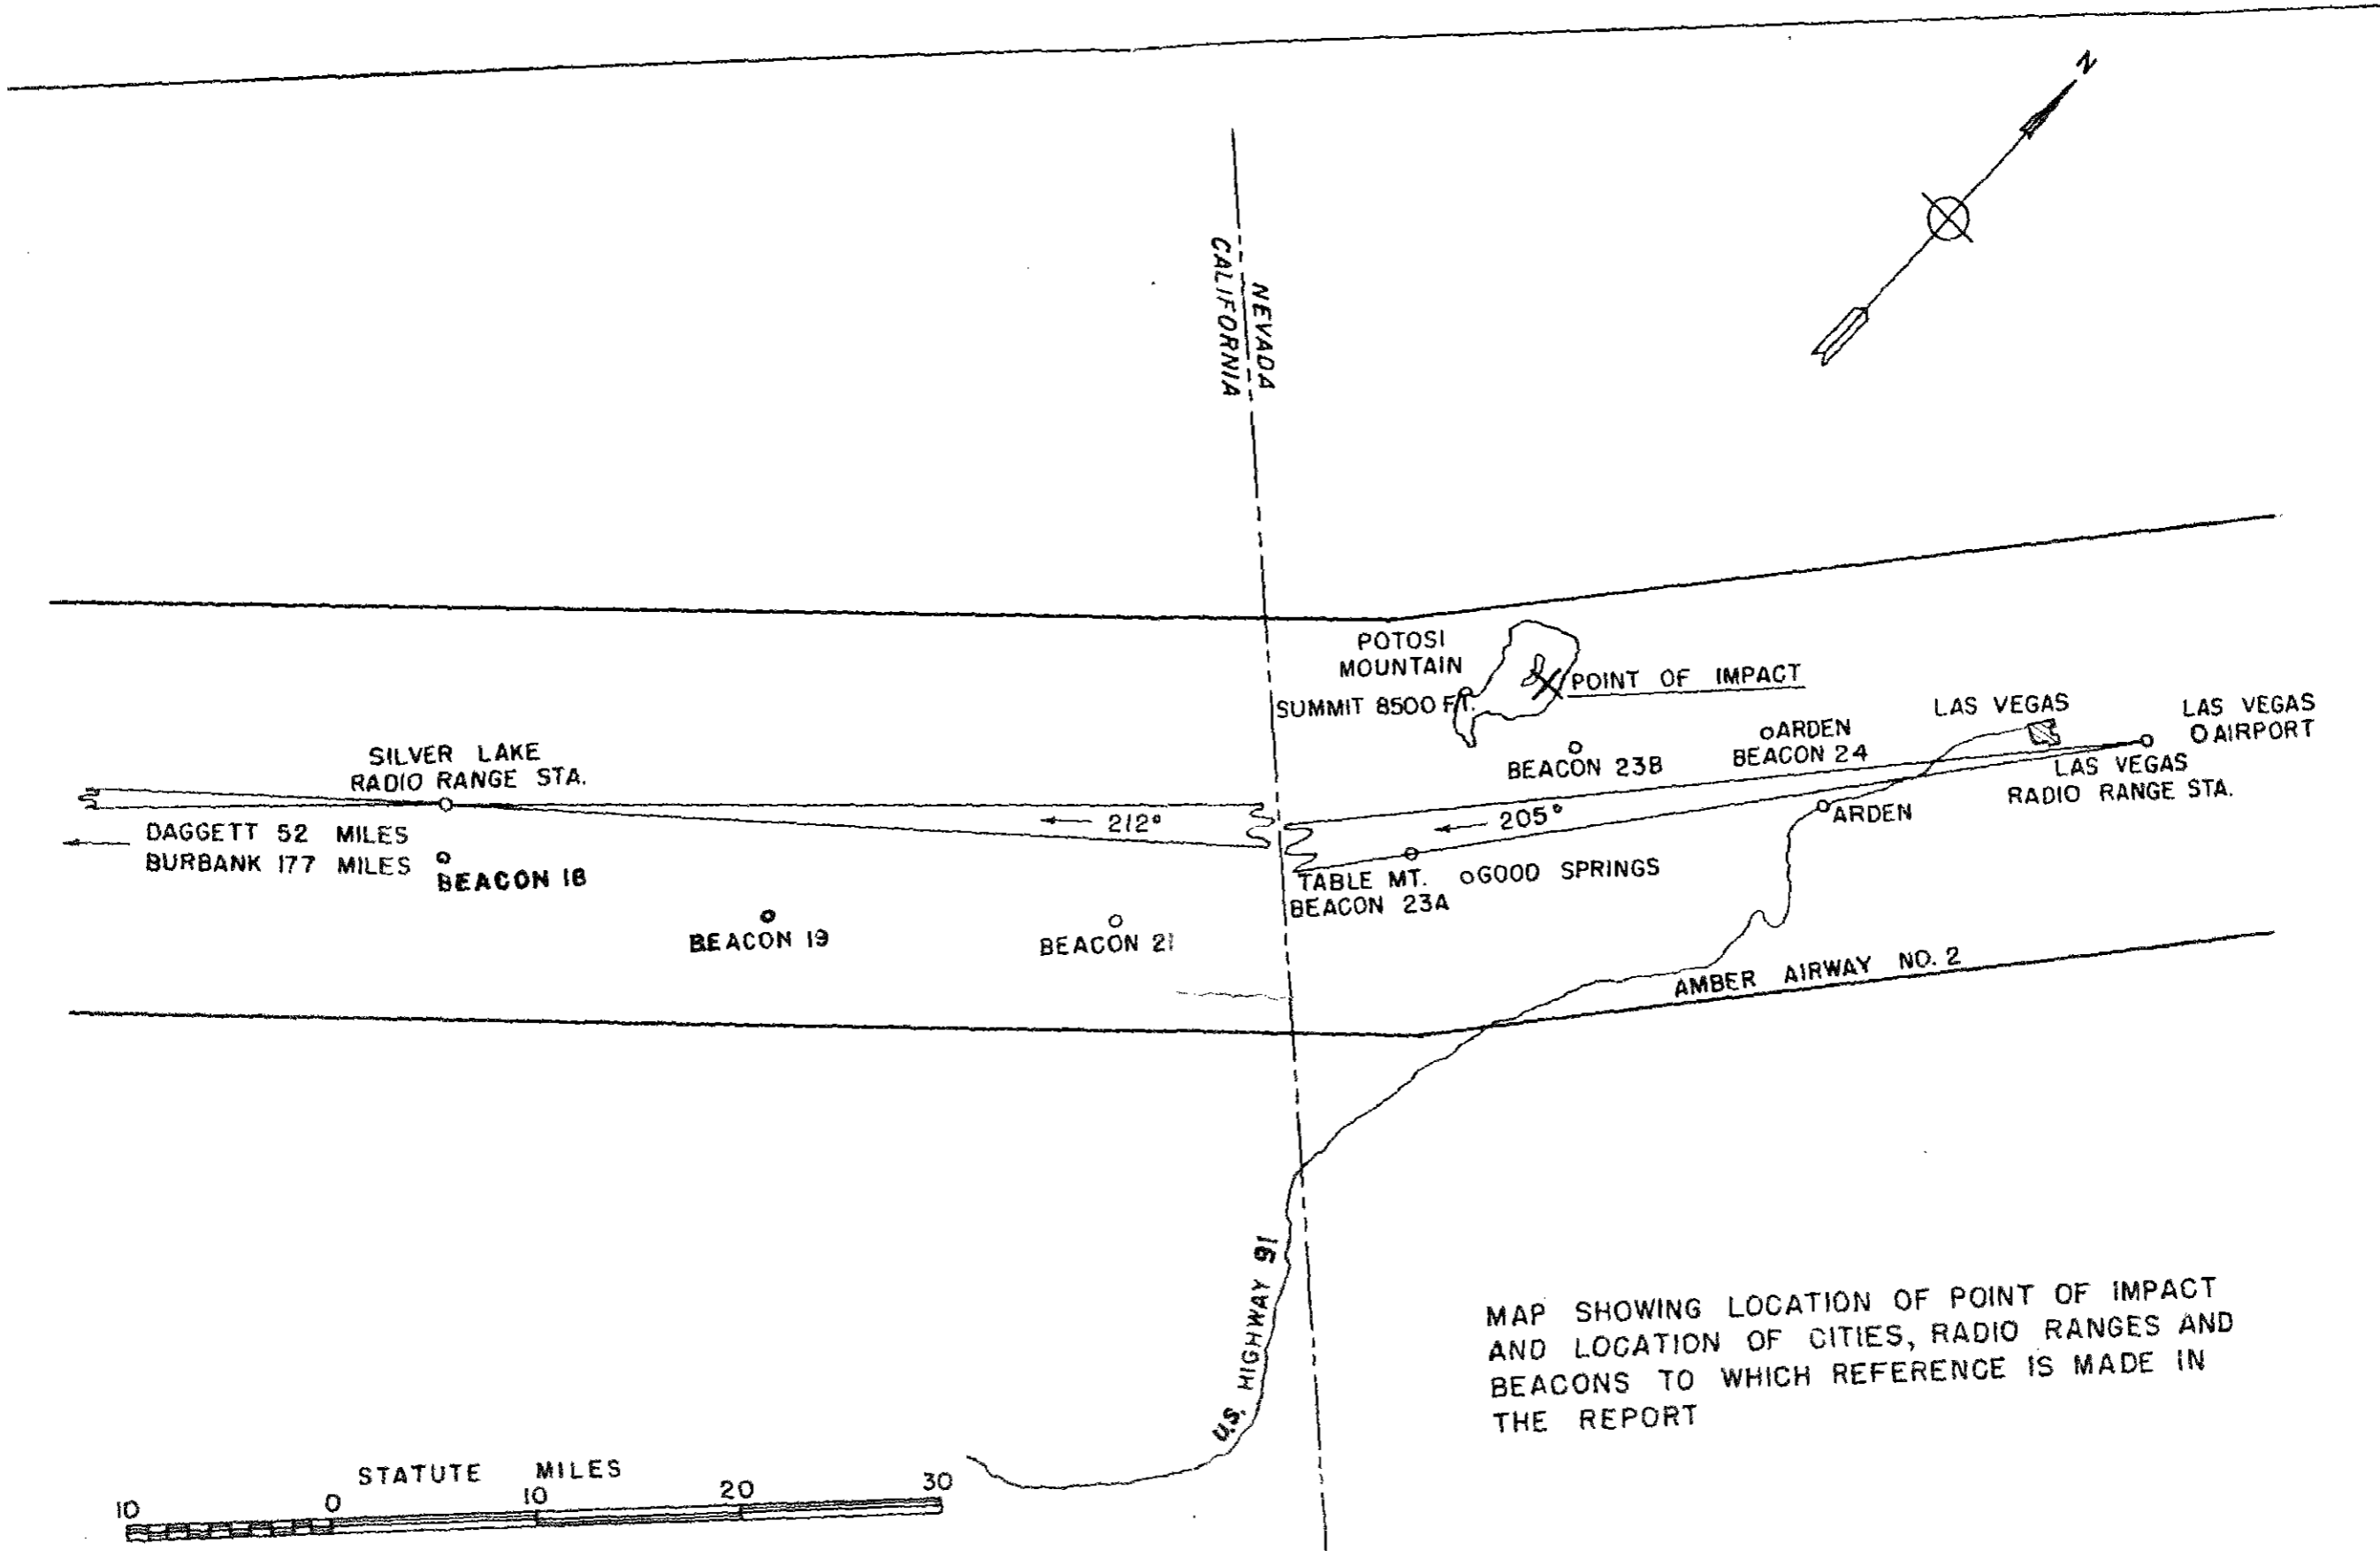
MAP SHOWING LOCATION OF POINT OF IMPACT AND LOCATION OF CITIES, RADIO RANGES AND BEACONS TO WHICH REFERENCE IS MADE IN THE REPORT

We shall now consider the propriety of the course used by the flight. As may be seen from the map opposite page 6, the center line of the southwest leg of the Las Vegas radio range has a true bearing of 221 degrees, or a magnetic bearing of 205 degrees, from the range station. The evidence indicates that a course following this center line, or varying from it by no more than a few degrees, is the only course considered proper for flight out of Las Vegas, on the route toward Burbank, until arrival at a point in the vicinity of the Table Mountain beacon, at which point it becomes necessary to assume a magnetic course of approximately 212 degrees in order to proceed to Silver Lake and on to Daggett.

The point at which the accident occurred has a bearing of approximately 215 degrees, magnetic, from the Las Vegas airport, and, as previously indicated, is at an elevation of about 7,770 feet. In view of the fact that witnesses who observed the airplane as it was flying between Las Vegas and Potosi Mountain testified that its flight path appeared to be in a straight line northwest of the general line of flight on which the airline planes usually travel in that vicinity, it appears probable that the airplane proceeded directly from the airport to the point of impact. This conclusion is substantiated by the fact that the elapsed time between departure from Las Vegas and the time at which the fire was observed was determined to be a normal amount of time for direct flight between the two points.

Although the airplane, at the time of the accident, was within the limits of the airway, it was 6.7 miles from the center line of the Las Vegas radio range log. Furthermore, the course being flown, if it were continued, would place the airplane outside the limits of the airway.
