REPORT OF THE CIVIL AERONAUTICS BOARD

On the investigation of an accident involving aircraft of United States registry NC 41380 in the Bay of Explois, Bonaville, Newfoundland, on October 3, 1942

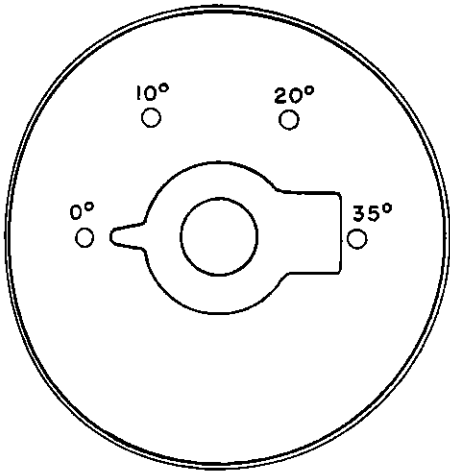
The flap selector switch, as originally installed, was of somewhat different design than the one being used on the subject flight. On the former switch the "off" was located on a relative point of the clock dial at 9:00 o'clock; " $10^{\circ}$ " at 11:00 o'clock; " $20^{\circ}$ " at 1:00 o'clock, and " $35^{\circ}$ " at 3:00 o'clock. As a safety measure, this switch was redesigned and on June 3, 1942 the new switch was installed. This new design added a "flight" and a "raise" position, both of which operated the flaps to result in  $0^{\circ}$  setting. The "off" position then was to permit the stopping of the flaps at any point the operator desired from  $0^{\circ}$  to  $35^{\circ}$ . The  $35^{\circ}$  position was changed to 8:00 o'clock, which was below the "flight" and "raise" and "off", at the lowest position of the dial. In addition, a safety stop-spring arrangement was provided so that in order to put the switch on "raise", "off" or " $35^{\circ}$ ", it was necessary for the operator to release the stop-spring. It appears from the testimony that this stop-spring had not been on the switch for sometime previous to the accident and it could not be ascertained whether it had been broken off or had been taken off. Furthermore, the captain and first officer testified that they had no recollection of there ever having been a stop-spring on the flap control

ORIGINAL SWITCH  
WHICH WAS DISCARDED

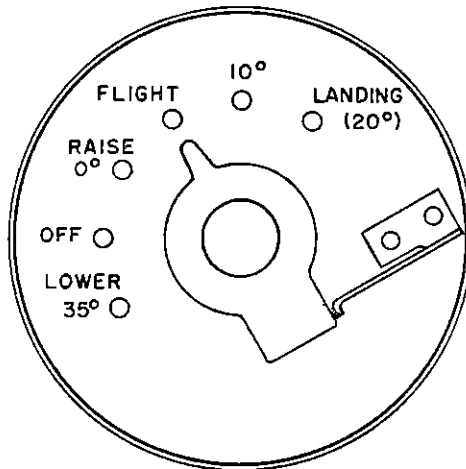
switch on any of this model airplane which they had flown. However, it was determined that these new switches with the stop-spring had been installed on all of these planes. (See sketches of old and new switches on page 11A.)

NEW SWITCH AS IT WAS  
INSTALLED (WITH STOP)

It has been recommended that the Civil Aeronautics Administration check any of this type aircraft engaged in commercial operation and require the safety stop-spring to be reinstalled on the flap selector switch.

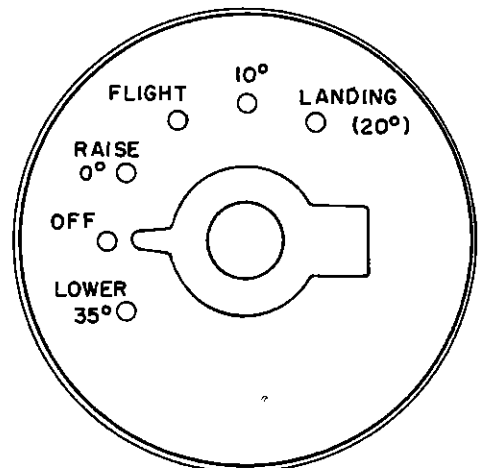
9. The flap control switch had been equipped with a safety stop to prevent an inadvertent application of 35° flaps, but the evidence indicates that this safety stop had been broken or removed sometime previous to the subject flight.

CONTRIBUTING FACTOR: Absence of the required stop-spring on the flap control switch which was for the sole purpose of preventing inadvertent application of the 35° flap.

SWITCH AS IT WAS ON  
SUBJECT FLIGHT  
(NO STOP)

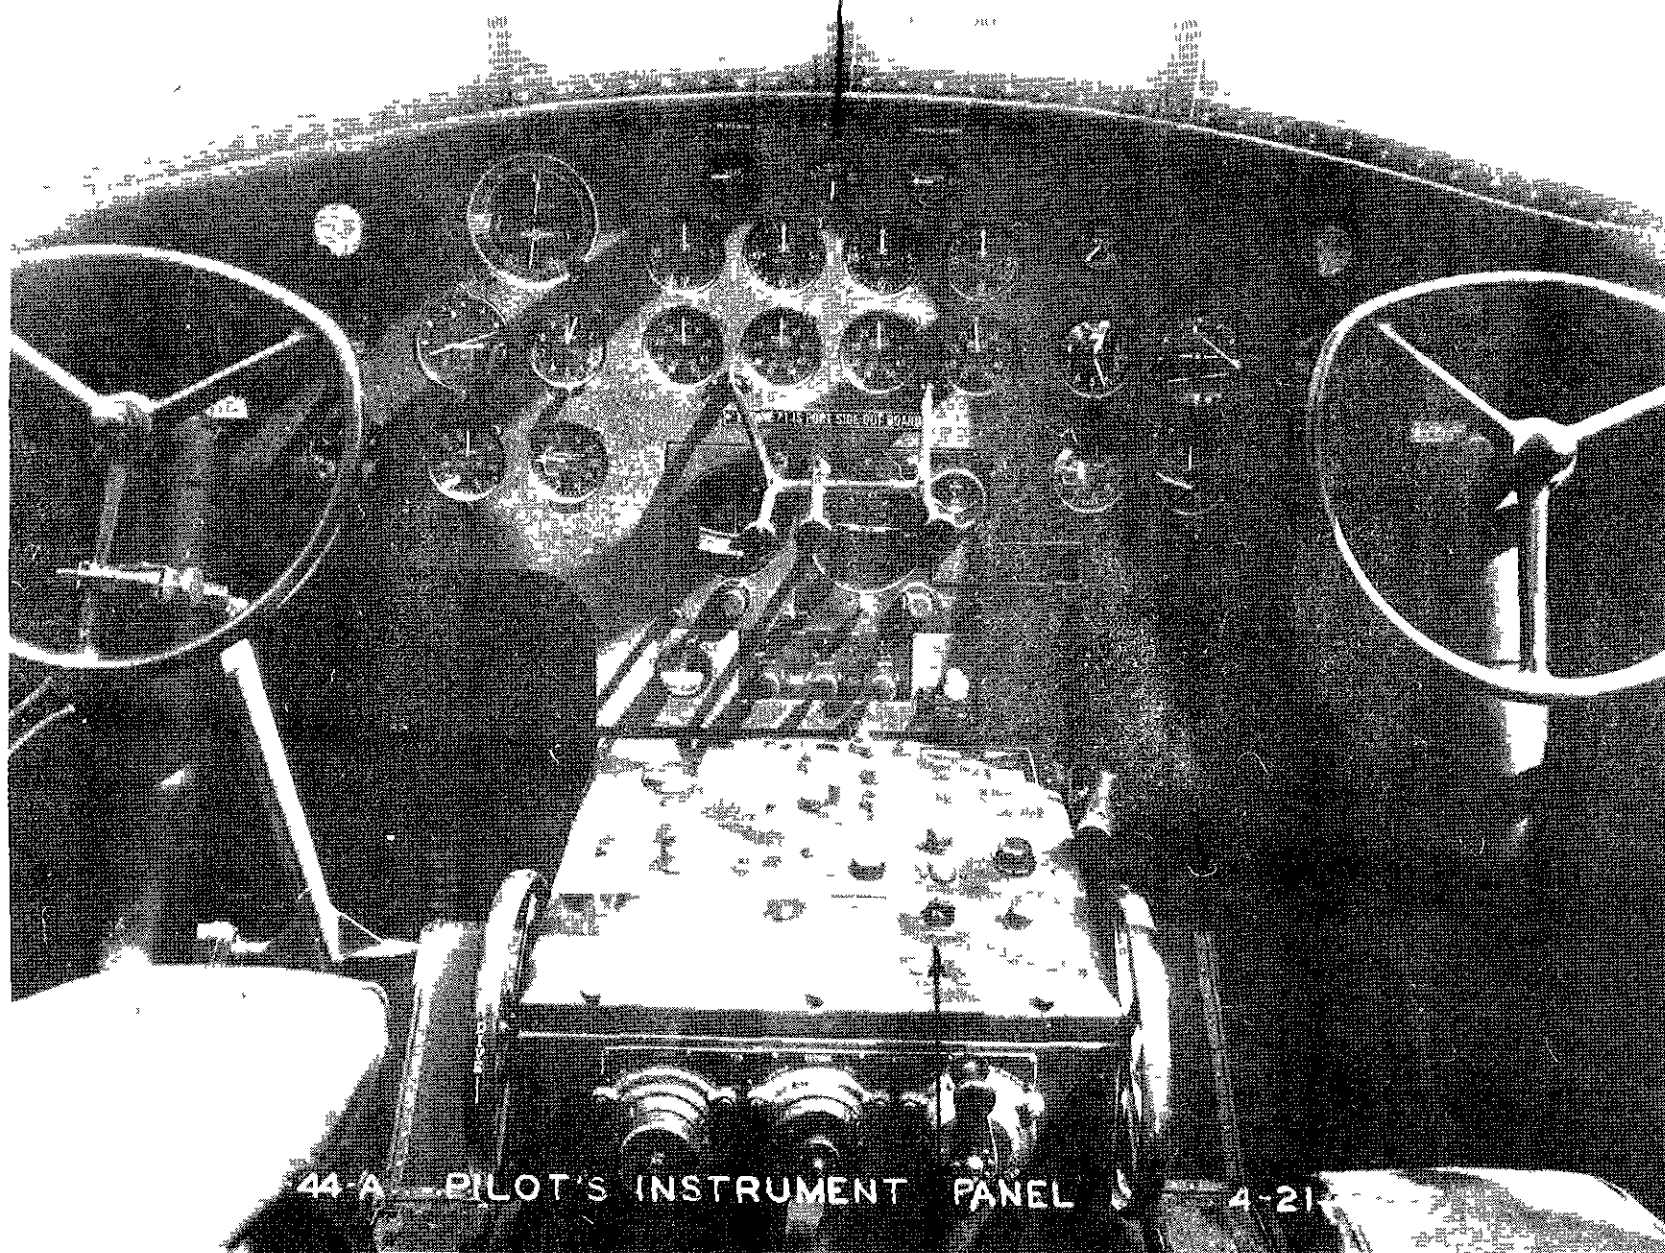
44-A PILOT'S INSTRUMENT PANEL 4-21

The instrument panel sank with the bow of the hull and was not recovered. It carried the flap selector switch mounted on a metal box, the top of which is about 15 inches above the floor of the cockpit. (See photograph, page 12A.)

The location of the flap selector switch on this instrument panel and the proximity of the instrument panel to the first officer's seat make necessary the consideration of the possibility that the first officer may have inadvertently struck this switch with his foot as he raised his foot

over the instrument panel to take his seat. It would have taken only a small force to move this switch the short distance necessary to change it from "off" to "35°" and, furthermore, the switch knob rotates in the same direction of the motion that would be taken by the first officer's foot as he was seating himself. The possibility of this theory was tried out in a similar aircraft and it was found that the switch could have been actuated in this manner.
