REPORT OF THE CIVIL AERONAUTICS BOARD

On the Investigation of an accident,
involving aircraft of United States
registry NC 17603, in the Tagus River,
Lisbon, Portugal, on February 22, 1943.

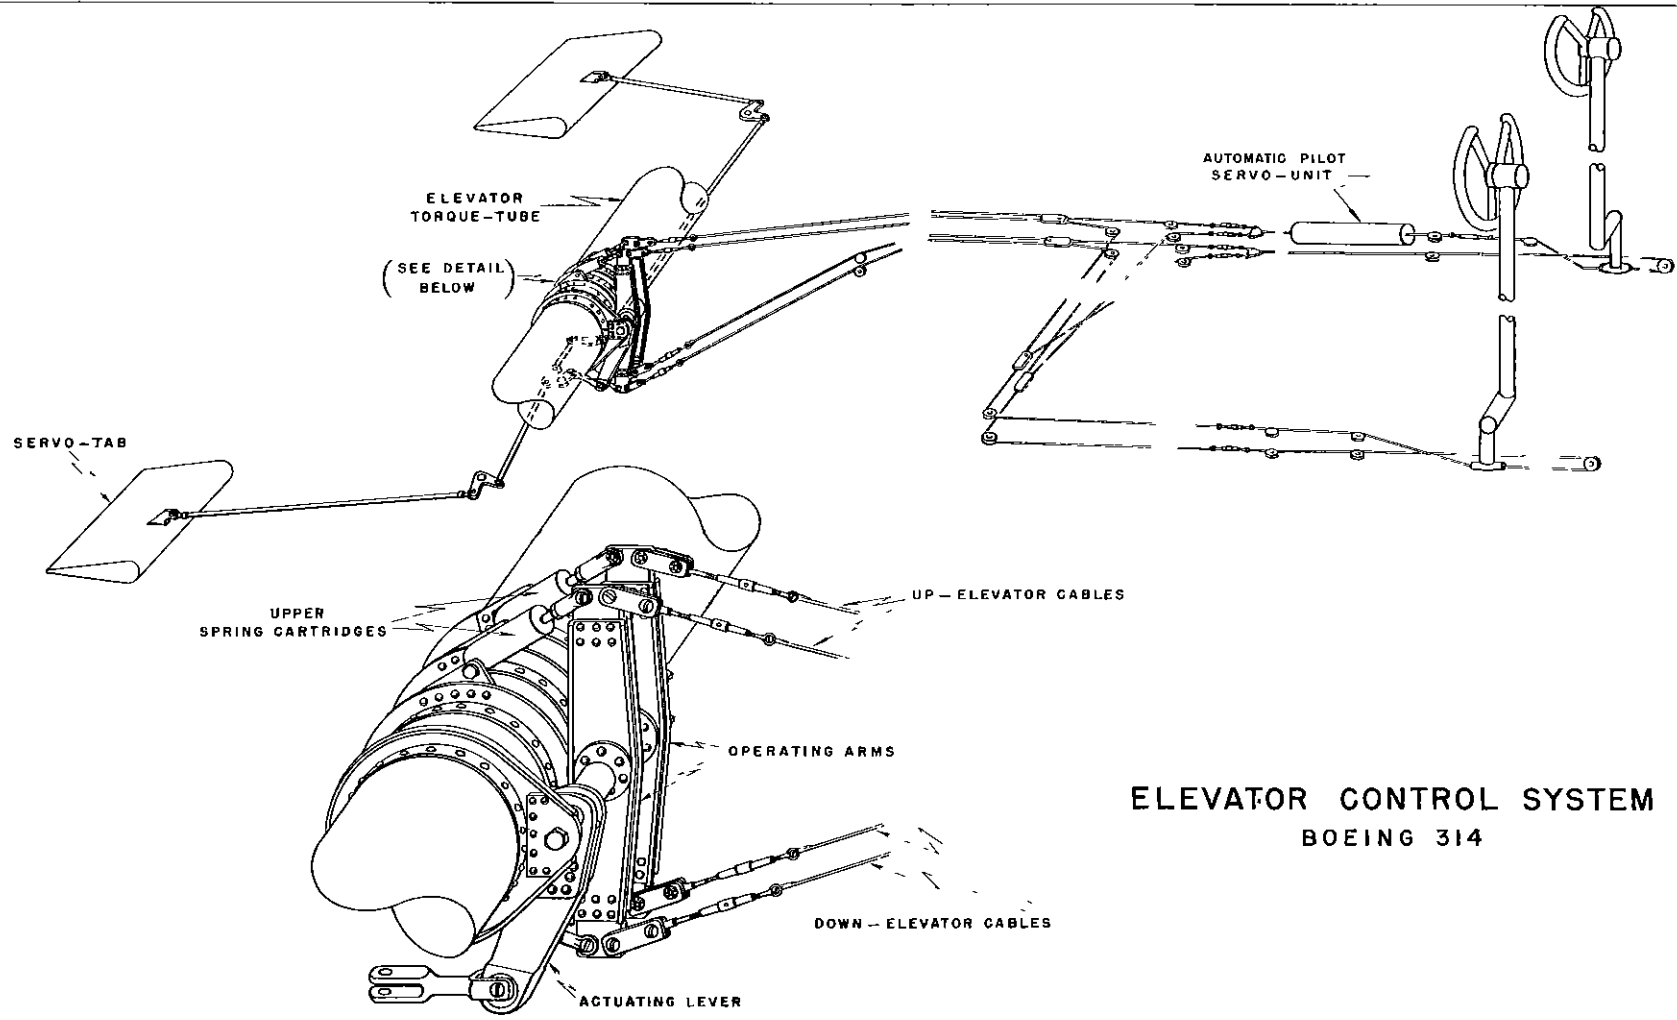
**ELEVATOR CONTROL SYSTEM
BOEING 314**

The elevator control system of the Boeing 314 consists of two sets of cables which permit operation of the elevator through an initial range of approximately 20° either side of the position of zero hinge moment by means of servo-tabs.^{4/} An additional 5° motion in either direction is attained by direct operation of the elevator through the torque-tube. The four ends of the operating arms are also connected to the torque-tube by means of four independent spring-cartridges. The purpose of these cartridges is to permit the operation of the elevators through the normal operating range by means of the servo-tabs, while still permitting direct operation of the elevators

The only individual failures in the cable control system which could render the elevators inoperative are the two cable connecting links which were recovered from the wreckage undamaged and intact.

The dual set of cables enables either the captain or first officer, or both, to operate the system in case any one cable fails. If one of the servo-tab systems should become inoperative, the other set would operate the elevators sufficiently for control. Even the failure of the hinge bolt supporting the operating arms, or the failure of the actuating lever, would not deprive the airplane completely of elevator control. The failure of one, or even all four of the cartridges would not influence the operation of the elevator through the first 20° of surface movement.

Sufficient parts of the elevator control system were recovered to permit detailed examination and study and to establish beyond reasonable doubt that the system was functioning prior to impact. The only element found to have been broken was the rod of the lower starboard spring cartridge. This break had the appearance of having occurred sometime prior to the accident. However this finding is not considered to be relevant in establishing the cause of the accident, inasmuch as even had this cartridge been broken, it would have had no effect on the operation of the airplane. Although this conclusion seemed quite apparent from a study of the design of the elevator control system, nevertheless the Board arranged with PanAm for specific tests to clarify this matter beyond a doubt. During these tests, one or more of the cartridges were disconnected and the operation of the elevator control system was found to remain normal.
