File No. 2203-43

Docket No. SA-79

REPORT OF THE CIVIL AERONAUTICS BOARD

On the investigation of a mid-air collision between two aircraft engaged in local instruction flights, which occurred near Wichita, Kansas, on June 3, 1943.

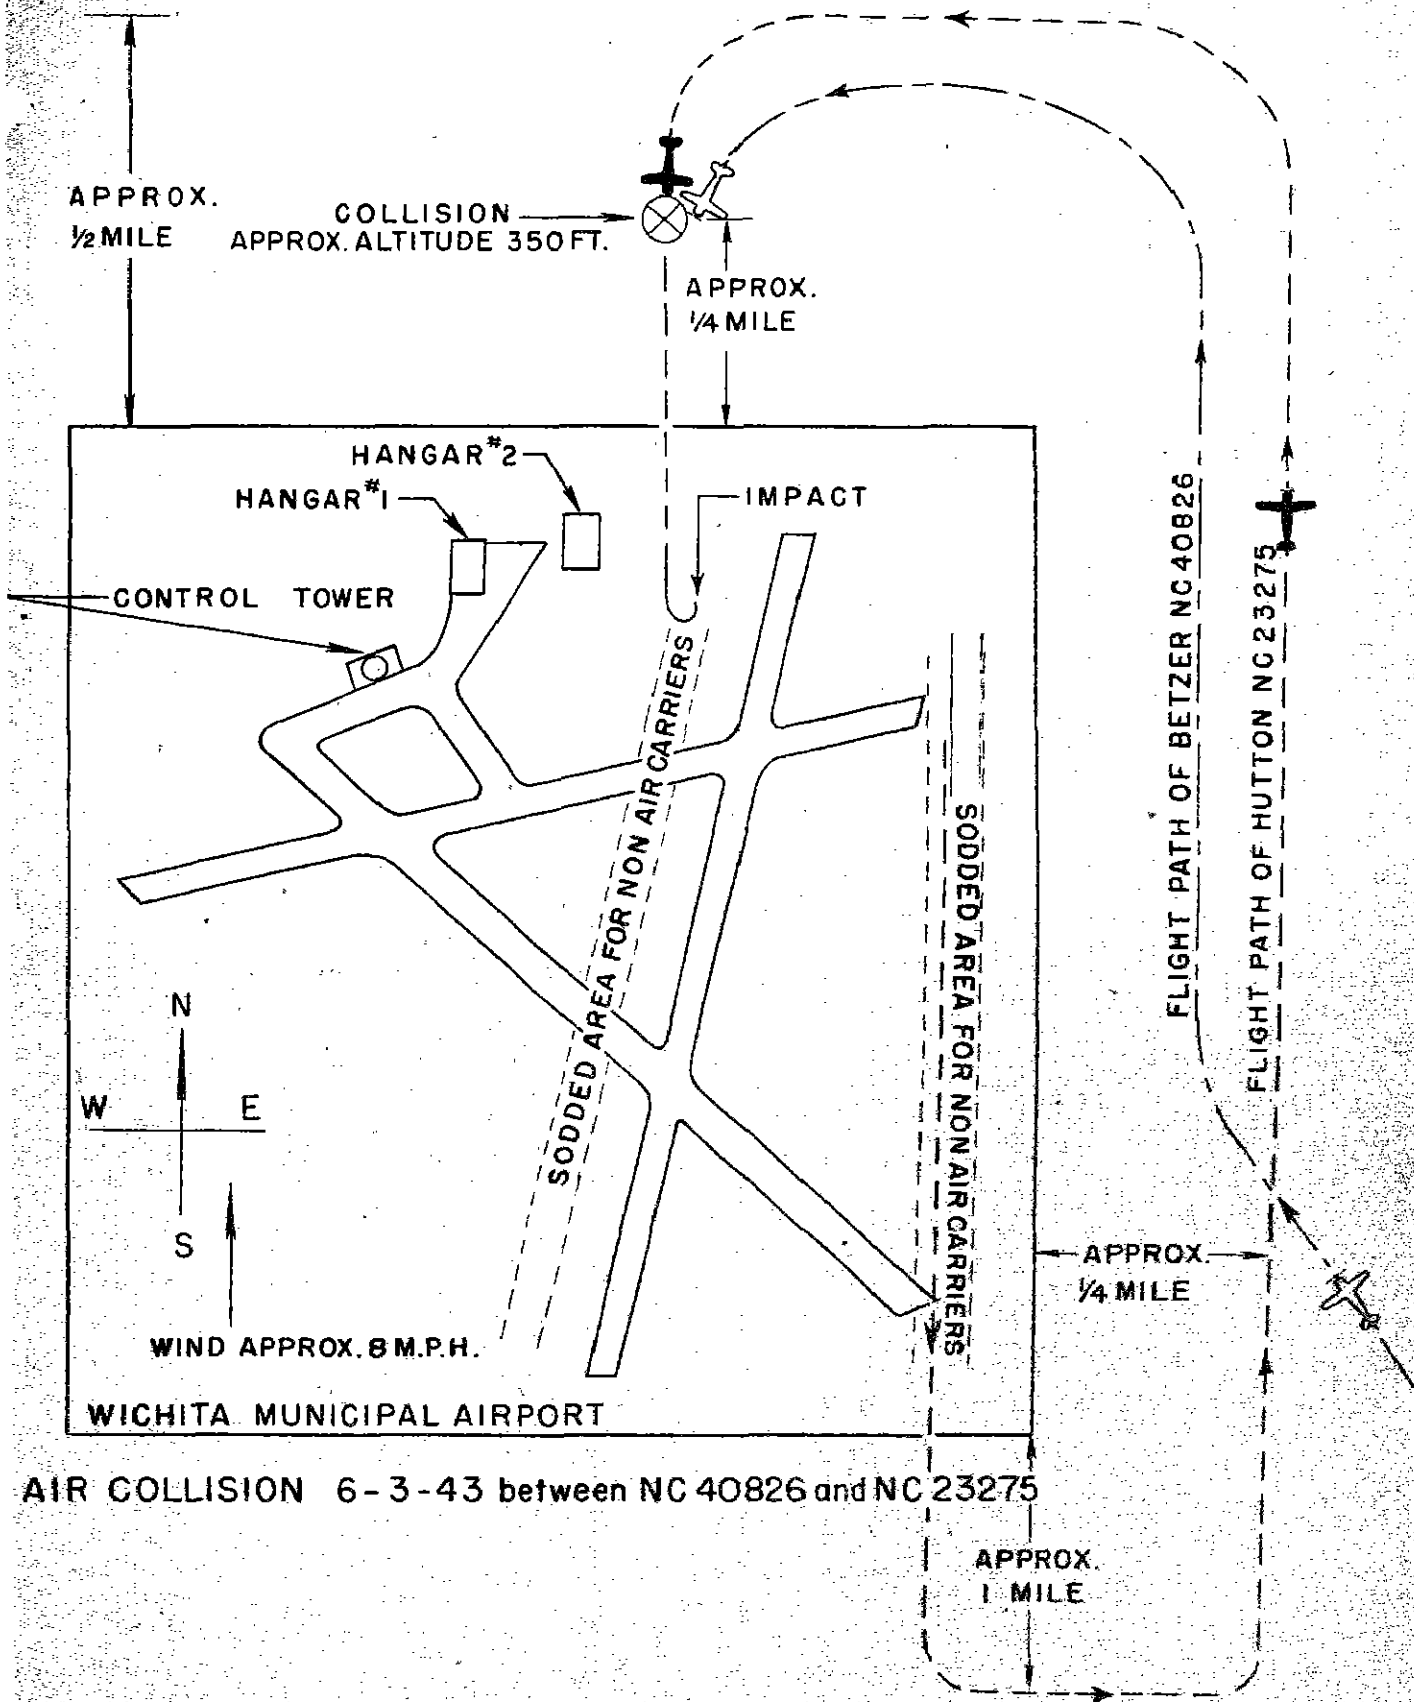
AIR COLLISION 6-3-43 between NC 40826 and NC 23275

Examination of the wreckage disclosed marks on each aircraft which indicated that about 17" of the tip of the rear spar of the right wing tip of Betzer's plane had penetrated, broken off, and remained in the bottom of the fuselage of Hutton's plane, under the pilot's seat. The left landing wheel of Hutton's plane had broken through the upper surface of the right wing of the other aircraft at Number 1 and 2 compression struts, just forward of the rear spar inboard from the wing tip. The impact of the wheel into this wing completely demolished and tore out all ribs and

interbracings from the compression struts to the wing tip, presumably as the two planes separated. There was no indication of failure of any part of either aircraft prior to the collision.
