REPORT OF THE CIVIL AERONAUTICS BOARD  
on the  
Investigation of a Mid-Air Collision Between Two  
Local Instruction Flights

Mid-air collision at Cedar City, Utah, August 27, 1943

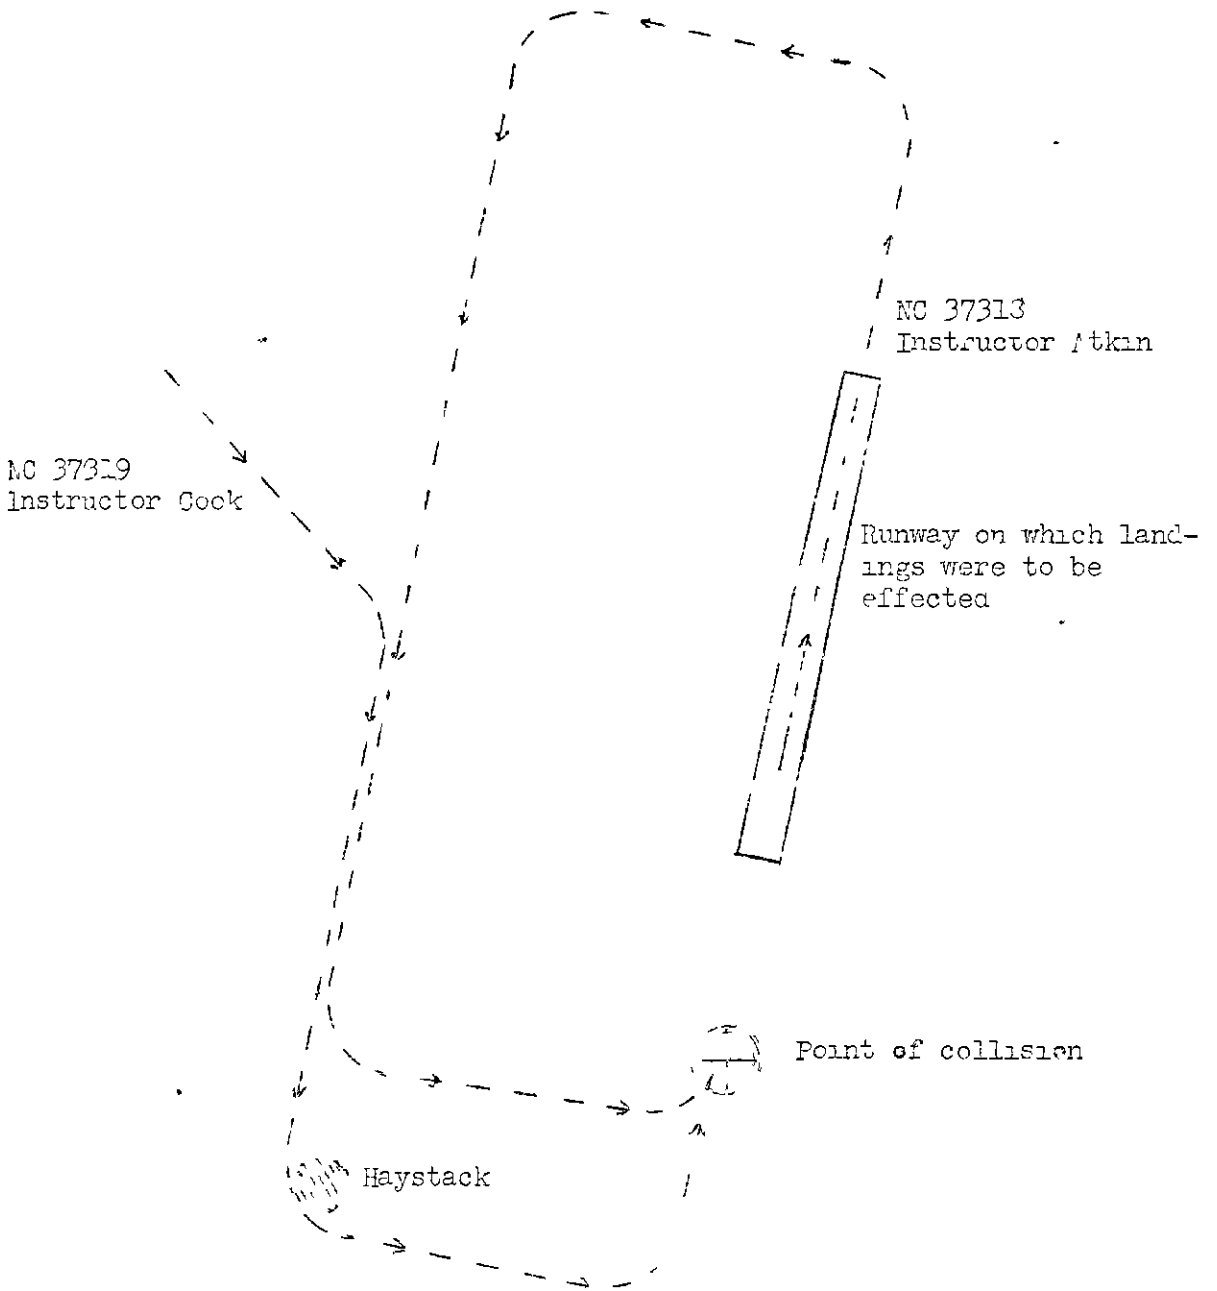
Instructor Cook and Student Christian, returning to land at the Cedar City Airport, entered and followed the traffic pattern, according to regulations, and about one-half way down on the downwind leg headed in a southerly direction. Instructor Atkin and Student Adamowitz, after practicing elementary maneuvers, had returned to the subject airport and were engaged in take-off and landing practice. They were in the pattern behind Cook, about one-quarter way down the downwind leg, also heading in a southerly direction. A third plane, flying at the same altitude and piloted by Instructor Raymond Duerksen, entered the pattern just in front of Atkin and headed in the same direction. In an apparent effort to cut off Duerksen, Atkin cut his turn short about 500 feet before reaching the prescribed turning point in the pattern from the downwind leg onto the base leg. Meanwhile, Cook, in the lead, had made his turn from the downwind leg and was flying the base leg well ahead of Duerksen, who was still on the downwind leg. Atkin continued, heading east inside the base leg, and then entered a shallow gliding left turn onto his approach leg. At an altitude of approximately 150 feet his flight path converged with that of Cook, who meanwhile had followed the proper base leg path, made his approach turn and was gliding in a straight course on the approach leg preparing to land. A collision followed and the two planes interlocked and fell together to the ground. (See sketch, Page 2.) Duerksen continued his flight on the regular pattern and landed his airplane.

Investigation revealed that Duerksen entered the traffic pattern between Cook and Atkin with less than the 500 feet horizontal spacing prescribed by regulations. He stated that he increased his speed as he "realized that the distance of 500 feet that must be maintained was approaching the border line" and that his distance ahead of Atkin "might have been less than 500 feet, or approximately 400 feet." Atkin stated to the investigator for the Board that he became very much irritated when Duerksen entered the pattern "just ahead" of him, and in his written statement concerning the accident he estimated the distance at 200 feet. He also stated that he made

his turn from the downwind leg onto the base leg at what he termed "my usual turning place," while all of the students and instructors at the airport who were questioned were clear in their understanding that the prescribed ground mark for this turn was a well-defined haystack about 500 feet beyond the point where Atkin turned. According to the assistant chief pilot of the operation, who witnessed the flights involved and the actual collision, neither aircraft made an attempt to alter its course before impact in the air, which would indicate that the pilots failed to observe each other.

From the evidence it is apparent that while Duerksen erred in entering the traffic pattern ahead of an approaching plane under the prescribed horizontal distance of spacing, there can be no justification for Atkin's disregard of local airport and Civil Air Regulations in deliberately passing Duerksen on the left by turning onto the base leg so short that he allowed himself less than the regulation 1000-foot straight-in approach for a landing. The collision occurred approximately 500 feet from the approach end of the runway and Atkin was making his approach turn at the time.

Although Pilot Cook had the right-of-way, he was lax in his failure to observe and avoid the aircraft whose flight path was converging with his own. While the action of Pilot Duerksen was undoubtedly a contributing factor, the probable cause of the accident was the poor and hasty judgment of Atkin, who, in addition to shortening and altering his flight path from that prescribed, also failed to observe and avoid a landing aircraft which was on course and had the right-of-way.
