REPORT OF THE CIVIL AERONAUTICS BOARD  
on the  
Investigation of a Mid-Air Collision Which Occurred  
Between Two Local Instruction Flights

A mid-air collision which occurred approximately  $2\frac{1}{2}$  miles southwest of the Municipal Airport, Burlington, Vermont, about 10:00 a.m. on December 28, 1943, resulted in fatal injuries to Instructor Rene Phillip DeLaricheliere and his student, Harry M. Hollander, and in the complete destruction of the aircraft in which they were flying, a Piper J3L-65, NC 38844. Instructor Robert Jonas Birnbaum and his student, Morris I. Silber, occupants of the other aircraft involved, a Piper J3C-65, NC 35073, effected a safe landing with minor injury to the student and major damage to the aircraft. Instructor DeLaricheliere held a commercial pilot certificate with single-engine land, 0-330 h.p., and flight instructor ratings. He had flown about 1280 hours, 1000 of which were in the type of aircraft involved. Instructor Birnbaum held a commercial pilot certificate with single-engine land, 0-80 h.p., and flight instructor ratings. He had flown approximately 870 hours, 700 of which were in the type of aircraft involved. Students Hollander and Silber

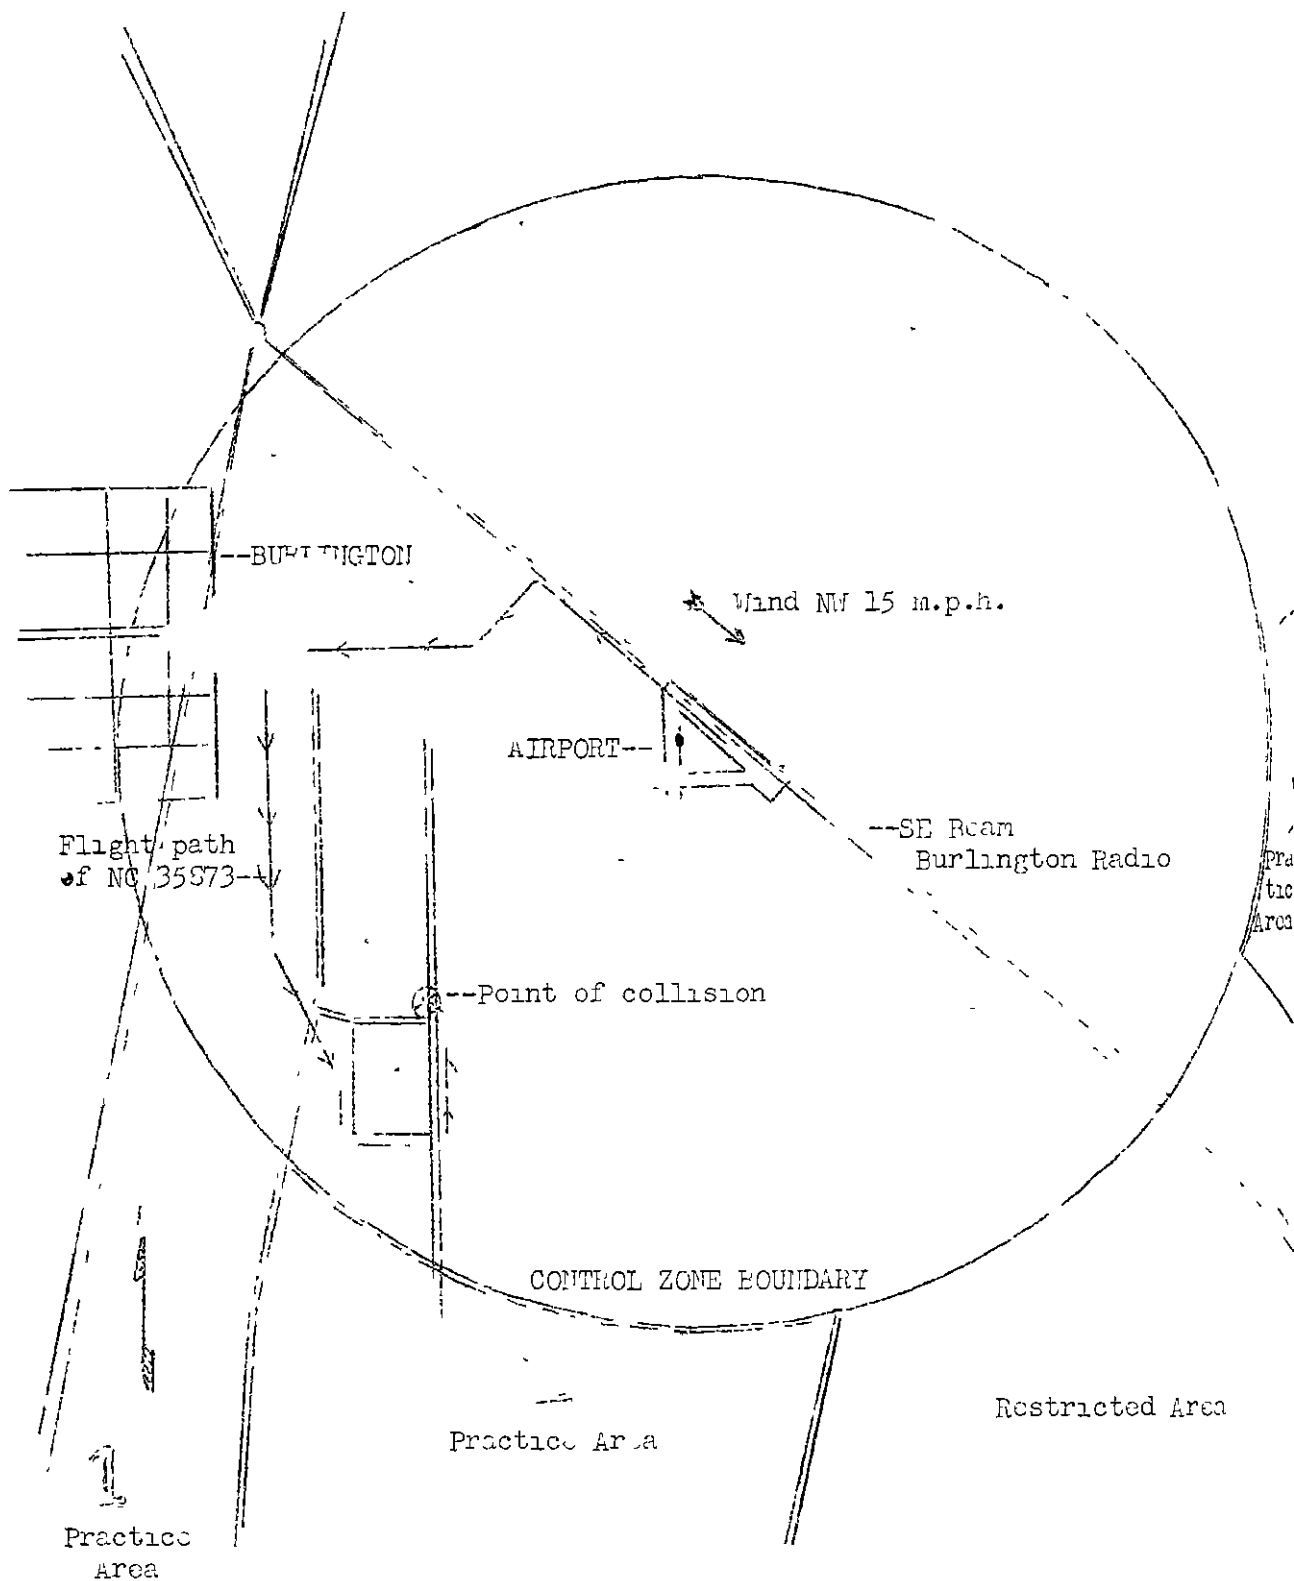
Instructor Birnbaum, occupying the rear seat and Student Silber the front, took off from the Burlington Municipal Airport at approximately 9:40 a.m. on a routine instruction flight, and proceeded to their assigned practice area (No. 1), about  $2\frac{1}{2}$  miles southwest of the airport. While they were engaged in flying a rectangular pattern at an altitude of 500 feet, and during or immediately following a left turn from the upwind to the crosswind leg at the northeast corner of the rectangle, the student pointed ahead and shouted "Plane!". A head-on collision followed almost instantaneously. (See sketch on Page 2.) The right wing of the other plane struck and severed

one of their propeller blades and the right landing gear, then passed under them and disappeared. Barnbaum landed his plane in an open field, skidded approximately 40 feet on the bottom of the fuselage, and stopped in an upright position, heading northwest.

Marks on both aircraft indicated clearly that the collision was nearly head-on, with the plane being flown by DeLaricheliere on the right side of the other plane's fuselage and slightly lower. The right wing of DeLaricheliere's plane had struck and severed one propeller blade of Barnbaum's, approximately five inches below the hub, snared off the right landing gear and collapsed the left gear back into the left wing brace strut. The right wing of DeLaricheliere's plane was snared off about 4 feet in-board from the tip and had fallen free, while a section approximately  $4\frac{1}{2}$  feet long disintegrated at a point centered near the strut fittings. A portion of the right aileron of DeLaricheliere's plane was found looped over the left landing gear strut of the other plane. The severed propeller tip and the right landing gear of Barnbaum's plane were found in the vicinity of the collision a considerable distance from the wreckage. There was no indication of failure of any part of either aircraft prior to the collision.

Since this accident, certain precautionary measures have been taken. The operator has required that all pilots, after making the 45° turn leaving the control zone, shall climb to and maintain an altitude of 800 feet while going to and returning from practice areas, descending to 500 feet for practice after the assigned areas have been reached. The need for greater vigilance on the part of all instructors and students has been stressed.
