CIVIL AERONAUTICS BOARD

ACCIDENT INVESTIGATION REPORT

TRANSCONTINENTAL & WESTERN AIR, INC., WASHINGTON NATIONAL AIRPORT
MARCH 29, 1946

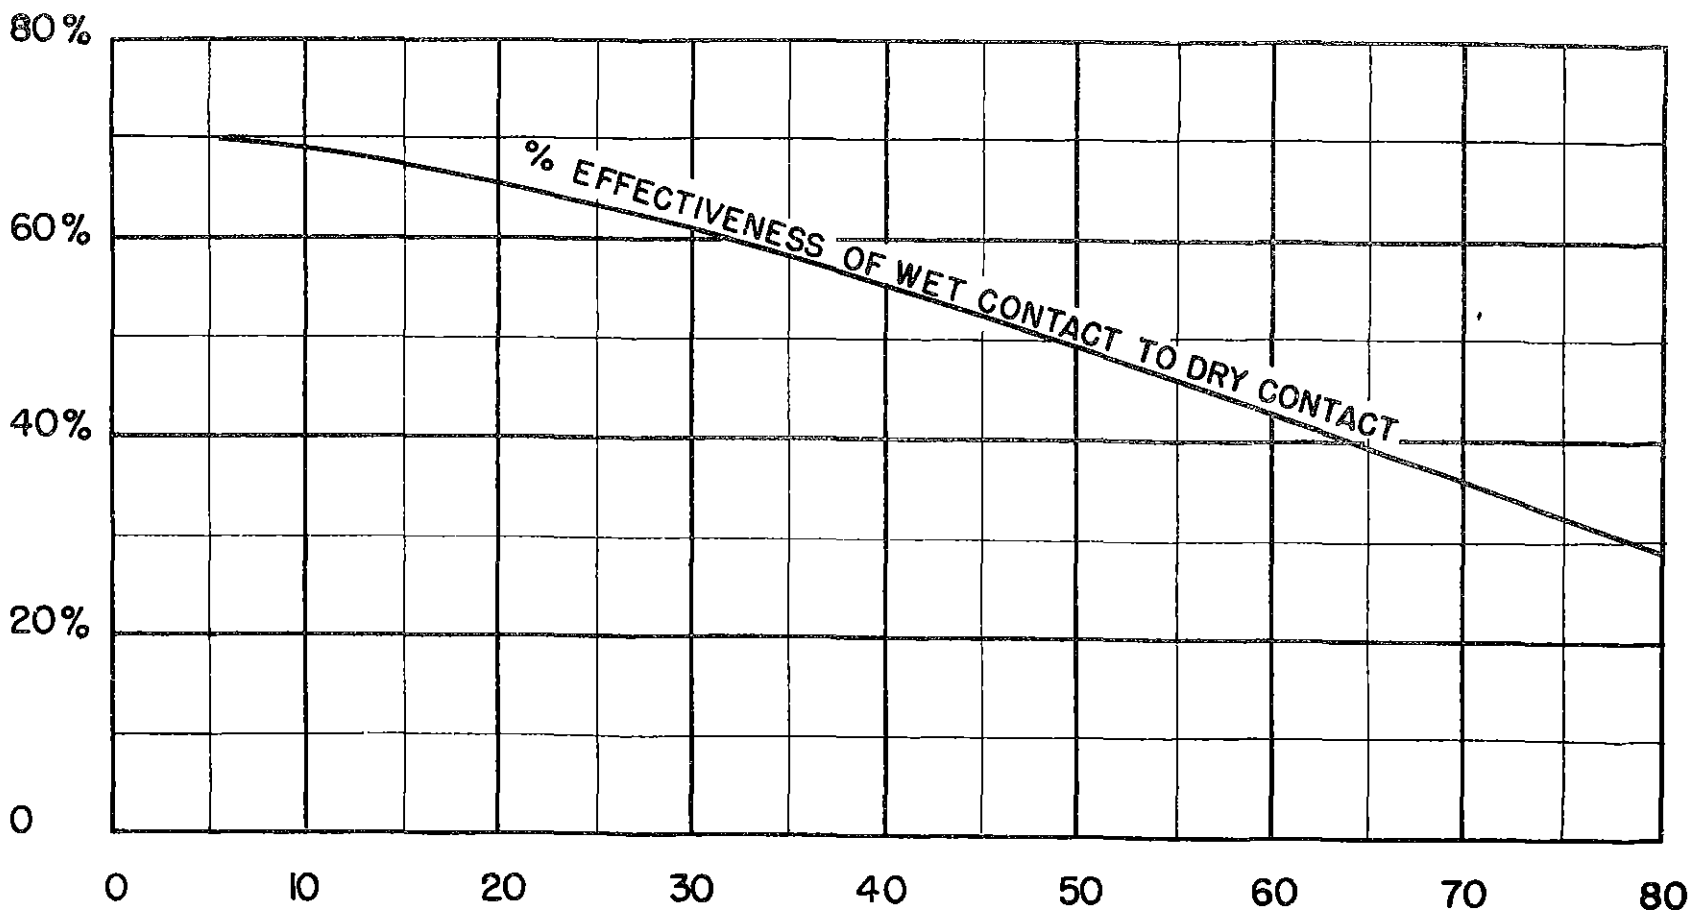
COEFFICIENT OF FRICTION
RUBBER TIRES ON PORTLAND CEMENT

these accidents failed to disclose any malfunctioning of the brake system although a serious lack of adequate deceleration on wet runways was indicated. It is probable that the coefficient of friction at the speed at which Flight 955 made contact with the wet runway is only 20 or 30 percent of that on a similar dry runway.⁴ It was apparent in this instance, as in previous accidents, that the pilots involved were not completely aware of the ineffectiveness of rubber tires on wet runways as compared with dry runways.

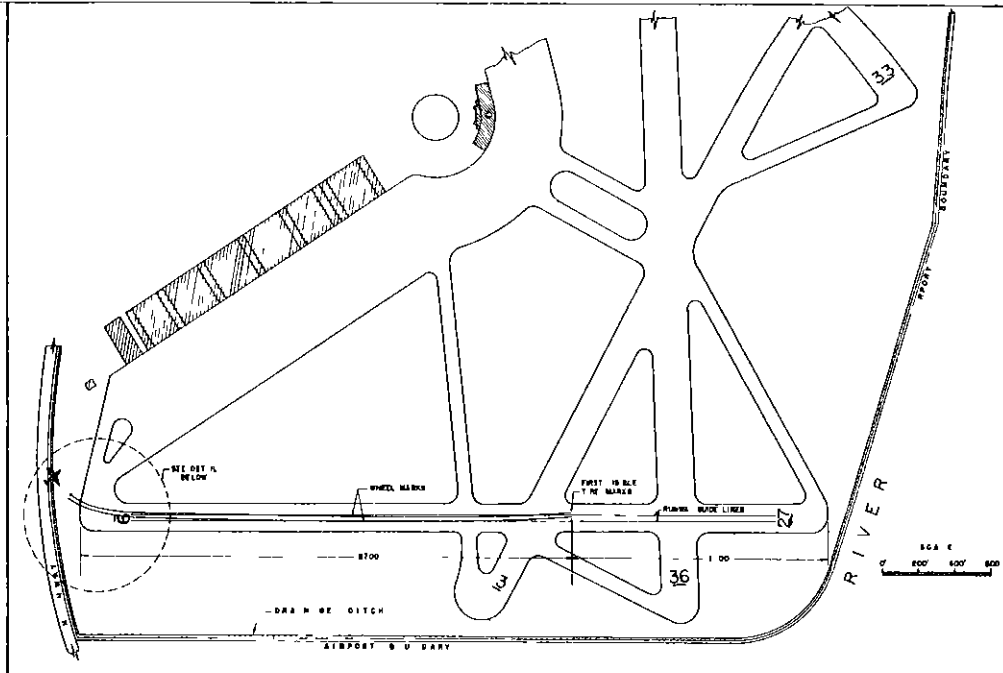
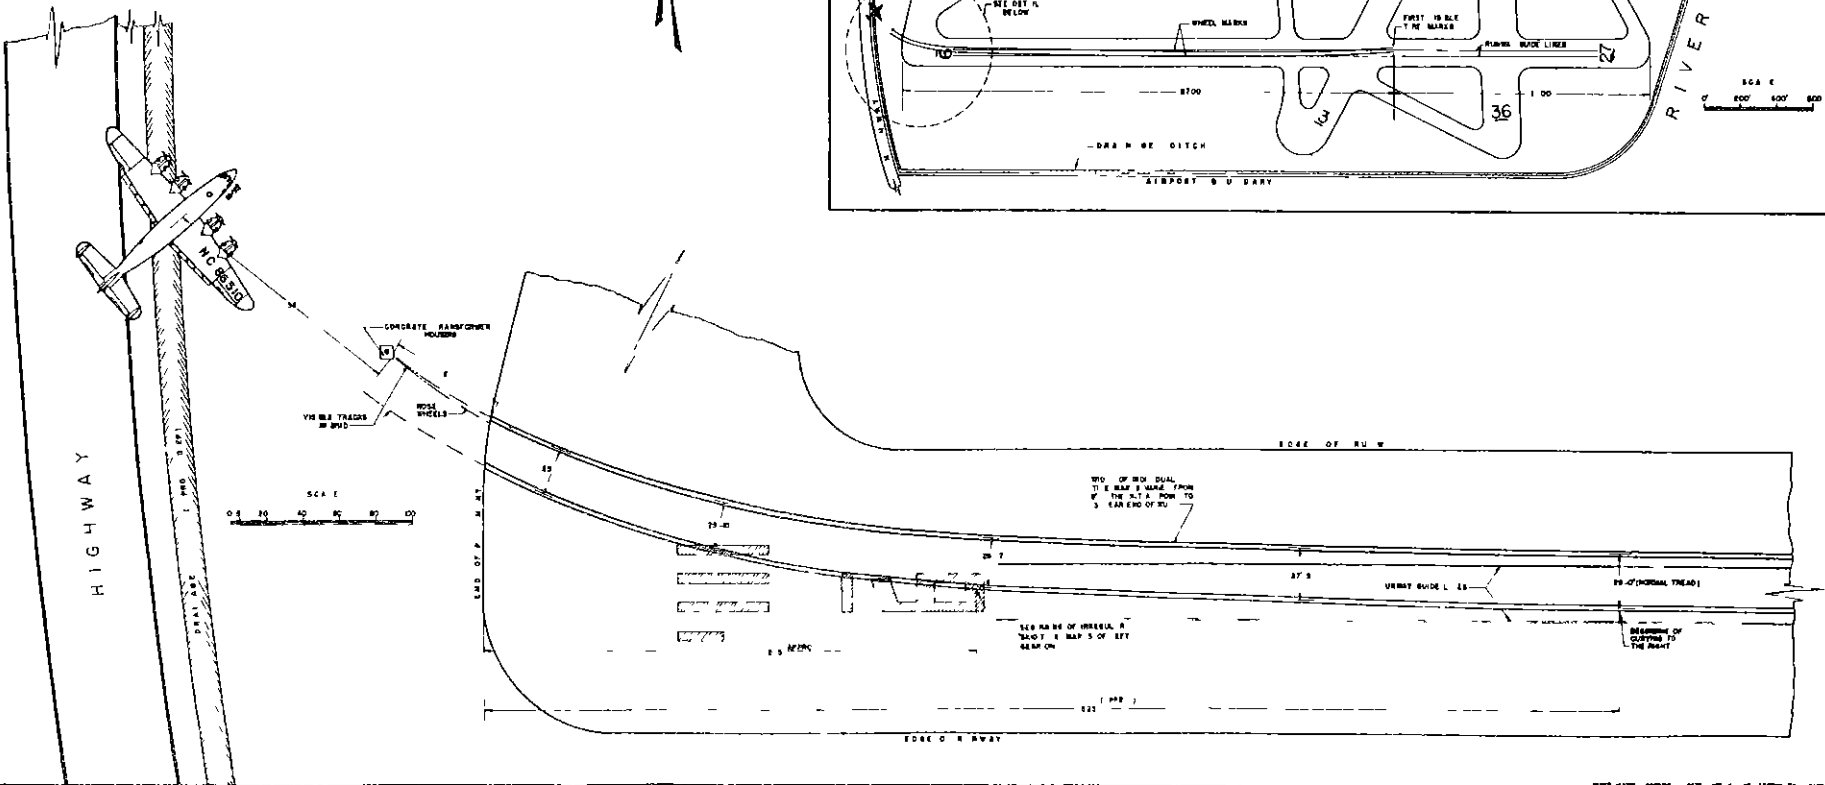
SKETCH

The flight approached the field from the northeast and while over the east bank of the Potomac River approximately 2/3 of a mile from the boundary of the airport, turned to the right and started a descent in final approach to Runway 27. According to the testimony of the pilots, initial contact was made with the runway between 800 and 1,000 feet from the approach end and the aircraft continued down the runway with less than normal deceleration. Approximately 600 feet from the far end of the runway the pilot attempted a turn to the right. After turning approximately 30 degrees, the aircraft rolled beyond the runway end and struck a concrete transformer housing. The aircraft whipped approximately 90 degrees to the right and came to rest across a drainage ditch with its empennage extending over the highway which adjoins the airport.

Runway 27 is 4,100 feet long and is the shortest of the runways at Washington National Airport. From the point of initial touchdown a maximum of 3,300 feet of runway remained in which to decelerate. However, testimony of witnesses who observed the approach and landing indicated that its speed at touchdown was higher than normal and that the aircraft did not appear to decelerate normally. The pilots stated that brakes were applied intermittently but no deceleration due to braking action was apparent to any of the crew. Tire marks were visible for the last 2,700 feet of the runway, no marks within the first 1,400 feet of the runway could be identified as having been made by Flight 955. Therefore, while it cannot be determined that no contact was made in this portion of the runway, it is nevertheless apparent that no deceleration due to braking action occurred in the first 1,400 feet. Inspection of scuff marks on the aircraft tires indicates conclusively that these tires had skidded for a considerable distance on the wet runway.
