CIVIL AERONAUTICS BOARD

ACCIDENT INVESTIGATION REPORT

PAN. AMERICAN AIRWAYS - WILLIMANTIC, CONNECTICUT, June 18, 1946

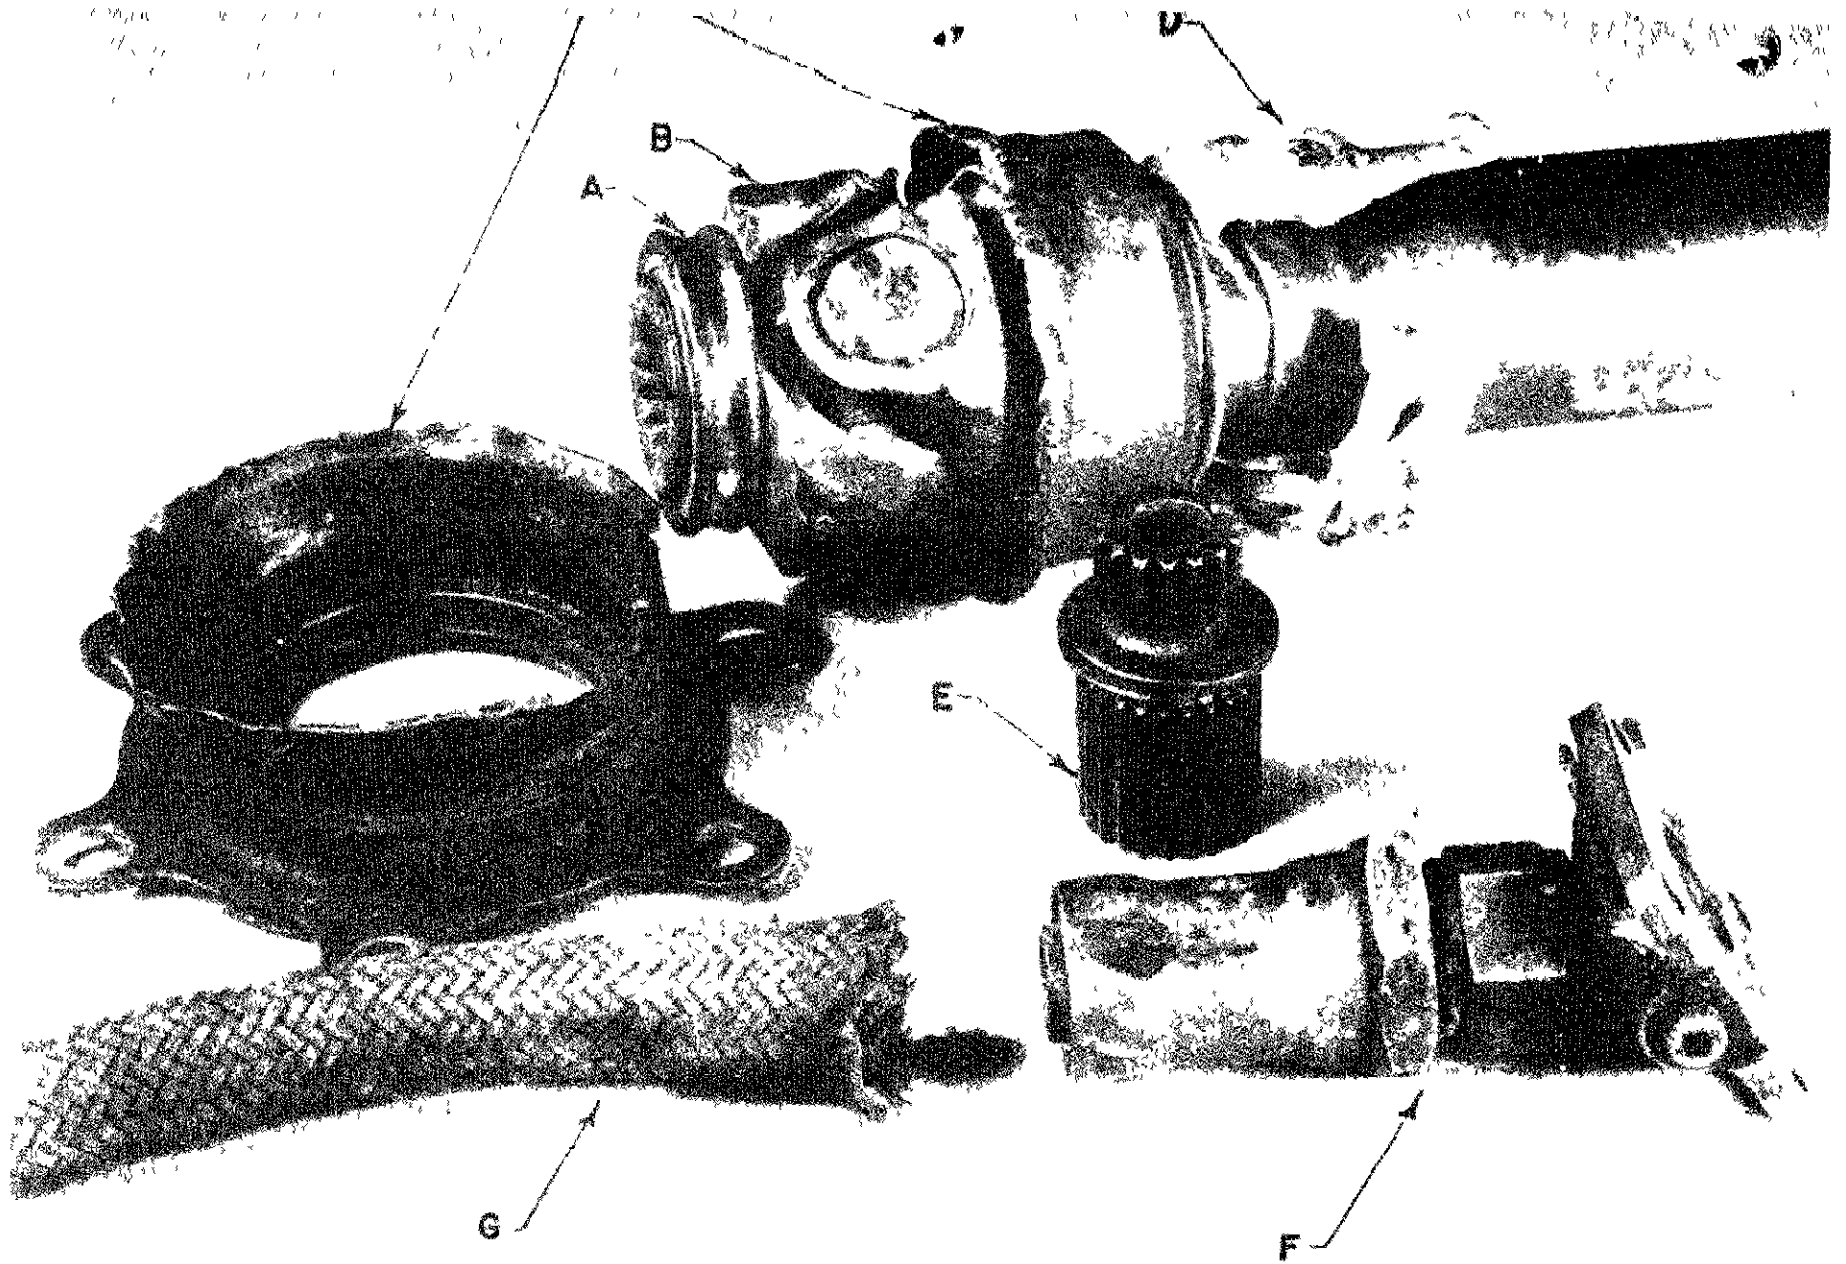
Figure 1. An enlarged view of the disassembly of the engine end of the cabin supercharger drive shaft and the hydraulic out-line fitting indicating the nature of the failure. A. Shaft bearing B. Universal joint, C. Universal joint housing; D. Aluminum spring-shield; E. Drive coupling shear section; F. Hydraulic out-fitting; G. Hydraulic line (rubber covering consumed exposing steel braid).

fitting is located approximately 3/8" above the forward end of the cabin supercharger drive shaft. The cabin supercharger drive shaft universal joint housing, which is attached to the engine gear box, had fractured circumferentially at the mid-section, and the rear half of the housing had moved rearward and was lodged over the spring assembly expander. Its ragged edge bore indications of having struck adjacent objects and was rolled inward in such a manner as to indicate considerable force of contact while rotating.

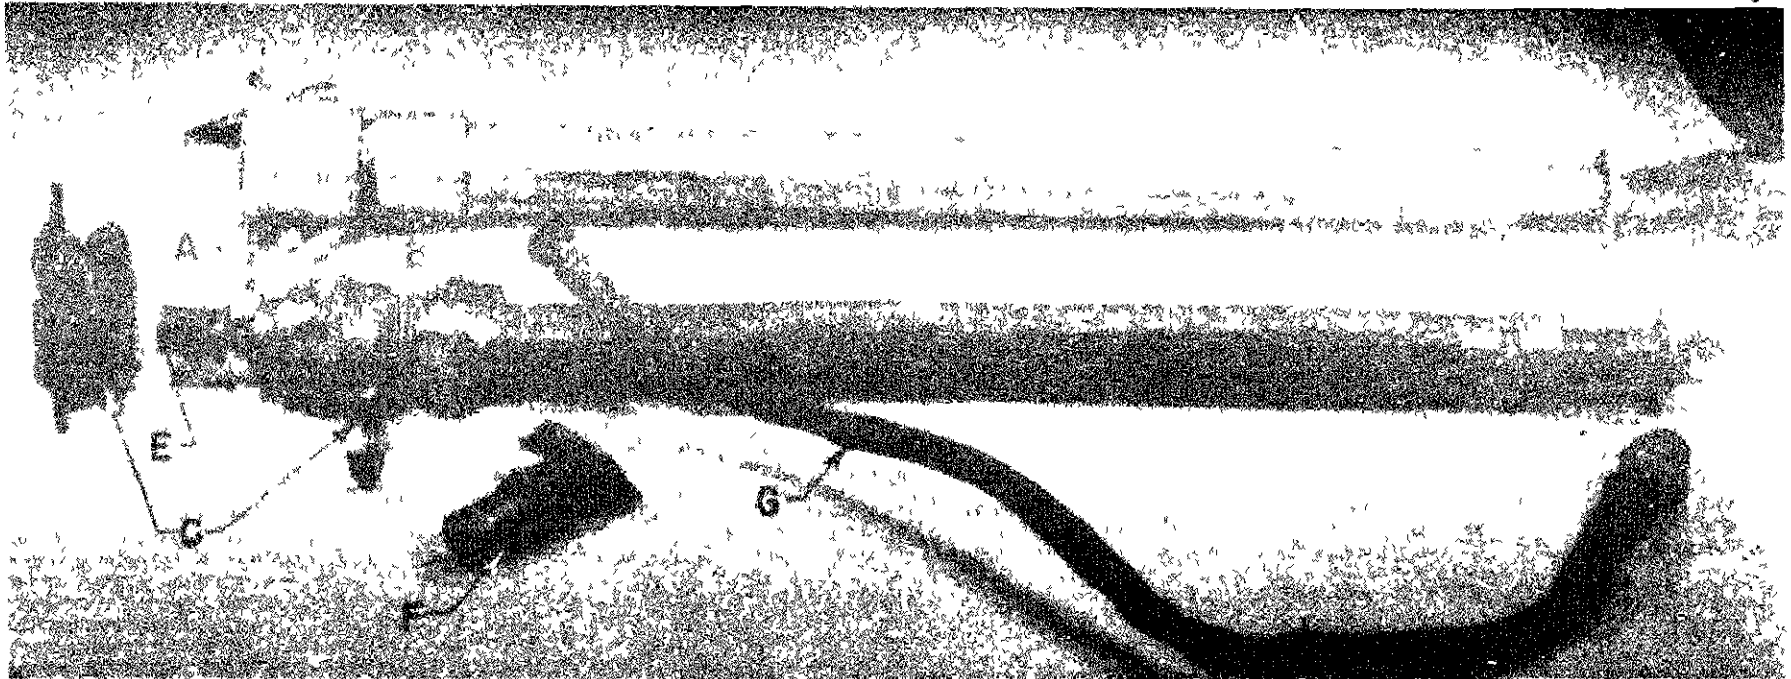
Figure 2. The cabin supercharger drive shaft assembly installed in NC 88858 is shown beside a new unit. The drive coupling shear section (E) is shown partially installed.

The shaft bearing failed due to lack of lubrication and the inner race (A) became separated from the outer race. This resulted in violent contact between the universal joint (B) and the universal joint housing (C). The housing eventually fractured circumferentially and the shaft was permitted to vibrate while rotating. The fractured edge of the universal joint housing (C) still on the shaft contacted the hydraulic out-fitting (F) breaking the seal and causing a spray of hydraulic fluid throughout the area.

The drive coupling shear section (E) was so constructed as to permit a failure in shear under such circumstances. This unit, however, did not shear in this instance and the failure occurred in the universal joint housing instead.

Item D indicates the aluminum spring-shield.

Item G indicates the hydraulic line with the rubber covering consumed exposing the steel braid.

supercharger drive shaft and housing came in contact with the hydraulic line fitting with considerable force causing leakage of hydraulic fluid. Inasmuch as this line is under a pressure of at least 1,500 pounds per square inch, the fluid was evidently released forcefully in a fine spray. The cause of the ignition of the hydraulic fluid was not positively determined, however, block tests were conducted on the supercharger drive shaft by Lockheed Aircraft Corporation in which such a situation was simulated, and it was determined that this condition resulted in a shower of sparks accompanied by considerable heat. These tests revealed, furthermore, that the heat developed in burning out the supercharger drive shaft bearing and fracturing the guard left the universal joint red-hot. The failure of the universal bearing, therefore, was capable of causing leakage of the hydraulic fluid and of producing the heat necessary to ignite it.

Shearing of the drive shaft coupling would have prevented the damage which resulted from failure of the forward bearing by permitting the drive shaft to stop. It is not known whether the torsional loads for which the unit was designed exceeded those encountered in this instance. However, failure of the shear section had averted serious damage on other occasions in which the supercharger drive shaft bearing had failed in this model aircraft. Because of the difficulty of designing a shear unit adequate for all possible load conditions resulting from failures in the drive shaft assembly, consideration should be given the installation of a more satisfactory means whereby the shaft may be disconnected from the engine accessory gear section.

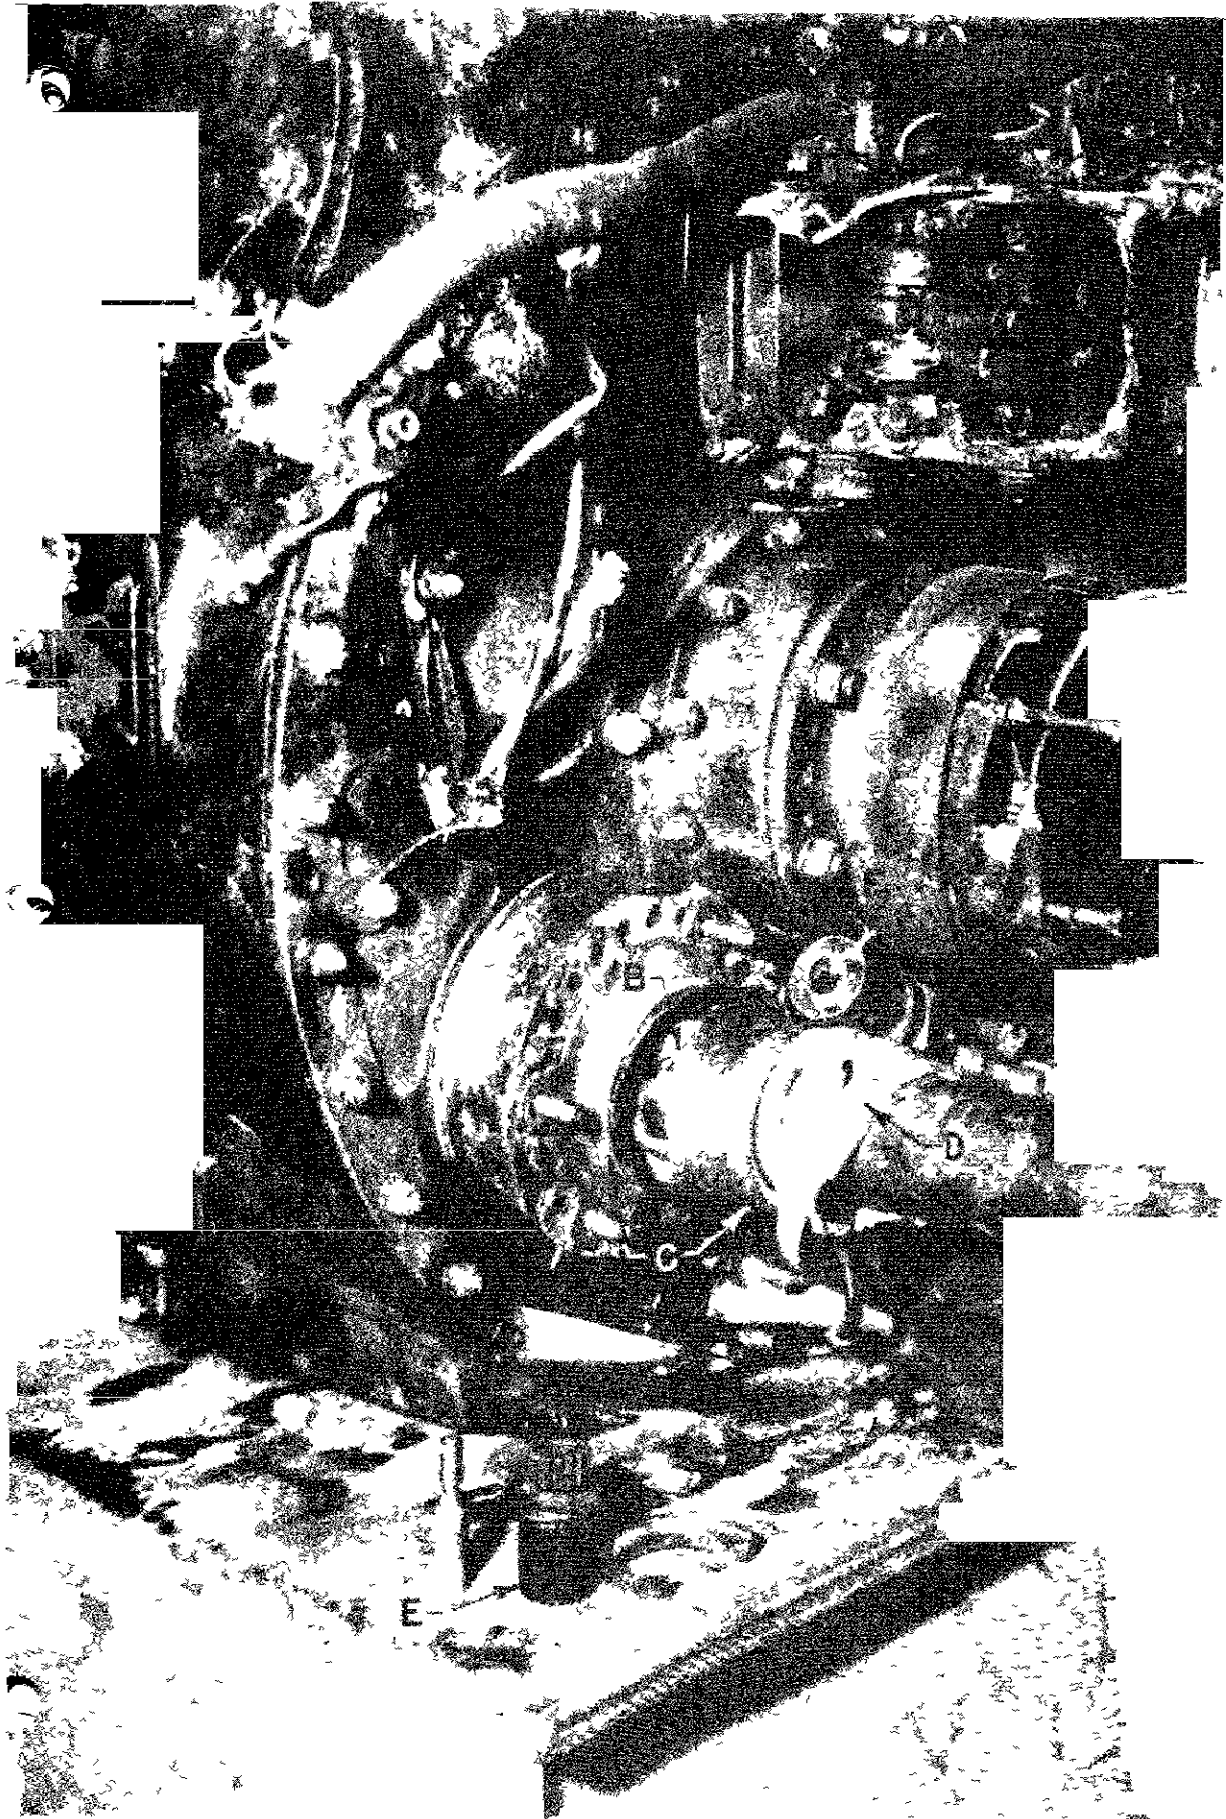
Figure 3. Build-up of the power plant and illustration of the cabin supercharger's 1/8" shaft and the relative position of the hydraulic out-fitting.
