CIVIL AERONAUTICS BOARD

ACCIDENT INVESTIGATION REPORT

Adopted: November 29, 1946Released: December 18, 1946TRANSCONTINENTAL AND WESTERN AIR, INC., READING, PA., JULY 11, 1946The Accident

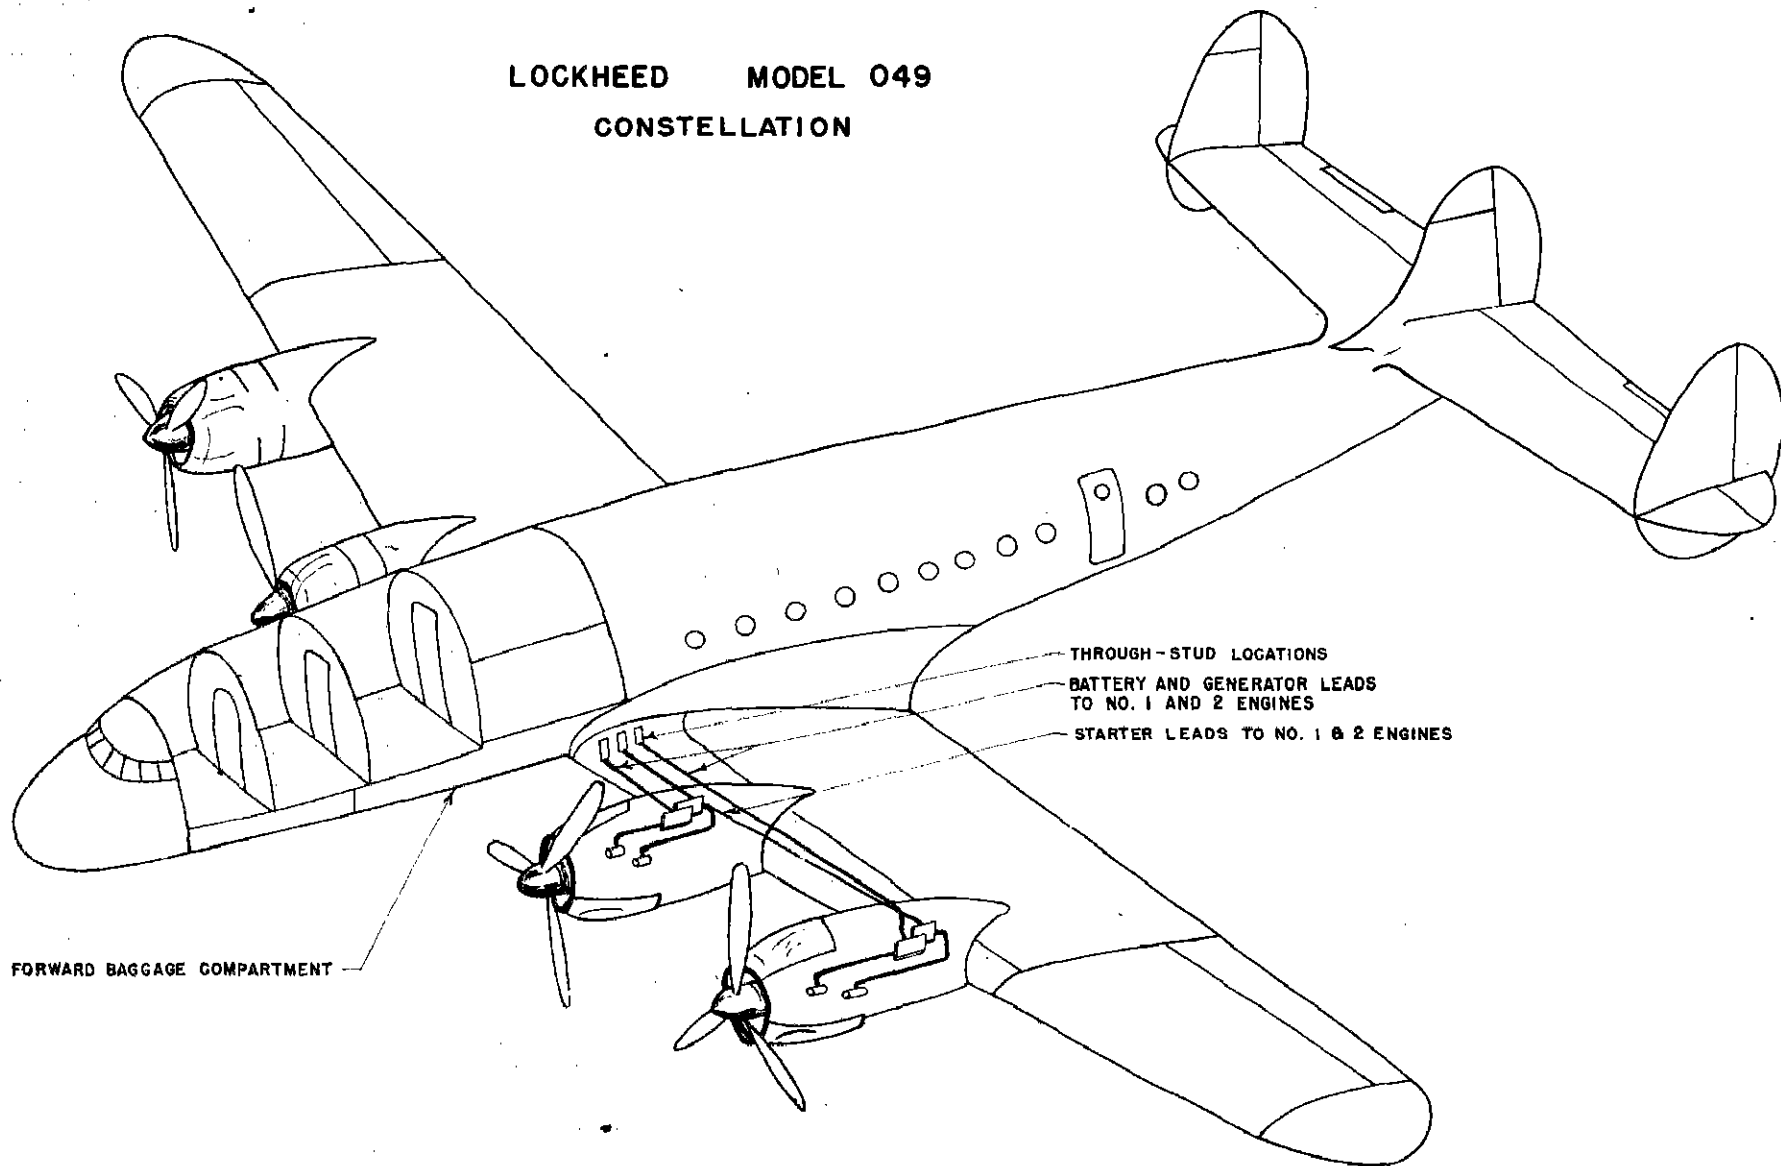
FIG. 1 THE ABOVE DIAGRAM IS A SCHEMATIC ONLY AND DESCRIBES THE APPROXIMATE LOCATION OF THE THROUGH STUDS WITHIN THE LEFT WING-ROOT SECTION. A SIMILAR INSTALLATION IS INCLUDED WITHIN THE RIGHT WING.

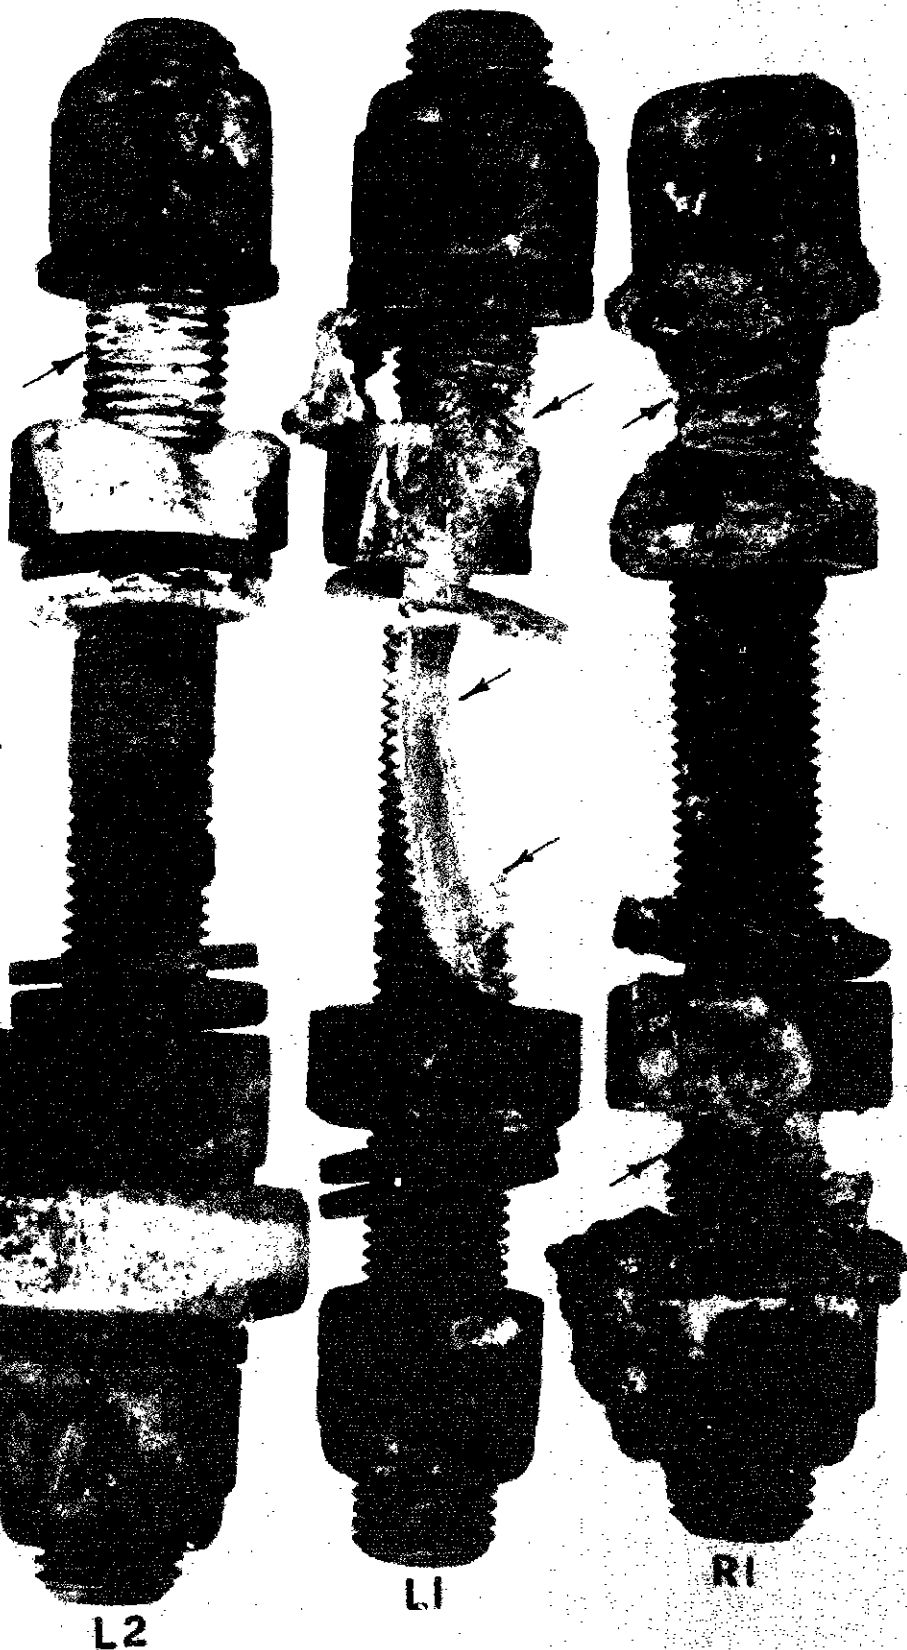
The remains of the six through-studs from Aircraft 513 were subsequently located and it was noted that some of them appeared to have been subjected to local burning suggestive of electrical arcing. These studs were sent to the National Bureau of Standards for closer inspection in order to determine their condition prior to the crash. The National Bureau of Standards subjected the six through-studs to extremely detailed study immediately upon their receipt. The conclusions of this investigation established the fact that all of the through-studs from Aircraft 513 contained evidence of arcing and that at least two of these studs were sufficiently burned due to arcing as to have caused a fire while in flight. It was further determined that the length of time necessary for the studs to have been burned to the extent observed in at least two of the studs from Aircraft 513 covered a period considerably longer than that which elapsed during the disintegration of the aircraft

All six of the through studs recovered from the wreckage bore indications of intense local heating attributable to electrical arcing. The consumed portion of the three studs illustrated indicate the extensiveness of the arcing (arrows). The localized nature of the burned areas and the sharpness of the threads on the remainder of the bolts dispel the possibility of the damage having resulted from external heating.

Fig. 2 Evidence of arcing on 3 of the lead-through studs. L1 and L2 are from the left side of NC 86513; R1 is from the right side.

16. All six through-studs in the forward baggage compartment contained some evidence of arcing and at least two of these studs were sufficiently burned during flight to have ignited the fuselage insulation.

The insulation of certain wiring was modified to prevent possible damage from chafing and to prevent contact with parts of the aircraft. The fuselage through-stud assemblies were replaced with units of a new design. Undersized aluminum conductors in the generator circuits were replaced with copper cables. A general improvement was accomplished in circuit breakers, fuses, and control switches to prevent shorting.
