## SUPPLEMENTAL DATA

### Investigation and Hearing

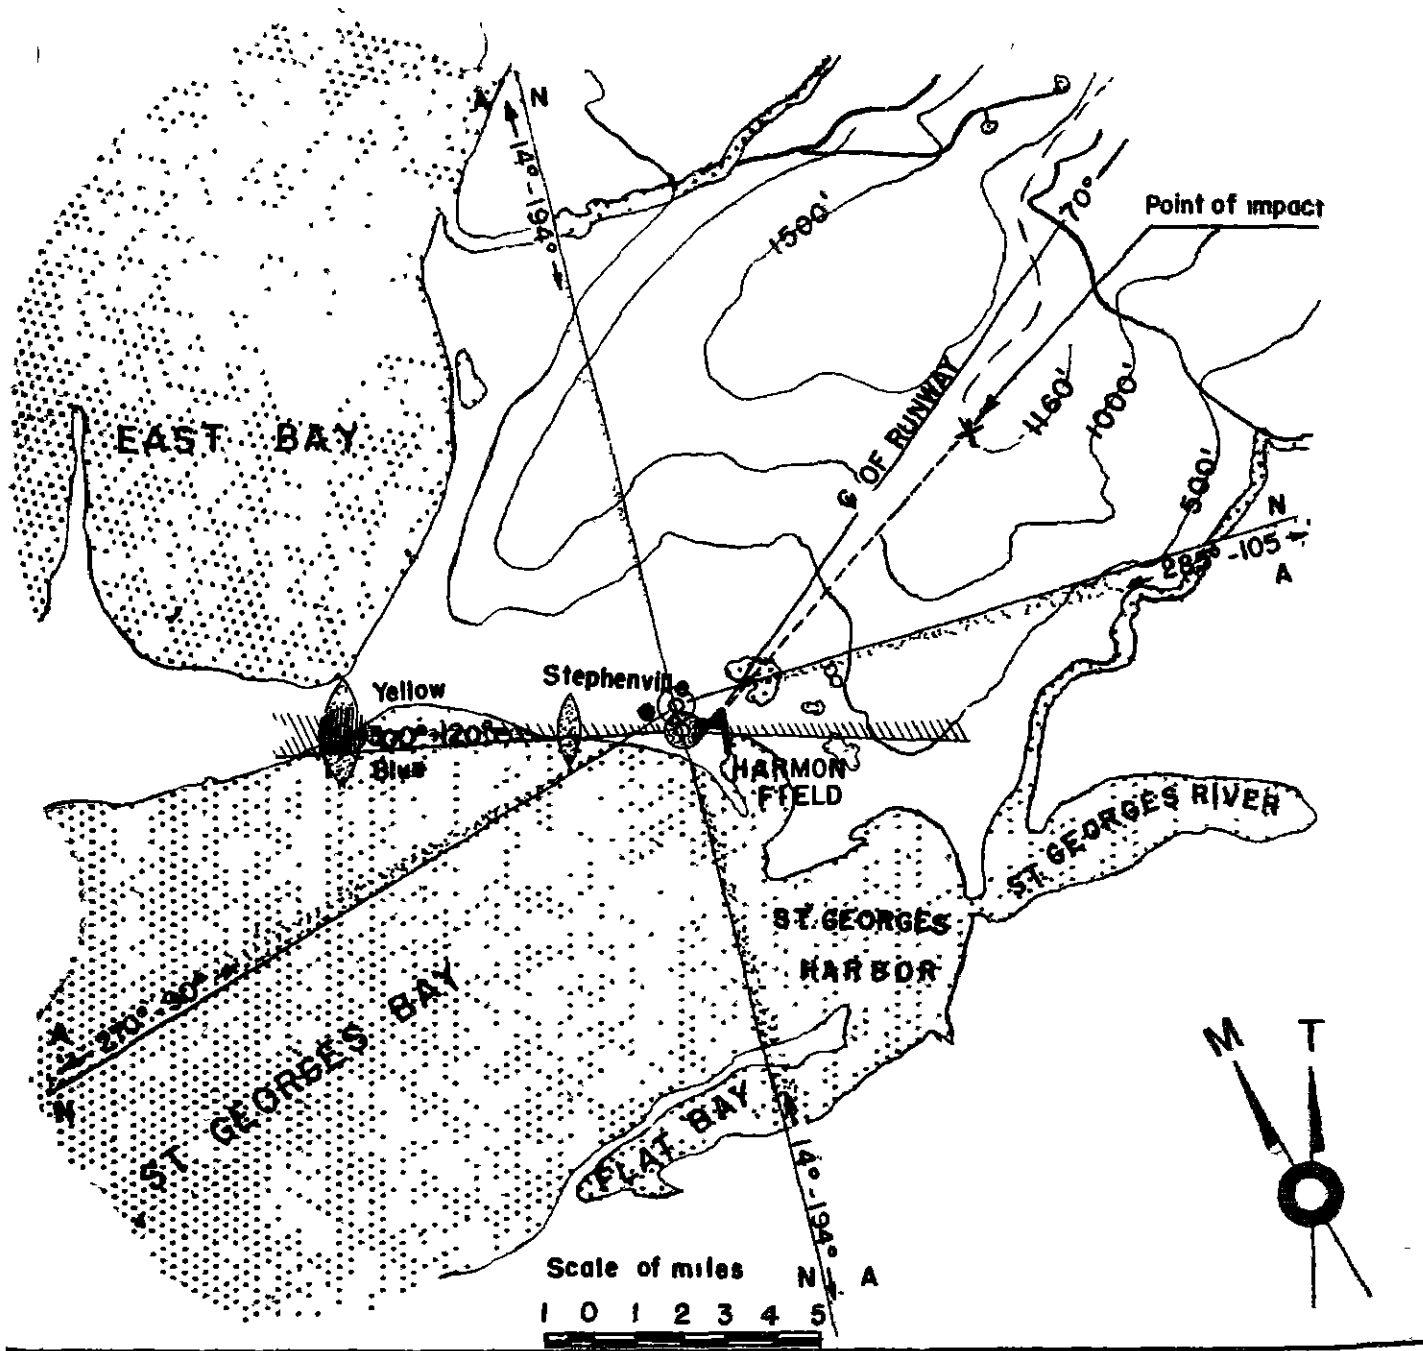
CHART OF THE STEPHENVILLE AREA

The above chart shows the approximate flight path of Aircraft 904 after take-off from Harmon Field, and the point of impact. The contours clearly illustrate that a turn may have been safely made following take-off from Runway 7 and that a climb could have been accomplished away from the high terrain north of the field.

The aircraft had crashed against a steep ridge at a point 7.1 miles from the take-off end of Runway 7 at a magnetic bearing of 76 degrees 45 minutes from the center of the airport and at an elevation of 1,160 feet.\* The elevation of Harmon Field is 22 feet. An inspection of contour charts of this area indicates that the terrain northeast of Harmon Field rises to an elevation in excess of 1,500 feet through an azimuth extending from approximately 20 degrees magnetic to 90 degrees magnetic. Directly in line with Runway 7 and approximately 7-1/2 miles from the airport lies a depression the lowest elevation of which is slightly under 1,000 feet. The terrain toward the southeast is relatively flat. The field is bounded by St. George Bay toward the south. Toward the northwest several hills rise to an elevation between 1,000 and 2,000 feet.

Although there exists a saddle or pass in the terrain northeast of Hannon Field directly in line with Runway 7, the horizontal distance across this pass is not sufficient to render practicable the passage of aircraft through it as a normal and safe climb procedure, and it is unlikely that the pilot was attempting such a procedure in this instance. Since the hills on both sides of the pass are unlighted and the contour of the terrain is not visible under the conditions of darkness experienced at the time of this flight, navigation through the pass at night would be very difficult. In order to guarantee a minimum terrain clearance, therefore, the existence of this pass must be disregarded for determining the climb procedure after take-off.

Irrespective of whether this particular flight had been complicated by some mechanical malfunctioning not apparent in the investigation, with a normal rate of climb following take-off from Runway 7, a safe margin of clearance over the terrain northeast of Hannon Field could not be obtained. From the facts disclosed during the investigation it must be concluded that take-off from Runway 7, under the conditions which existed the morning of October 3, was hazardous unless the flight crews were aware of the high terrain northeast of the airport and so maneuvered as to avoid it. Regardless of the wind, safe take-off procedure when using Runway 7 requires a turn shortly after take-off and a climb to a safe altitude away from the high terrain.

employed in international operation, the Board has circulated proposed regulations which are designed to indicate specifically the responsibility of all U. S. air carriers in this regard.\* These regulations would require the carrier to define clearly the procedures for climb from each airport in the vicinity of which terrain or other obstructions present a hazard to flights at night or under instrument conditions. Furthermore, the Board is reviewing the subject of airport approval for scheduled air carrier operations with a view toward revision of the Civil Air Regulations in order to assure a complete understanding throughout the industry of the nature and extent of airport surveys and the areas to which take-off limitations apply.
