CIVIL AERONAUTICS BOARD

ACCIDENT INVESTIGATION REPORT

WESTERN AIR LINES, INC.—LEBEC, CALIFORNIA, NOVEMBER 13, 1946

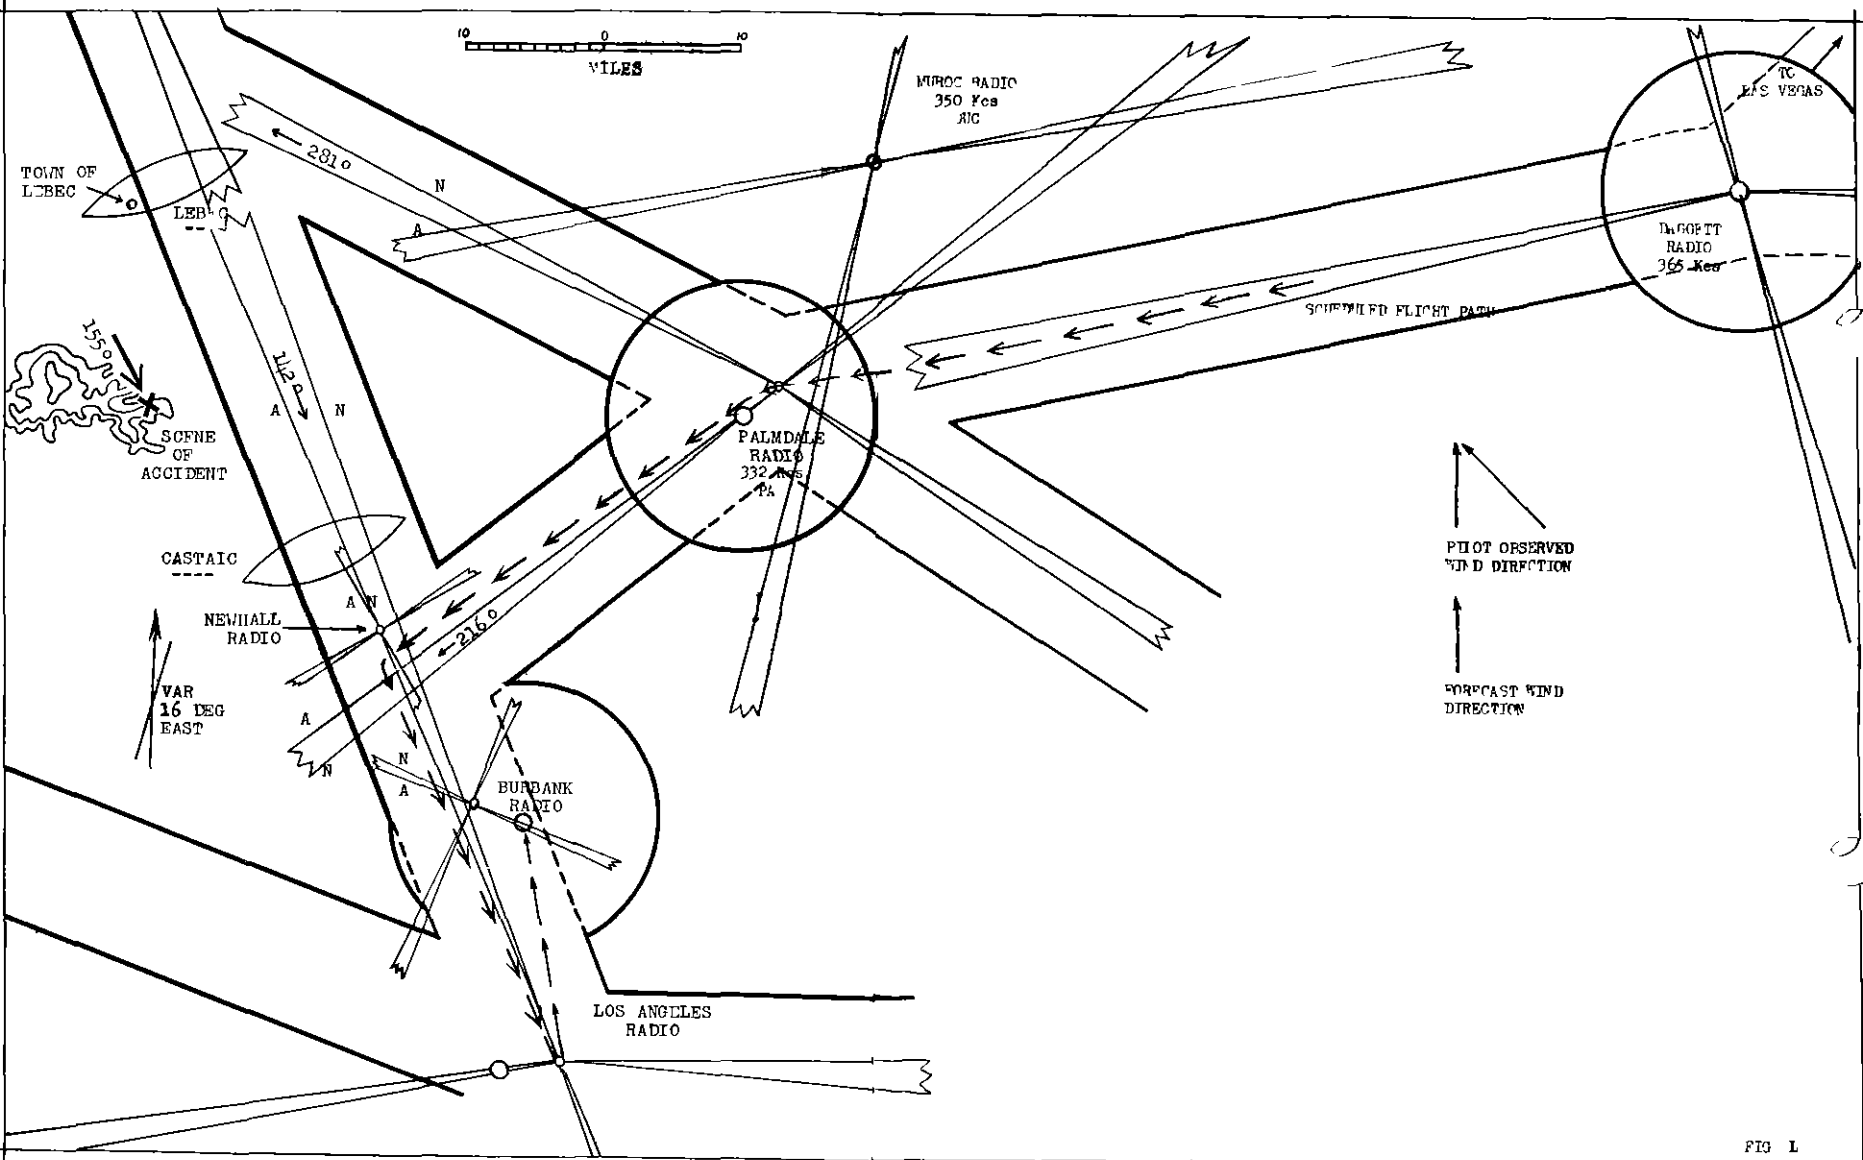
FIG 1

12. The scene of the accident is located 27 miles northwest of the intersection of the southwest leg of the Palmdale radio range and northwest leg of the Los Angeles radio range and 10 miles to the right of the radio range leg on which initial approach let-down was to be made
