CIVIL AERONAUTICS BOARD
SAFETY BUREAU

ACCIDENT INVESTIGATION REPORT

EASTERN AIR LINES, INC.—UNIVERSAL AIR LINES—ABERDEEN, MARYLAND—
DECEMBER 19, 1946

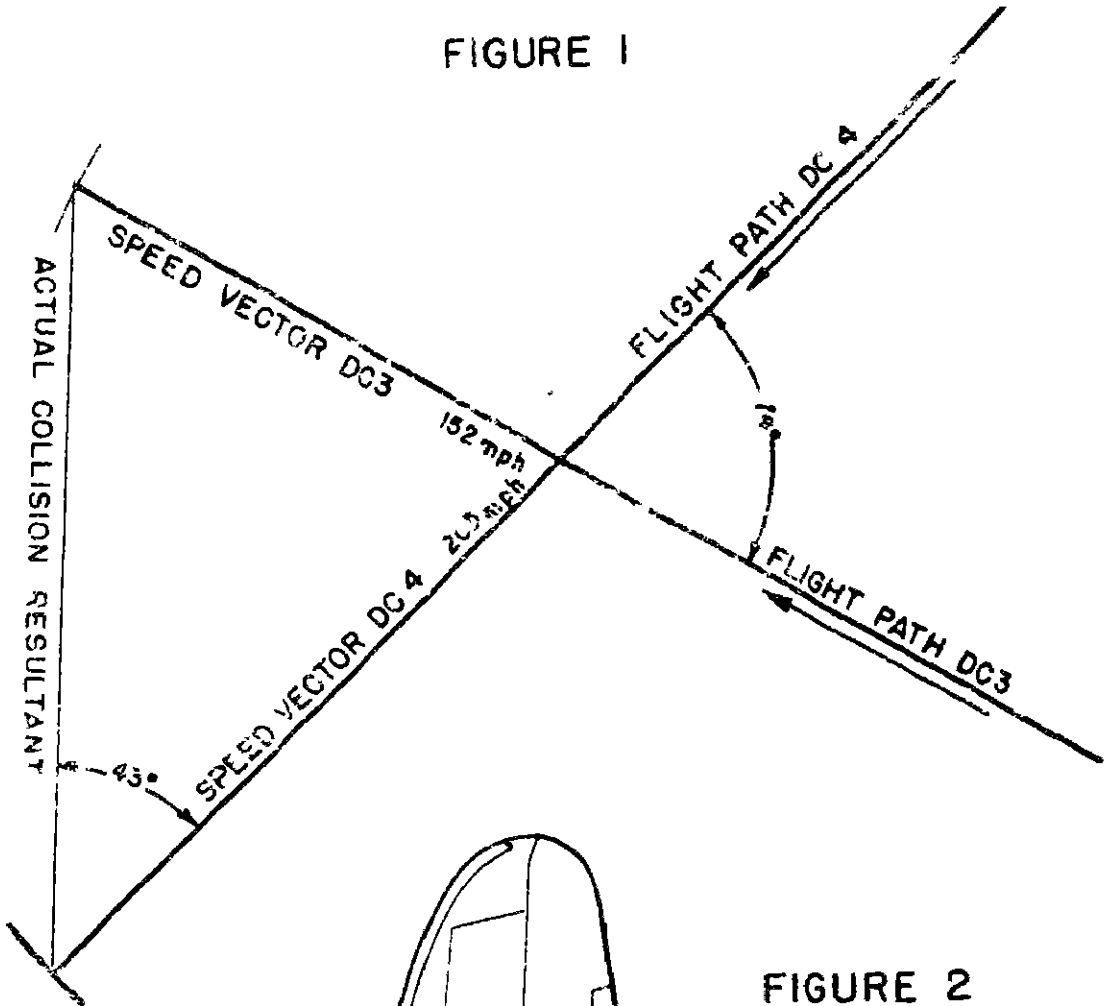
FIGURE 1

The structural member between the side window and the sliding panel in the DC-4 cockpit restricts somewhat the pilot's vision at a relative bearing of 45

²See figure 1

degrees to the left of a plane parallel to the longitudinal axis of the aircraft. It appears, in this instance, that the DC-3 remained approximately within a range of reference with respect to the DC-4, which may have partially hidden the DC-3 from sight until immediately before the accident occurred. However, it must be recognized that no aircraft exists in air carrier operation which does not possess some restriction to visibility in the cockpit. Since such obstructions to visibility are common knowledge to pilots operating DC-4 equipment and as the extent of such obstructions cannot be considered hazardous when due caution is exercised by the crew, it must be concluded that safe operation of this equipment requires that the pilot assume the responsibility for looking around structural members in order to permit such surveillance of the area ahead of the flight as would assure protection from collision with other aircraft.

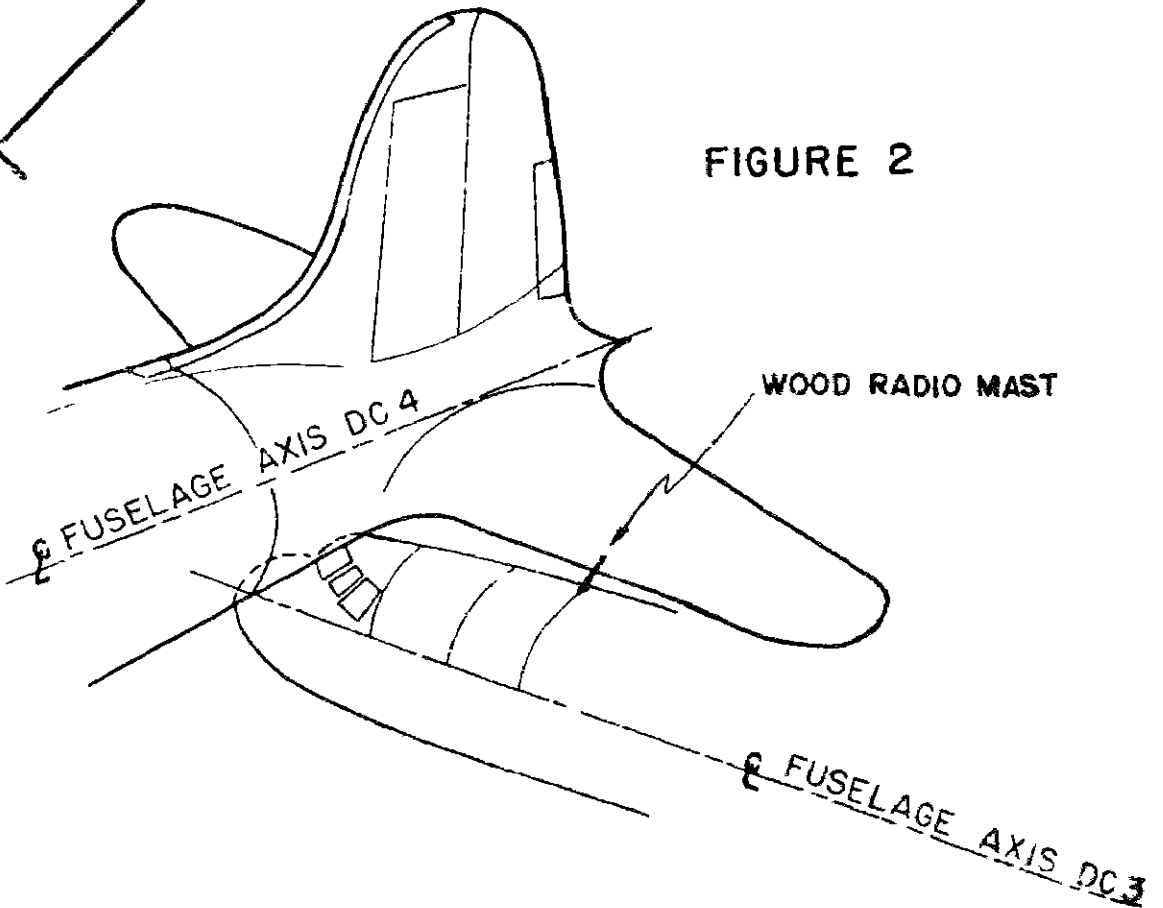
FIGURE 2

Analysis of the impact marks and the airspeeds of each aircraft indicated that, at the moment of collision, their flight paths intersected at an angle of 74 degrees. From this analysis it can be determined that immediately prior to impact the DC-3 was at an approximate relative bearing of 43 degrees to the left of the point of impact on the empennage of the DC-4.² Such a location should have rendered the DC-3 visible to the pilots of the DC-4 until immediately before the accident occurred. Shortly before the collision, the DC-4 was at a relative bearing approximately 63 degrees to the right of the pilot compartment of the DC-3. The DC-4, therefore, should have been visible to the pilots of the DC-3 shortly before and until the moment of collision.

¹See figure 2
